Beckett Bridge

Project Development & Environment (PD&E) Study

Preliminary Engineering Report **Volume 2: Appendices**

Project #13040 - Beckett Bridge over Whitcomb Bayou (Riverside Drive)

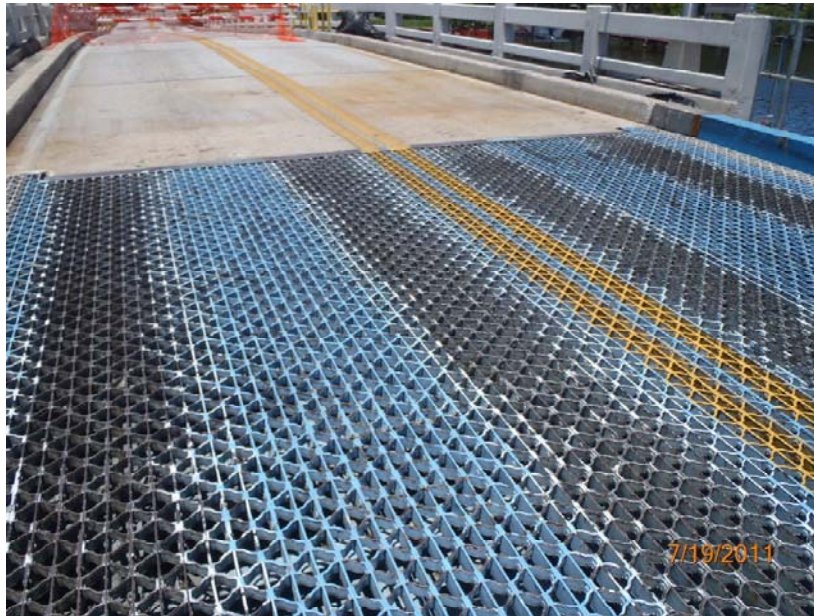
PHOTO 1: 28/4 Steel Deck/Open Grid

The open steel grating and cantilevered sidewalk supports exhibit widespread areas of peeling paint and moderate to heavy corrosion.

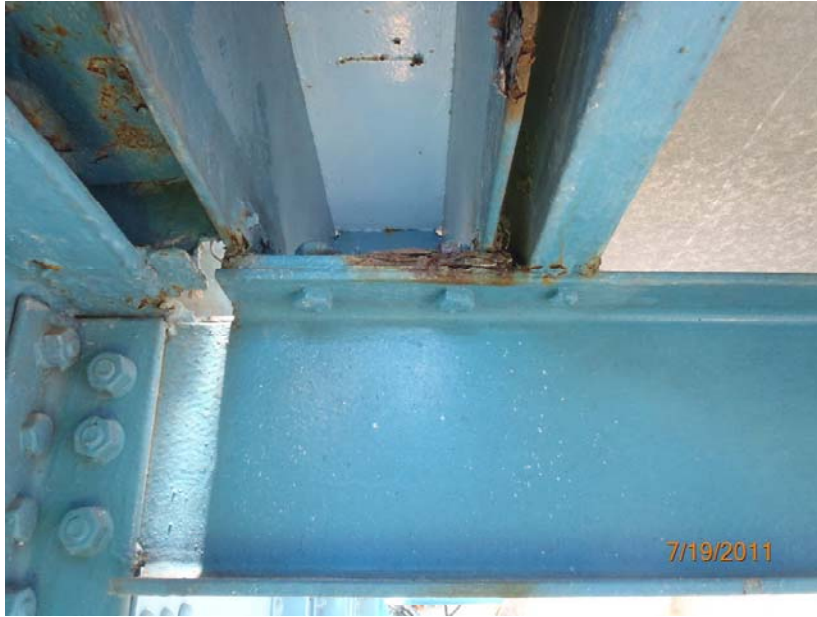
PHOTO 2: 28/4 Steel Deck/Open Grid

The open steel grating and cantilevered sidewalk supports exhibit widespread areas of peeling paint and moderate to heavy corrosion.

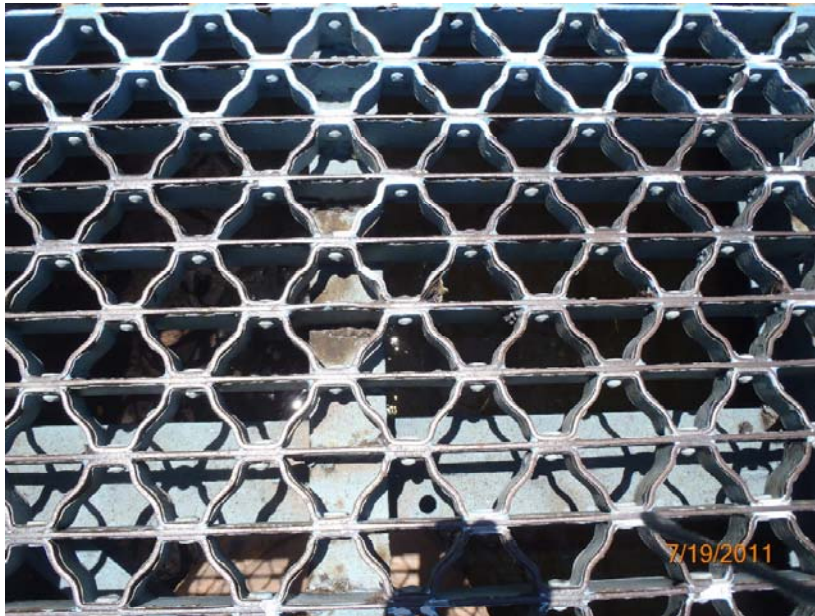
PHOTO 3: 28/4 Steel Deck/Open Grid

The transverse deck supports exhibit blistered paint and moderate to heavy corrosion at many of the deck connections.

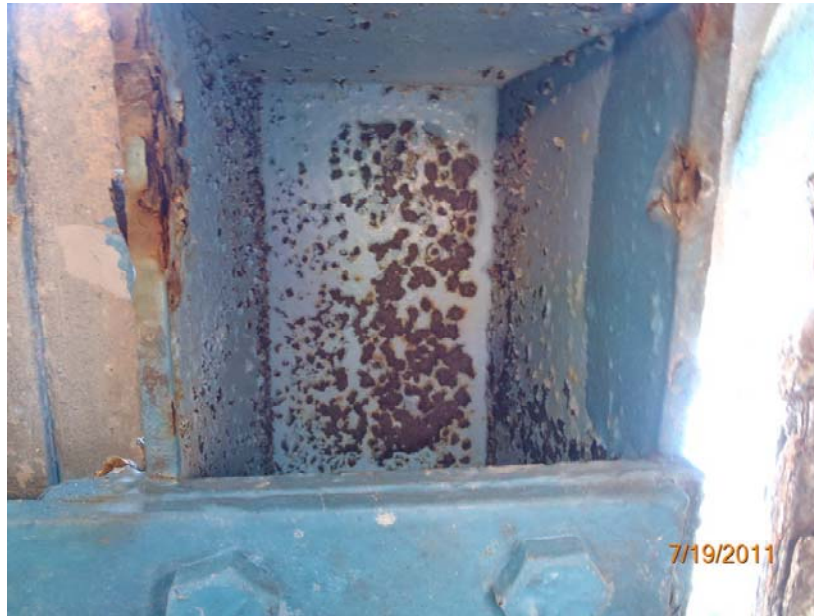
PHOTO 4: 28/4 Steel Deck/Open Grid

The inside of the steel box curbs exhibits areas of blistered paint and moderate to heavy active corrosion.

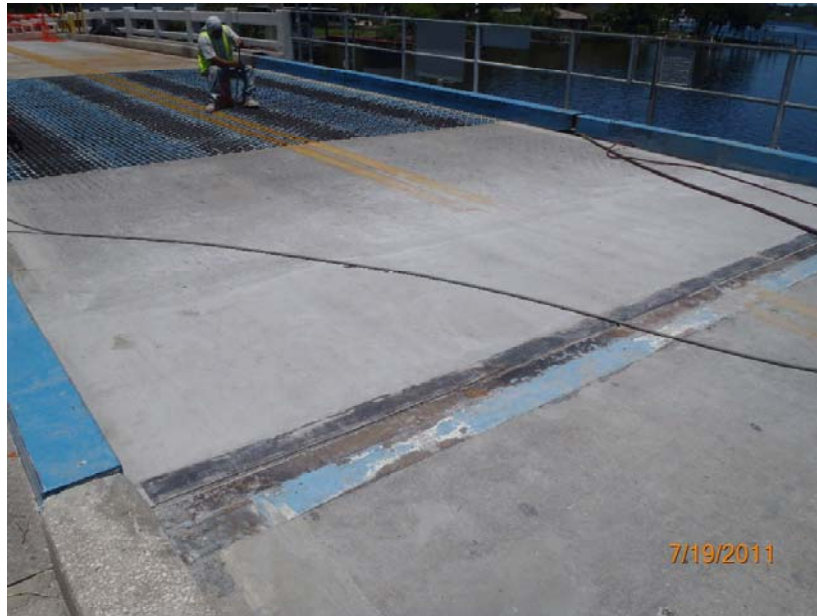
PHOTO 5: 29/4 Steel Deck/Conc Grid

There are several exposed grate bars with moderate to heavy surface corrosion within 2 ft. of the open grid.

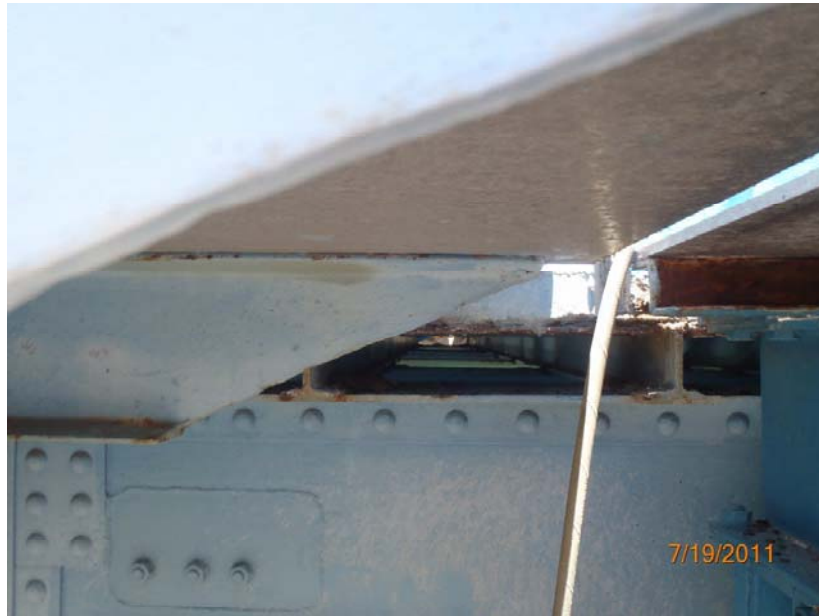
PHOTO 6: 29/4 Steel Deck/Conc Grid

The underside of the concrete filled steel grid deck exhibits areas of moderate active corrosion.

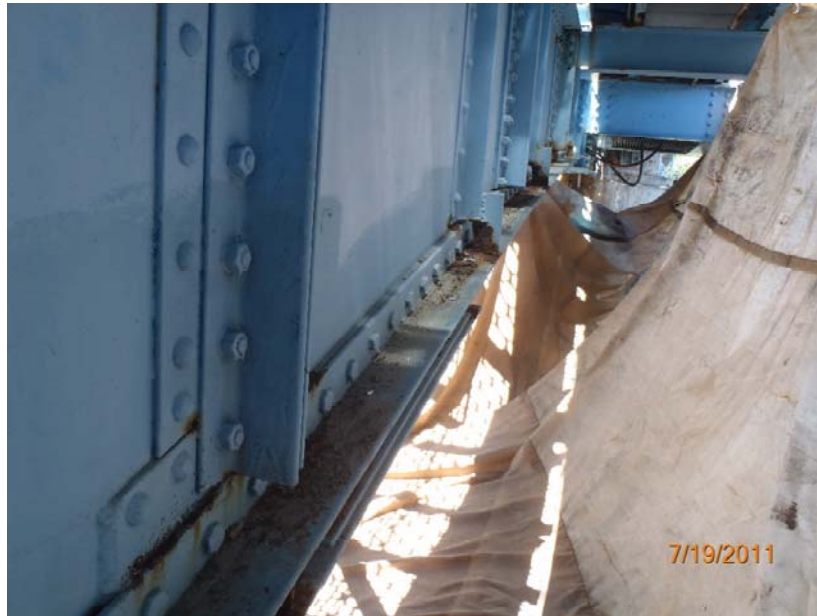
PHOTO 8: 107/4 Paint Stl Opn Girder

Both main girders exhibit areas of active corrosion at the floor beams, vertical stiffeners and at the curve tracks.

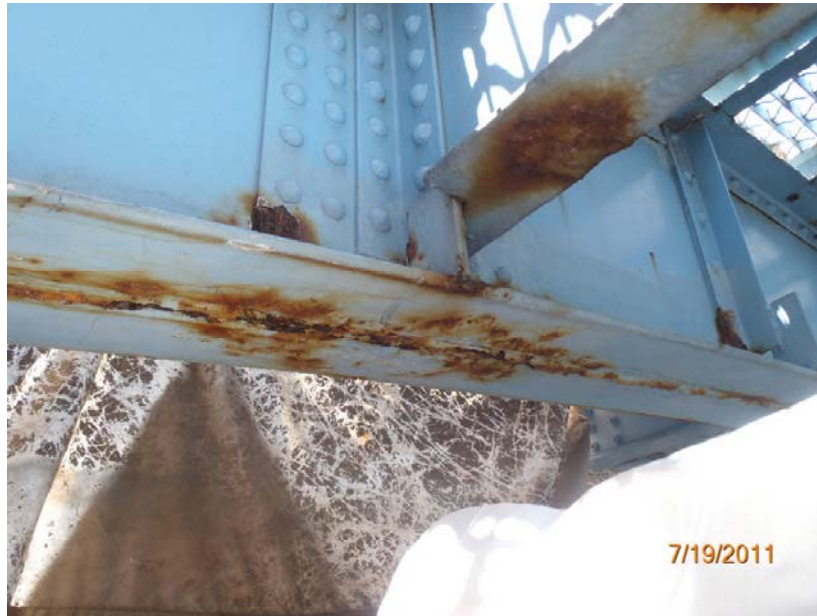
PHOTO 9: 152/4 Paint Stl Floor Beam

Floor Beam 6-2 exhibits a 1 ft. long area of moderate corrosion in the bottom flange at Main Girder 6-2.

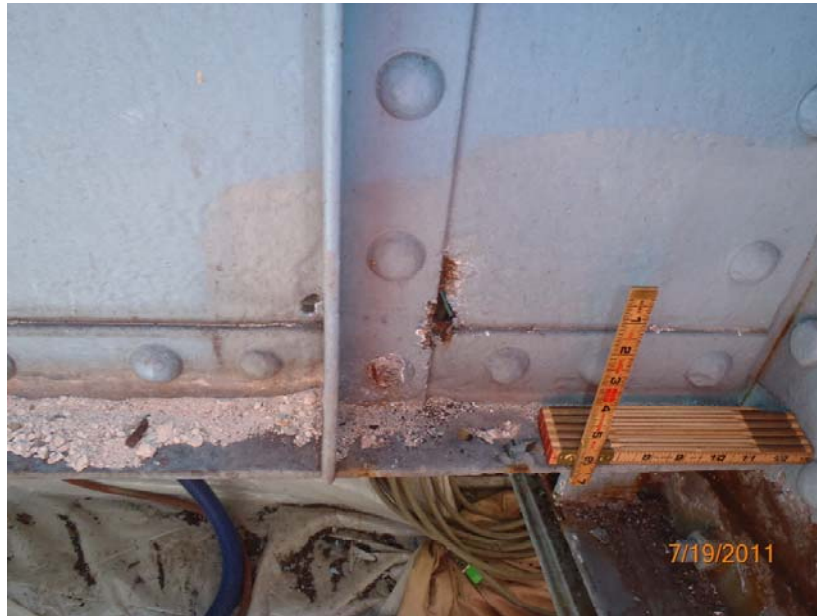
PHOTO 10: 152/4 Paint Stl Floor Beam

Floor Beam 6-3 exhibits three small corrosion holes up to $\frac{3}{4}$ in. in the lower portion of the web at the two southernmost vertical stiffeners and painted over pitting up to $\frac{1}{4}$ in. deep throughout the remainder of the floor beam.

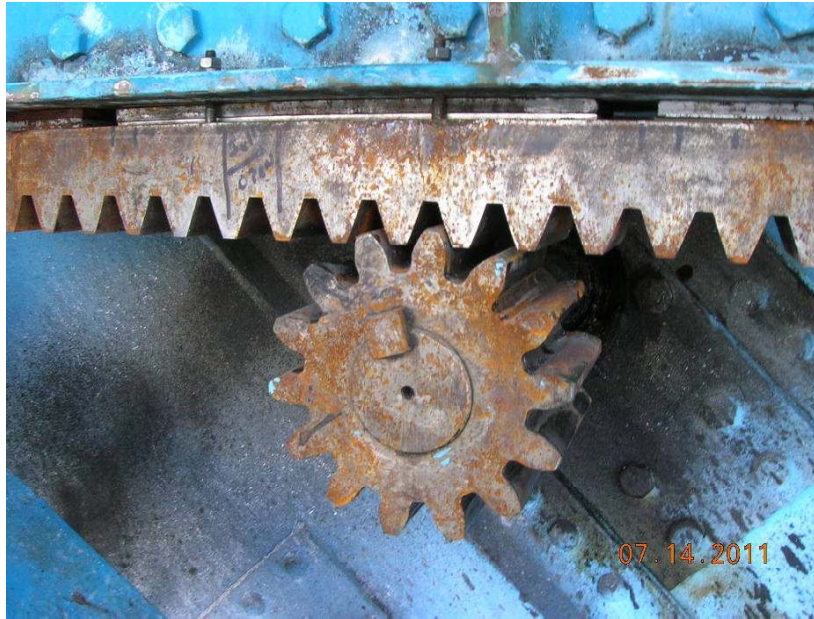
PHOTO 11: 540/4 Open Gearing & 542/4 Shafts

Poor engagement of north pinion (P-5N) with rack due to bent shaft.
Corrosion forming on all unpainted areas for all rack and pinion assemblies.

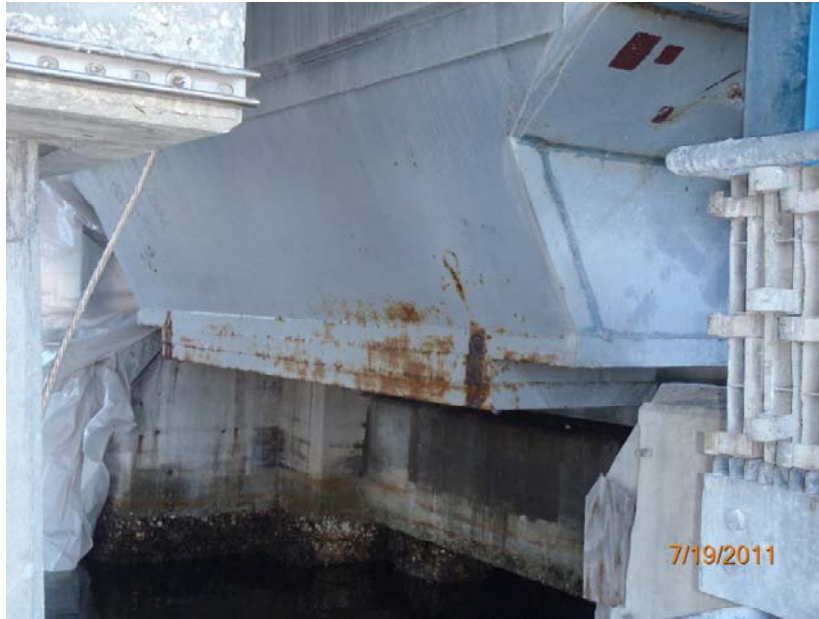
PHOTO 13: 562/4 Counterweight Support

The lower east edge of the counterweight support exhibits, moderate surface corrosion.

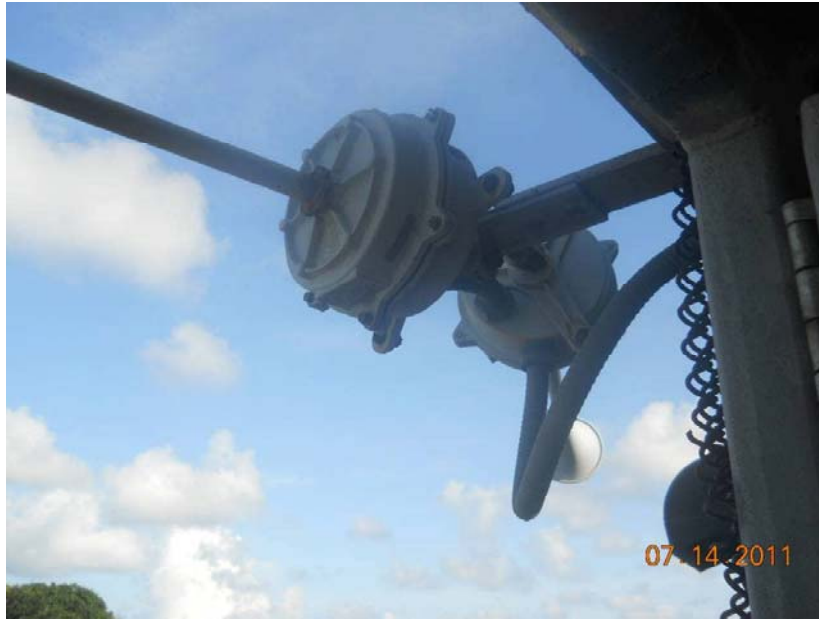
PHOTO 15: 563/4 Acc Ladd & Plat

Anchor bolts to horn exhibit heavy corrosion.

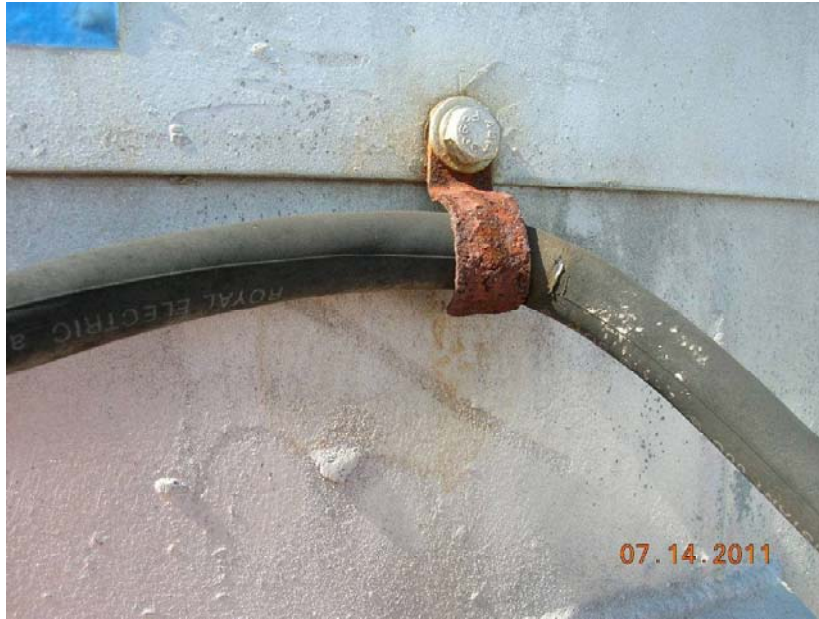
PHOTO 17: 572/4 Conduit & Junc. Box

Typical view of heavy corrosion in several conduit cable clamps throughout bridge.

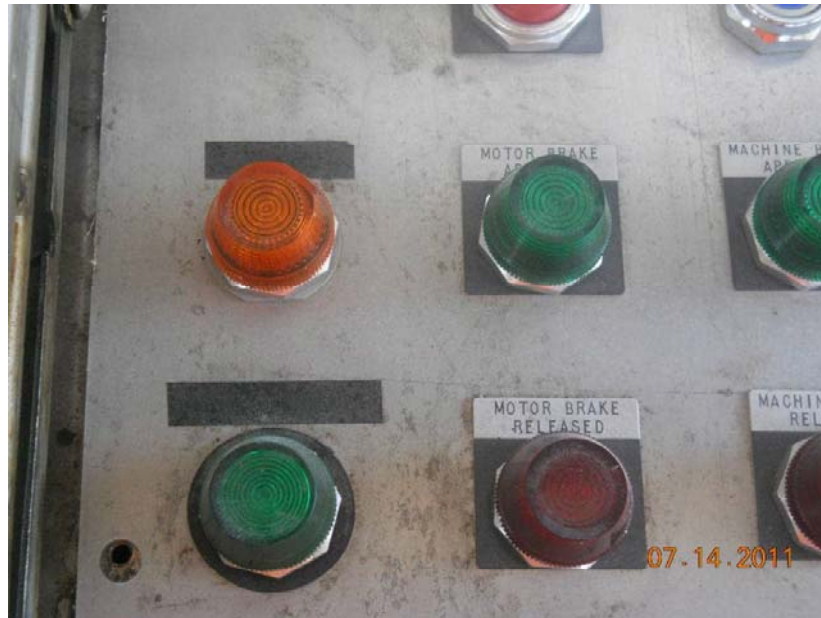
PHOTO 21: 574/4 Control Console

There are missing nameplates for indicator lights and switches on the control console.

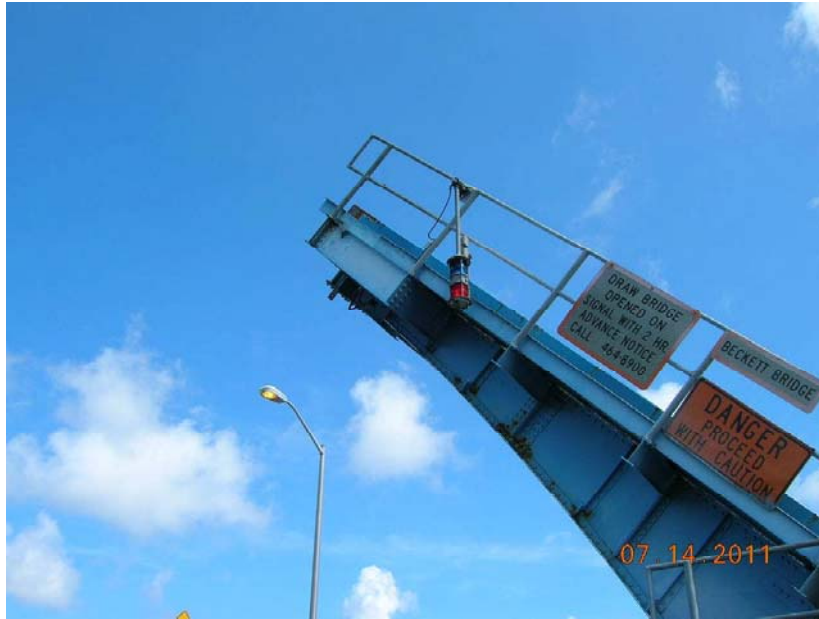
PHOTO 22: 580/4 Navigational Lights

South side tip swing light with cracked bottom and chain is missing.

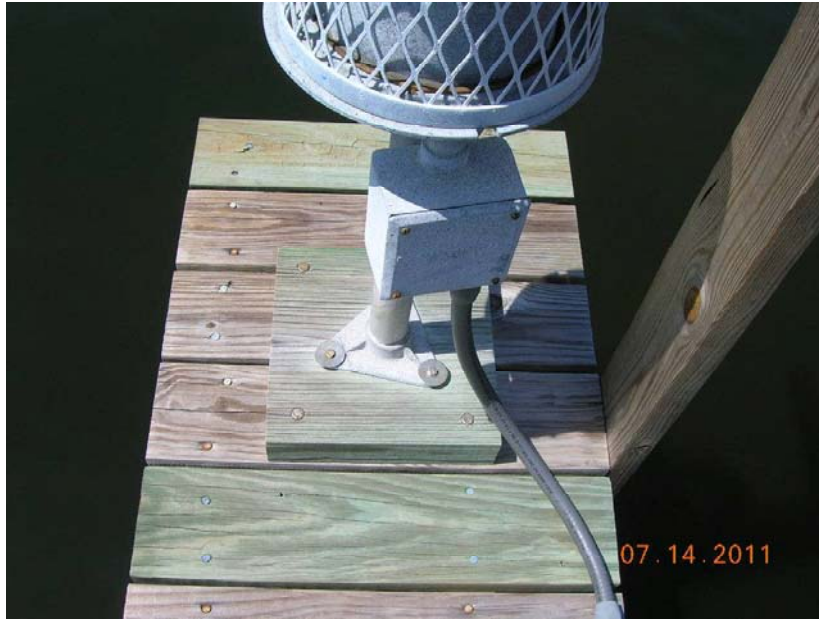
PHOTO 23: 580/4 Navigational Lights

Broken base on southwest fender light.

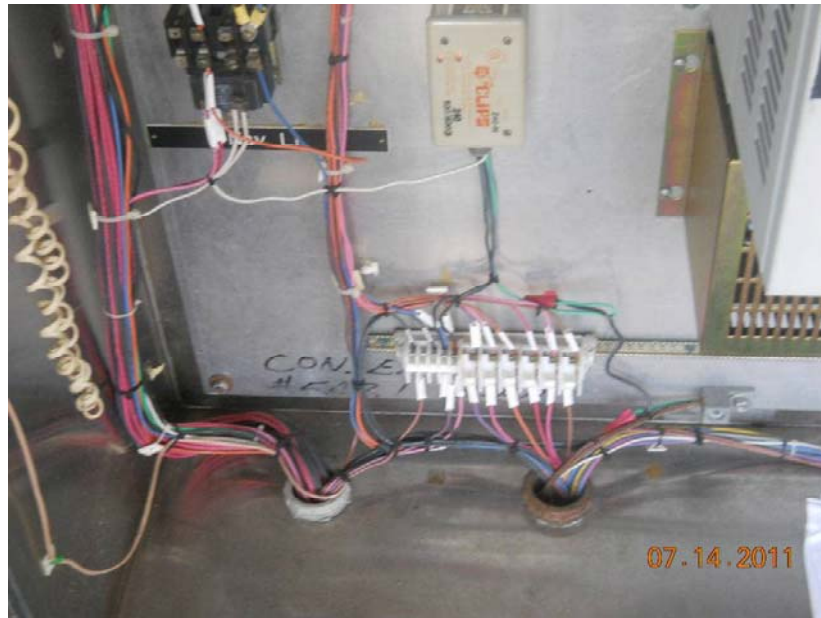
PHOTO 24: 580/4 Navigational Lights

Navigational Light UPS is missing.

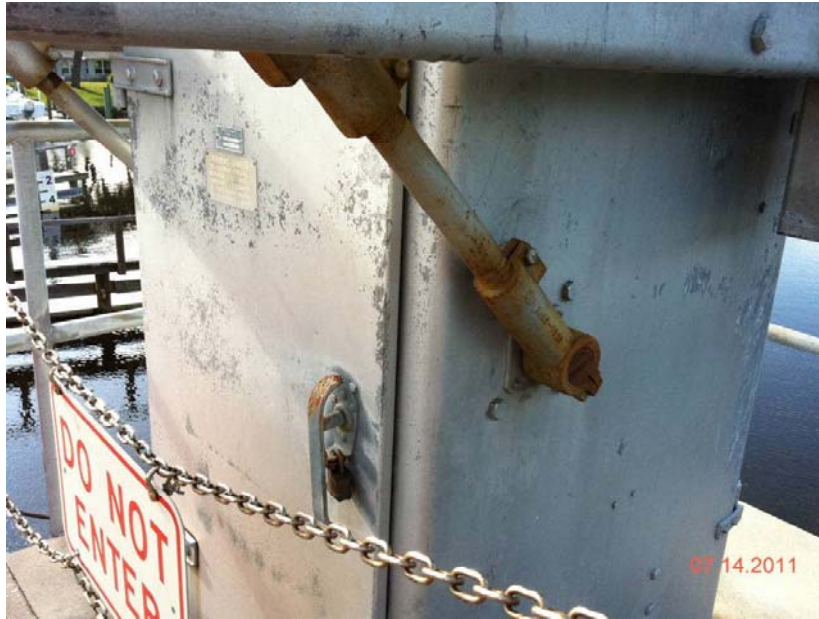
PHOTO 25: 590/4 Resistance Barriers

The control arm of the resistance barrier exhibits spotty corrosion within the housing and spotty corrosion in the exterior of the housing.

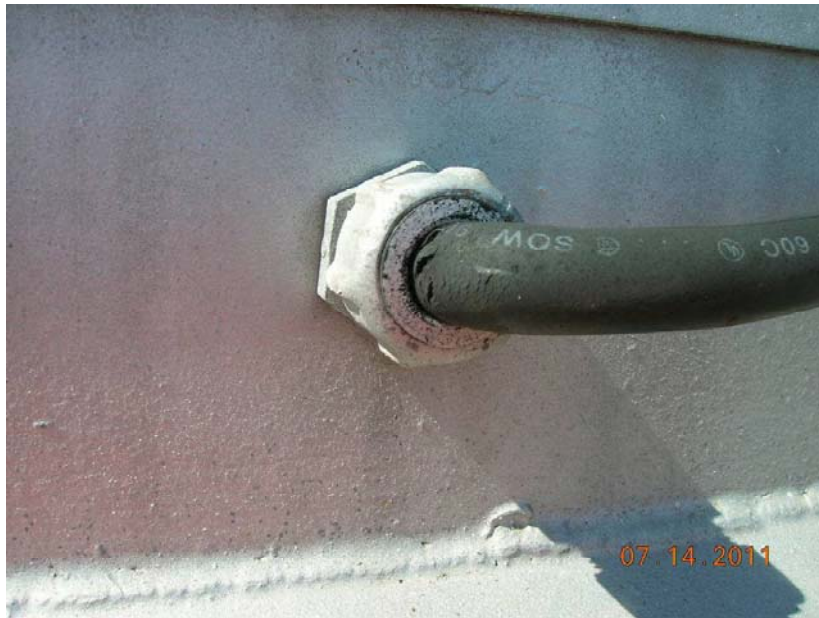
PHOTO 26: 590/4 Resistance Barriers

The SOW cable to barrier gate housing is beginning to crack.

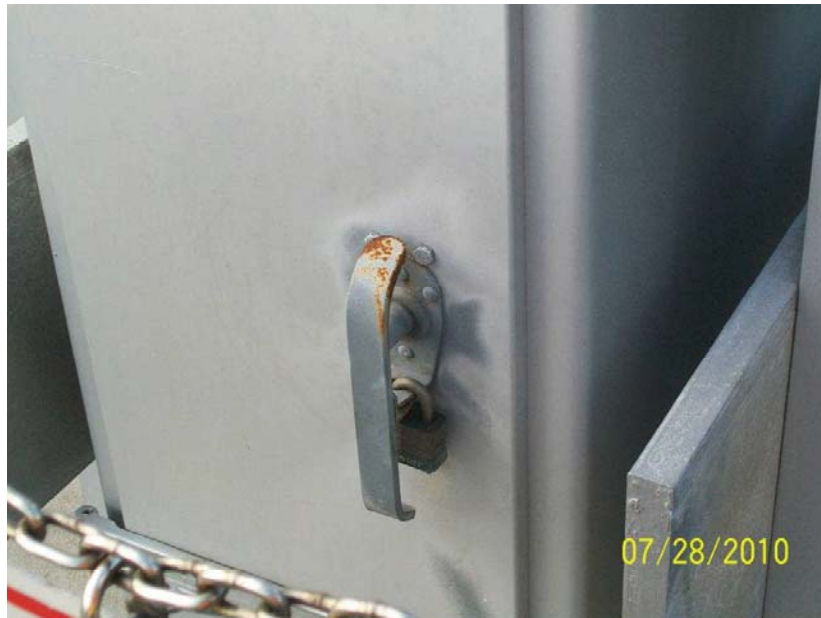
PHOTO 28: 591/4 Warning Gates

Typical recurring corrosion in the gate housing.

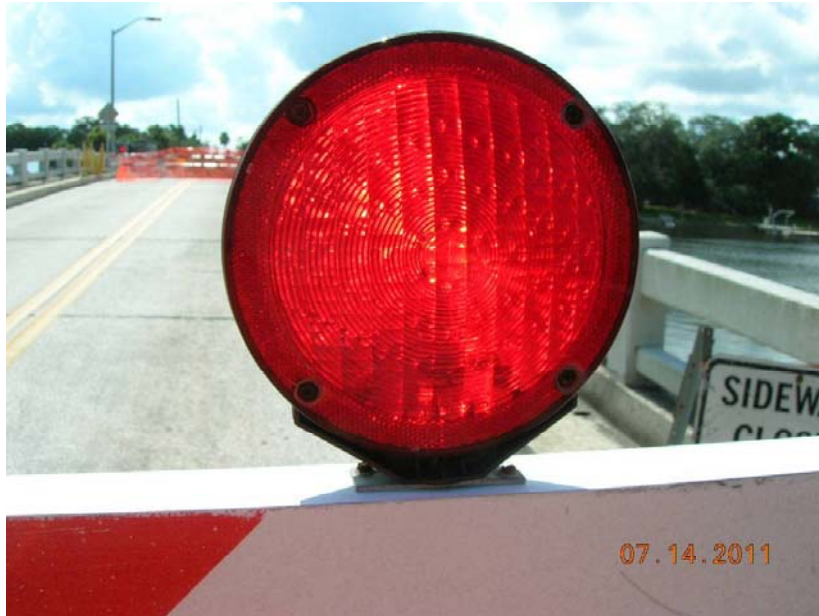
PHOTO 29: 591/4 Warning Gates

Several fasteners to all of the traffic gate warning lights exhibit heavy corrosion.

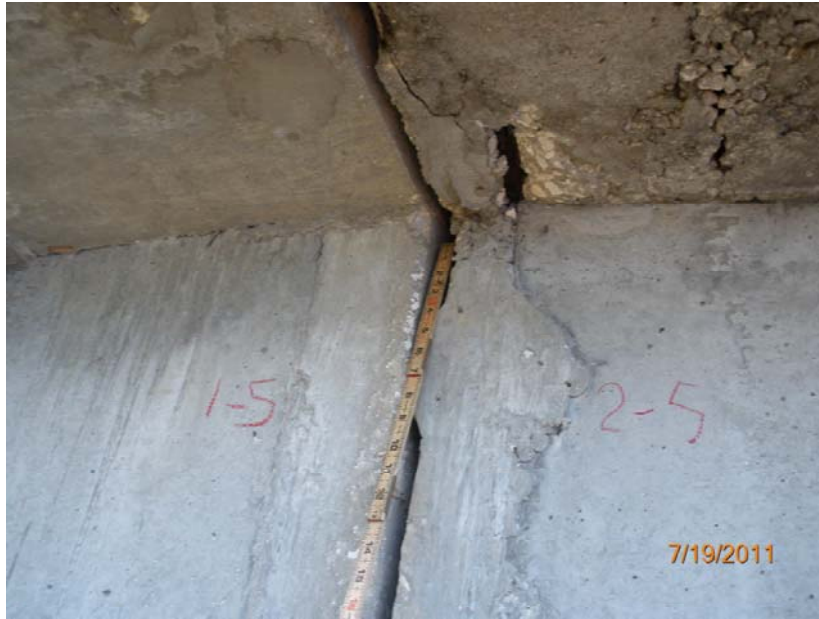
PHOTO 32: 12/4 Bare Concrete Deck

The right deck soffit exhibits an 8 in. x 1 ft. x 1-1/2 in. delamination/spall with exposed, corroded reinforcing steel in Span 2 at Bent 2.

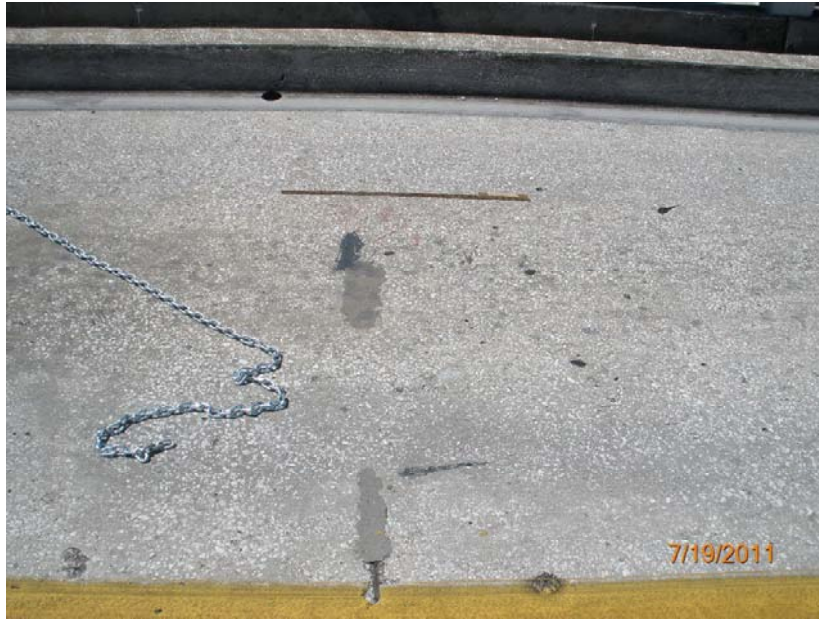
PHOTO 33: 12/4 Bare Concrete Deck

The 3/4 point in the middle of Lane 2 of Span 2 exhibits (3) delaminations/spalls with exposed steel up to 5 in. x 3 in. x 1/2 in.

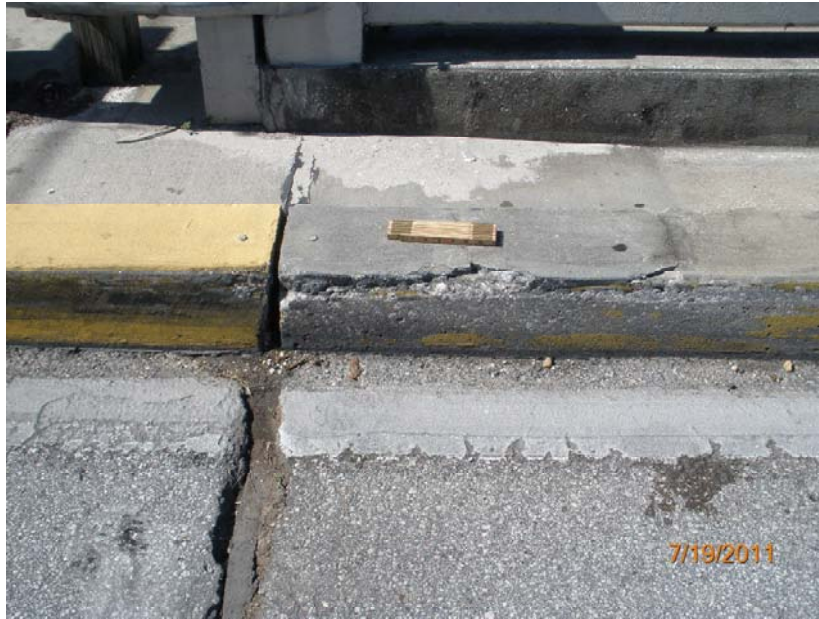
PHOTO 34: 12/4 Bare Concrete Deck

The top of the right curb adjacent to the joint at Abutment 11 exhibits a 30 in. x full width delaminated repair.

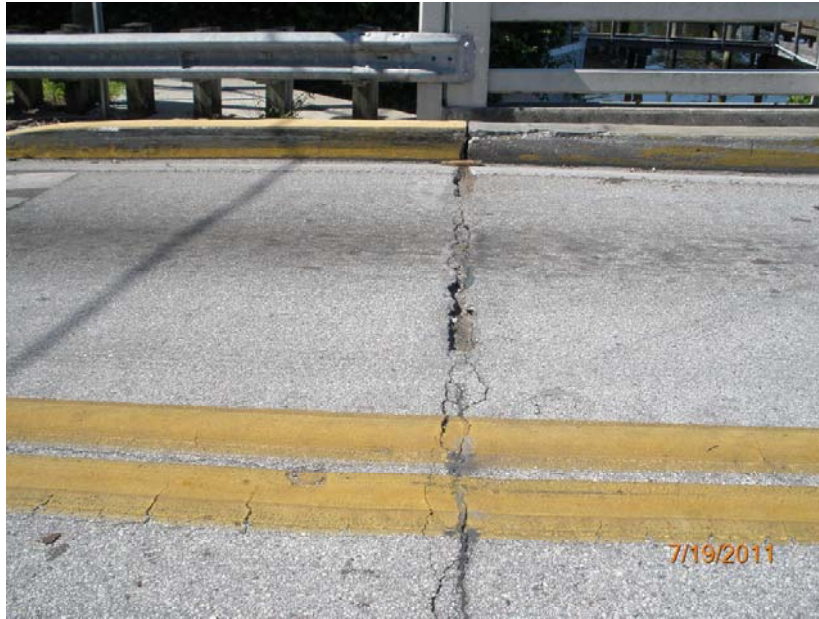
PHOTO 35: 301/4 Pourable Joint Seal

There are two potholes up to 4 ft. x 4 in. that have exposed joint sealant with major adhesion failure at Abutment 11.

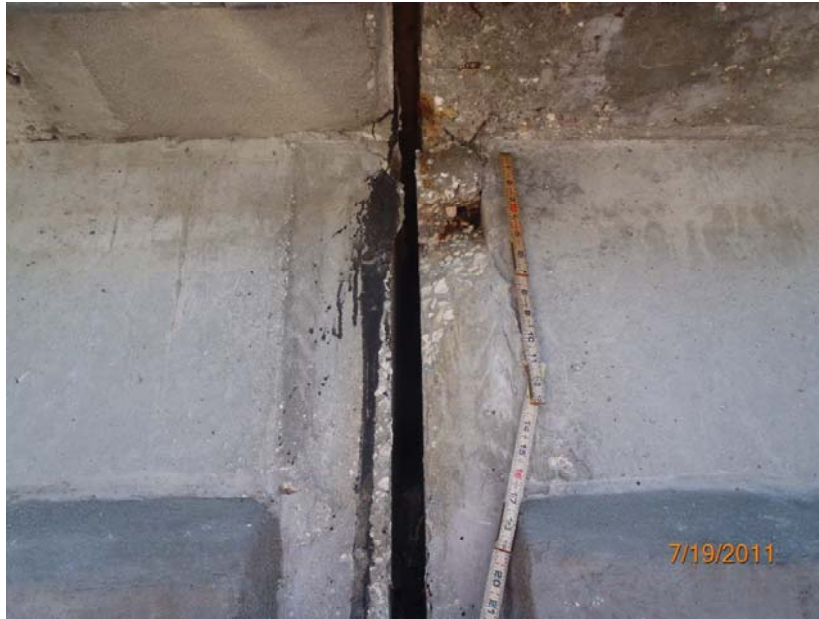
PHOTO 36: 109/4 P/S Conc Open Girder

The beam end of Beam 4-5 at Bent 4 exhibits a 3 in. x 10 in. x 2 in spall with exposed, corroded reinforcing steel.

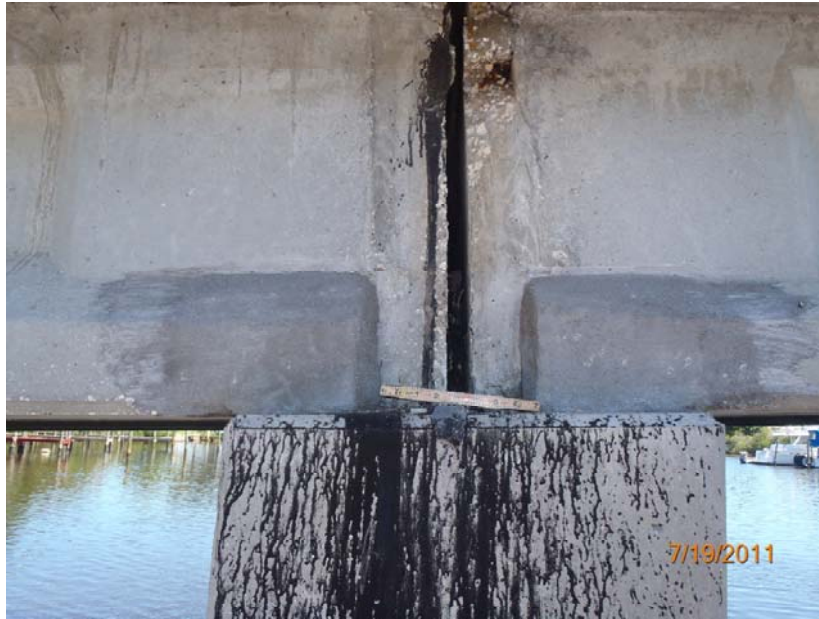
PHOTO 37: 109/4 P/S Conc Open Girder

Beams 3-5 and 4-5, south faces, exhibit delaminated repairs up to 4 in. x 8 in. over Bent 4.

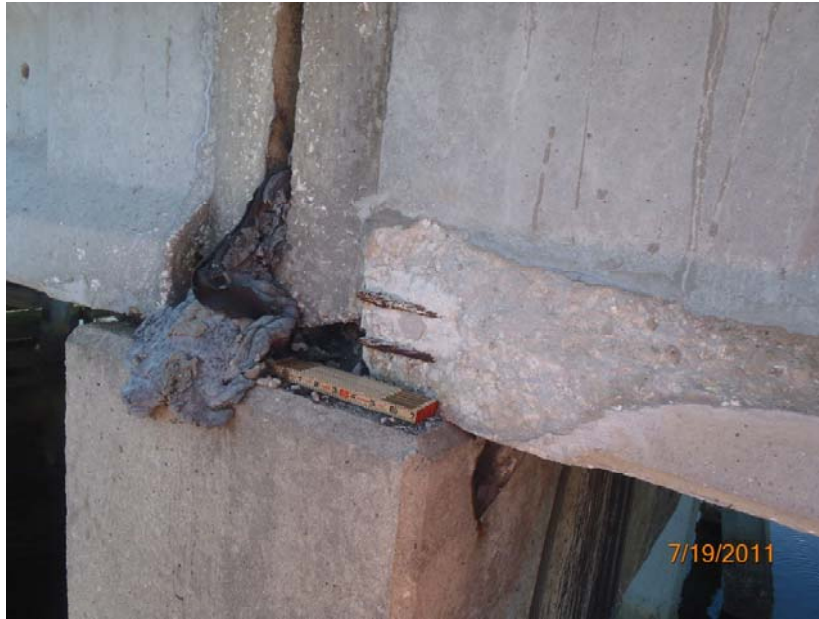
PHOTO 38: 109/4 P/S Conc Open Girder

Beam 4-1, north face, exhibits a 30 in. x 8 in. x 2 in spall with two exposed, corroded pre-stressing strands at Bent 5.

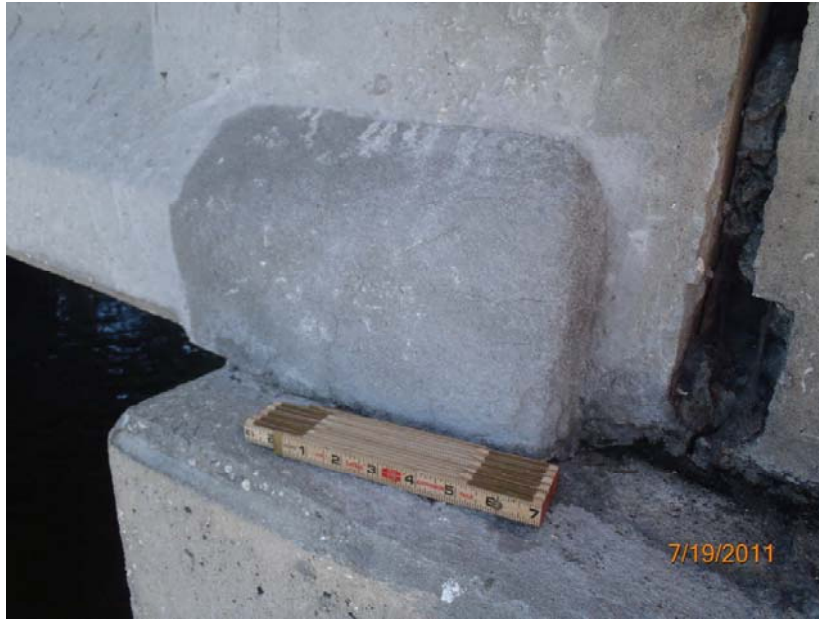
PHOTO 39: 109/4 P/S Conc Open Girder

Beam 7-5, previously reported as 7-1, exhibits a 12 in. x 8 in. delaminated repair at Bent 8.

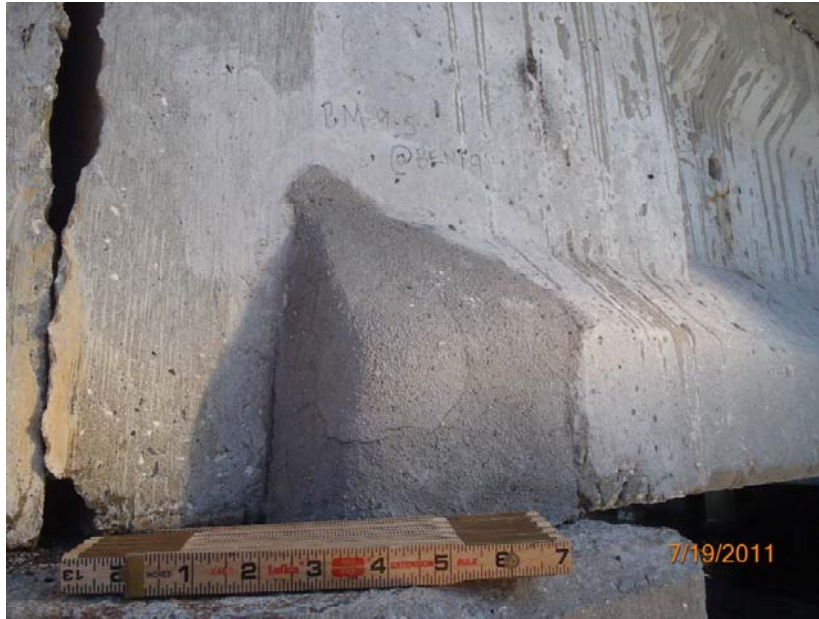
PHOTO 40: 109/4 P/S Conc Open Girder

Beam 9-5, south face, exhibits a 6 in. x 8 in delaminated repair at Bent 9.

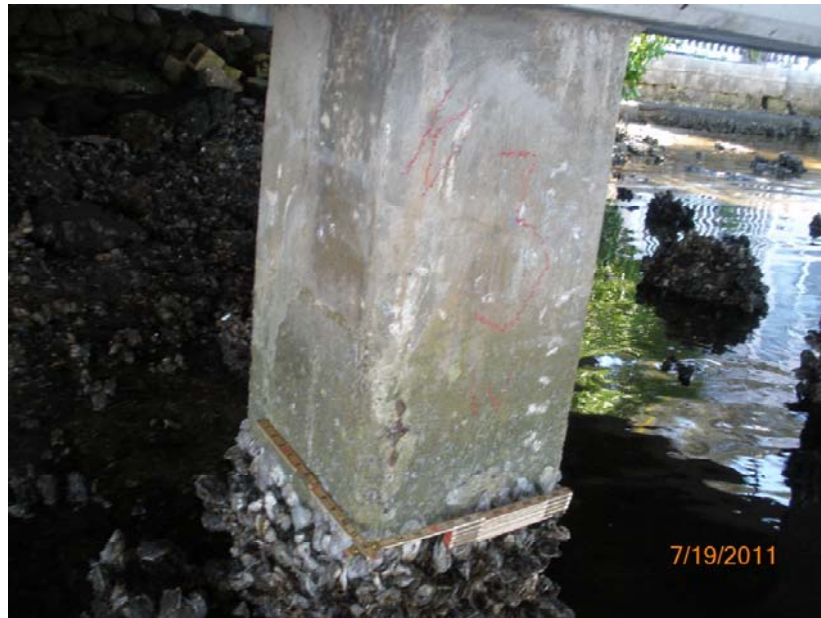
PHOTO 42: 204/4 P/S Conc Column

The west face of Pile 10-3 from the cap down exhibits a delamination with corrosion staining, 26 in. H x 14 in. W.

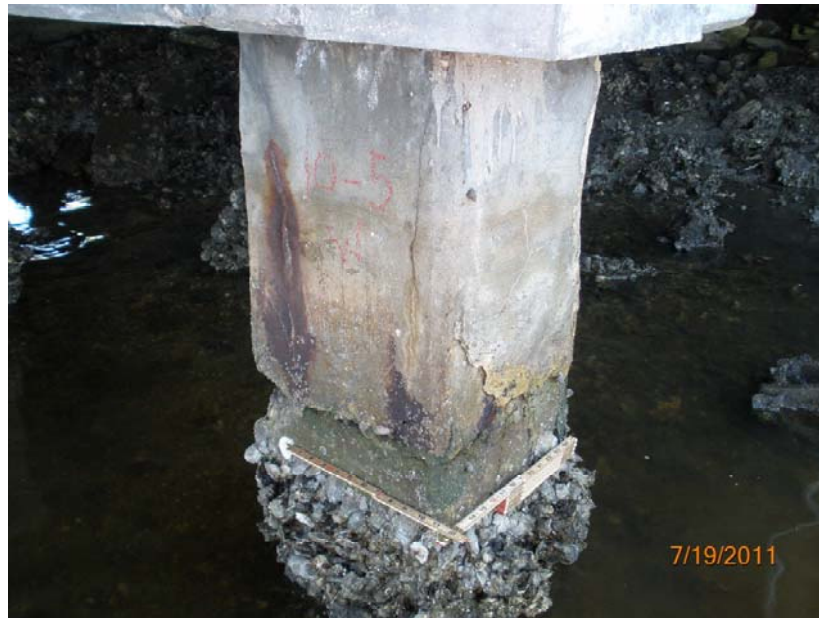
PHOTO 43: 204/4 P/S Conc Column

The upper 24 in. of Pile 10-5 is built-up with cracks and delaminations in all four faces up to 1/16in. wide with corrosion staining. There are minor spalls in the bottom of the build-up. The epoxy patches on the pile are beginning to crack.

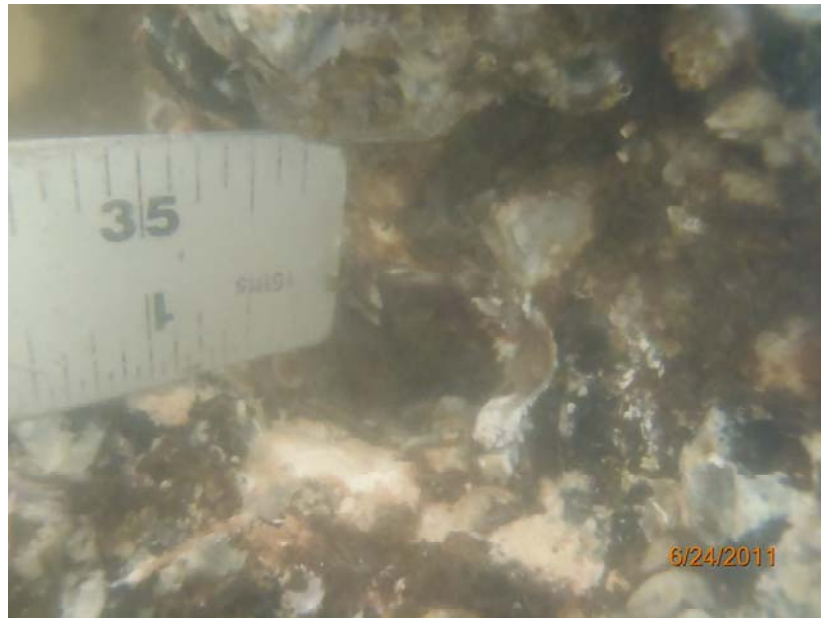
PHOTO 44: 204/4 P/S Conc Column

Pile 8-4 exhibits minor spalls around the splice between the pile and the build-up, 3 ft. 3 in. below the top of the marine growth. This spall is located in the southwest edge and measures 4 in. H x 4 in. W x 3 in. D with 100% deteriorated exposed steel.

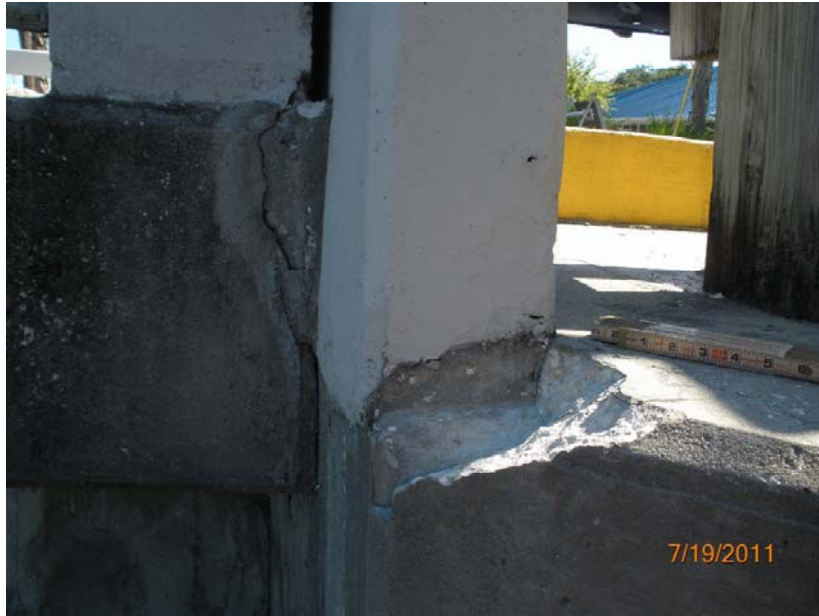
PHOTO 48: 474/4 Wall Uncoated

There is a 1 ft. x 6 in. x 3 in. spall with no exposed steel in the NW edge of the SE wing wall cap.

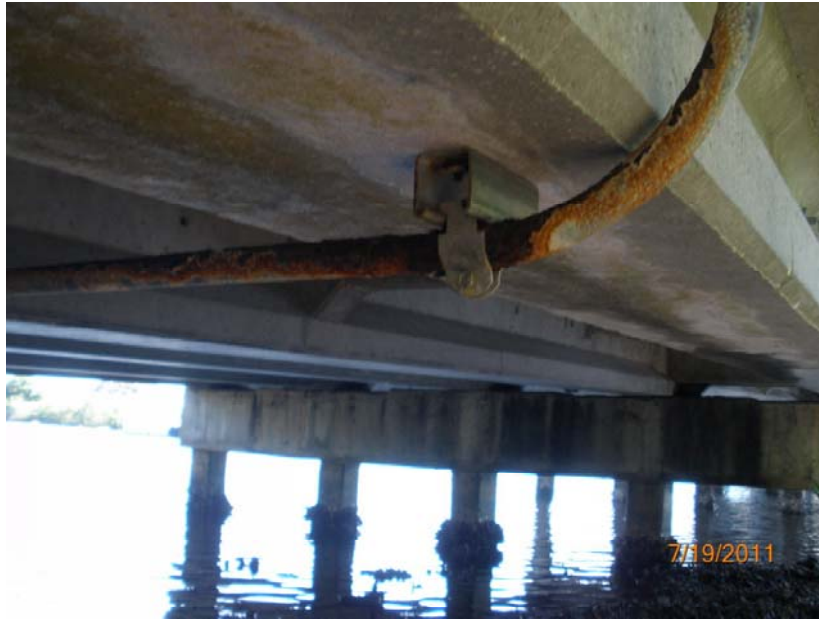
PHOTO 49: Inspection Notes

There is a heavily corroded conduit under Span 1.

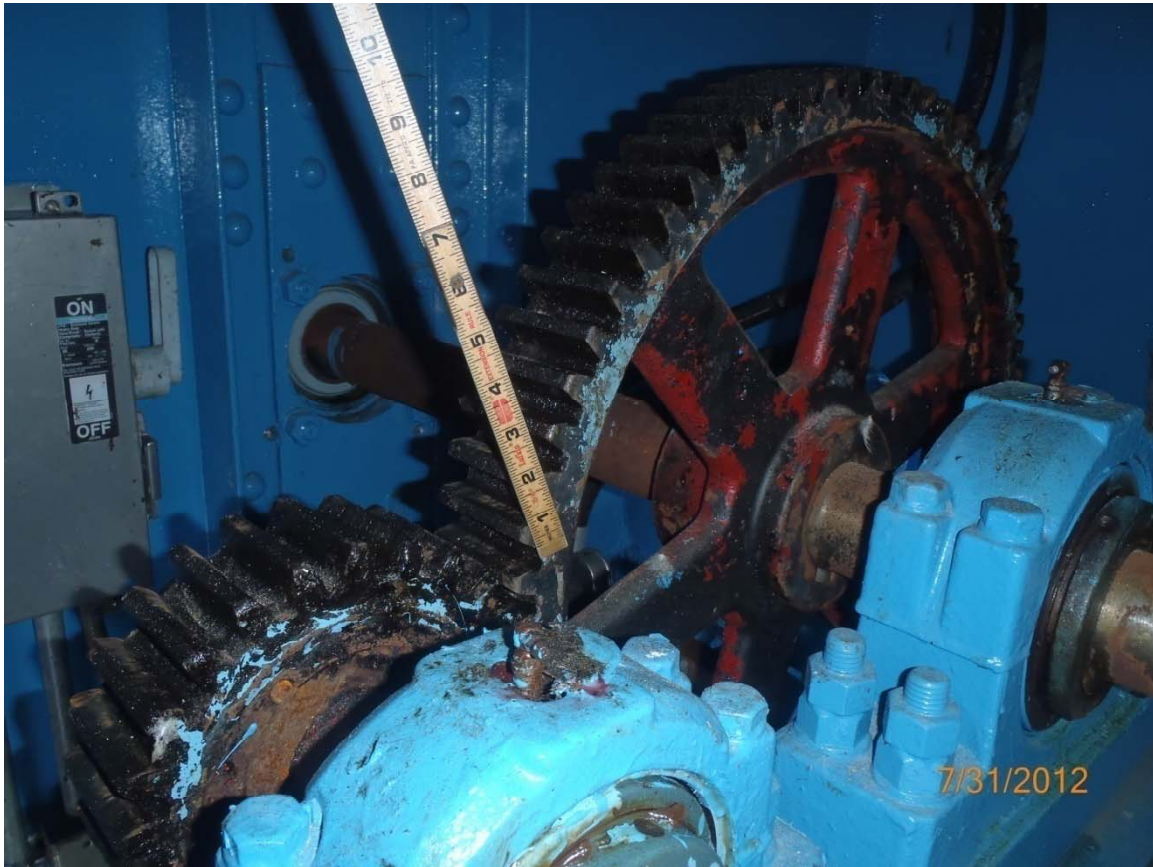
PHOTO 1: 540/4 – Open Gearing

Typical corrosion on gear sets (P/G-4N shown).

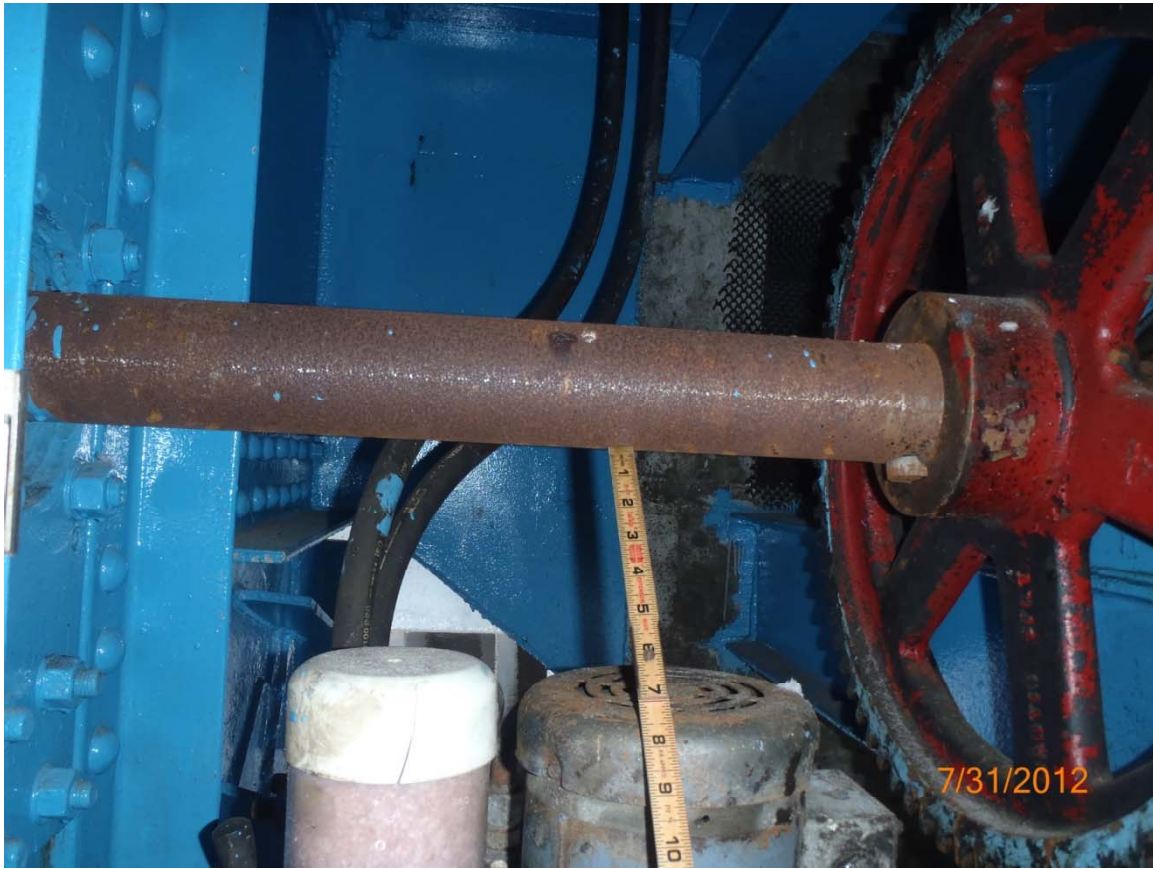
PHOTO 2: 542/4 - Shafts

Typical corrosion in shafts (S-5N shown).

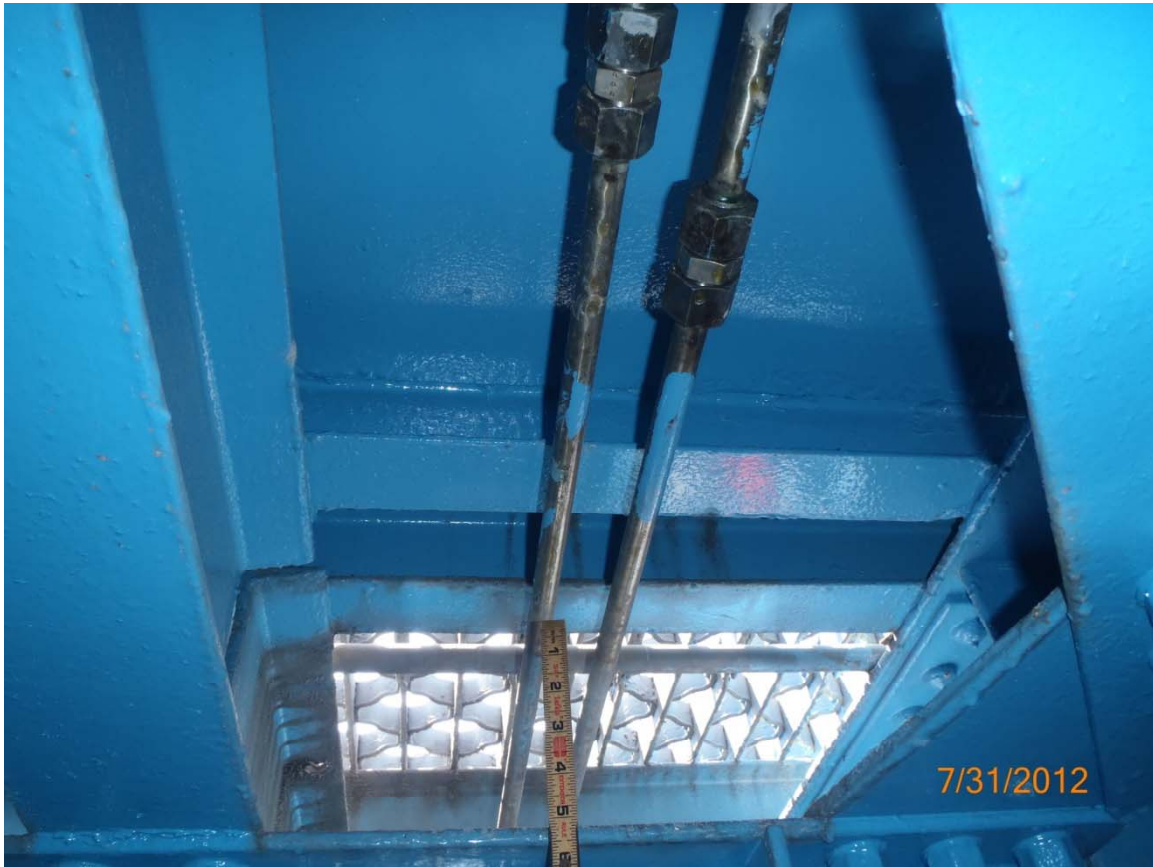
PHOTO 3: 548/4 – Hydraulic Piping Sys

Loose compression fittings for north span lock hydraulic piping.

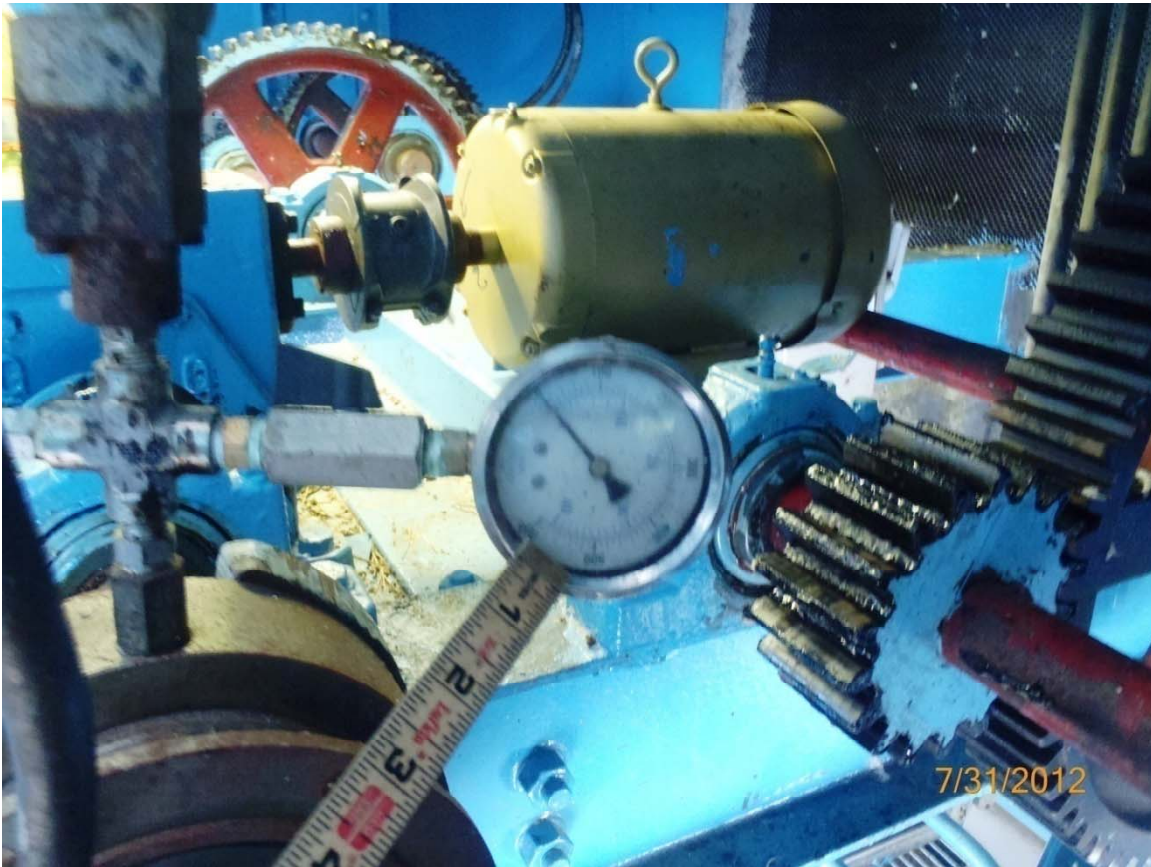
PHOTO 4: 548/4 – Hydraulic Piping Sys

Pressure gauge for Brake 1 (leaking oil).
