Beckett Bridge

Project Development & Environment (PD&E) Study

Preliminary Engineering Report **Volume 2: Appendices**

Project #13040 - Beckett Bridge over Whitcomb Bayou (Riverside Drive)

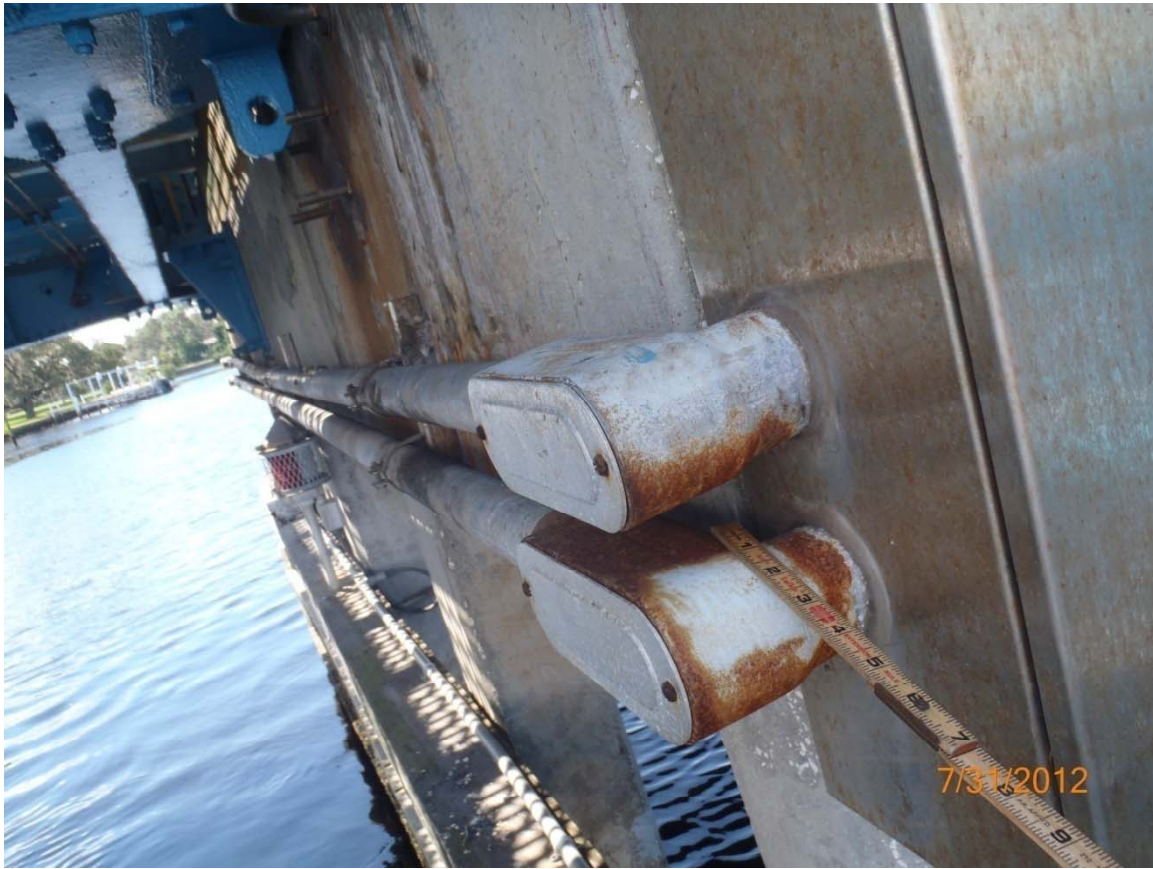
PHOTO 5: 572/4 – Conduit & Junc. Box

Typical corrosion in conduit bodies and junction boxes (at Rest Pier 6 shown).

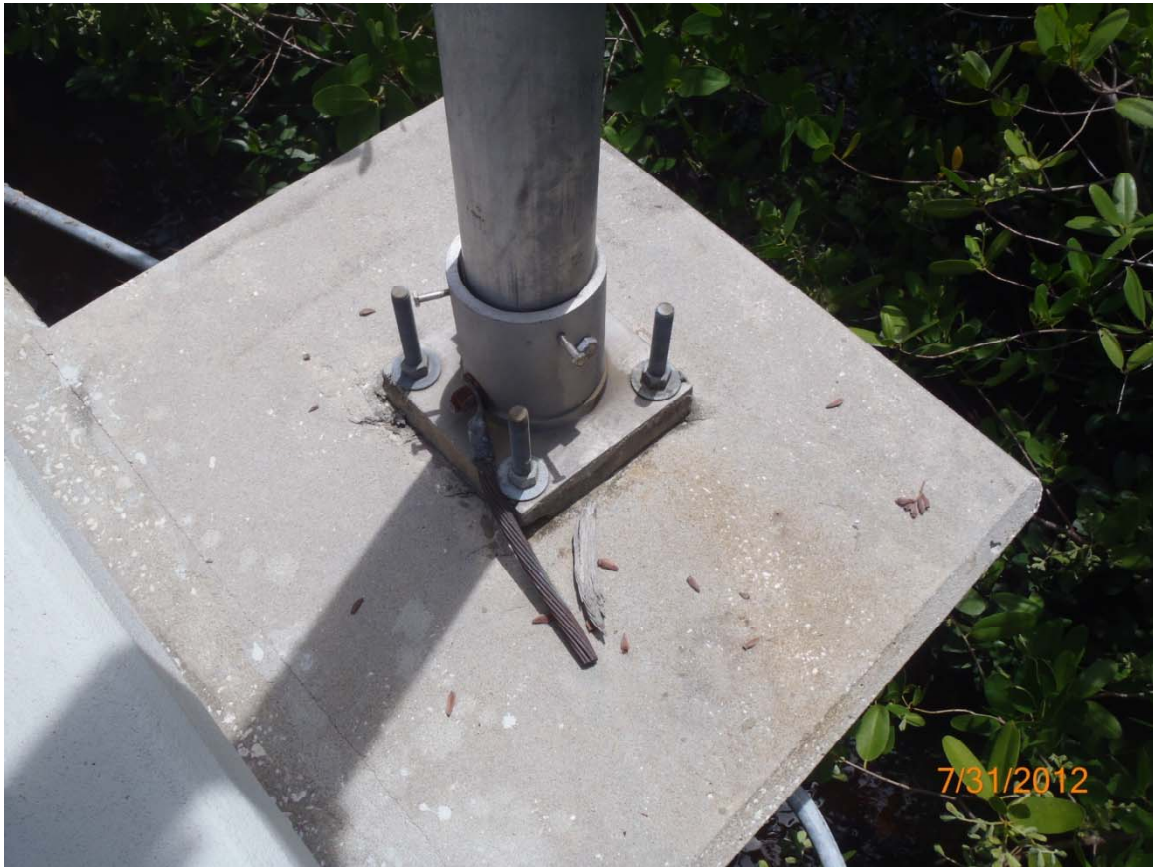
PHOTO 6: 572/4 – Conduit & Junc. Box

Typical missing grounding cable (at southwest traffic signal shown).

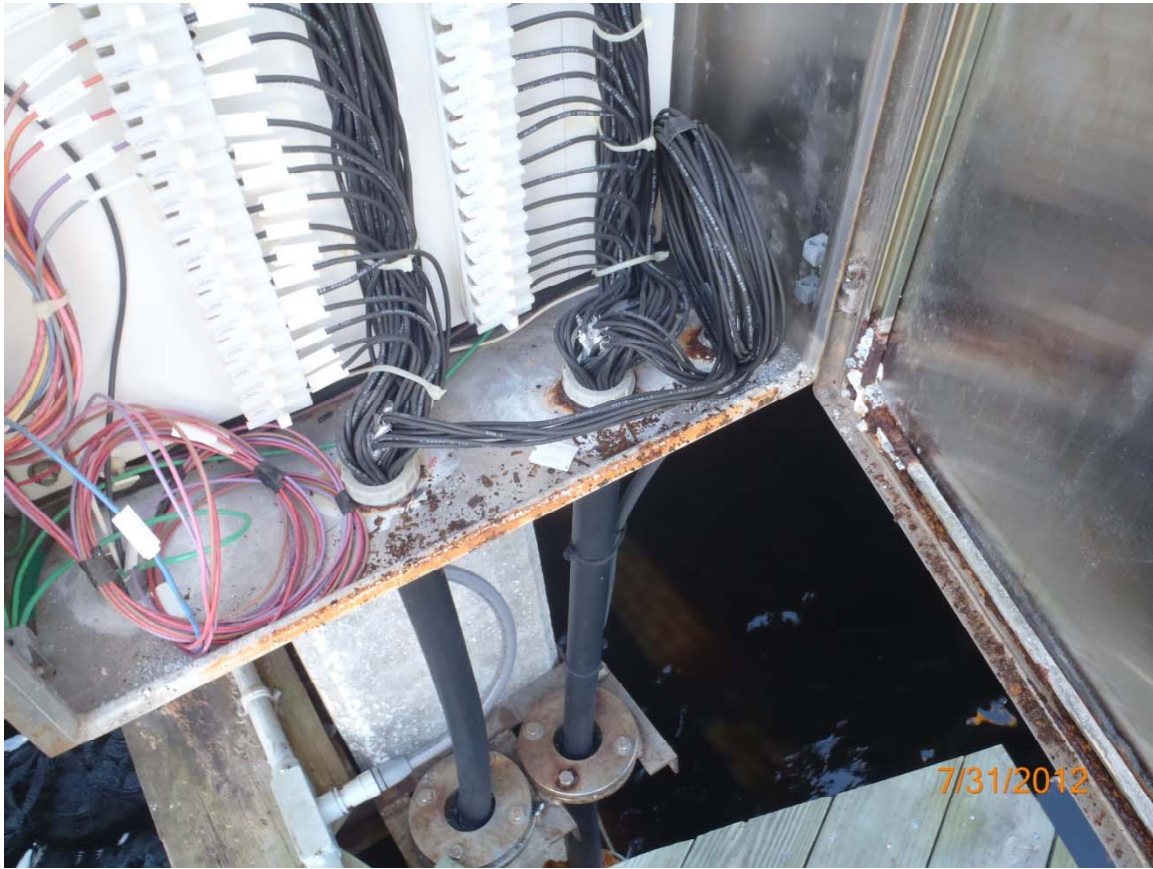
PHOTO 7: 572/4 – Conduit & Junc. Box

View of corrosion in submarine cable termination cabinet at Rest Pier 6.

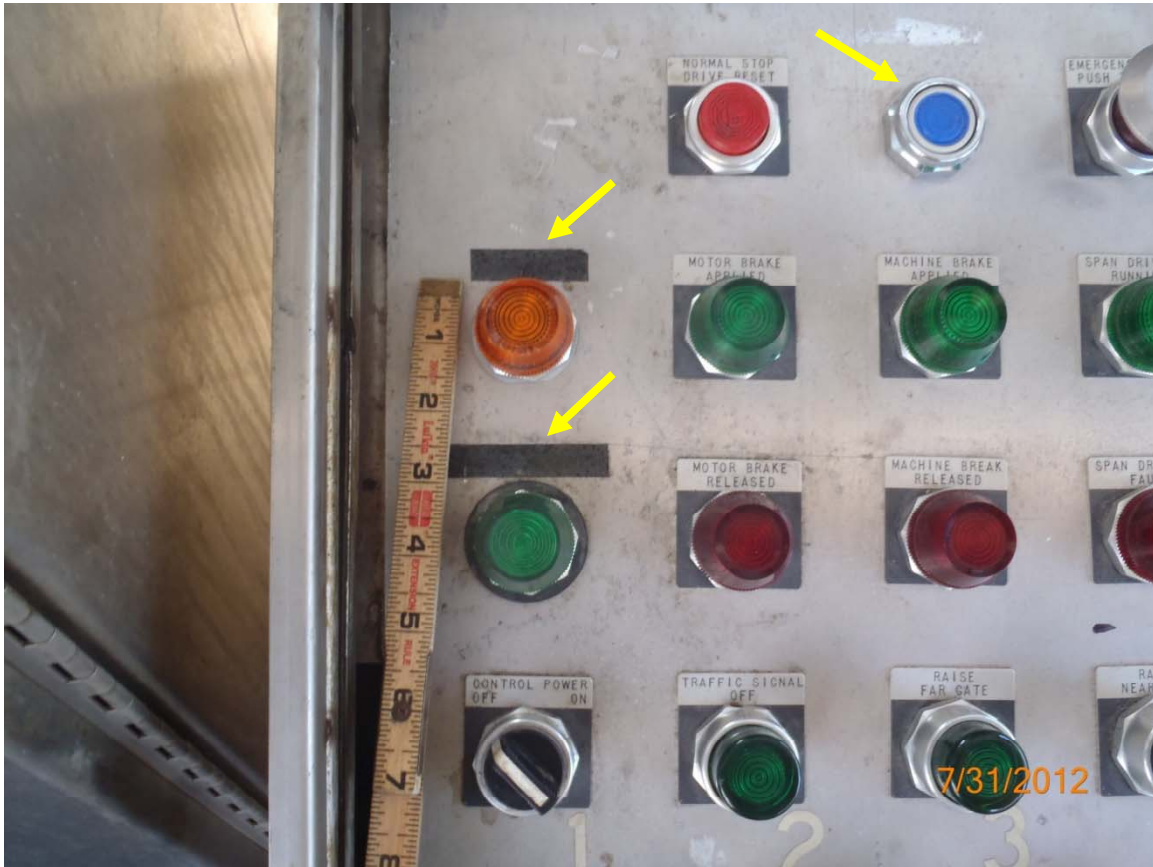
PHOTO 8: 574/4 – Control Console

View of missing nameplates for switches and indicator lights in control console.

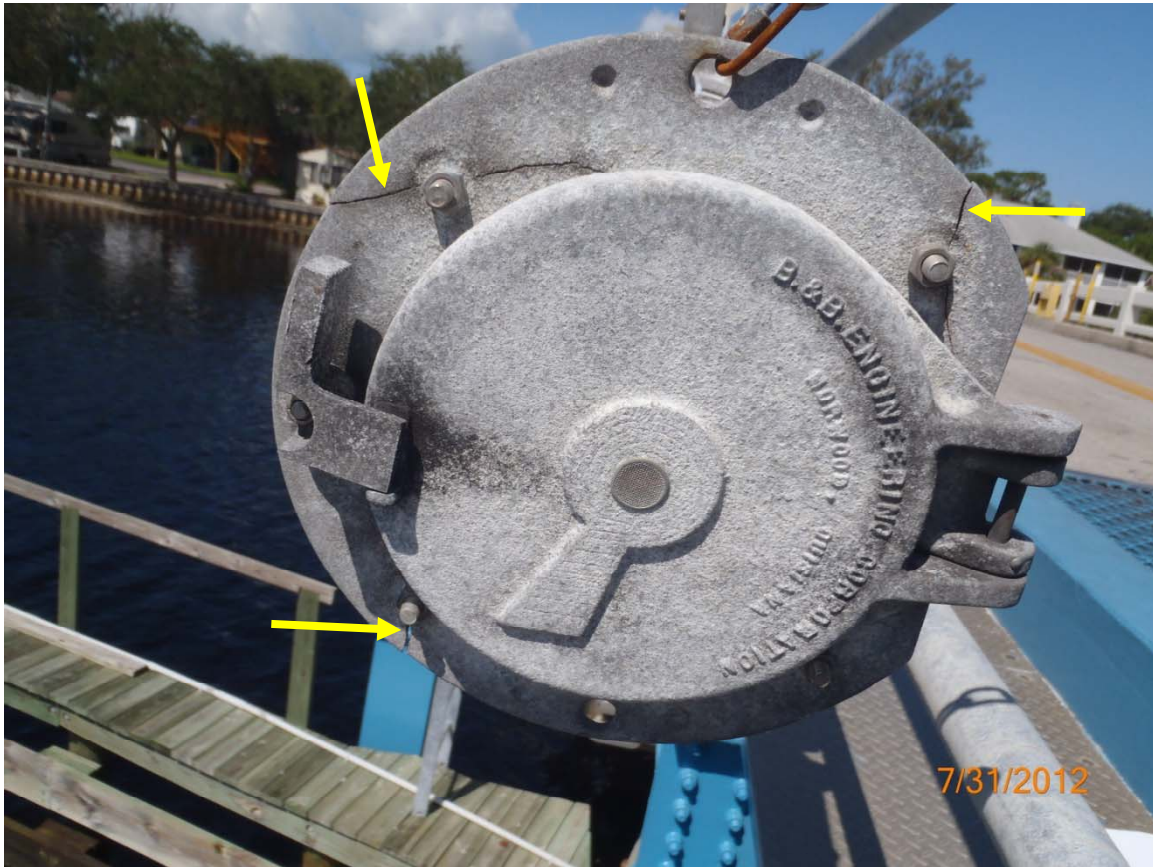
PHOTO 9: 580/4 - Navigational Lights

View of cracked bottom of south tip swing light.

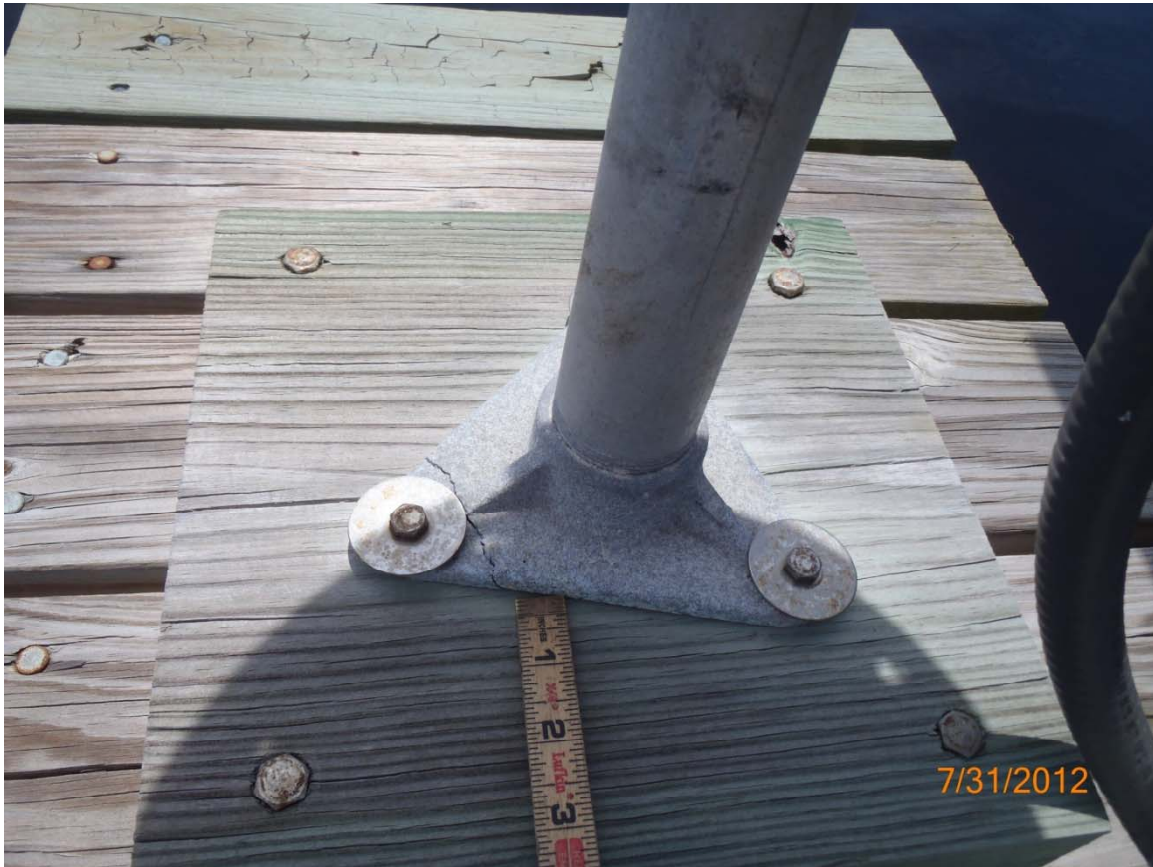
PHOTO 10: 580/4 - Navigational Lights

View of broken base of southwest fender light.

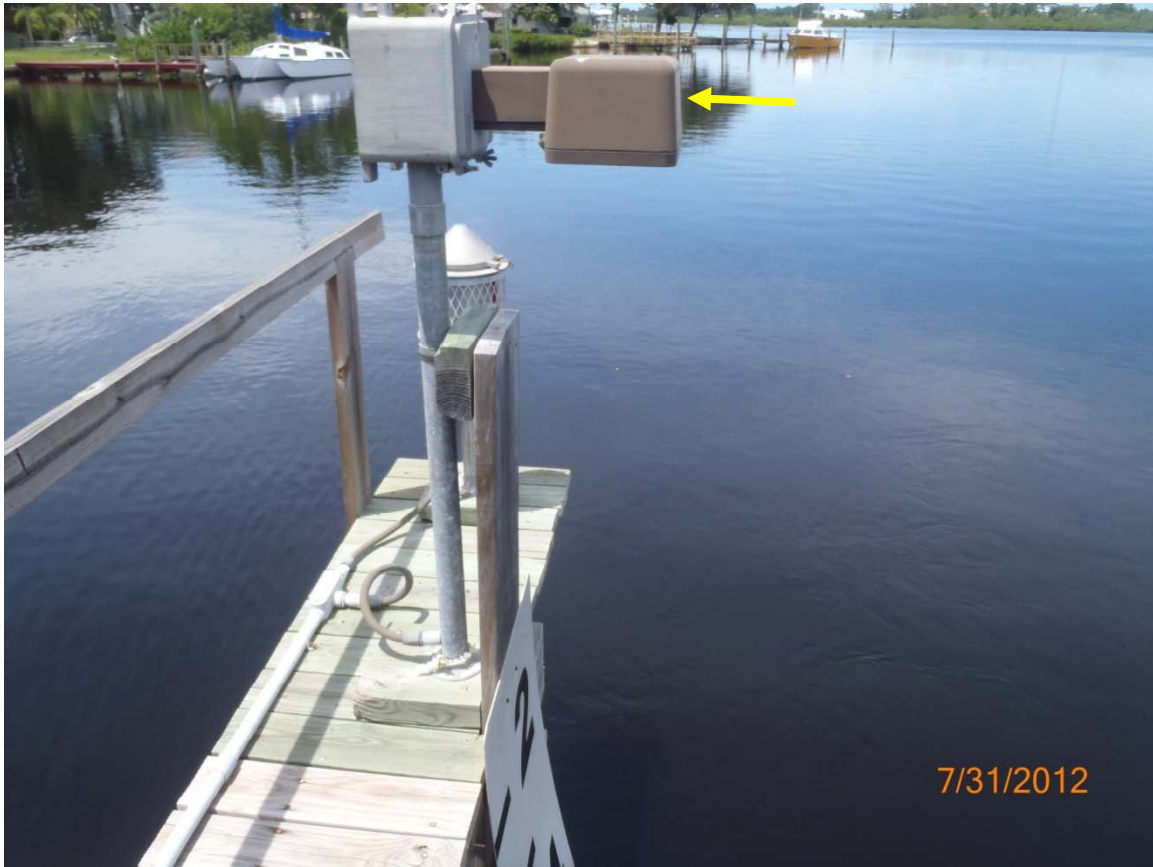
PHOTO 11: 580/4 – Navigational Lights

View of northwest clearance gauge light (bulb is burnt-out).

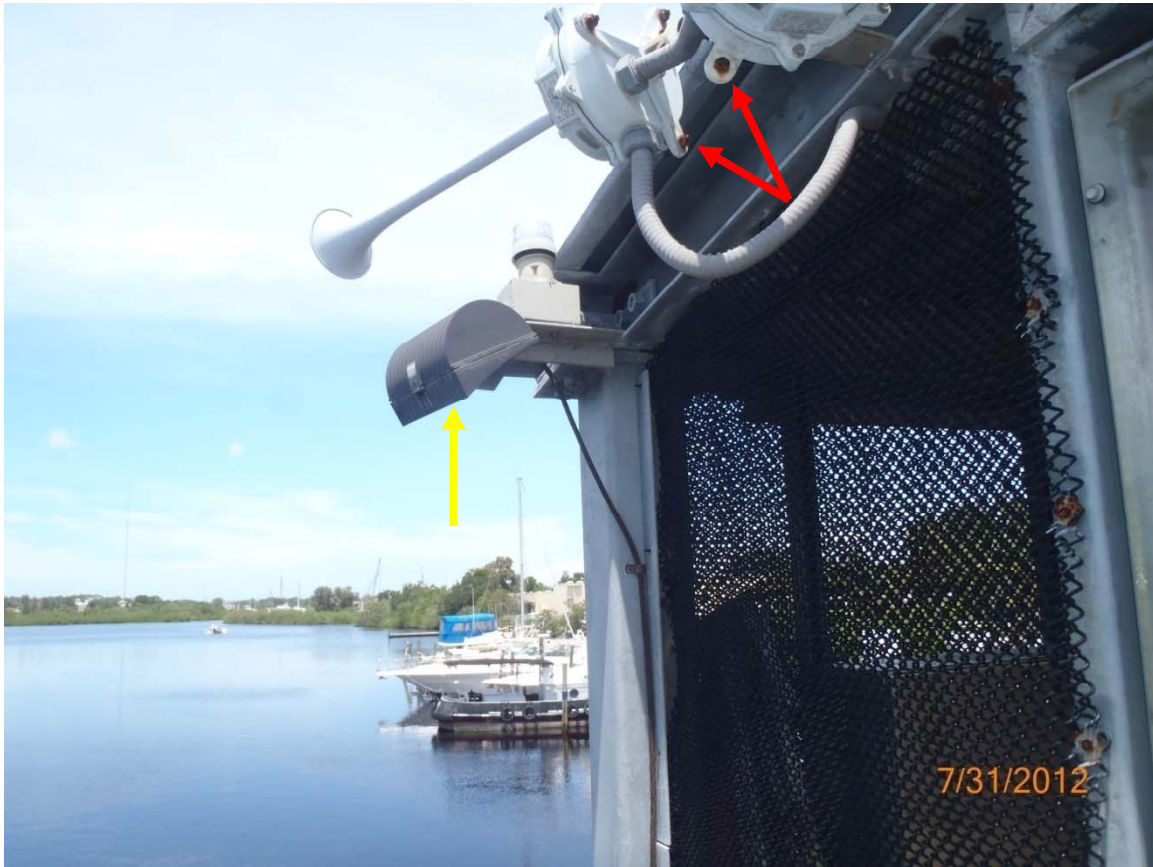
PHOTO 13: 581/4 – Operator Facilities

View of floodlight (bulb burnt-out) and signal horn (fasteners corroded) on west side of tender house.

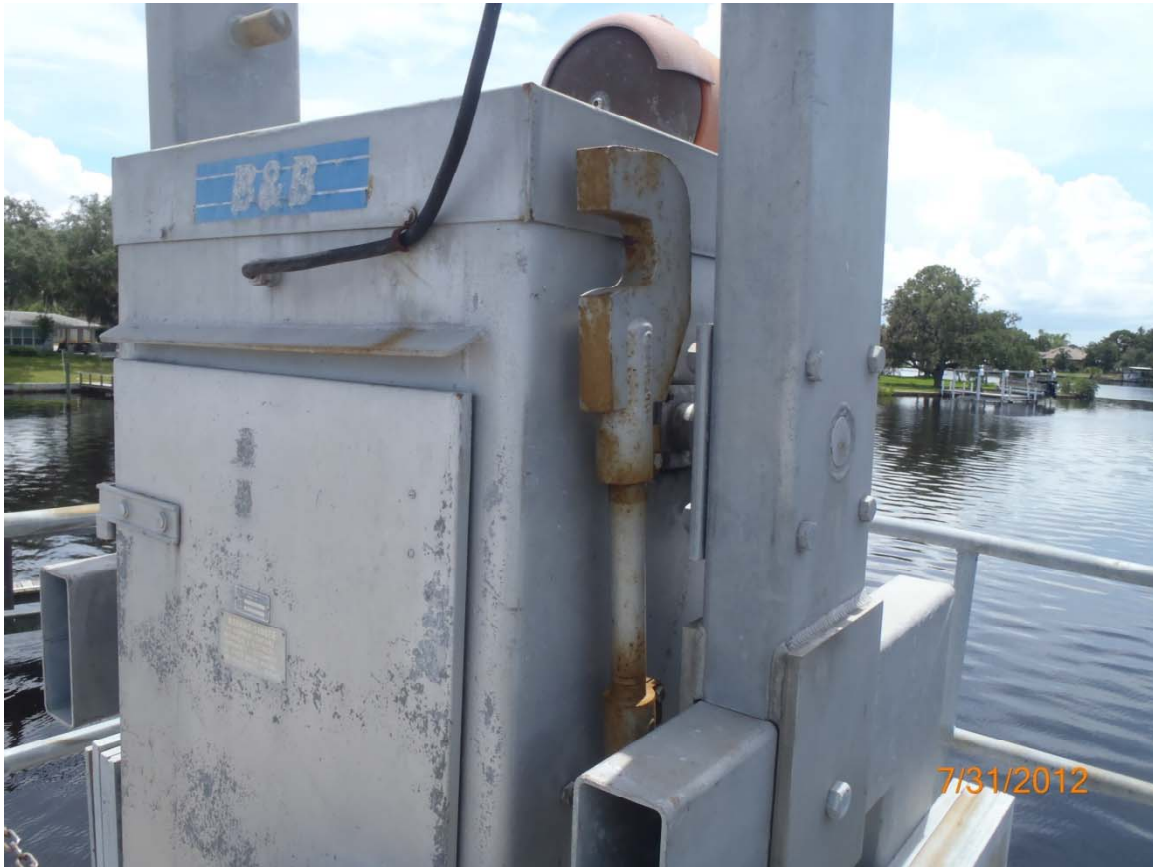
PHOTO 14: 590/4 - Resistance Barriers

Typical view of corrosion in resistance barrier.

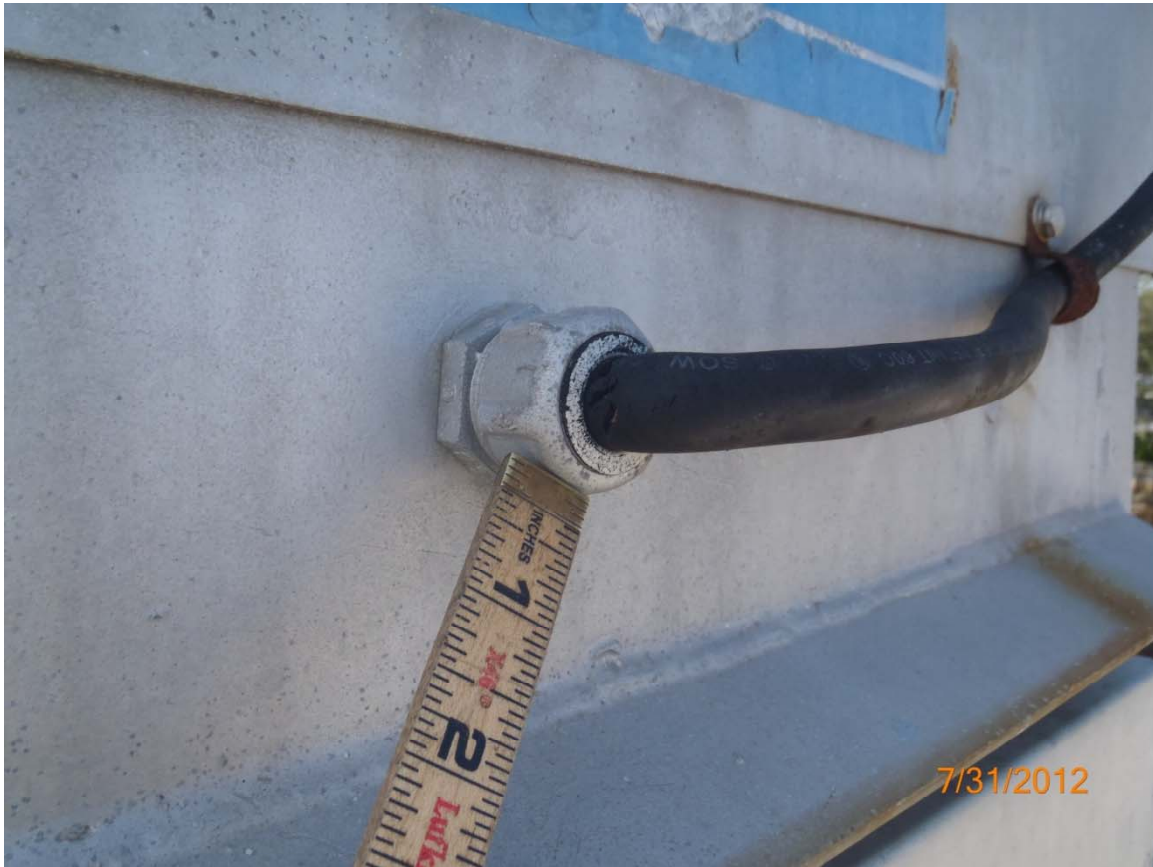
PHOTO 15: 590/4 – Resistance Barriers

Cracked SO cable at resistance barrier.

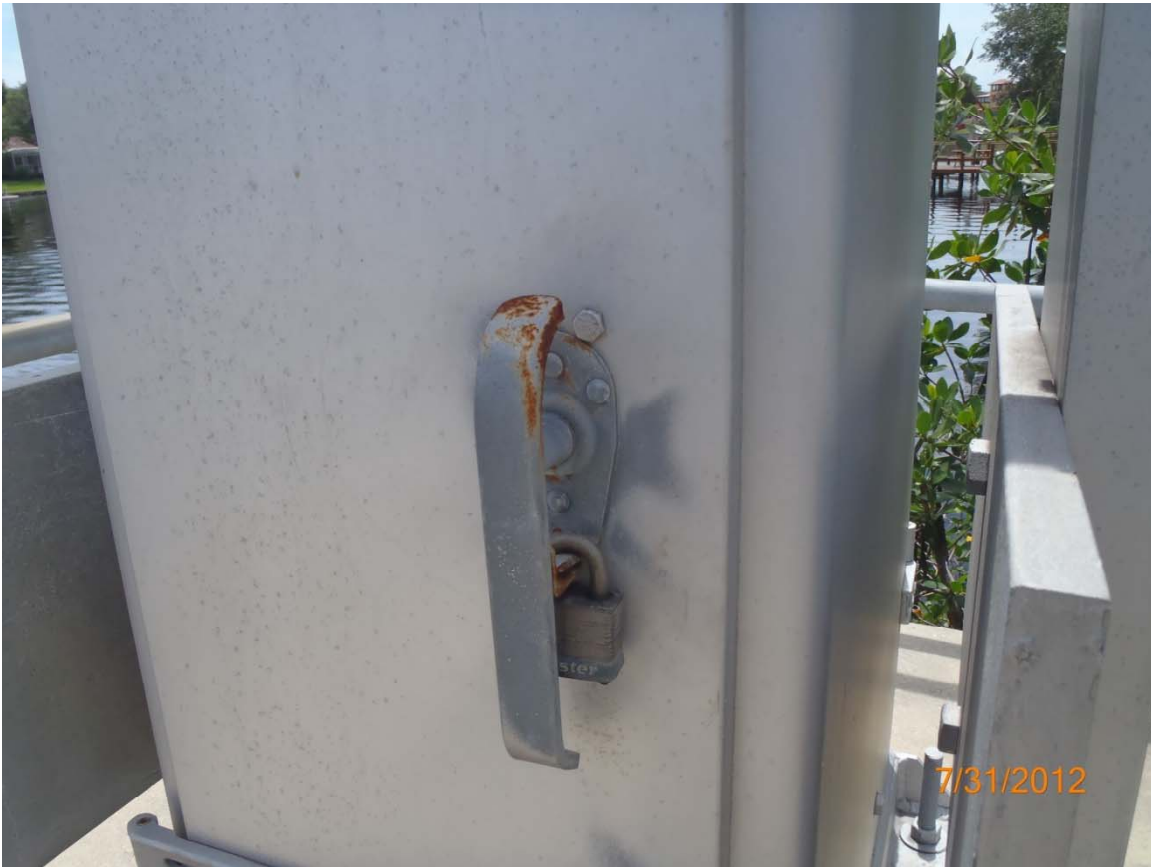
PHOTO 17: 591/4 - Warning Gates

Typical corrosion in warning gates (far oncoming shown).

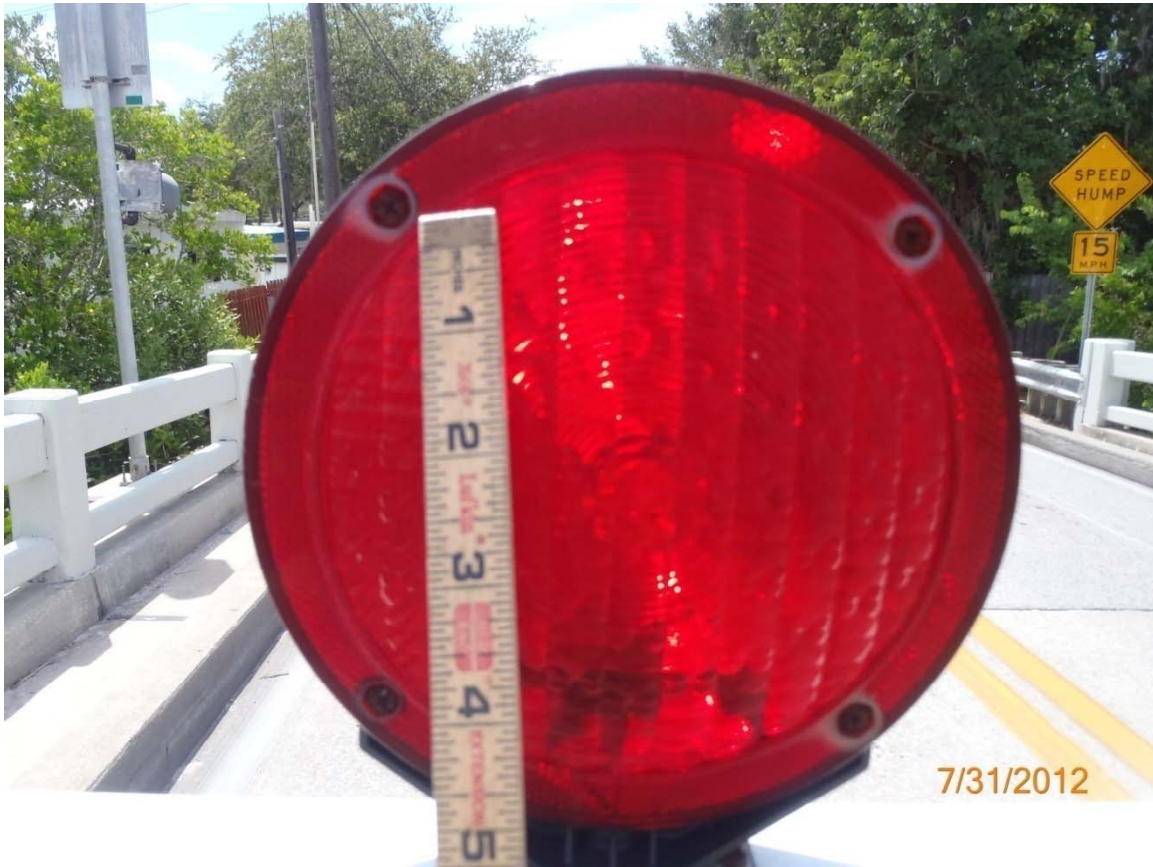
PHOTO 18: 591/4 - Warning Gates

Typical corroded fasteners in warning gate lights (far oncoming shown).
