Bridge Replacement Study (Phase 1)

San Martin Boulevard over Riviera Bay Bridge

**Project Number 154371
Pinellas County**

HDR Engineering, Inc.

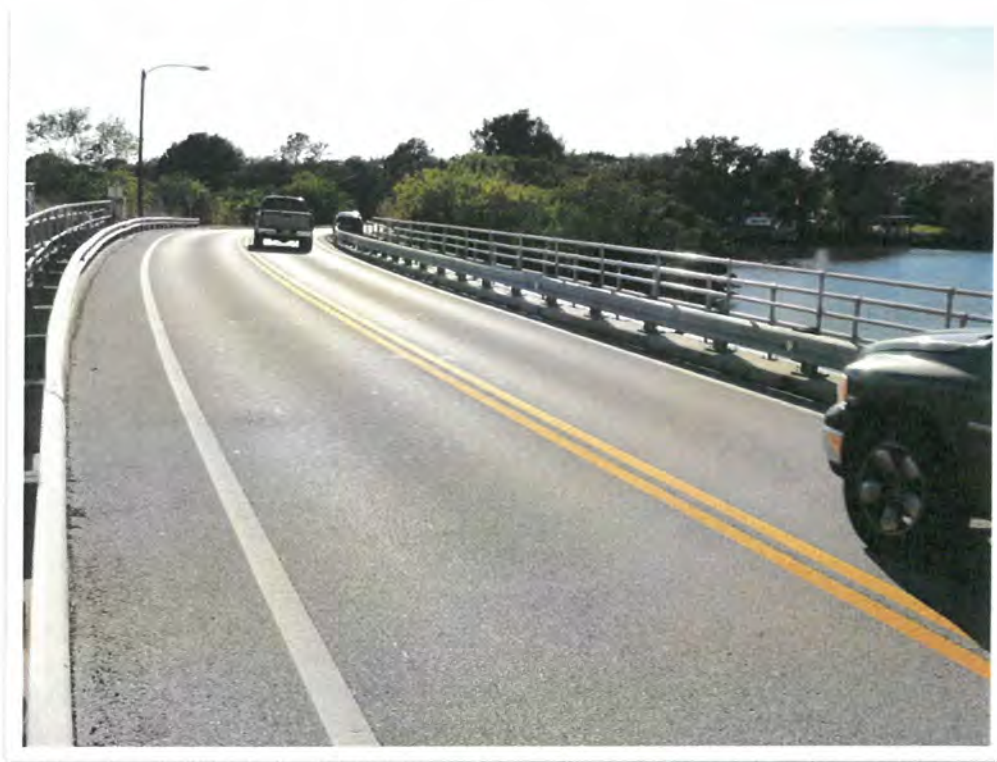
Figure 2-3 – View of Bridge Deck

The existing two-lane bridge carries a two-way traffic and pedestrian traffic over the Riviera Bay waterway. The existing bridge was built in 1962 consisting of five spans with a maximum span length of 24-ft and a total bridge length of 117.1-ft. The bridge is 32.5-ft wide with a clear roadway width between curbs of 24.6-ft and was designed using precast concrete slab units. The bridge has a 2"± asphaltic wearing surface, [Figure 2.3](#). According to the Bridge Inspection Reports, the bridge is classified as "Functionally Obsolete".

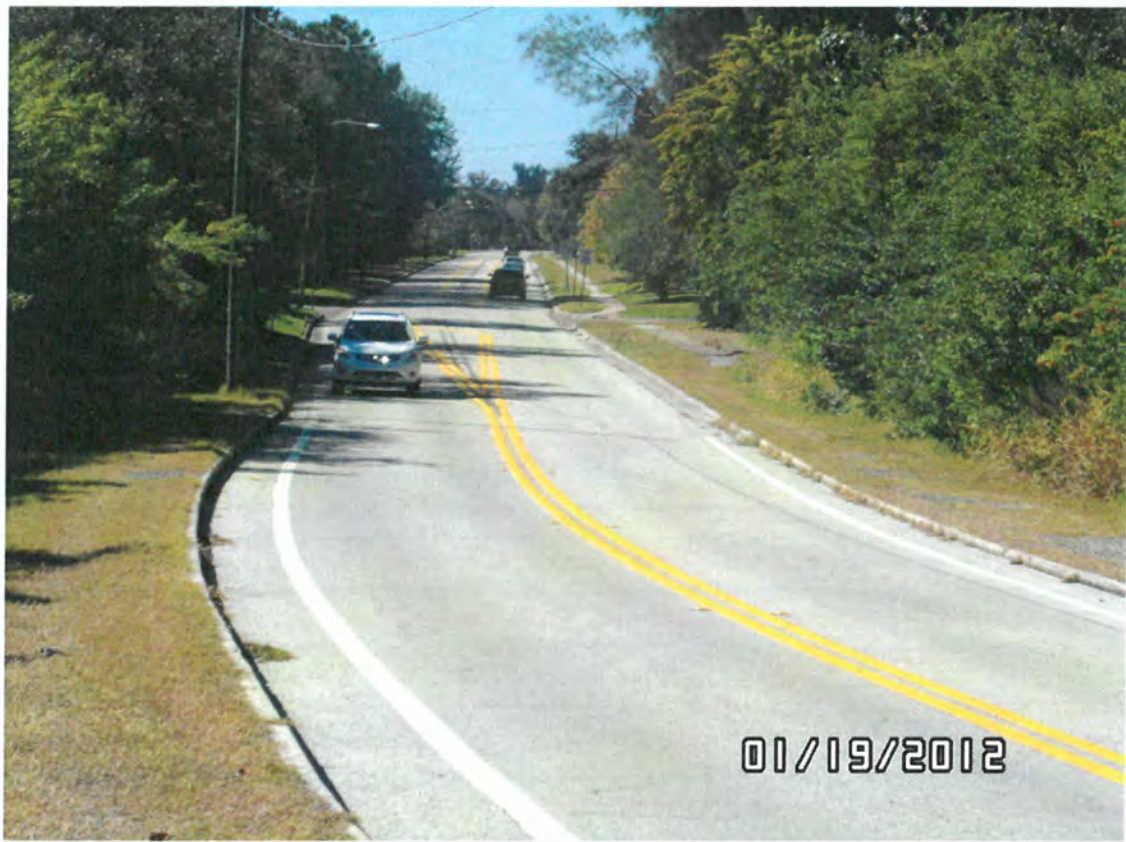
Figure 3-1 – Roadway Typical Section

Roadway surface, [Figure 3.1](#), consist of an asphalt surface that continues across the bridge. The existing bridge should be rehabilitated or replaced within the current alignment due to the proximity of existing homes and limited right-of-way at the proposed project location. At the approach roadway locations, the right-of-way is 100-ft and restrained due to the existing homes on either side of the Bay, [Figure 3.2](#). For this initial Phase 1 work, Right-of-way maps were not provided. The posted speed for this area is 35 mph.

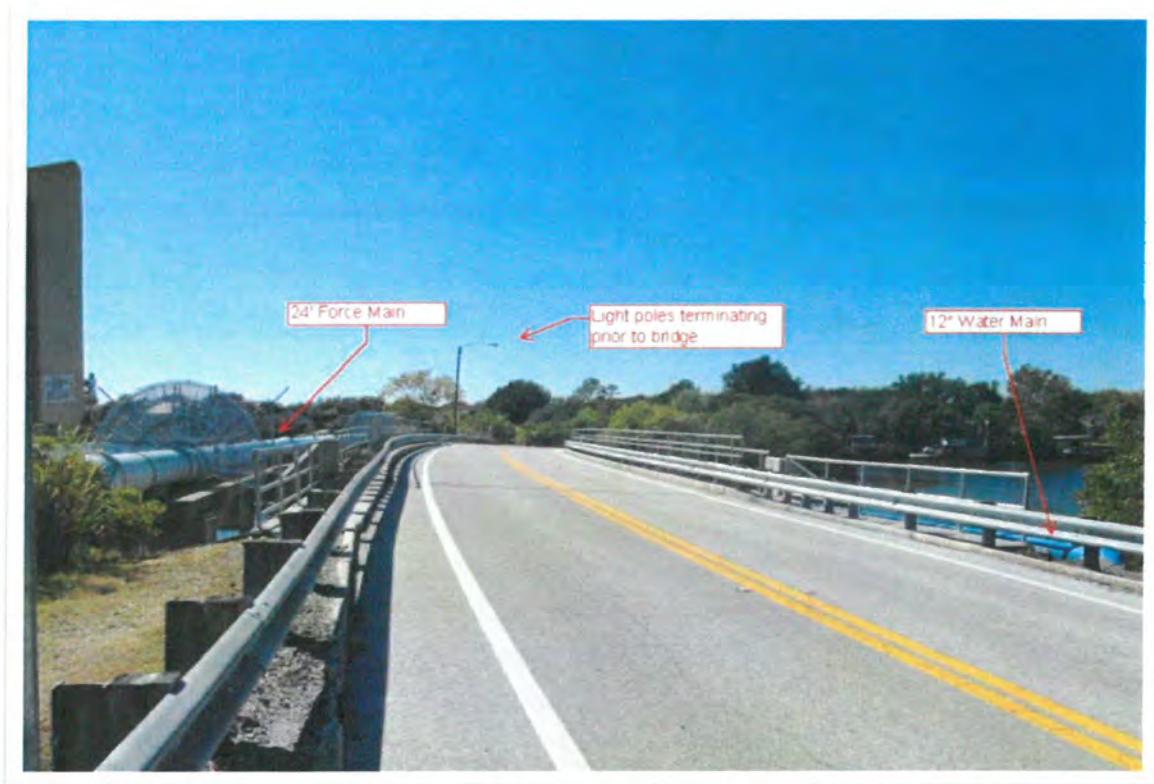
Figure 3-3 – Bridge Deck Section

Based on our field review, the following utilities were noted: [Figure 3.3](#)

- City of St. Pete - 12" water main attached to northerly side of the bridge
- City of St. Pete - 24" force main crossing on separate structure on the southerly side of the bridge

There is lighting on the bridge approaches but either goes under the existing channel or terminates at the bridge approaches. There are no other visible utilities on the bridge.
