Florida Department of Transportation
State Materials Office

**CORROSION CONDITION EVALUATION OF
PILES, BENT CAPS, AND THE UNDERSIDE OF
DECK OVERHANGS ON BRIDGE NO. 154371 IN
PINELLAS COUNTY**

FINAL REPORT
January 06, 2012

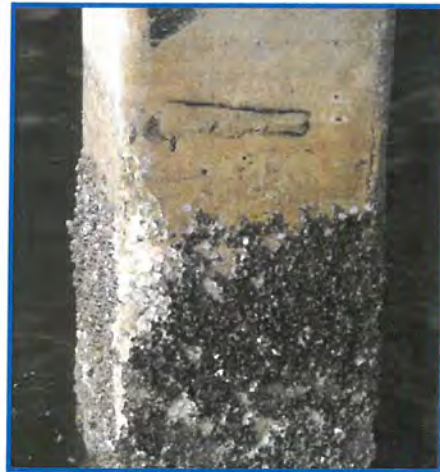
Figure 1. Typical spalled area on a pile that is believed to have been caused by an impact from a marine vessel.

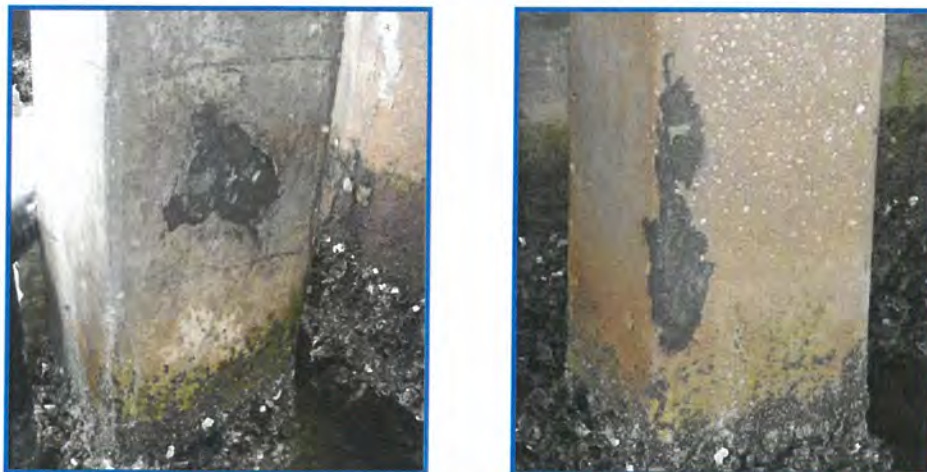
Figure 2. Typical patched areas on piles that are believed to be the result of lift hooks (left photograph) and impacts from marine vessels (right photograph).

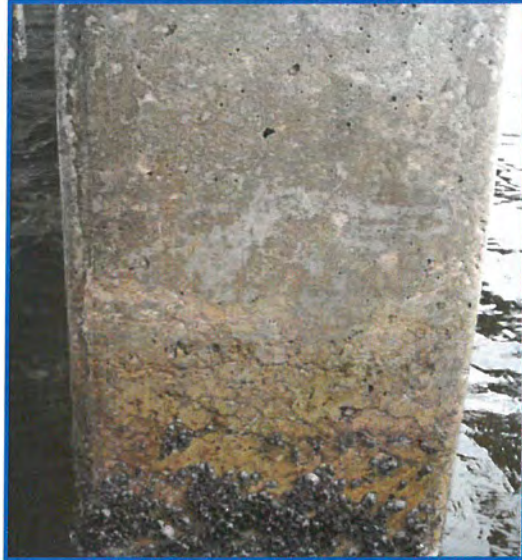
Figure 3. Typical scaling above the MGL on piles.

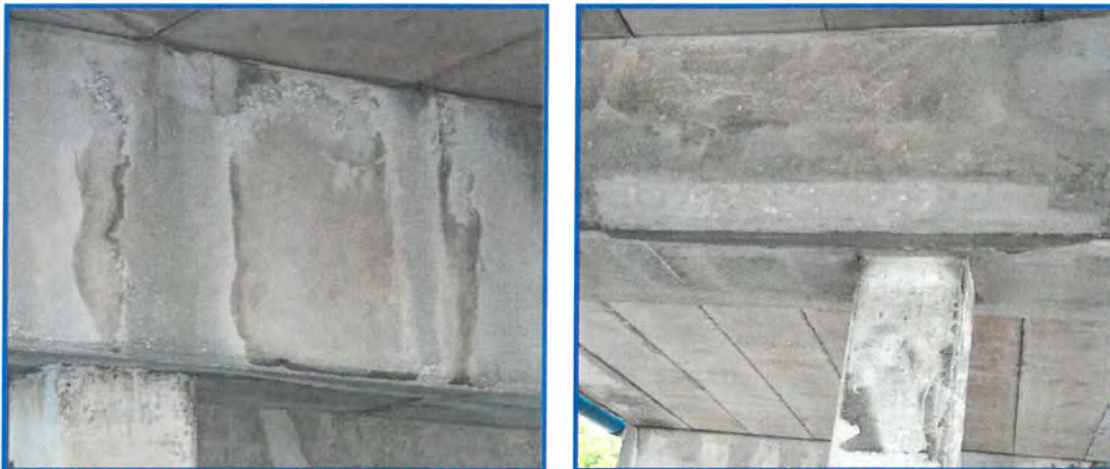
The bent caps typically have cracks and existing repaired areas at various locations (see Figure 4) and Bent Cap 4 has the most cracking and previous repairs relative to the other bent caps.

Figure 4. Typical repaired areas on bent caps.

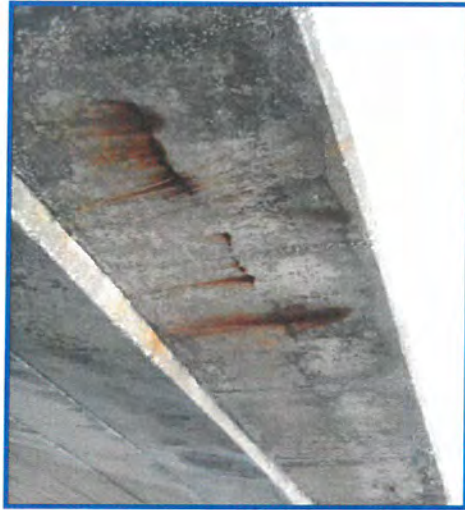
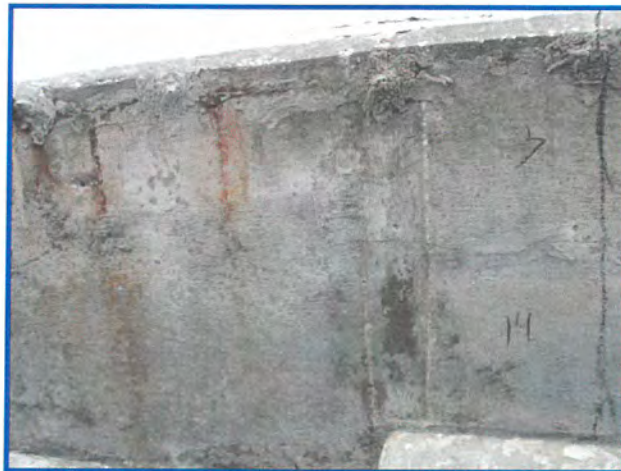
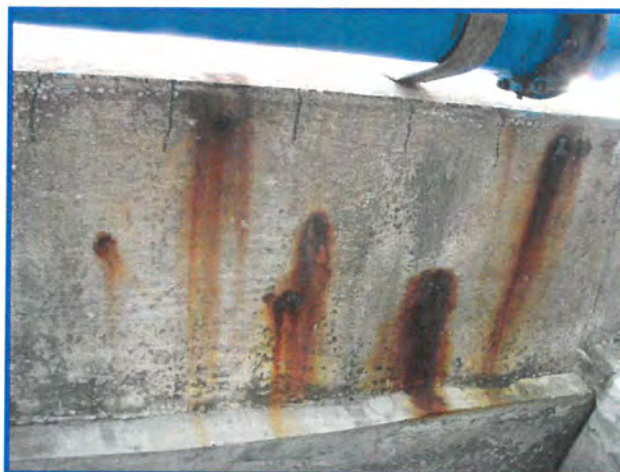
Figure 5. Typical examples of cracking, corrosion staining, and epoxy injection crack repairs on the overhangs.

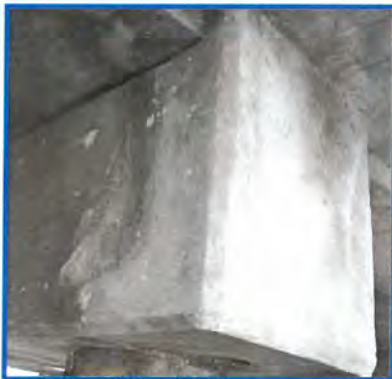
West end of the cap.

Figure 6. Three large repaired areas on Bent Cap 4.

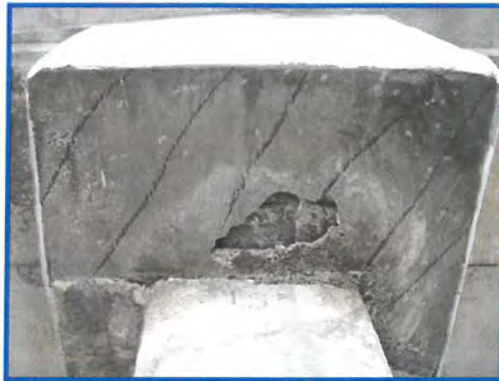
Figure 7. Delaminated repair area (shown with black crosshatch markings) with a 3" deep void on the bottom surface of Bent Cap 4.

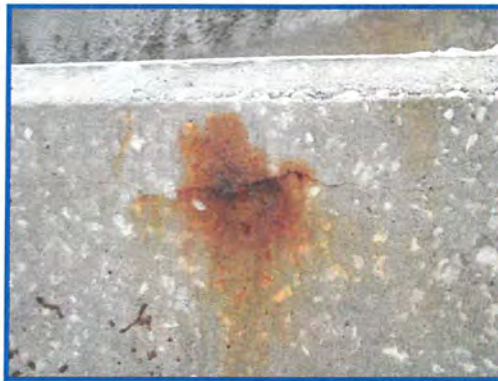
Figure 8. Corrosion staining on a crack on the bottom surface of Bent Cap 4.

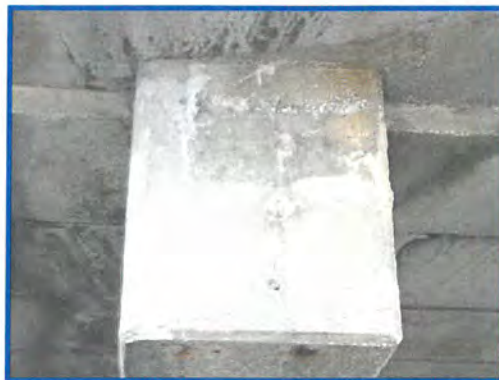
Figure 9. East face of Bent Cap 4 with multiple cracks, three small spalled areas, and three small patched areas.

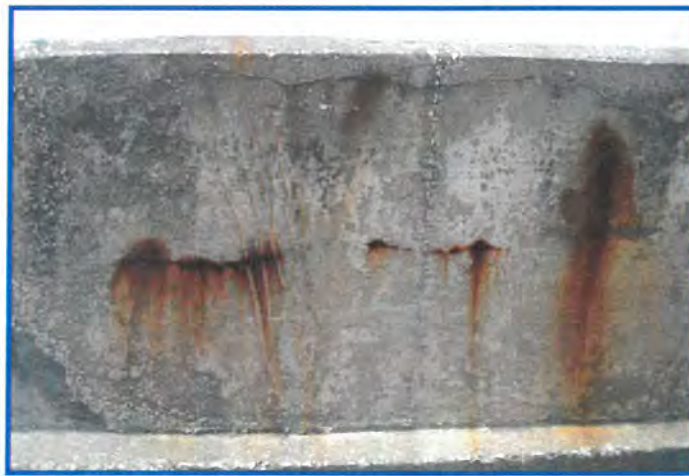
On the underside of the east deck overhang in Span 2 there were multiple corrosion induced longitudinal cracks with corrosion staining and efflorescence (see Figure 10). The width of the cracks ranged from 6 mils to 125 mils. Some of the cracks had been repaired by epoxy injection and the repairs have failed as shown in Figure 11. The longitudinal cracks were located near the outside edge of the overhang, along the center of the overhang, and adjacent to the deck panel. There was also a 3 ft² delamination that encompassed a portion of several of the cracks (see Figure 12). In addition, there was corrosion staining in one area that appeared to be caused by a steel chair or form nail and there were two epoxy repair areas on the vertical face of the overhang.

Figure 10. Longitudinal cracks with corrosion staining on the east deck overhang in Span 2.

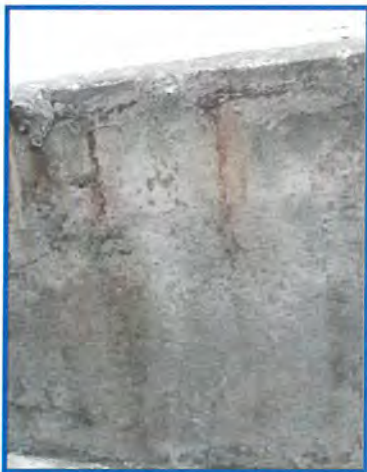
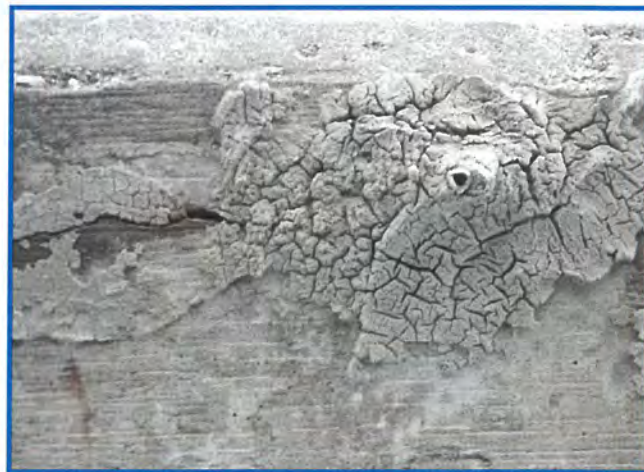
Figure 11. Typical failed epoxy injection crack repairs on the east deck overhang in Span 2.

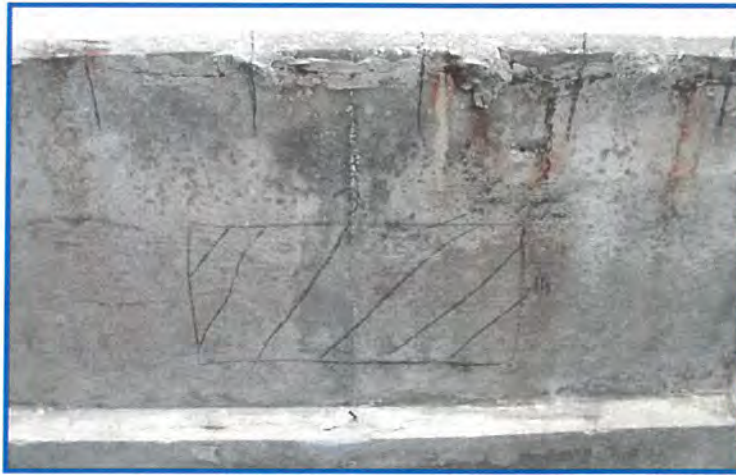
Figure 12. Cracked and delaminated area (shown with black crosshatch markings) on the east deck overhang in Span 2.

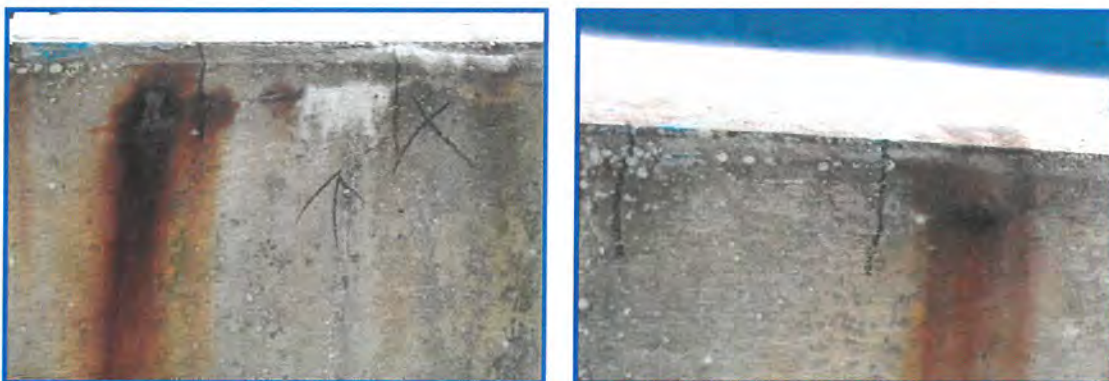
On the underside of the west deck overhang in Span 3 there were several relatively short longitudinal cracks with some corrosion staining and efflorescence (see Figure 13). The width of the cracks ranged from 10 mils to 30 mils. The cracks were all located near the outside edge of the overhang and two of the cracks continued onto the outside vertical face. There was also a 1.7 ft² delamination that encompassed a portion of one of the cracks (see Figure 14). The delamination extended onto the outside vertical surface and was immediately adjacent to a 14 ft² repaired area at the south end of the overhang. The repair area extended across the entire width of the overhang and continued onto the outside vertical surface. In addition, there was corrosion staining in several areas on the overhang that appeared to be caused by steel chairs or form nails (see Figure 15).

Figure 13. Longitudinal cracks with corrosion staining and efflorescence on the west deck overhang in Span 3.

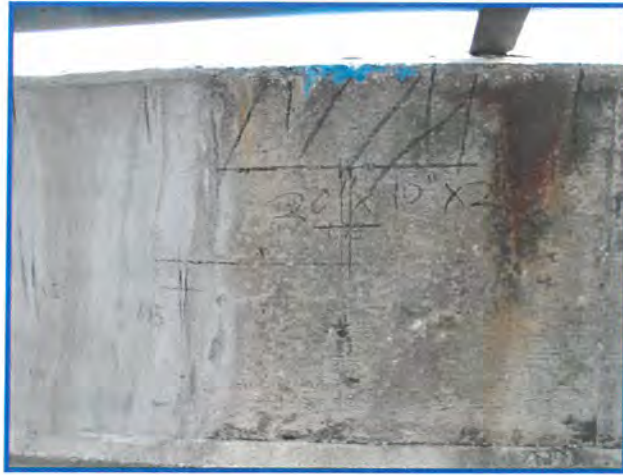
Figure 14. Cracked and delaminated area (shown with black crosshatch markings) immediately adjacent to a repaired area on the west deck overhang in Span 3.

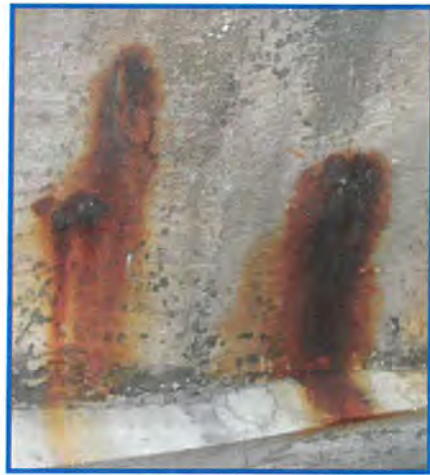
Figure 15. Typical areas with corrosion staining caused by steel chairs or form nails on the west deck overhang in Span 3.

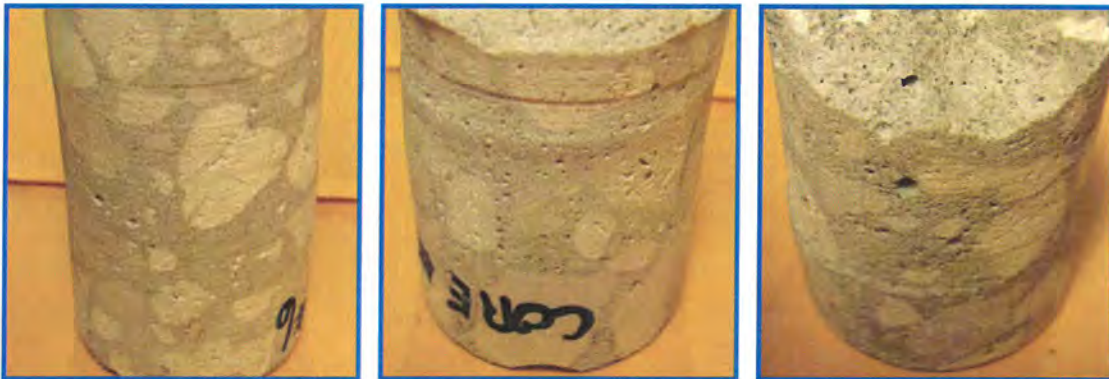
Based on the visual appearance of the core samples obtained, the original concrete comprising the piles, bent caps, and deck overhangs is well consolidated, dense, and has a typical amount of small entrapped air voids (see Figure 16). As shown in Figure 17, the repair concrete used on Bent Cap 4 and the deck overhangs has larger entrapped air voids relative to the respective original concrete. In addition, some of the voids in the repair concretes are quite large and may be indicative of inadequate consolidation, particularly in the repair concrete used on the deck overhangs.

Figure 16. Condition of original pile, bent cap, and deck overhang concrete.

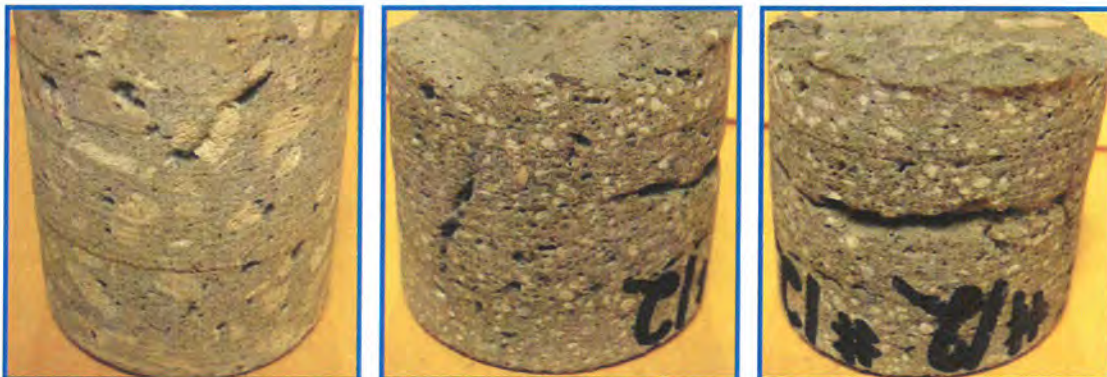
Overhang repair concrete (apparently trowel applied).

Figure 17. Condition of repair concrete on Bent Cap 4 and deck overhangs.

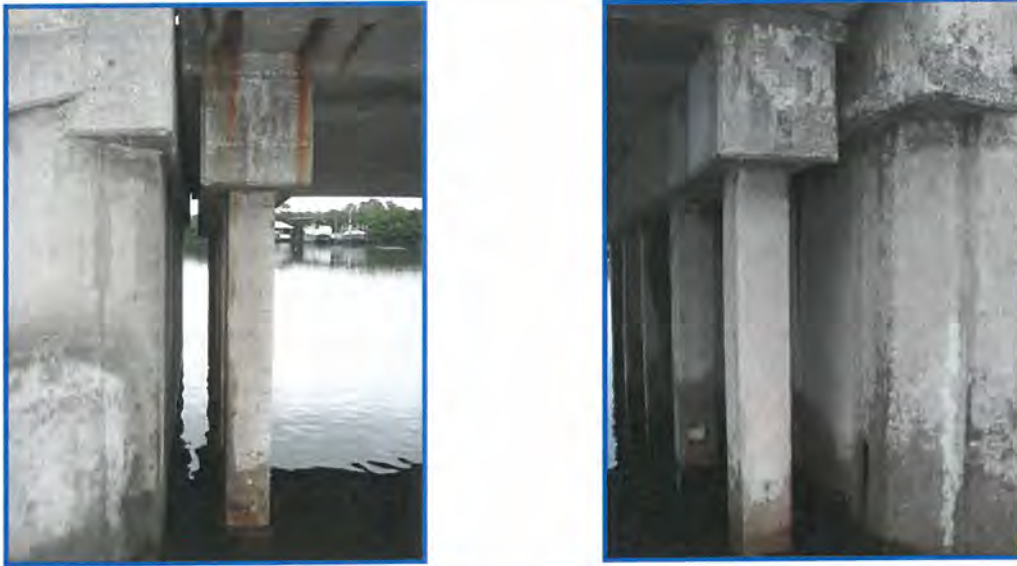
Figure 18. Limited available working space between Bent Caps 1 (left photograph) and 6 (right photograph) and the abutments.

During the rehabilitation work, any severely deteriorated reinforcing steel should be repaired as directed by a Bridge Structural Engineer and determination of the need to incorporate new structural reinforcing steel into the repairs should be made by a Bridge Structural Engineer. Also, during the rehabilitation design phase, special consideration will be needed to address the limited working space available (i.e. 5.5" to 6.5") between Bent Caps 1 and 6 and the corresponding abutments (see Figure 18).
