**Pinellas County, Florida
Waste-To-Energy Facility**

**Draft Operations Report for the
1st Quarter of Billing Year No. 1
(October - December 2014)**

April 2015

**CDM
Smith**

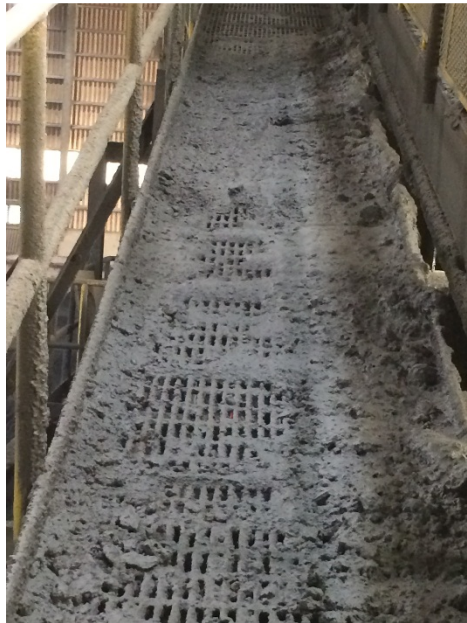
Figure 2-6
Poor housekeeping in RSPB on inclined grating along belt conveyor feeding
minus 5-inch ash to metal recovery system
(October 2014)

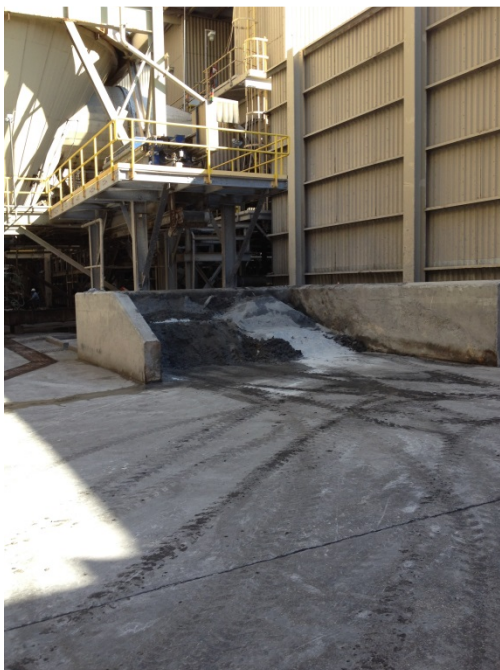
Figure 2-11
Dumped fly ash stored in belt filter press bunker for transfer to RSPB
(October 2014)

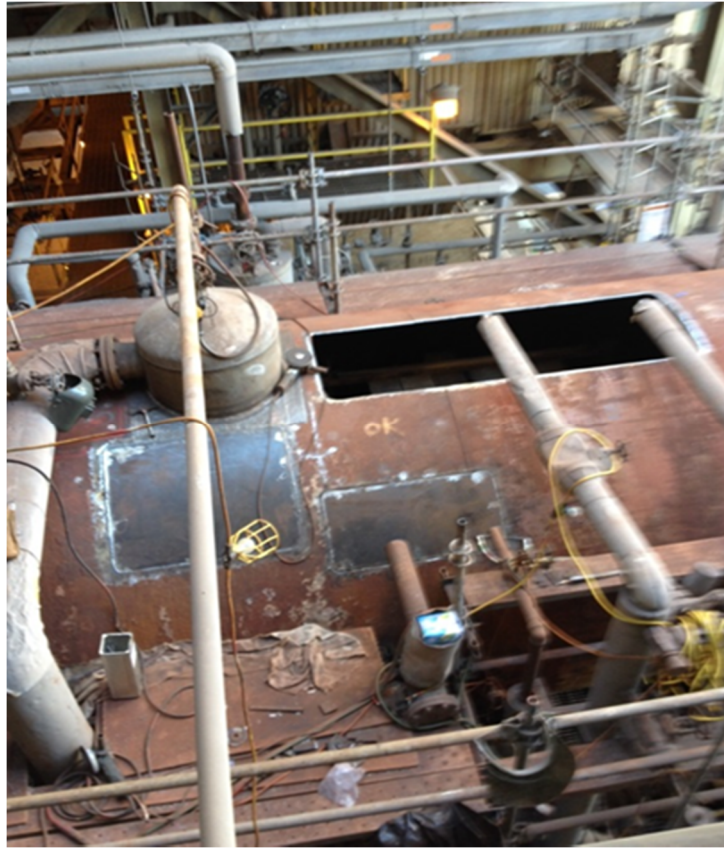
Repairs to Deaerator No. 2 Shell (December 2014)

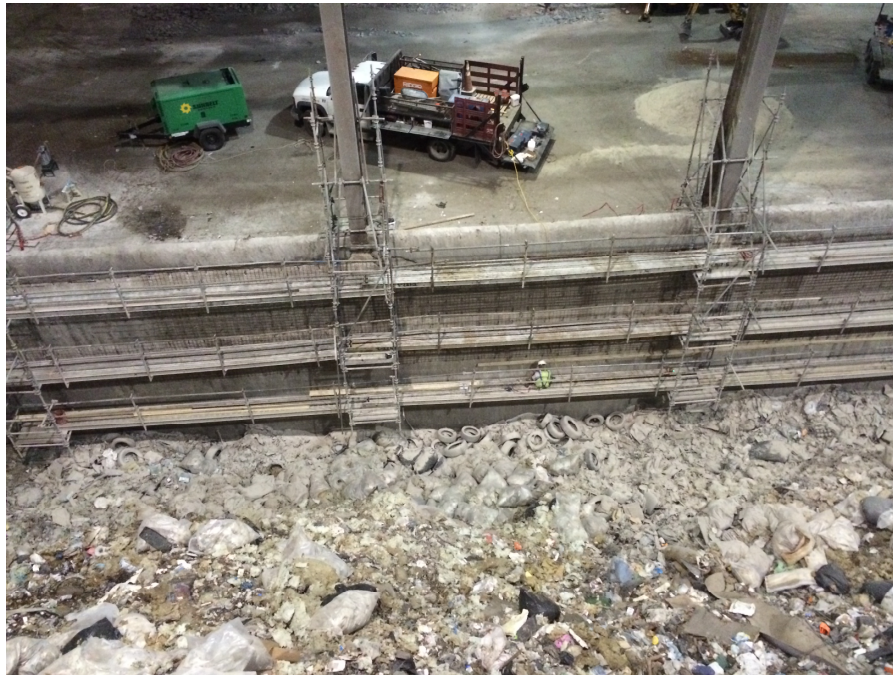
Scaffolding for structural repairs to tipping bays No. 3, 4 and 5

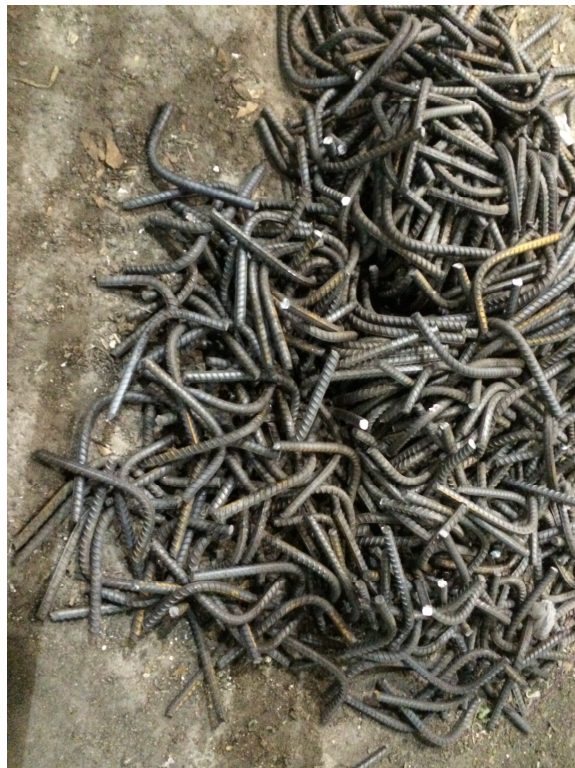
Dowels which were installed on 18 inch centers in refuse pit front wall

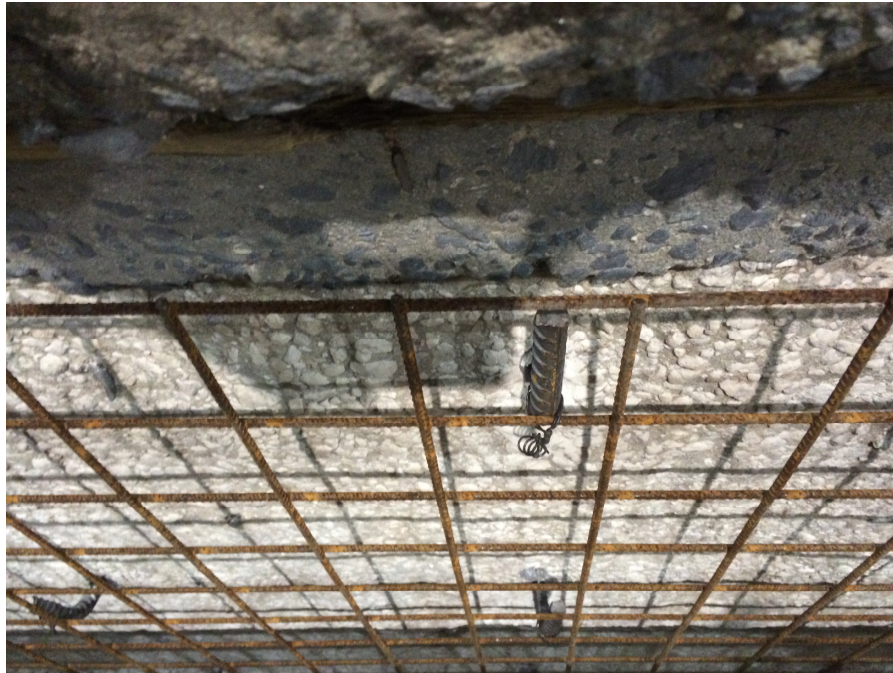
**Preparation for structural repairs to tipping bays 3, 4 and 5
(Dowels and WWF installed after sandblasting of area to be repaired)**

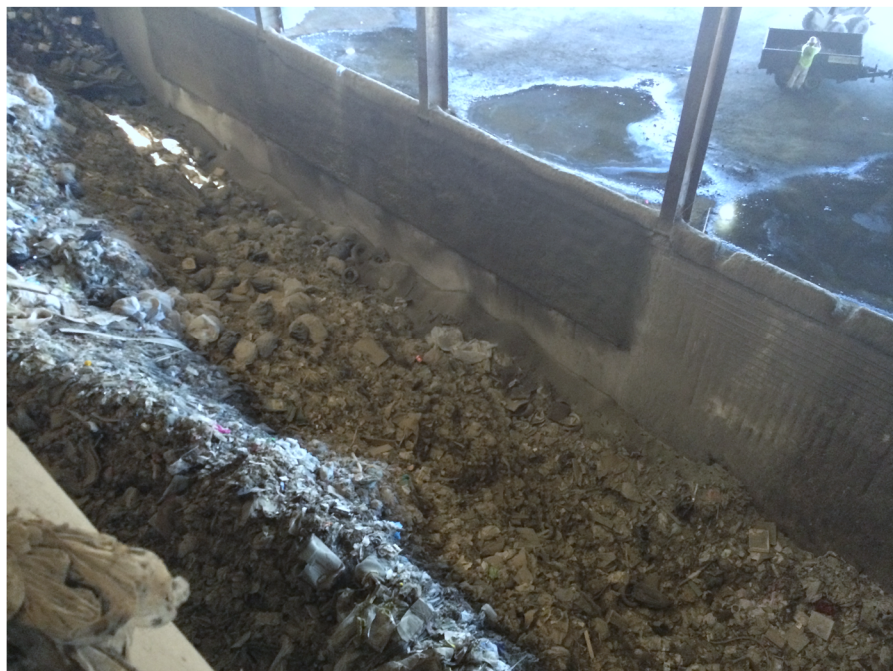
Structural repairs to tipping bays 3, 4 and 5 (note bay 6 to right still needs repaired)

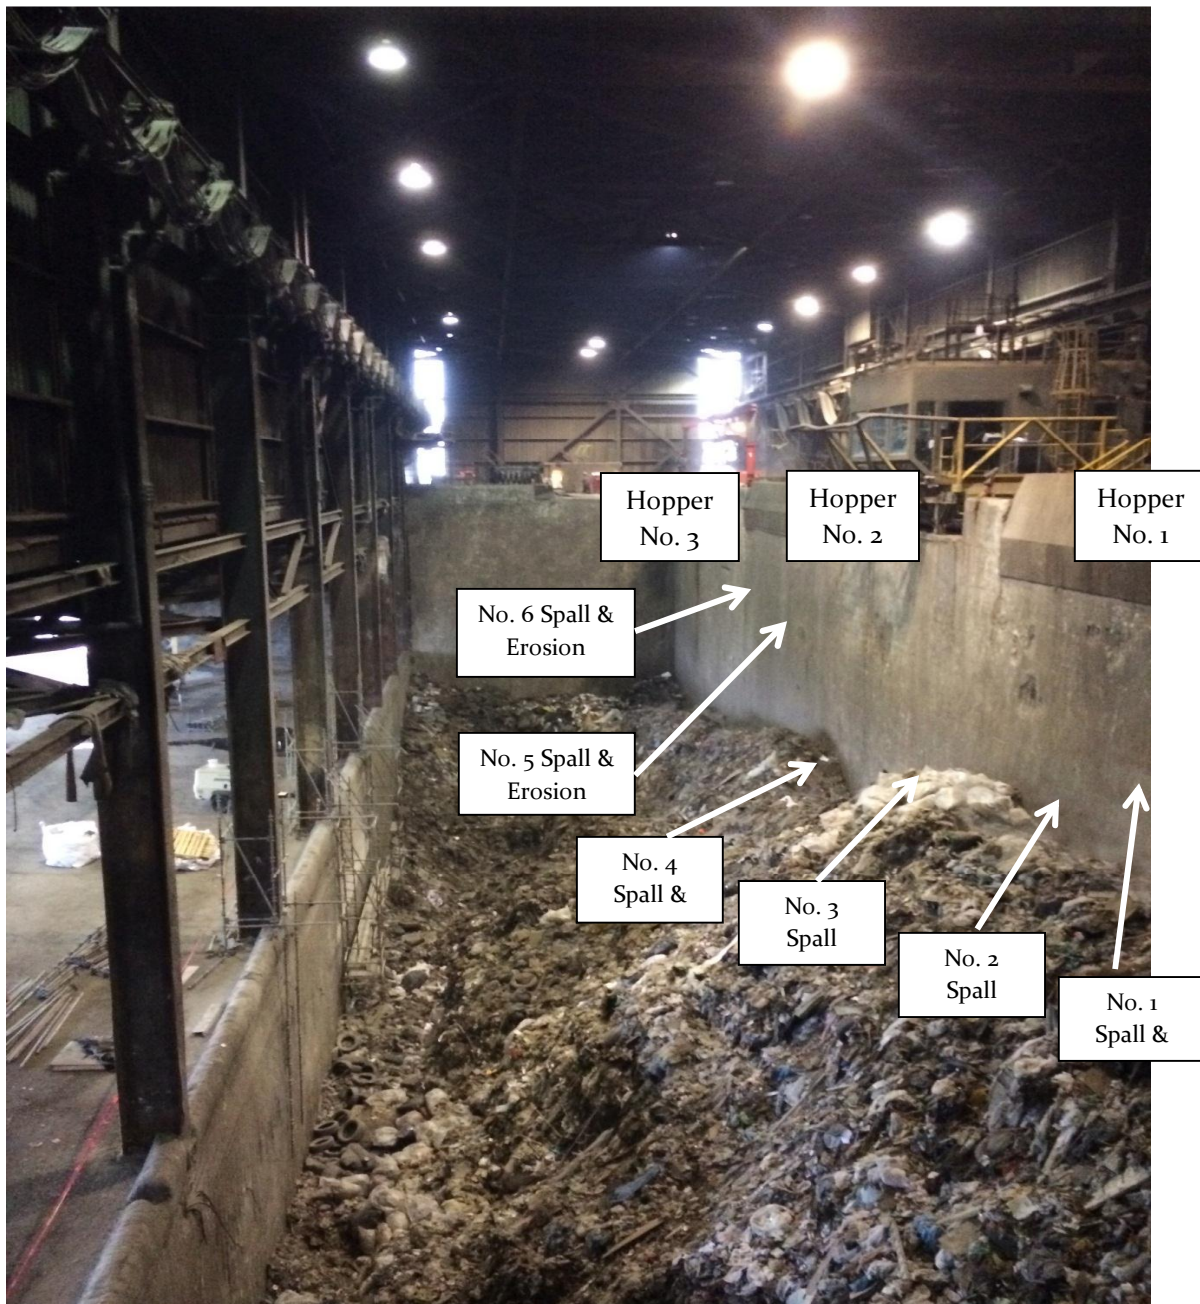
In addition to tipping bay 6 which remains to be repaired, CDM Smith observed six additional areas of damage (primarily spalled areas) to the refuse pit concrete on the opposite high wall of the refuse pit. These areas illustrated below have been noted for future repairs.

Overall view of refuse pit looking north with damaged areas noted in high wall (east)

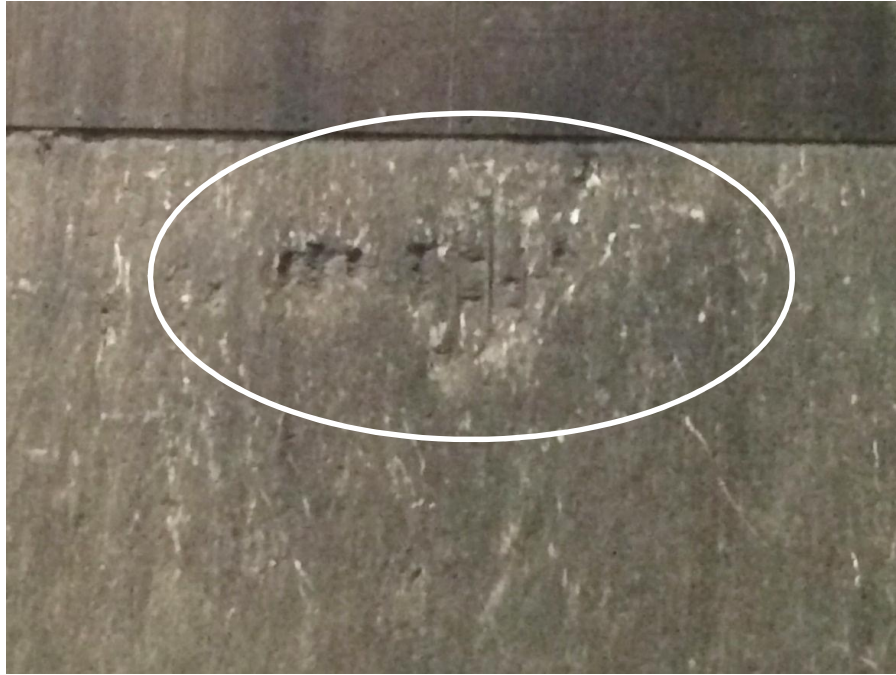
Photo of Damaged Area No. 1 – Spall and erosion damage under Feed Hopper No. 1 (center)

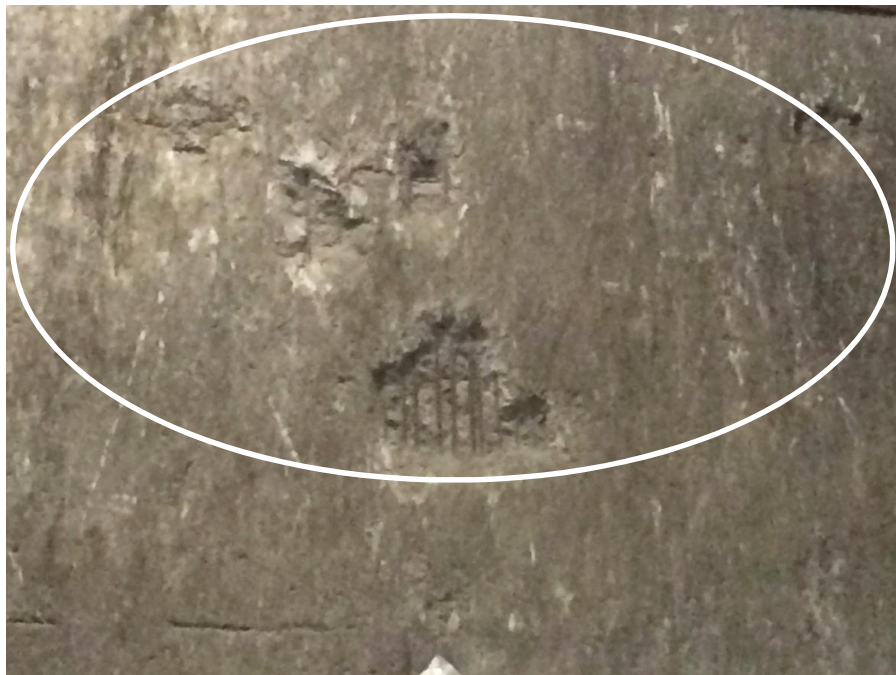
Photo of Damaged Area No. 2 – Spall damage under Feed Hopper No. 1 (north end)

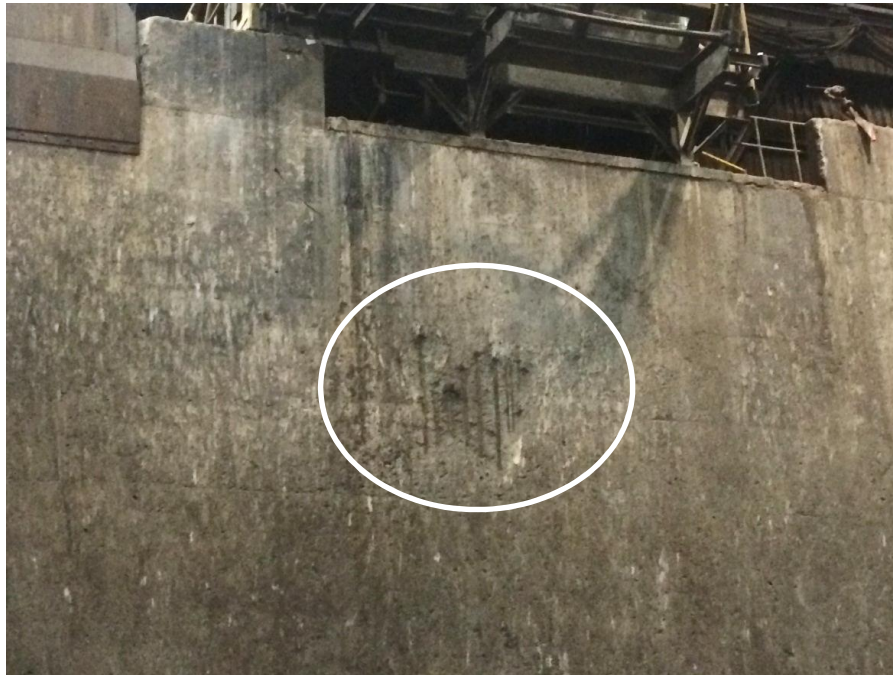
Photo of Damaged Area No. 3 – Spall damage under crane pulpit (north)

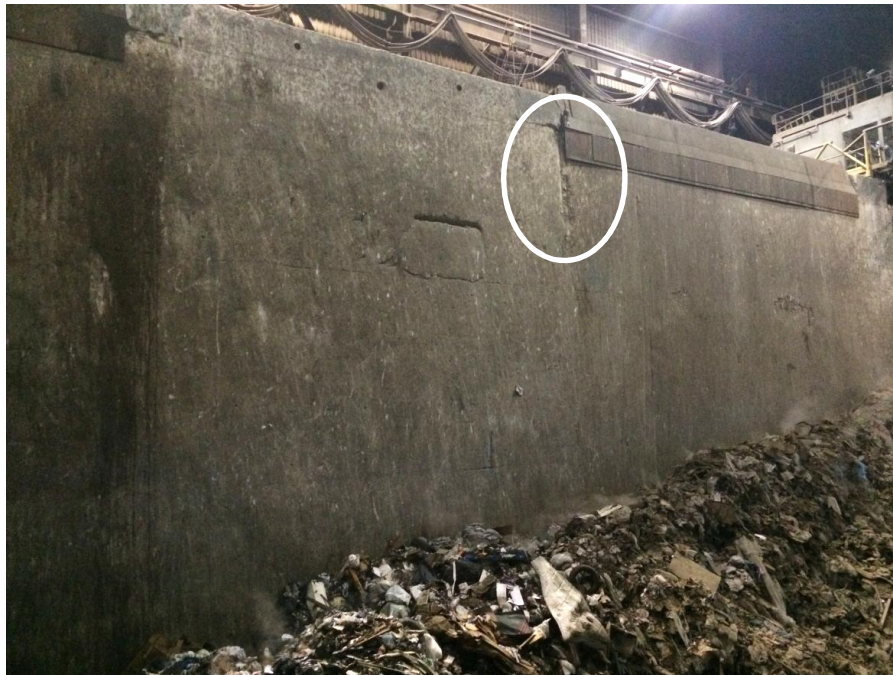
Photo of Damaged Area No. 4 – Spall and erosion damage under Feed Hopper No. 2

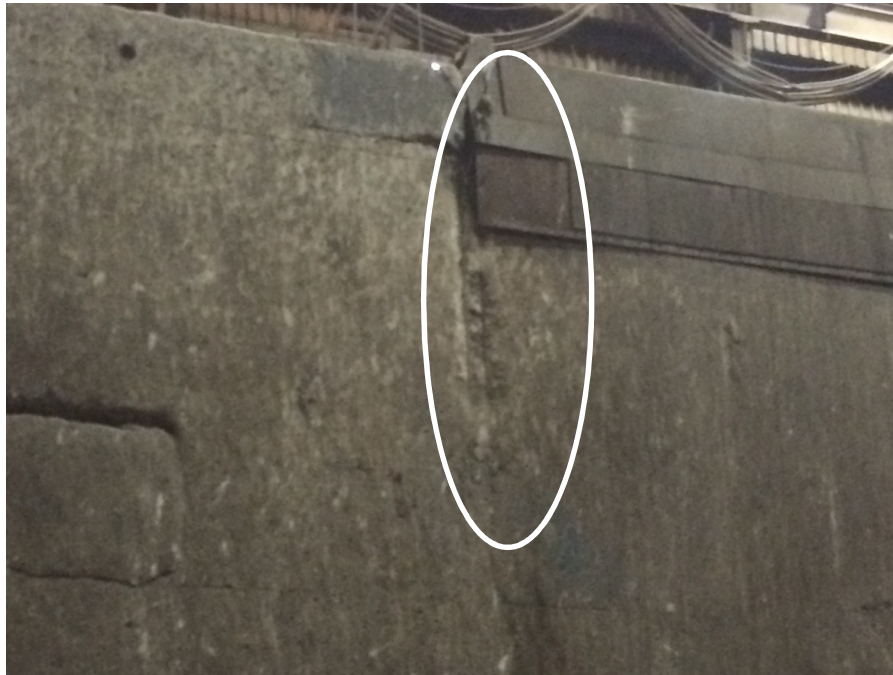
Photo of Damaged Area No. 5 – Erosion along north side of Feed Hopper No. 2

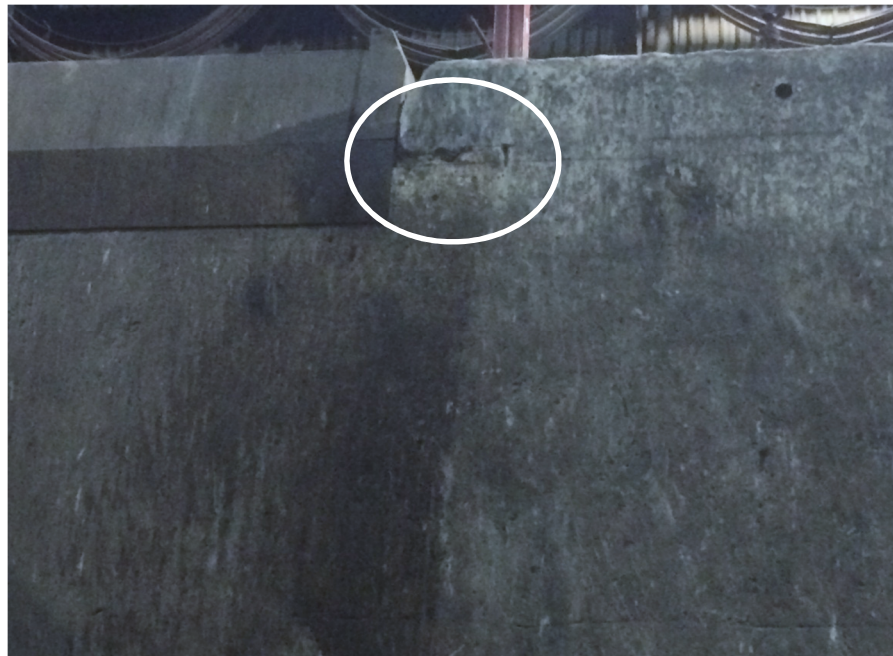
Photo of Damaged Area No. 6 – Spall/erosion along intersection of top of refuse pit, charging floor, and parapet wall on south side of Feed Hopper No. 3

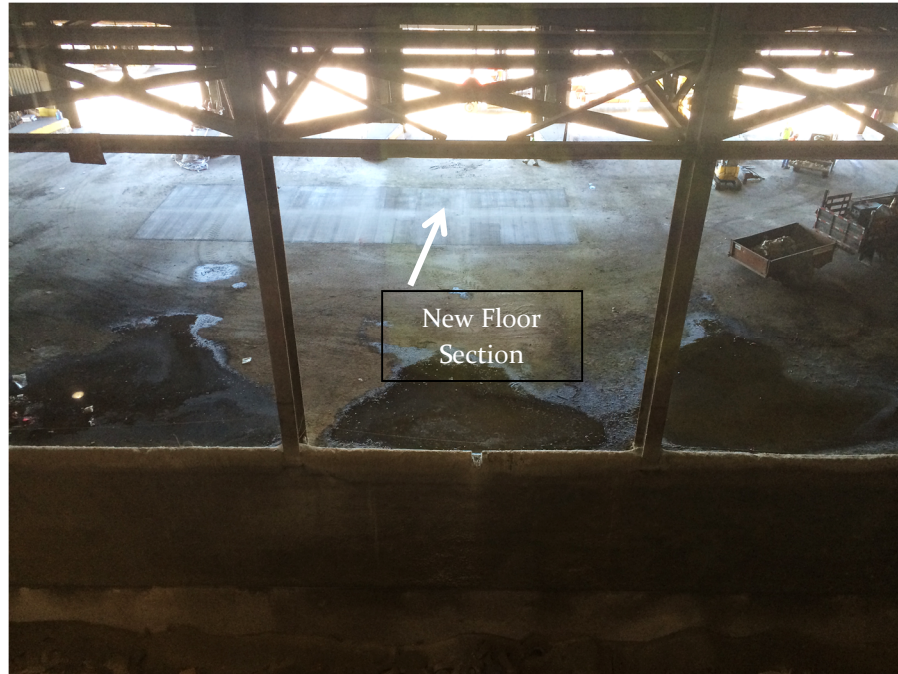
Section of new concrete tipping floor (opposite of bays 4 and 5)

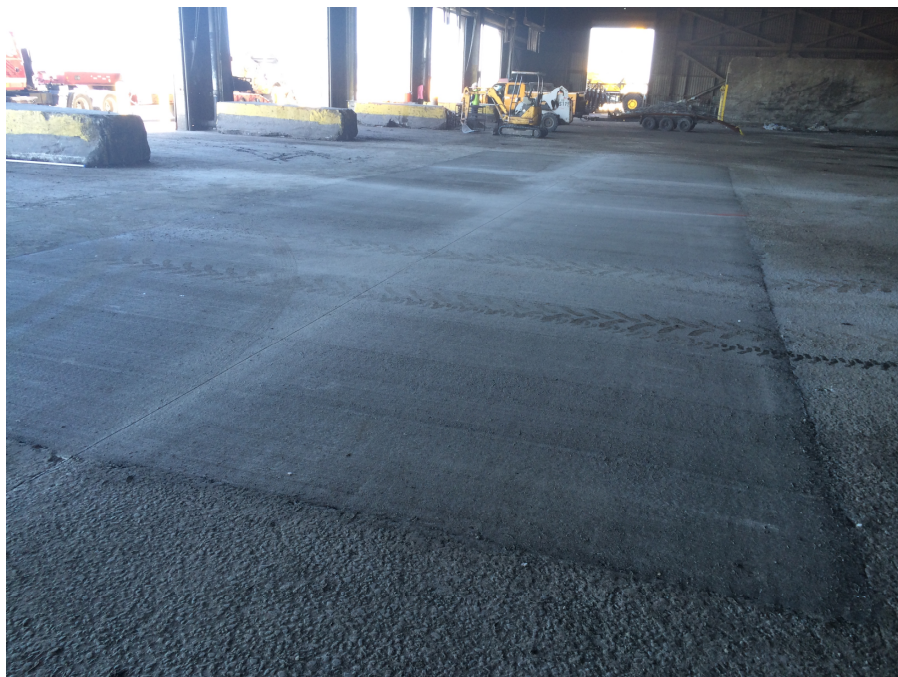
Close-up of new concrete tipping floor (opposite of bays 4 and 5)

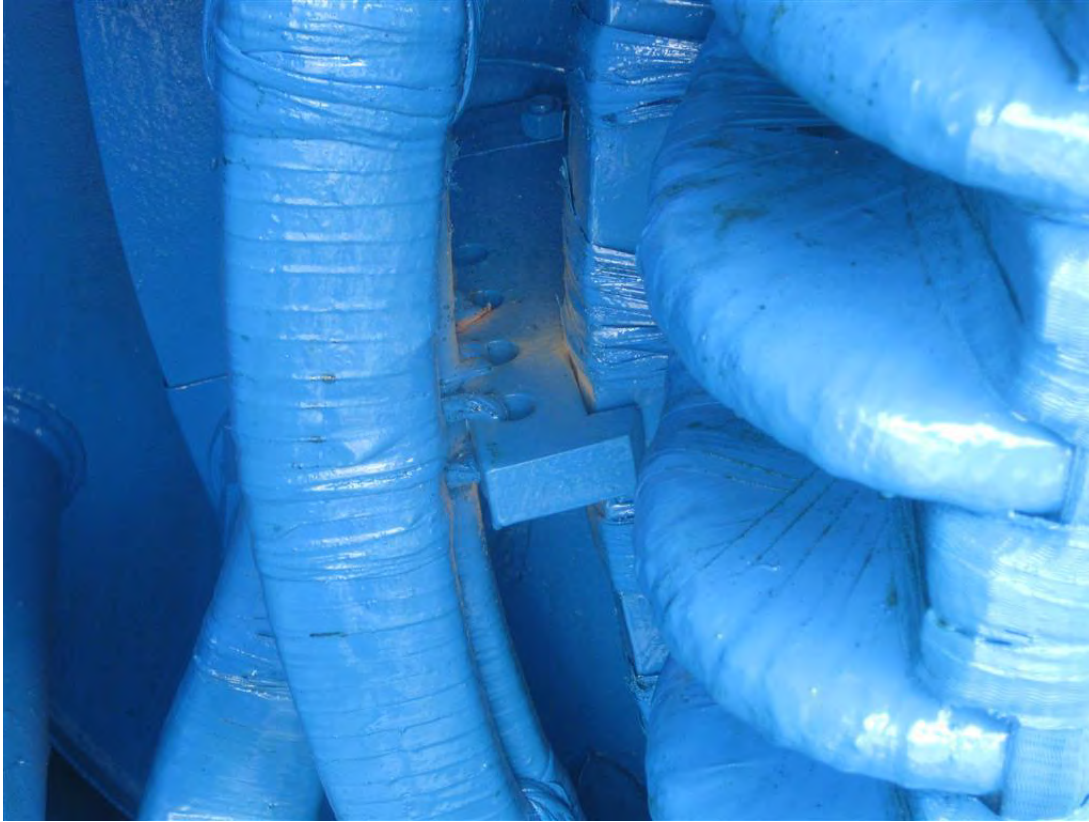
Figure 1 The white residue is referred to as "dusting" and is indicative of a poor bond between connected parts

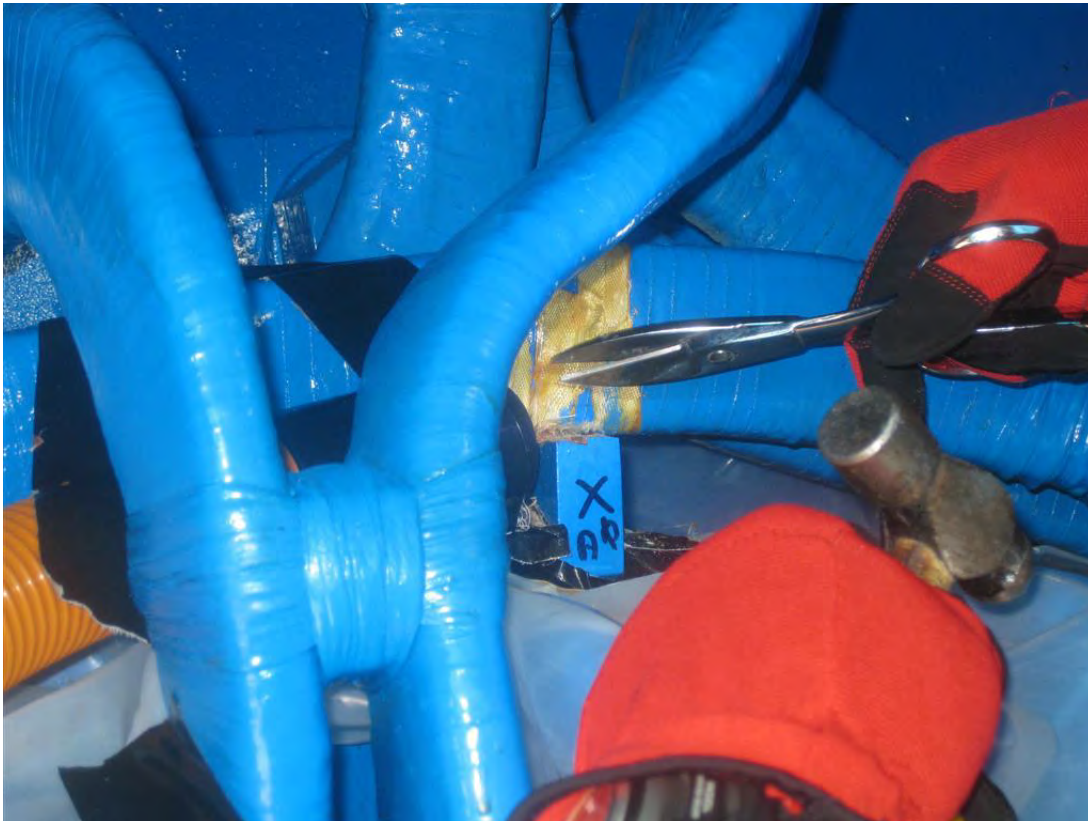
Figure 2 Loose binding being prepped for new binding materials and epoxy encapsulation

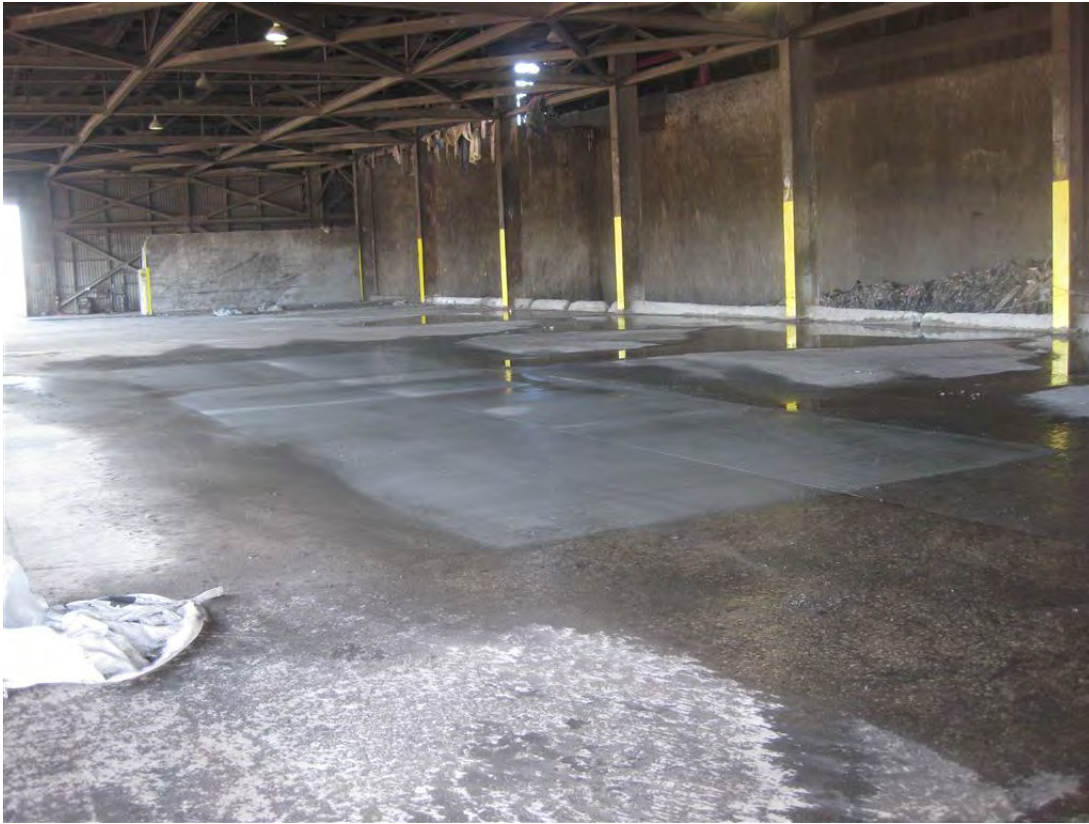
Figure 3 Replaced section (~15' x 30") of concrete floor in the Tipping Building

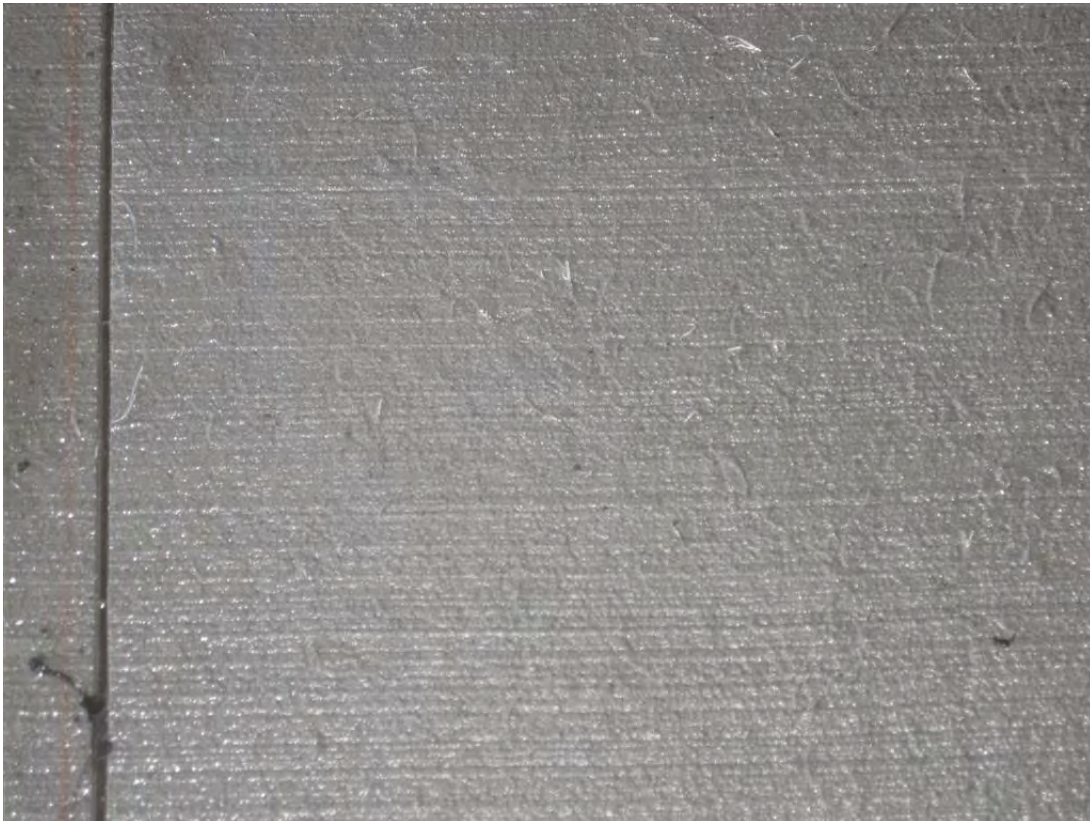
Figure 4 Note heavy concentrations of fiberglass fibers in the concrete. Fibers are intended to minimize cracks in the concrete.

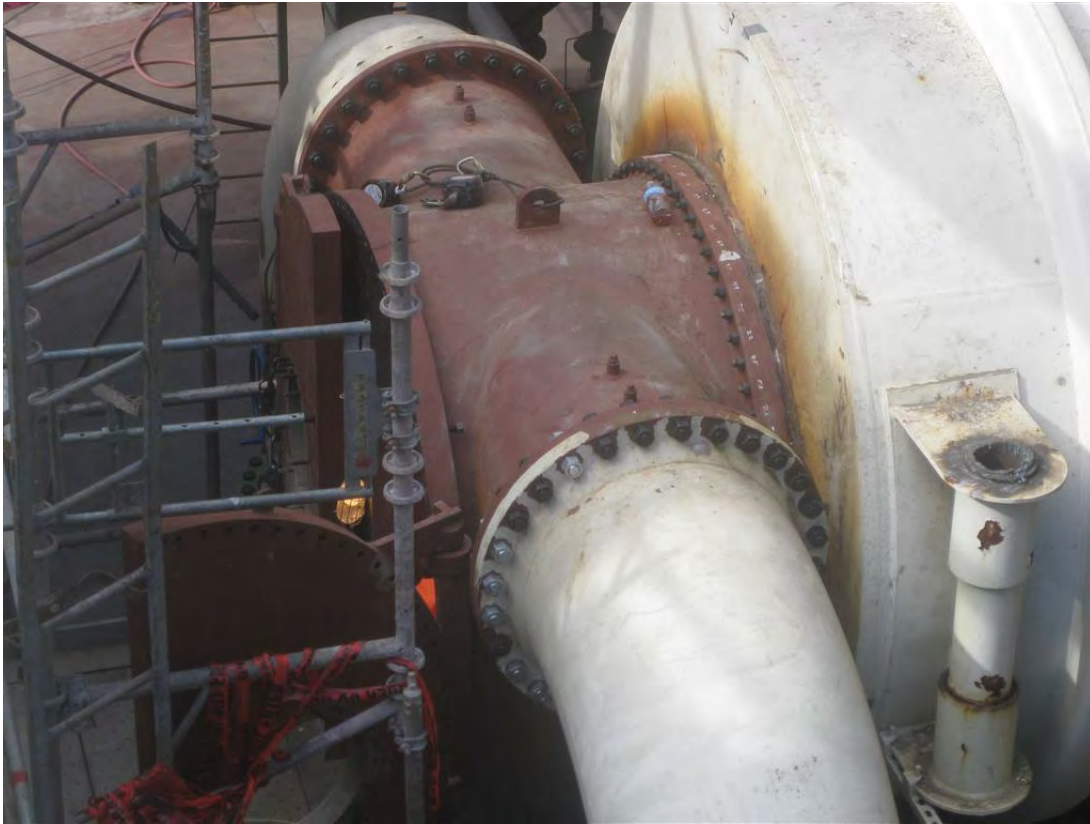
Figure 5 New inlet water box on Number 1 main steam condenser

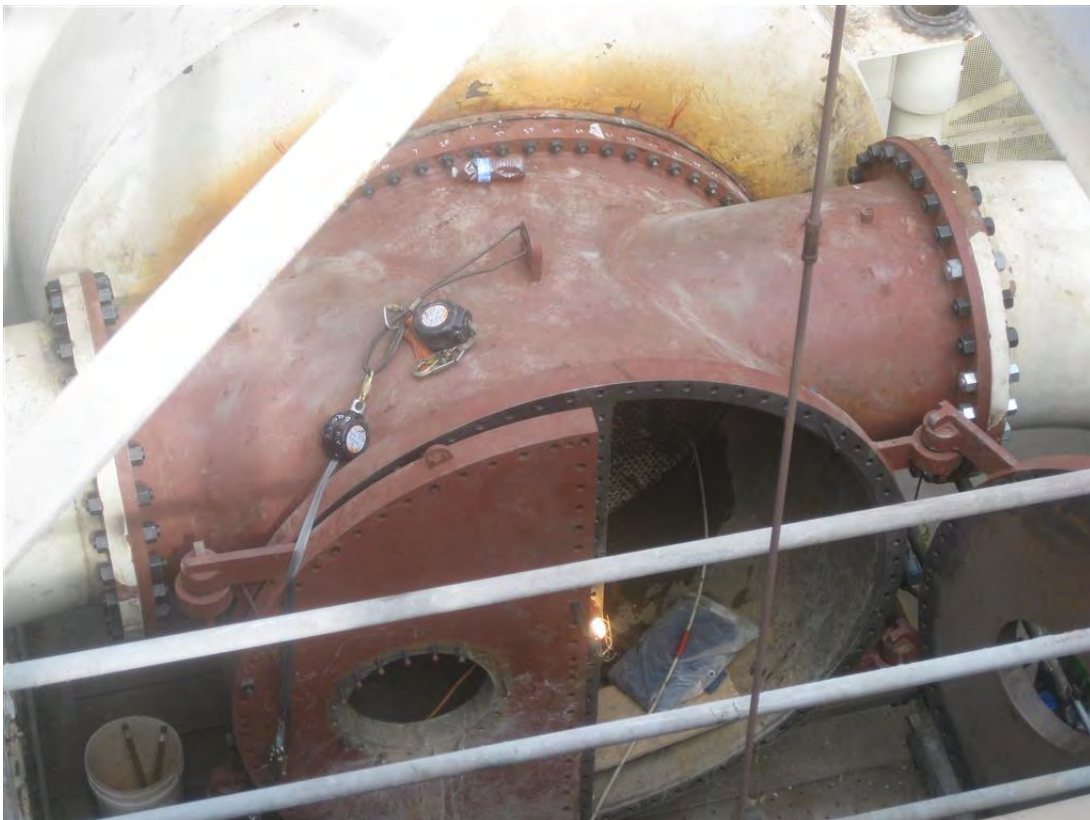
Figure 6 Number 1 Condenser water box

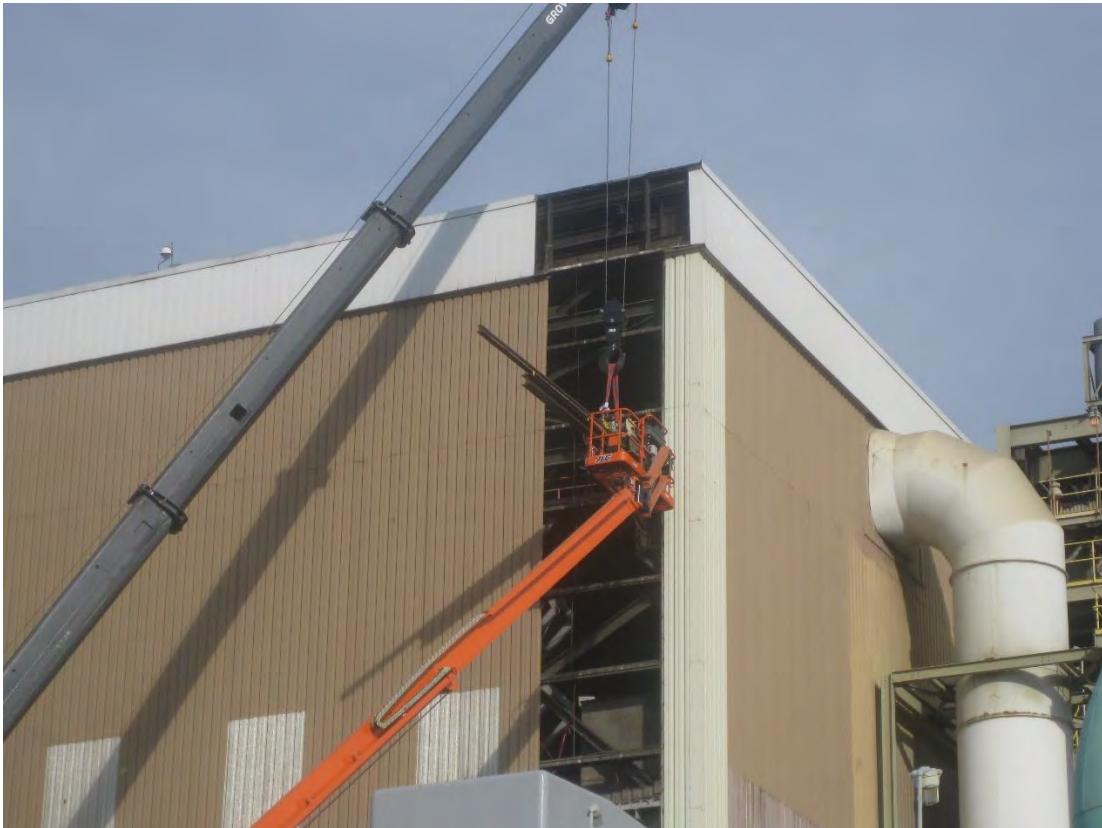
Figure 1 New east side rail for Refuse Cranes being lifted for installation in Refuse Building

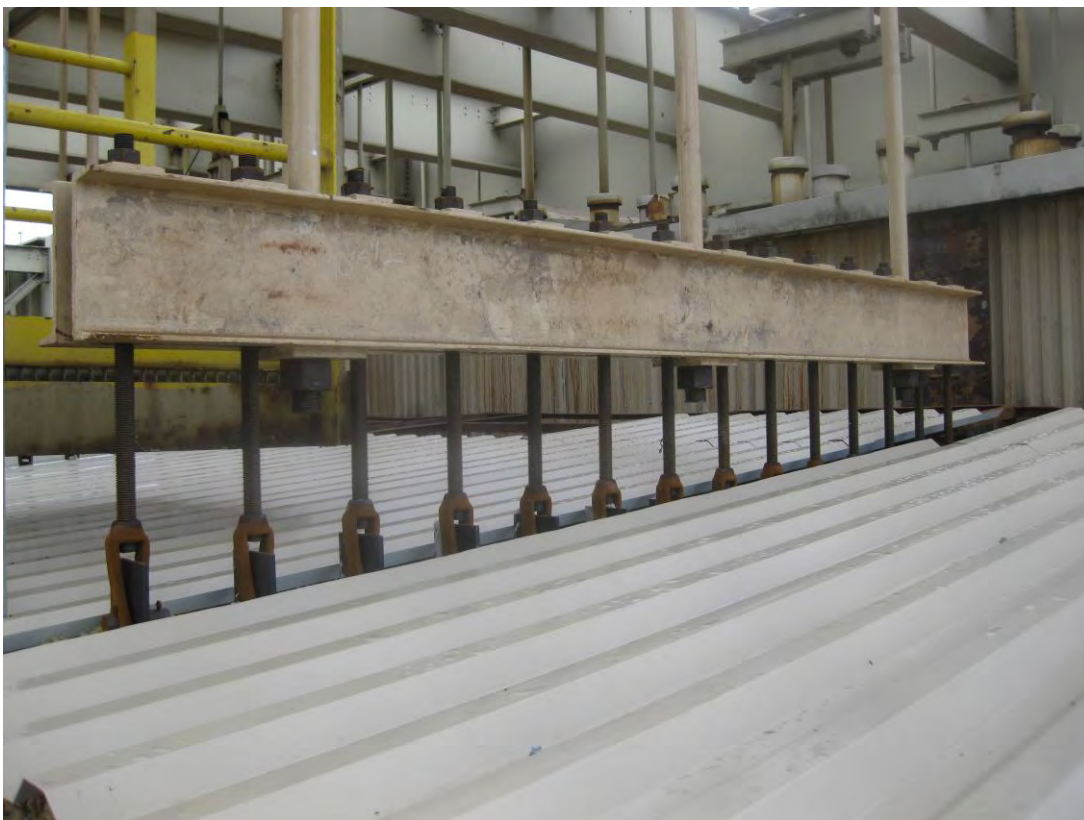
Figure 1 New Number 3 Economizer Stringer Tube Support Hanger System

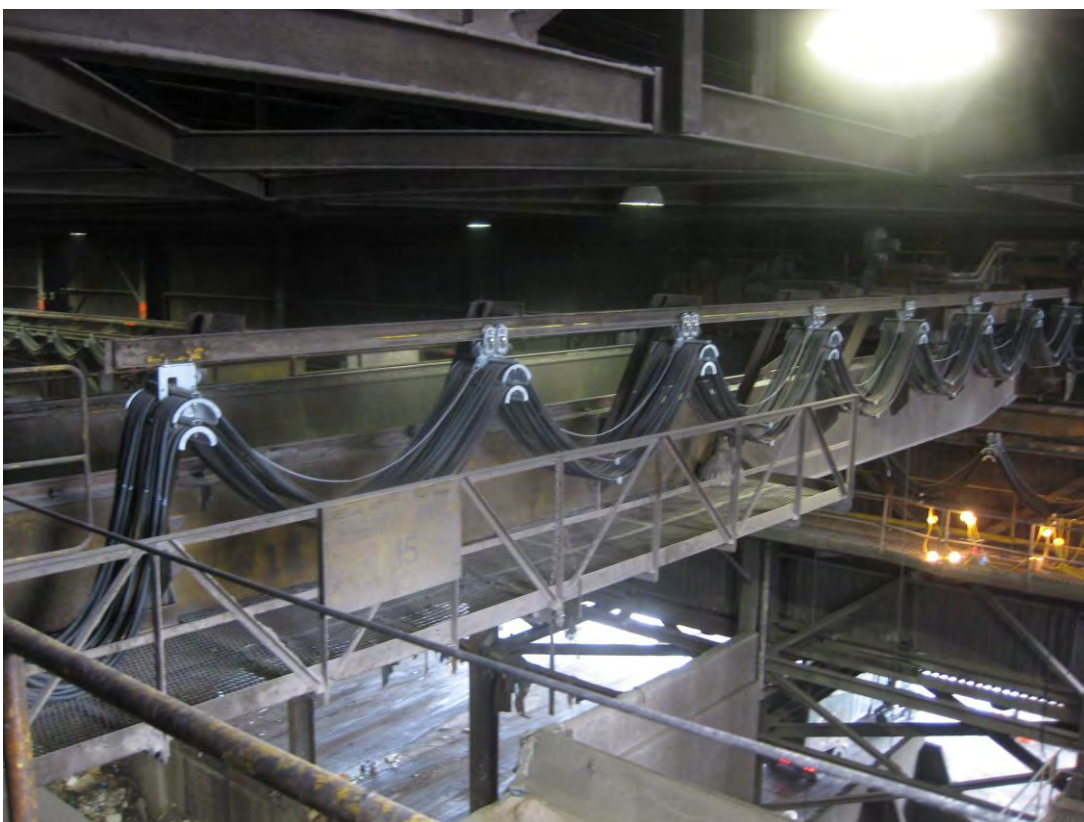
Figure 2 New Festoon Cables on Number Refuse Crane Trolley

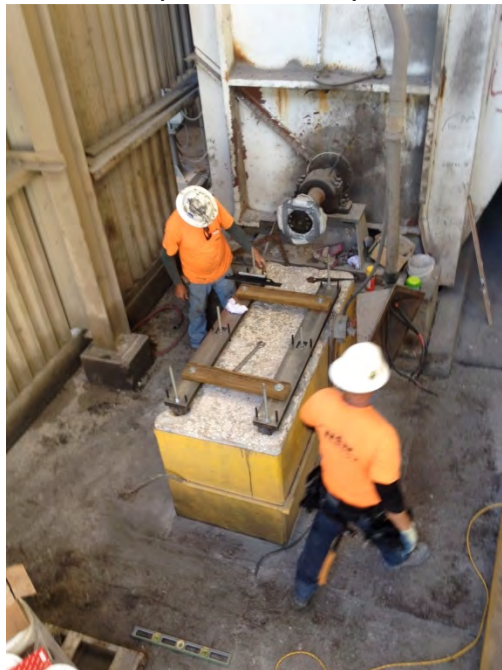
Figure B-15
Repaired concrete pedestal for FD Fan No. 1
(November 2014)

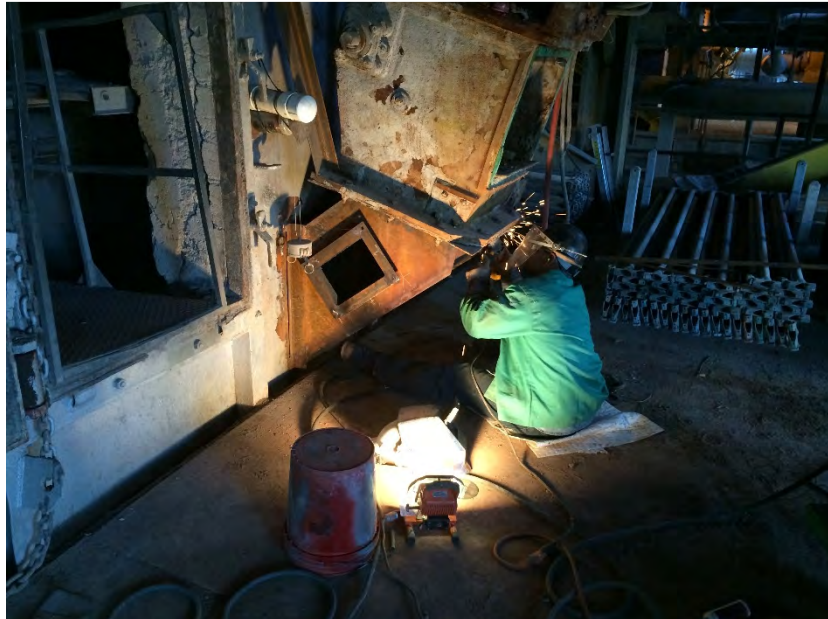
Figure B-25
Replacement of No. 3 economizer stringer tube and hanger support rods
(December 2014)

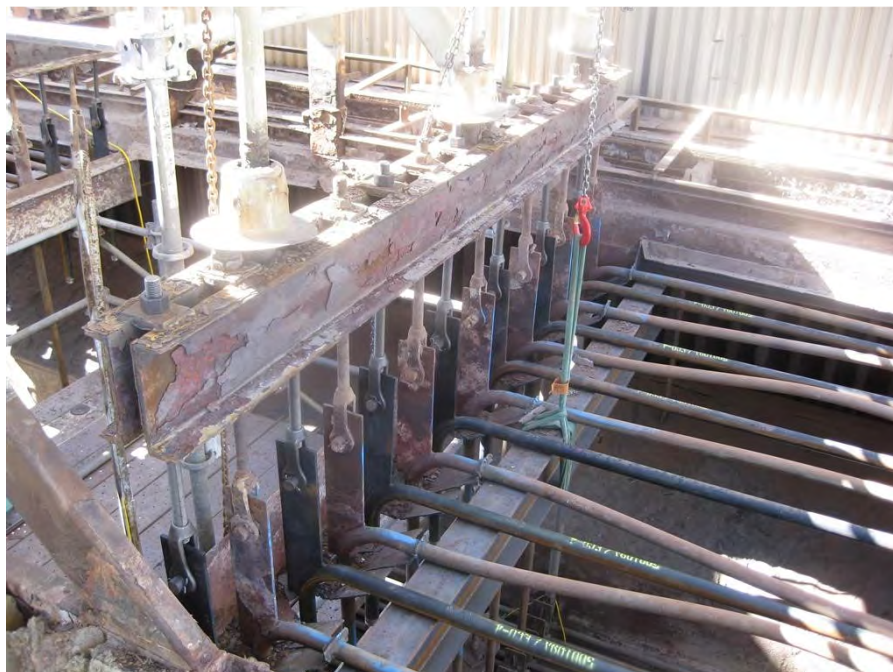
Figure B-26
New stringer tubes installed in No. 3 economizer roof
(December 2014)

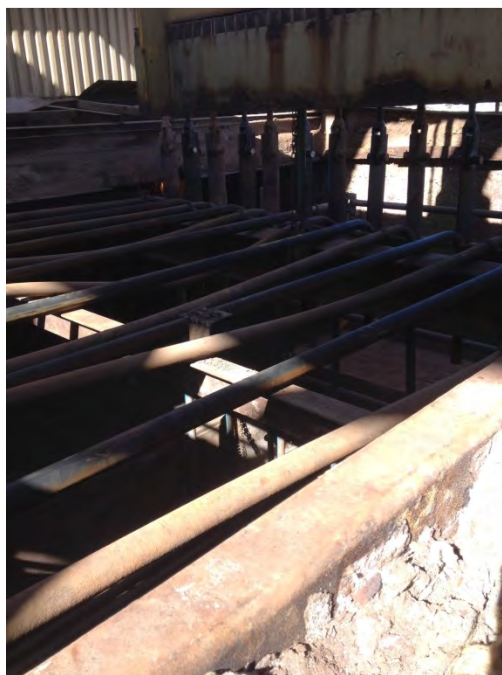
Figure B-27
Replacement of No. 3 economizer stringer tube and hanger support rods
(December 2014)

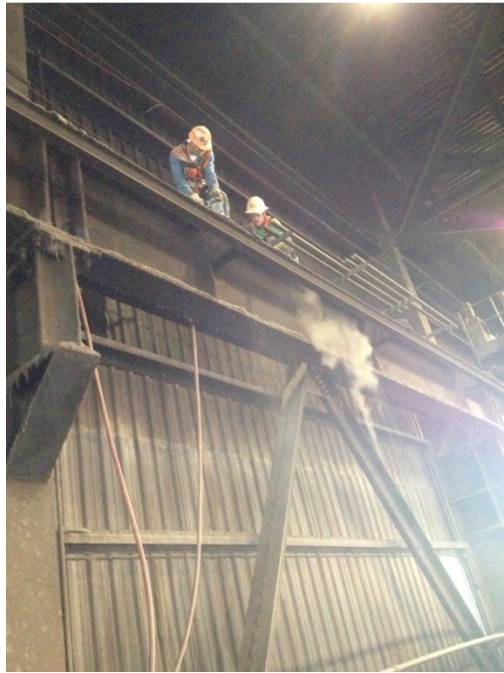
Figure B-34
Replacement of refuse crane rails in northeast corner of refuse building
(December 2014)

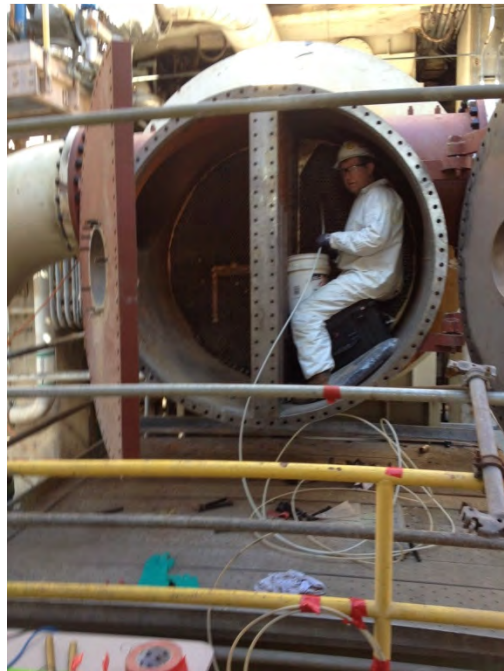
Figure B-41
Damage on the No. 3 flue
(December 2014)

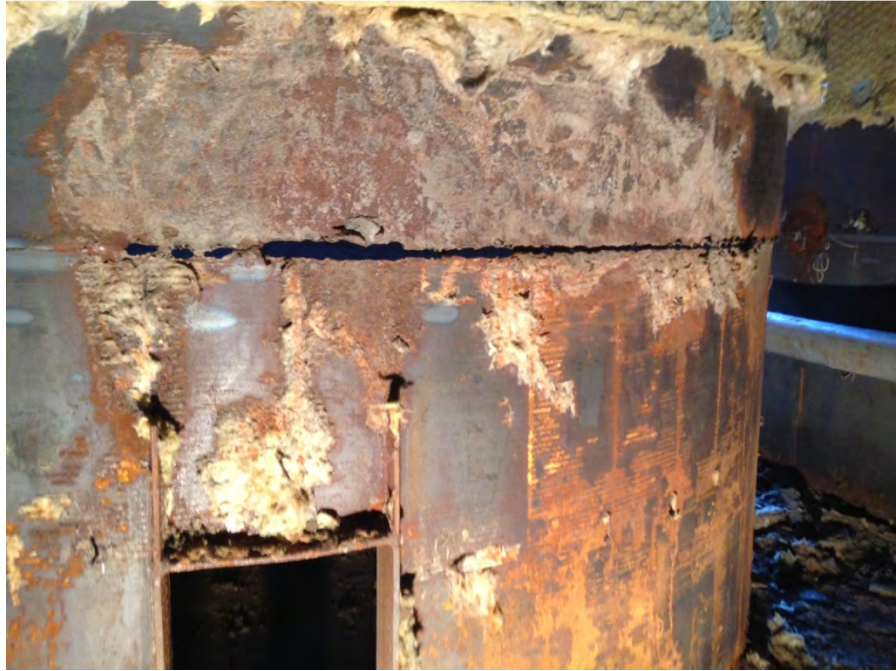
Figure B-42
Repairs to lower stack liners with replacement of lower 5 feet of liner
(December 2014)

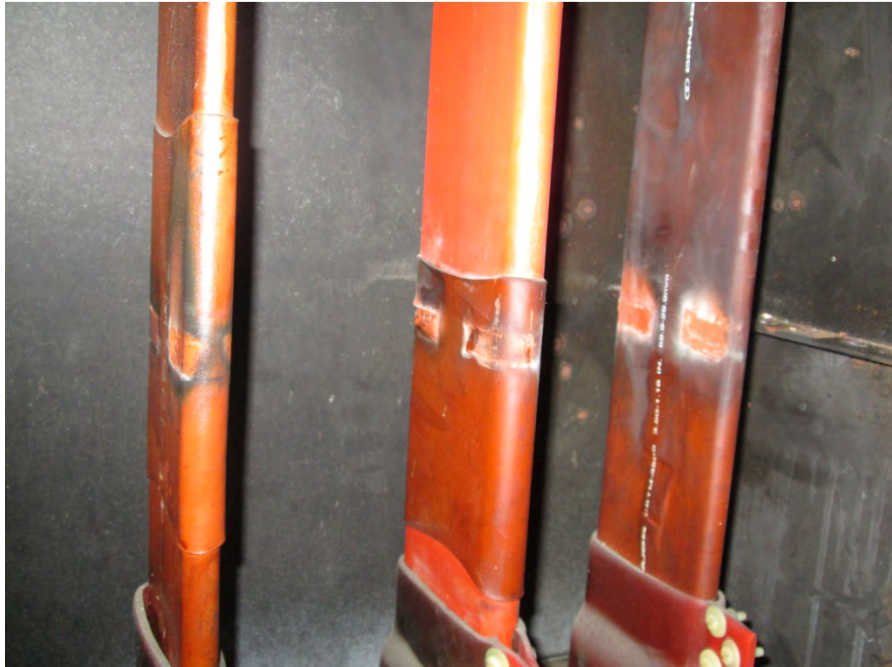
Figure B-45

**Grounding cluster installed prior to cleaning and testing the switchyard 13 KV SF6 circuit breaker
(December 2014)**
