Sediment Management Plan For the Watersheds of Clearwater Harbor and Saint Joseph Sound

Prepared for:
Pinellas County
Department of Environment
and Infrastructure

April, 2012

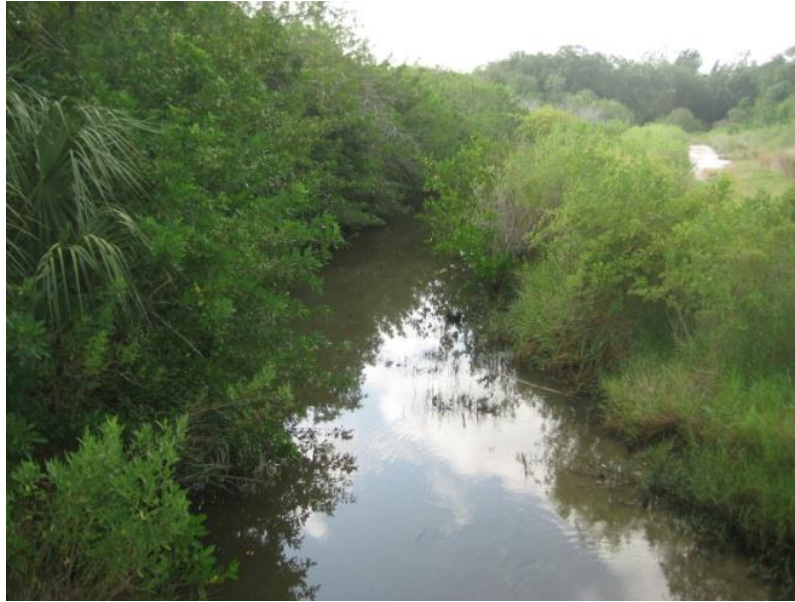
Site “Klosterman 1” is located just upstream of the stream crossing at Alternate US 19 (Figure 4-2). The reach is tidally influenced and has very little topographic relief. Water quality data indicate that the stream is brackish from its mouth to upstream of US 19 at the discharge point of the Innisbrook Resort lake system (Pinellas County, 2010; FDEP, 2008a). Much of the upstream drainage area is contained within the Innisbrook Resort water management system and very high flows at this site are not expected. The sediment probe was used to estimate fine-grained material and loose soft sand layers. Loose sediment layer depths ranged from 6 to 12 inches at the site.

Figure 4-2. Site Klosterman 1 looking upstream.

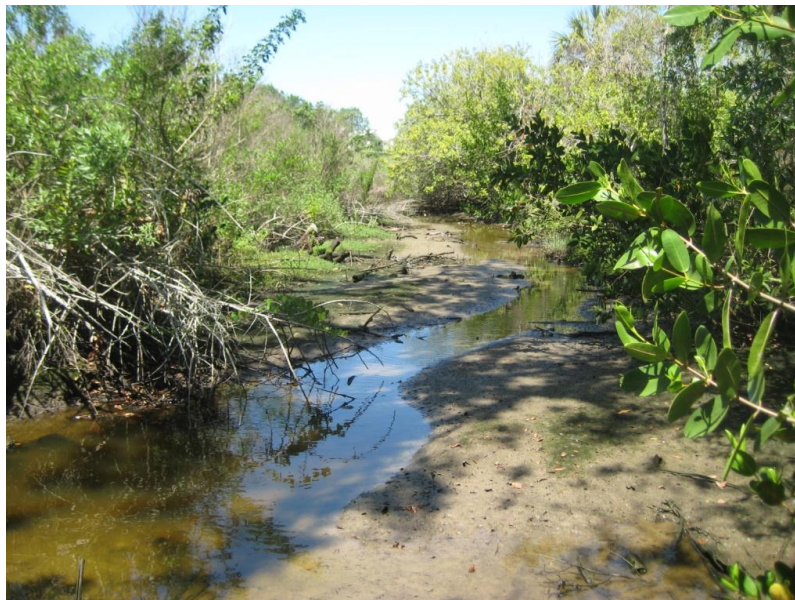
Figure 4-3. Site Klosterman 2 looking downstream.

Figure 4-3 shows the stream downstream of the trail. The stream reach is tidal and supports mangroves along the banks. Figure 4-4 shows the upstream reach to be overgrown, with significant amounts of detritus in the channel. However only a thin (1-inch) layer of silty/mucky sand sediment was observed. Although the channel banks were overgrown it appeared that the channel had been excavated at one time.

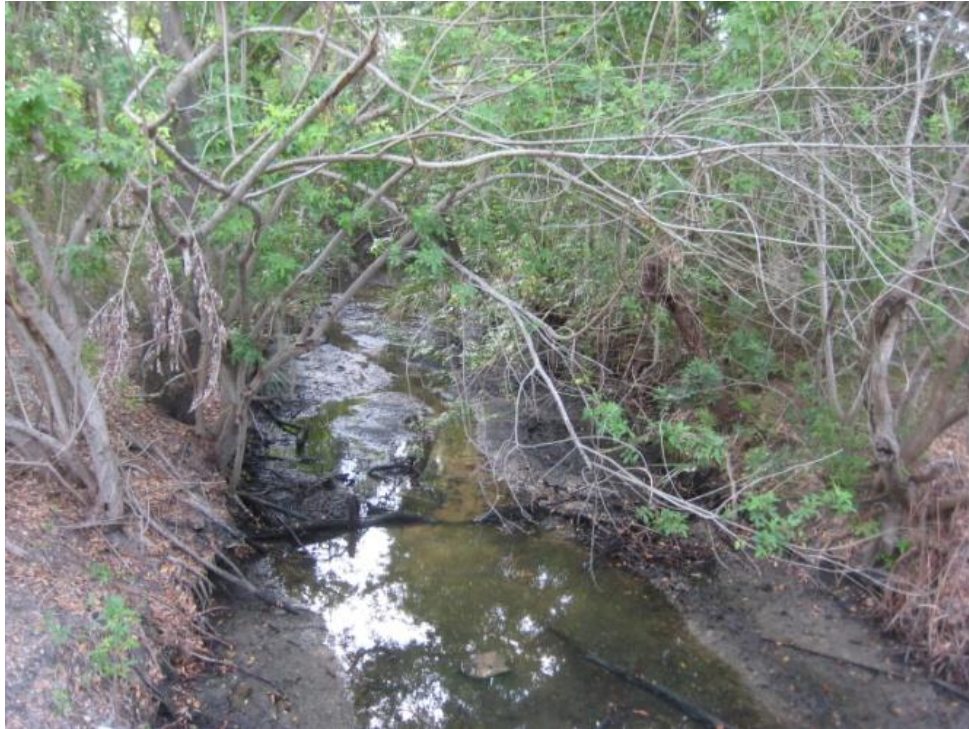
Figure 4-4. Site Klosterman 2 looking upstream.

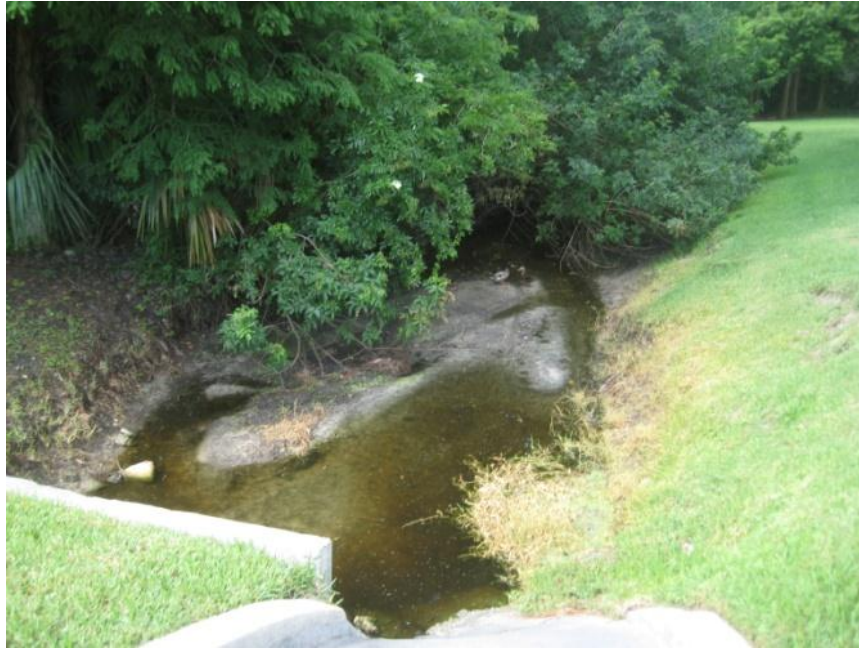
Site Klosterman 3 was on the Innisbrook Resort grounds near the stream headwaters. The stream was channelized with grassed side slopes (Figures 4-5 and 4-6). Soft sand with fine-grained material had accumulated to a depth of 10 inches upstream of the road crossing and had shoaled to 14 inches deep downstream of the Old Post Road culvert. Although potential issues with sediment accumulation were noted, the stream was on private property and its maintenance may not be a County responsibility

Figure 4-5. Site Klosterman 3 looking downstream.

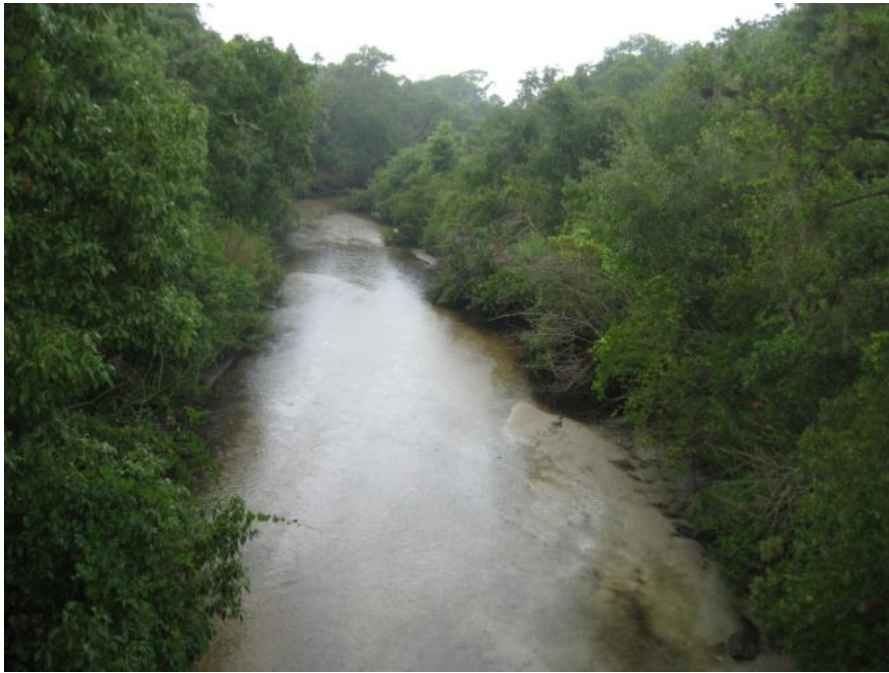
Figure 4-16. Site Curlew 1 looking downstream.

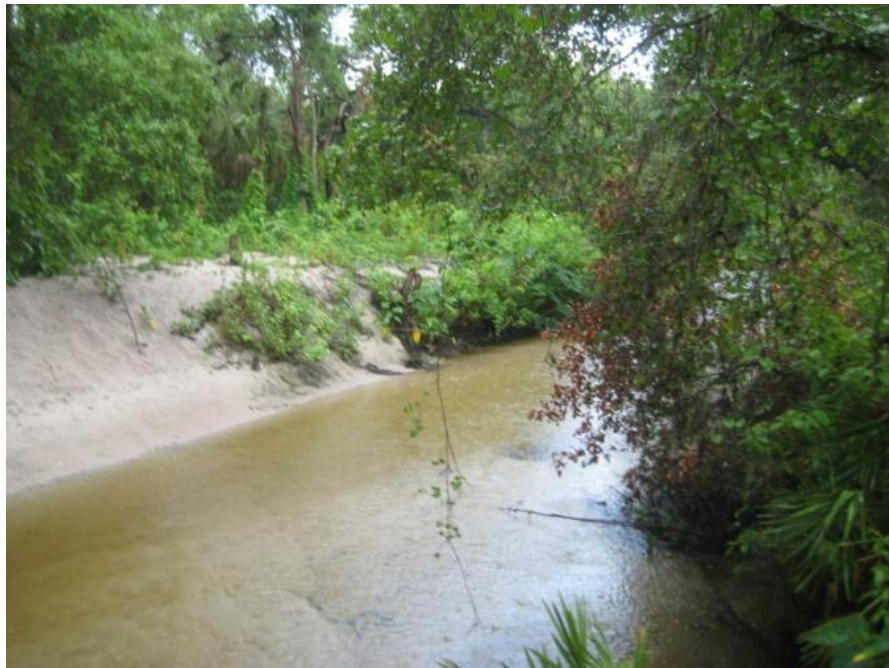
Site Curlew 2 is located in Curlew Creek Park about 0.2 miles upstream of Curlew 1. The channel is sinuous but the bed material is similar to that at Curlew 1 (about 2 – 3 inches of loose sand). There was virtually no fine-grained sediment visible in the channel. Figure 4-17 shows unstable loose sand banks, making this area susceptible to bank erosion.

Figure 4-17. Site Curlew 2 looking downstream.

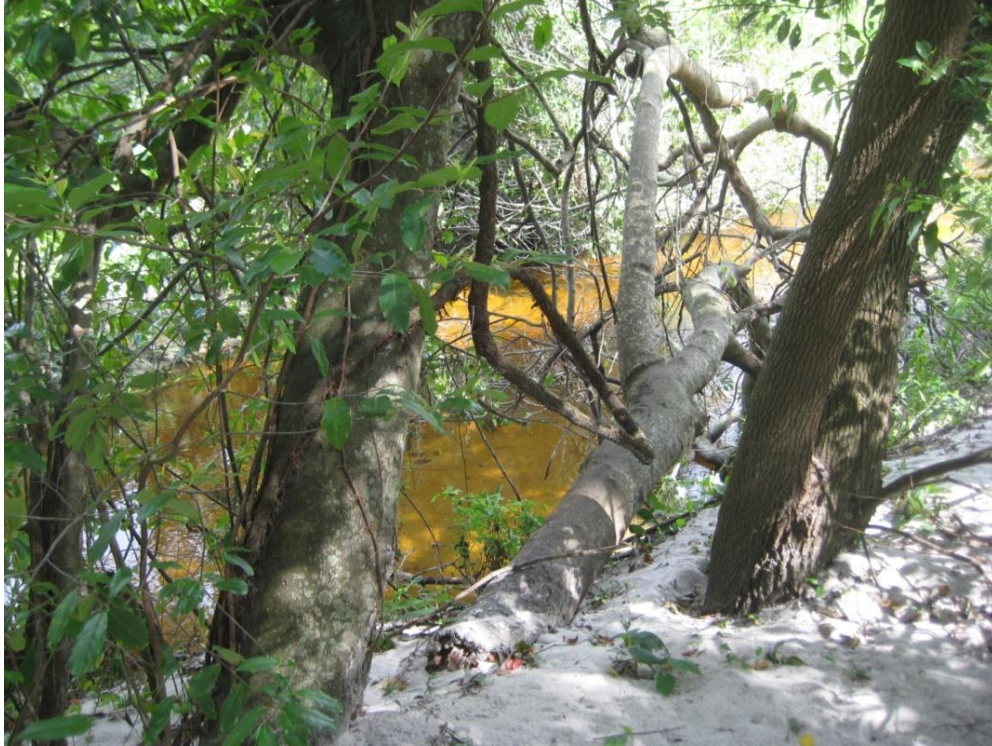
Site Curlew 3 is approximately 0.7 miles upstream of Curlew 2, 100 feet downstream of County Road 1. The channel is narrower than downstream reaches but the bed material appeared to be similar to Curlew 2, with about 2 inches of soft sand. Figure 4-18 shows tree damage caused by bank erosion. Figure 4-19 illustrates overbank shoaling at a residential lot caused by recent high flows in the stream.

Figure 4-18. Site Curlew 3 looking downstream showing tree downed during high flows.

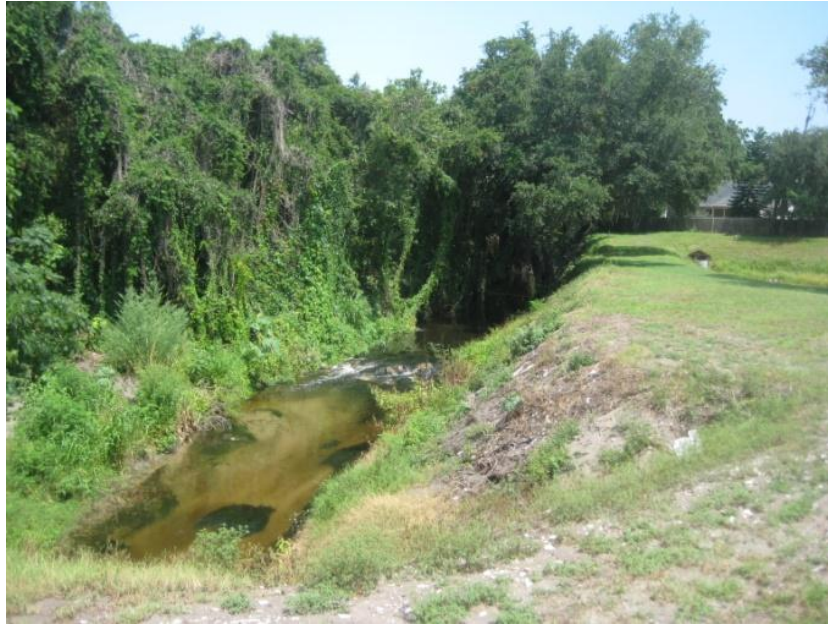
retention pond that was constructed in association with County Road 1 improvements. It is likely that the relatively steep south channel bank contributes material to the creek during rainfall events. Downstream, the bottom was generally clean with 2 – 3 inches of loose sand. Patches of fine-grained material and bottom algae were observed, but no major accumulations were noted.

Figure 4-20. Site Curlew 4 looking upstream.

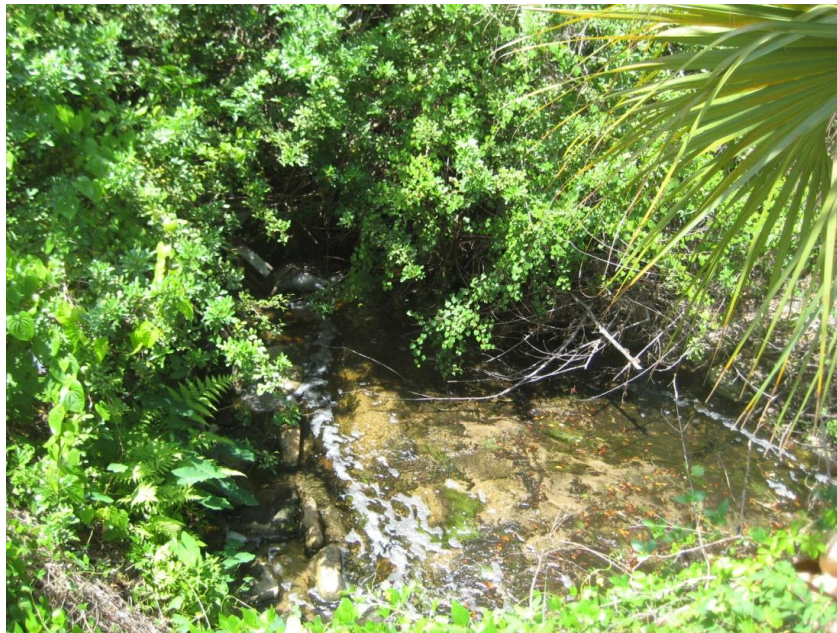
Site Curlew 5 is on the main stem at Estancia Blvd east of US 19. The channel was overgrown and had a sand bottom with 2 – 3 inches of loose sand. Figure 4-21 shows site conditions.

Figure 4-21. Site Curlew 5 looking downstream.

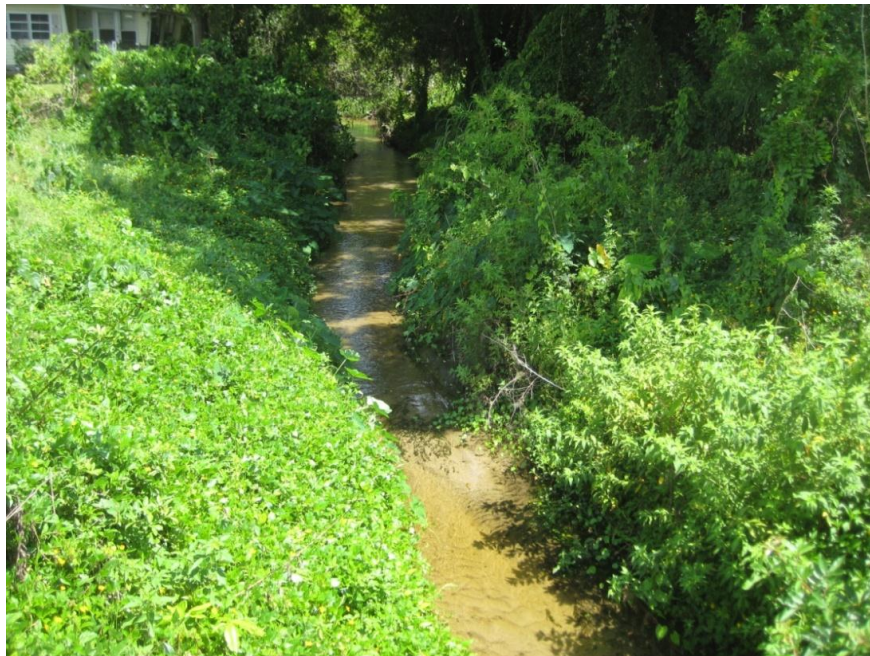
Site Curlew 6 is west of US 19 in Birch Court in the Silk Oak Trailer Park (Figure 4-22). The channel bottom is bare clean sand with some rocks with some shoaling and 3 – 4 inches of loose sand.

Figure 4-22. Site Curlew 6 looking upstream.

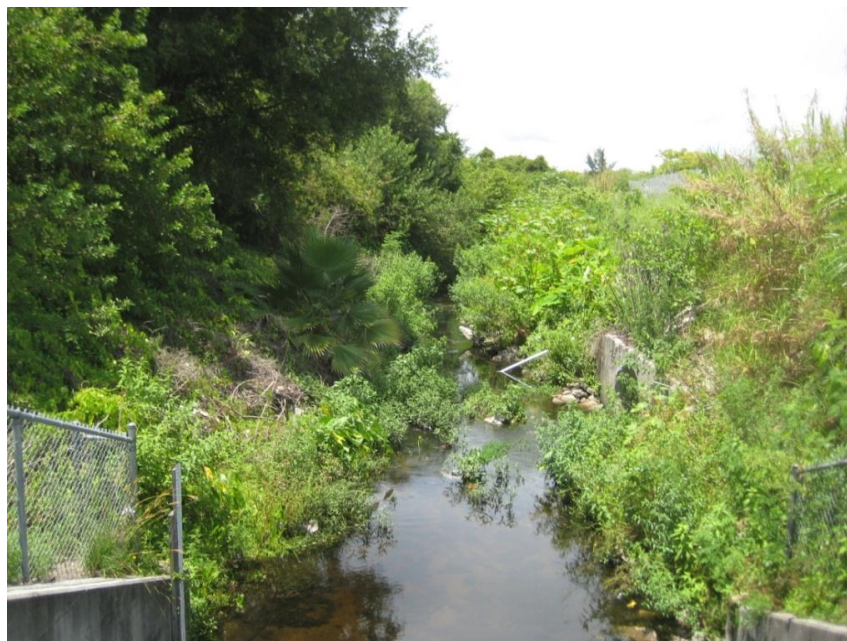
Site Curlew 7 is west of US 19 and north of Evans Road (Figure 4-23). The channel bottom was composed of coarse sand with silt and about 2 inches of loose sand. There is substantial debris in the channel, which receives runoff from an adjacent shopping center parking lot.

Figure 4-23. Site Curlew 7 looking downstream.

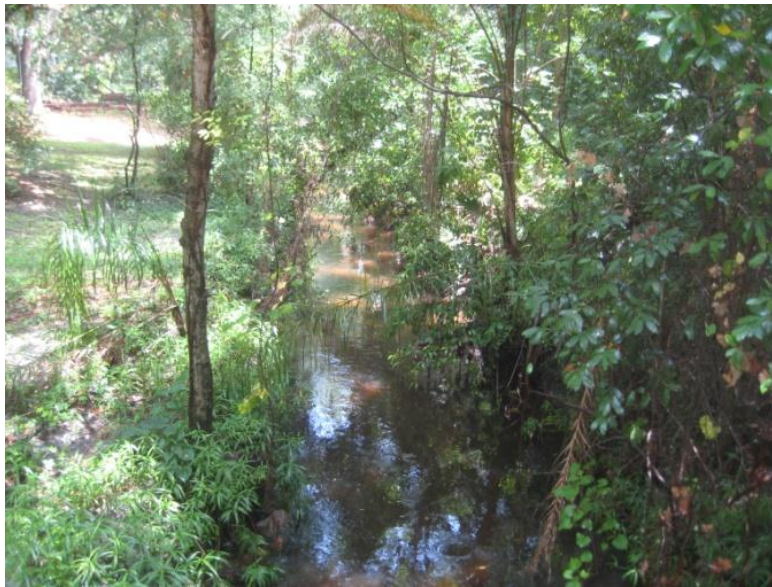
Site Curlew 8 is located on Brady Drive east of County Road 1 and is on Jerry Branch, a tributary of Curlew Creek. This is at one of the reaches within the Curlew Creek system with a higher channel slope. Figures 4-24 shows fairly incised banks.

Figure 4-24. Site Curlew 8 looking upstream.

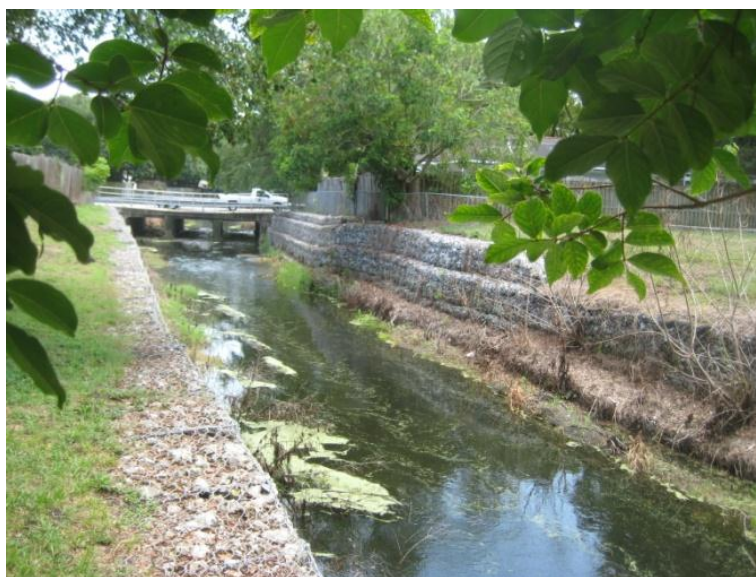
Site Curlew 9 is located at Laurelwood Lane west of Belcher Road. The channel is lined with gabions and is 7 – 8 feet deep as shown in Figure 4-25. There was mainly gravel on the gabion channel bottom.

Figure 4-25. Site Curlew 9 looking upstream.

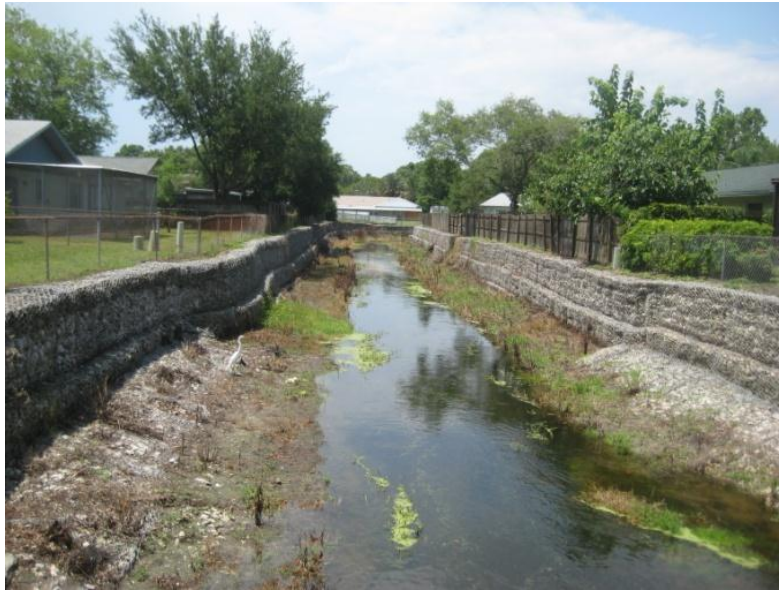
Site Curlew 10 is located at Solon east of Cottonwood Terrace. The channel is lined with gabions as shown in Figure 4-26, however there was a 3 – 4 inch layer of loose sand on the bottom at this site.

Figure 4-26. Site Curlew 10 looking downstream.

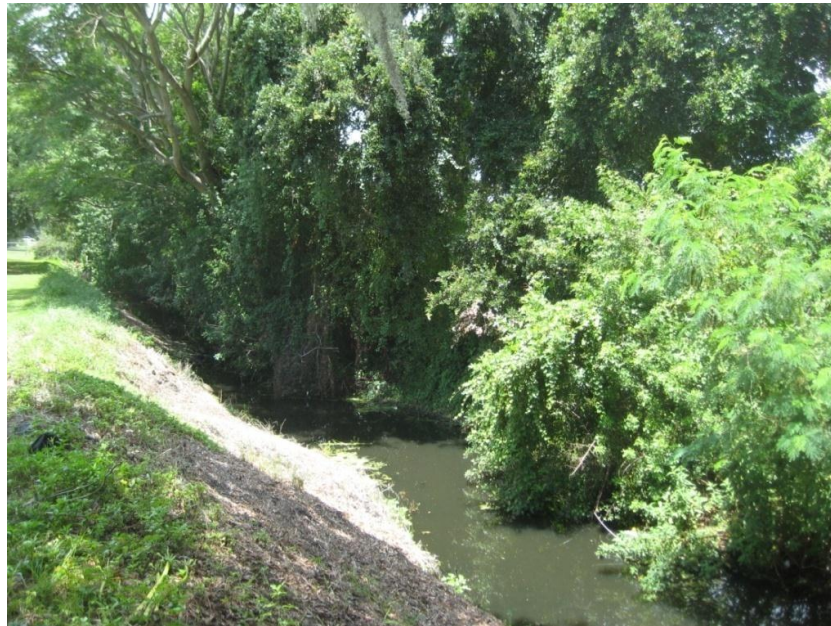
Site Curlew 11 is on Jerry Branch located south of Main Street and east of Creek Park Drive, and is shown in Figure 4-27. The west bank was maintained but the east bank was thickly overgrown. The channel bottom was composed of thick mucky fine-grained material. The 8 – 10 inch thick layer gave off sulfur smell and profuse bubbles when probed. There was limited bank erosion.

Figure 4-27. Site Curlew 11 looking upstream.

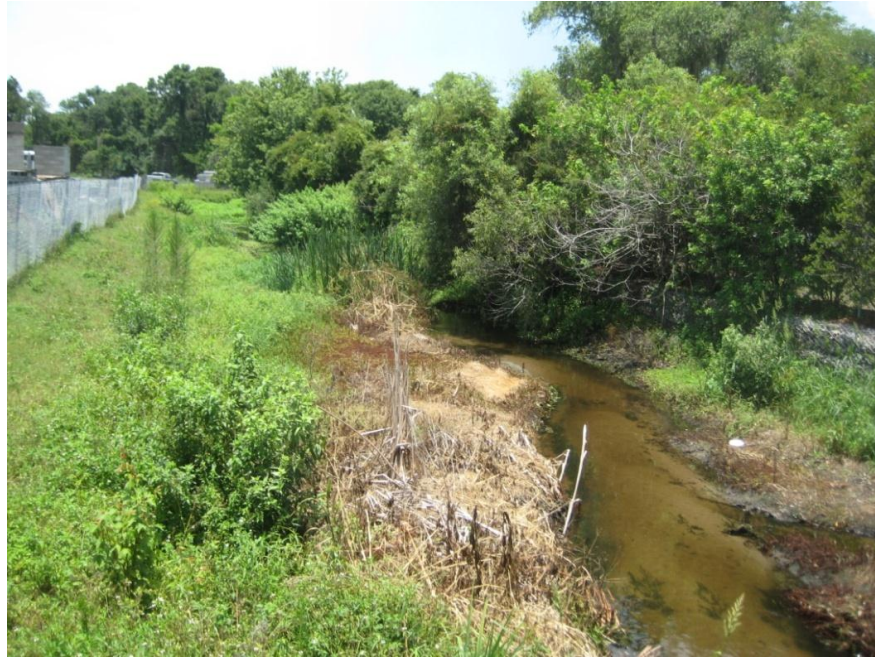
Site Curlew 12 is located at Greenbriar Blvd north of Virginia Ave. Gabions on the east bank are shown downstream in Figure 4-28. Upstream of the bridge both sides of the channel are lined with gabions (Figure 4-29). The upstream channel bottom was relatively clean but downstream a 2 – 4 inch layer of loose sand was observed.

Figure 4-28. Site Curlew 12 looking downstream.

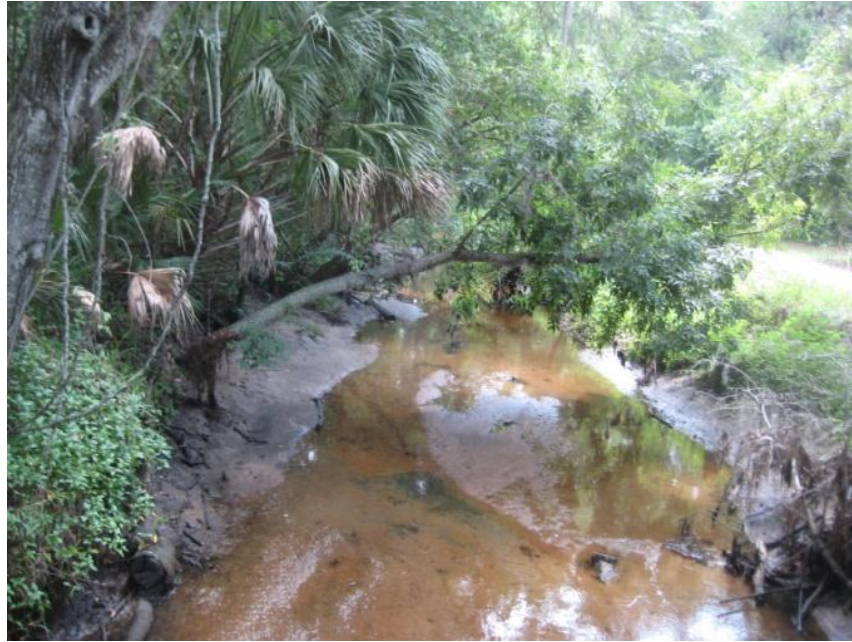
Site Cedar 1 is located in the park at the south end of Harvard Avenue, near Pinellas County water quality monitoring site 9-2. Figure 4-33 shows the channel to have shallow banks and to be relatively clear of fine-grained debris. A layer of loose sand approximately 2 – 4 inches deep was observed. The terrain is fairly flat and the channel has minimal slope.

Figure 4-33. Site Cedar 1 looking upstream.

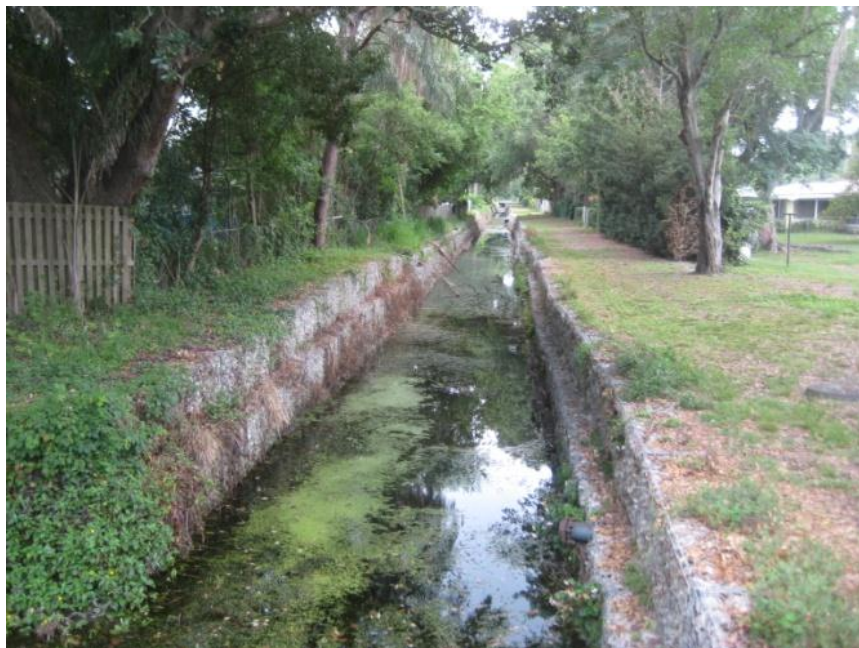
Site Cedar 2 is located west of Pinehurst at the end of Jackmar Road, near Pinellas County water quality monitoring site 9-3. Figure 4-34 shows that the channel is lined with gabions constructed to control channel erosion. Minimal loose sediment was observed at the site.

Figure 4-34. Site Cedar 2 looking upstream.

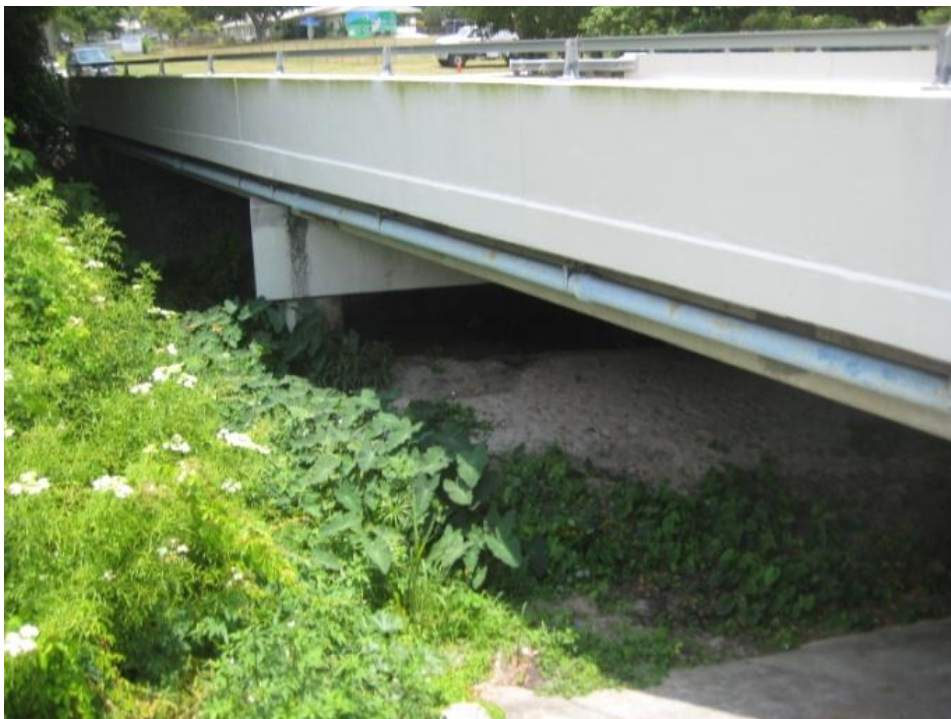
Figure 4-40. Site Stevenson 2 sand shoal under Lakeview Road bridge.

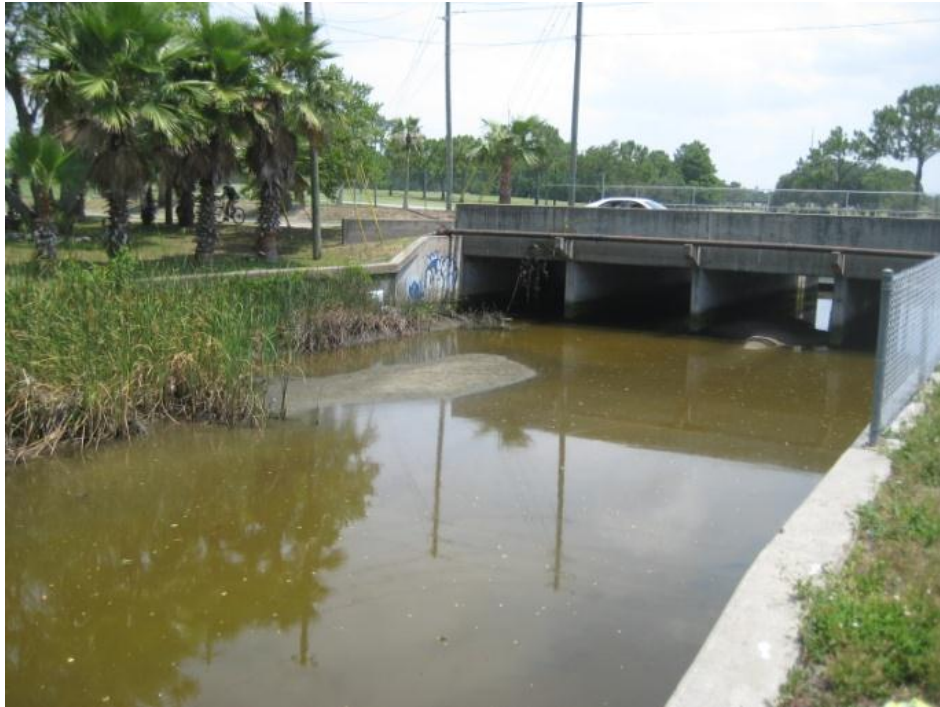
Site Stevenson 4 is located north of the Palmetto Street crossing, east of Betty Lane. The channel has seawalls on both sides but sediment accumulation on the east side has promoted the establishment of cattails and other vegetation as shown in Figure 4-43. A soft sand bottom approximately 4 inches thick was measured off the west seawall.

Figure 4-43. Site Stevenson 4 looking upstream.

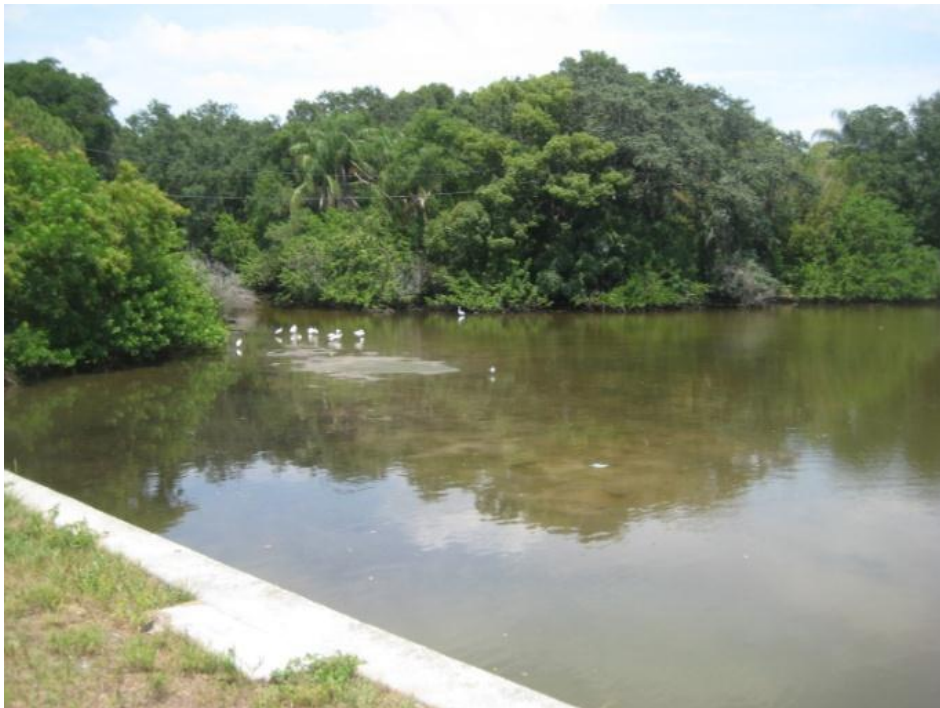
Site Stevenson 5 is located east of Betty Lane and south of Overlea Street, at a wide area of the channel where the main stem is joined by a tributary from the east. The channel widens, and significant sandy shoals were observed as shown in Figures 4-44.

Figure 4-44. Site Stevenson 5 looking upstream (SE).

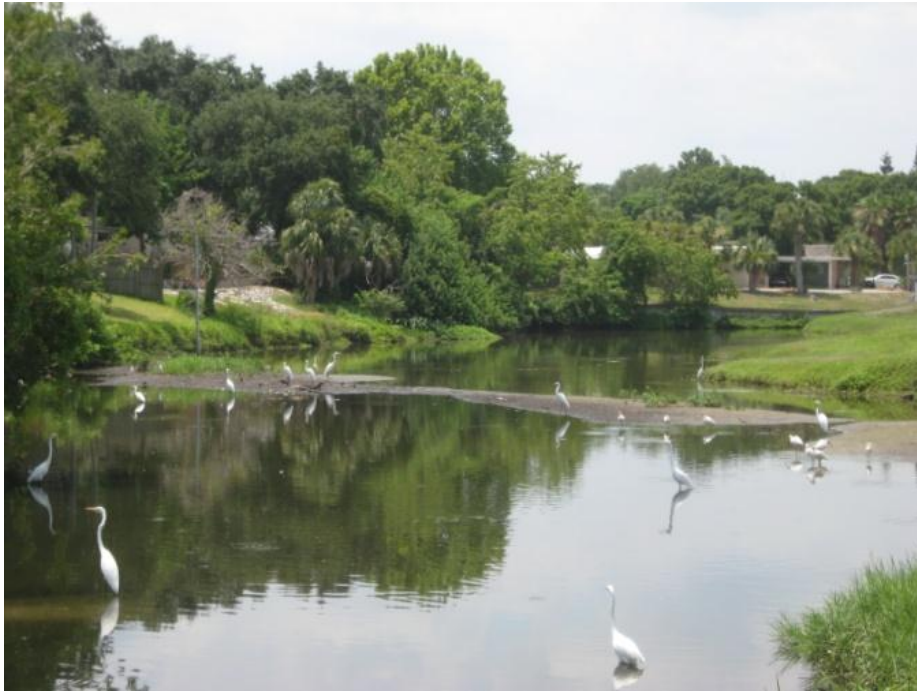
Figure 4-60. Site McKay 6 looking downstream at sediment sump.

- Reducing sediment transport was recommended for one site on McKay Creek. This could be accomplished by the enhancement of an existing sediment sump at SW 8th Ave.

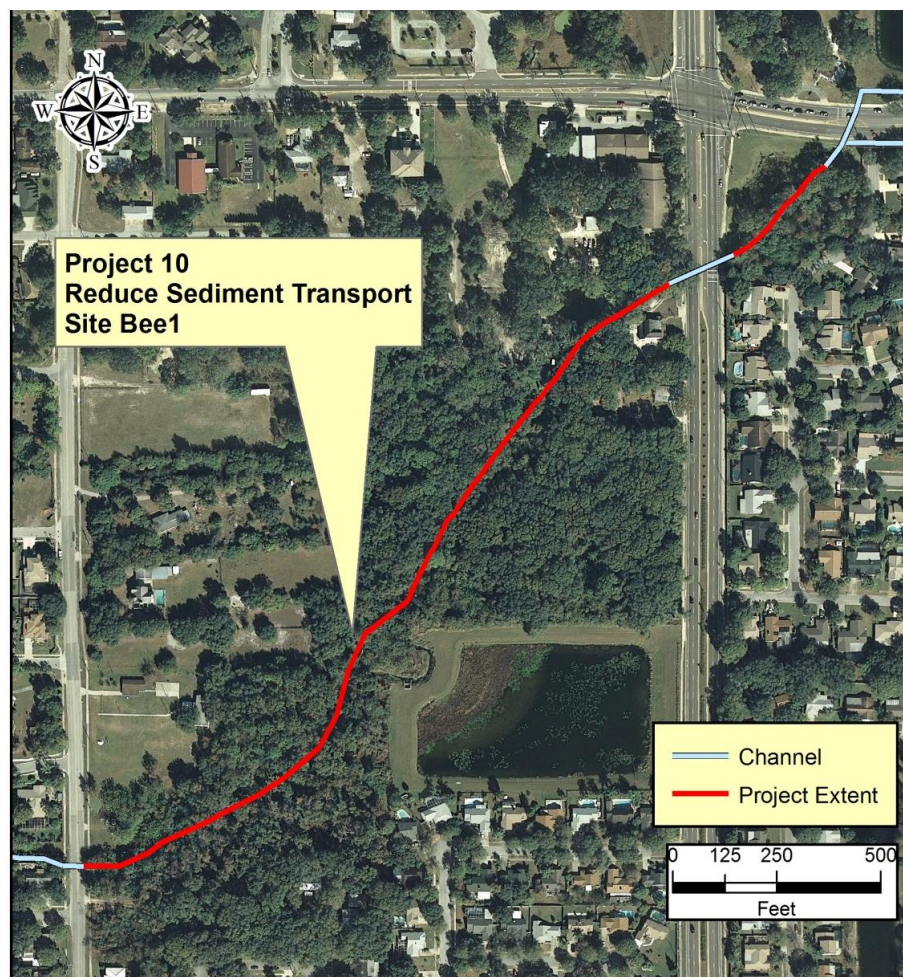
Site Bee 1 is the most upstream site, and is located just west of Belcher Road south of Nebraska Ave. Loose silty sand sediment was observed to be approximately 6 inches deep, with significant shoaling as shown in Figure 4-9. Bank undercutting suggests high flow velocities.

Figure 5-9. Project 10 at site Bee 1.

- Channel bed and bank stabilization was the focus of other recommended projects for Curlew Creek (downstream of County Rd. 1), Stevenson Creek (downstream of Bellevue Blvd.) and Bee Branch (near Belcher Rd. south of Nebraska Ave.). Erosion control for reaches of Curlew Creek and Bee Branch is currently an on-going effort for the County.
