Beckett Bridge

Project Development & Environment (PD&E) Study

Pinellas County Project ID: PID2161
FDOT Financial Project ID: 424385-1-28-01
Bridge No: 154000

Final Cultural Resource Assessment Survey Report

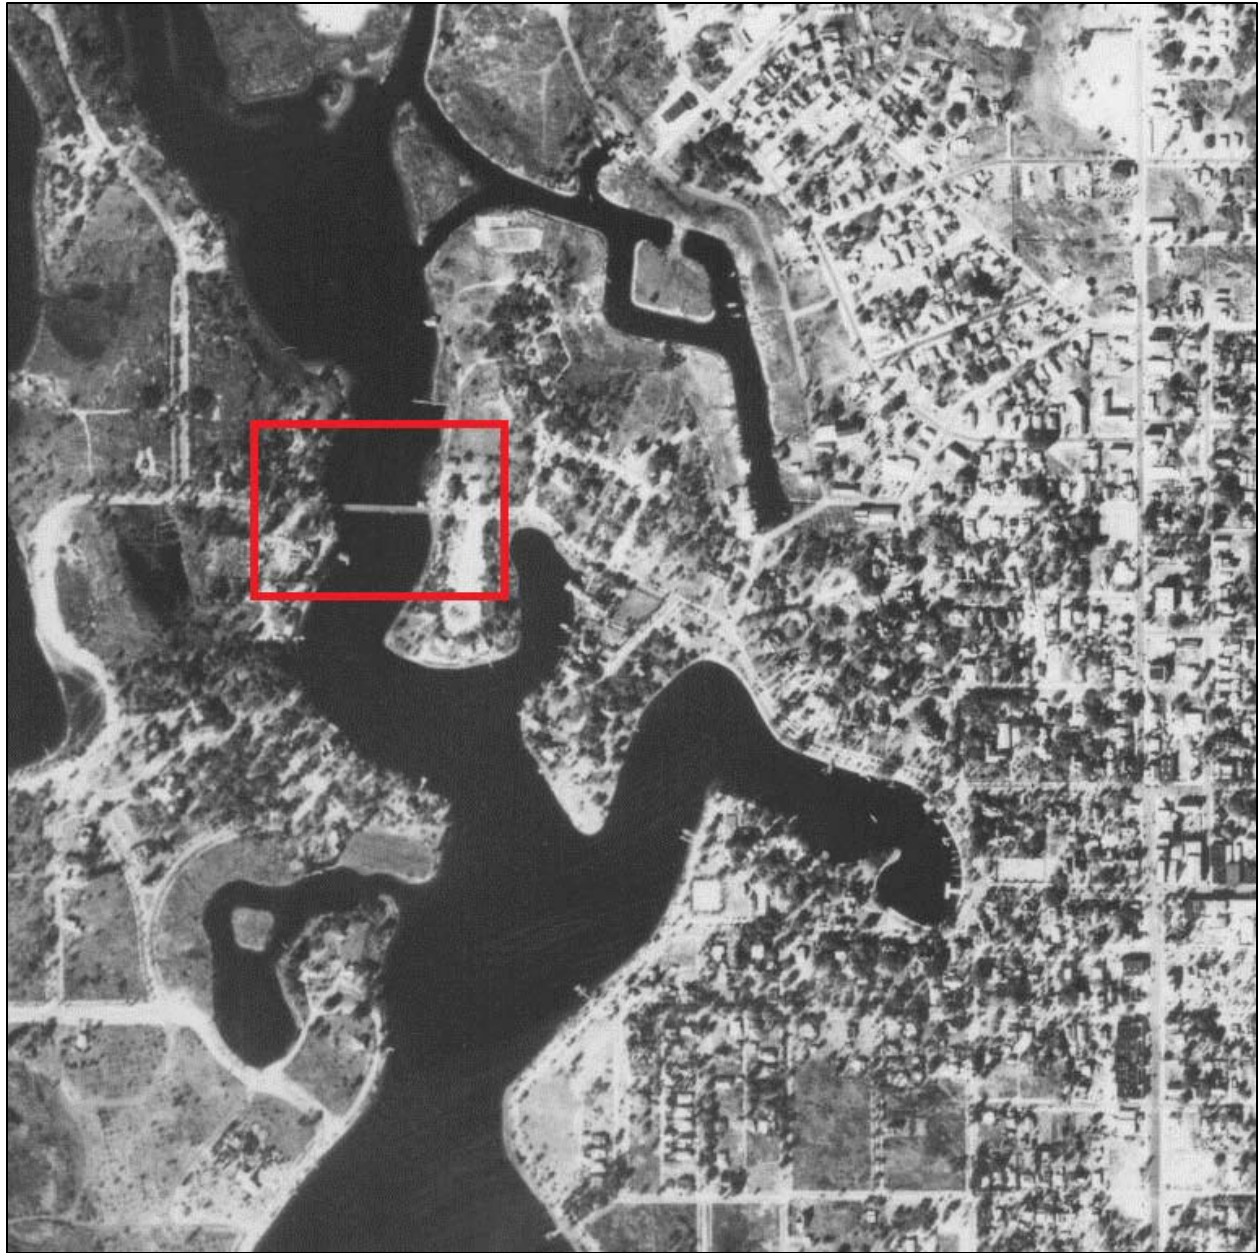
Figure 7.5 – 1941 Aerial Photograph showing the Beckett Bridge and Surrounding Area

After World War II, residential construction resumed in the neighborhoods in and surrounding the Tarpon Springs area, building out previously undeveloped lots. Figures 7.5–7.7 show the development of the area surrounding the Beckett Bridge. Streets were repaved, the seawall was replaced around Spring Bayou, City Hall was expanded and other City services were improved. The increased development and tourism, combined with the Beckett Bridge being the shortest travel route, lead to a high amount of traffic crossing the bridge on a daily basis.

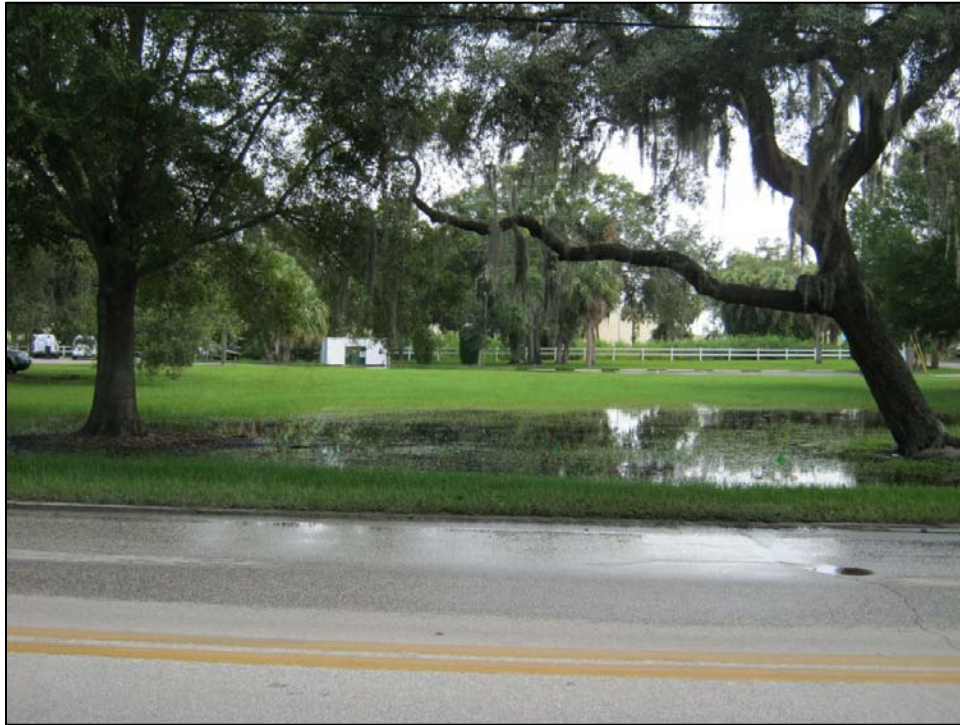
Figure 11.1 – Standing Water West of Pampas Avenue, facing north

No shovel tests were excavated in the archaeological APE due to the presence of sidewalks, buried utilities, and standing water (Figures 11.1–11.3) or due to lack of access to private property. However, the APE was subjected to windshield and pedestrian survey. No precontact or historic period archaeological sites were encountered during these investigations. For those areas of proposed new ROW associated with Fixed Bridge Alternatives Option A and B, archaeological testing was not conducted due to a lack of access. If these alternatives are selected for further analysis, archaeological testing will be conducted where warranted.

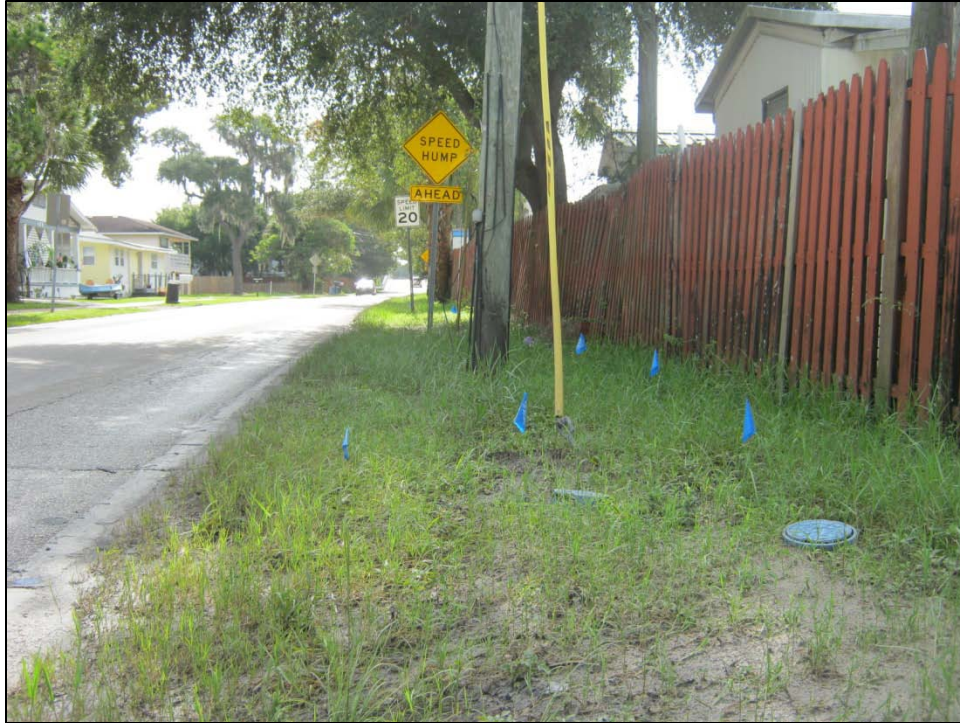
Figure 11.2 – Buried Utilities along Riverside Drive, facing east

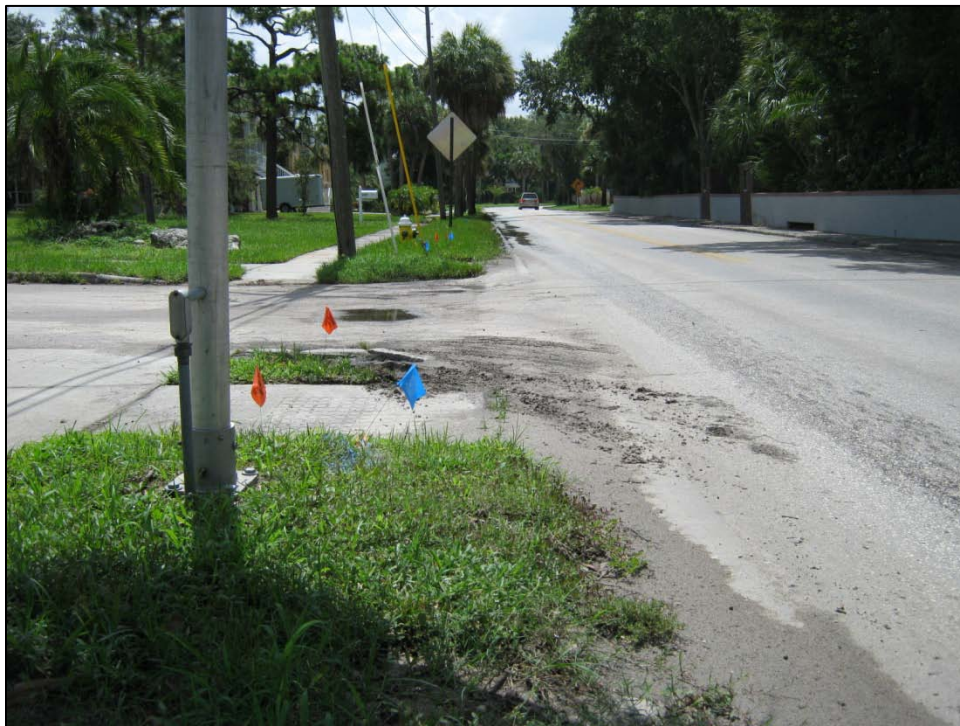
Figure 11.3 – Buried Utilities on Riverside Drive at Forest Avenue, facing east

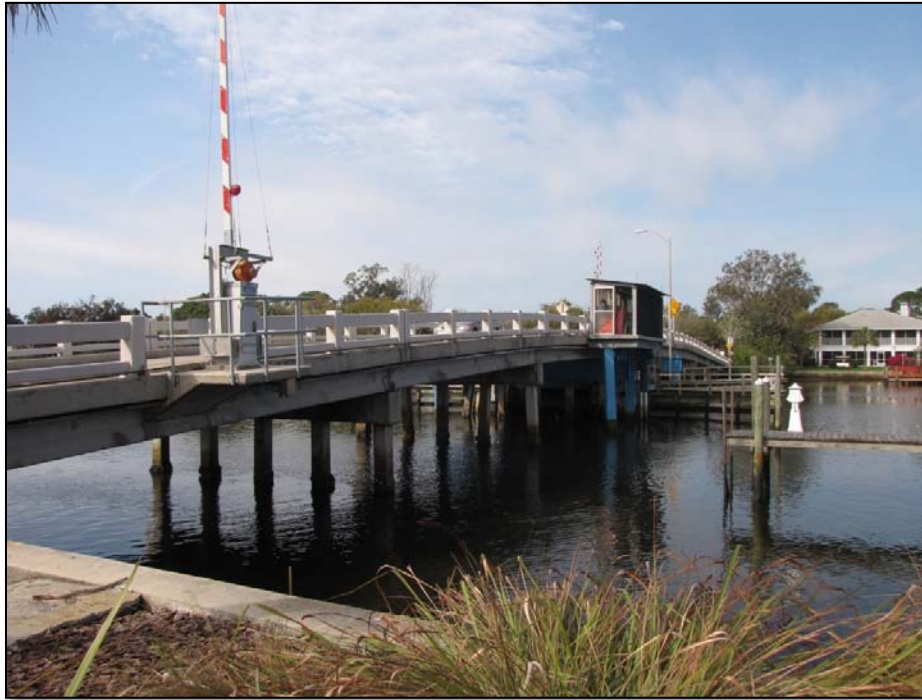
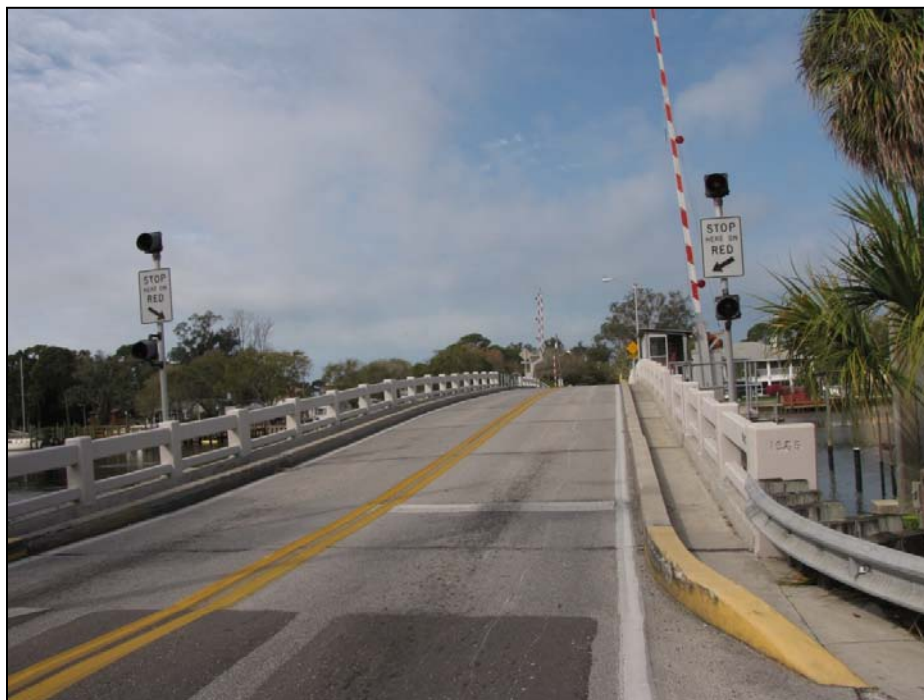
Figure 11.5 – Beckett Bridge (8PI12017) in Pinellas County, facing southwest

Figure 11.6 – Beckett Bridge (8PI12017) in Pinellas County, facing west

The Beckett Bridge (Figures 11.5 and 11.6) is located in Township 27 South, Range 15 East, and Sections 11 and 12 (USGS Quadrangle Tarpon Springs 1973, Photorevised 1987), in Pinellas County, Florida. The bridge is a steel, single-leaf, bottom counterweight, Scherzer rolling lift bascule bridge spanning approximately 360 feet in total length and approximately 28 feet in width. It carries Riverside Drive/North Spring Boulevard over Whitcomb Bayou in Tarpon Springs, Florida. The existing typical section of the bridge consists of two vehicular lanes measuring approximately 20 feet and a sidewalk measuring approximately 3 feet, with concrete railing on both sides. Nine approach spans and one main span are present. The main bridge span is a steel structure with a cast concrete deck. Railings flank the bridge approaches and the bascule span; these are simple concrete guardrail with concrete posts. Concrete piers support the pre-stressed concrete girder approach spans of this bridge. A galvanized pipe staircase with handrails leads to the bridge substructure from a utilitarian bridge tender's station that consists of a simple one-story rectangular building with a steel shed roof and Plexiglas windows. This structure, built in 1996, is located on the north side of the bridge.

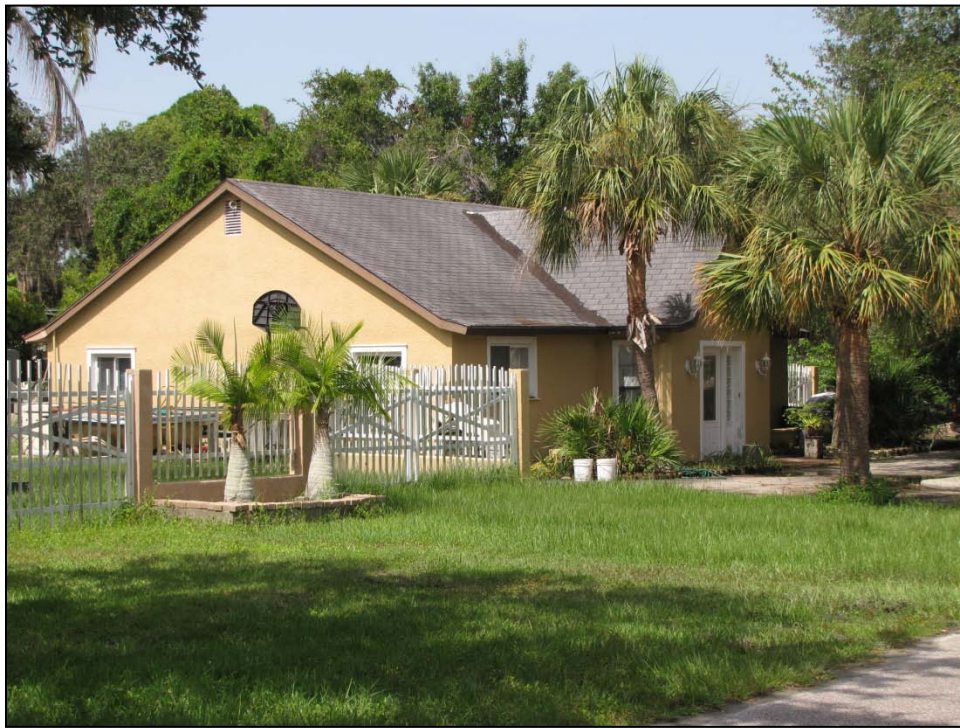
11.2.2.1 *8PII2069 (435 Doric Court)*

Figure 11.7 – 435 Doric Court (8PII2069) in Pinellas County, facing southwest

435 Doric Court (Figure 11.7) is located to the north of Riverside Drive at the end of Doric Court, Township 27 South, Range 15 East, Section 11 (USGS Quadrangle Tarpon Springs 1973, Photorevised 1987) in Pinellas County, Florida. The building was constructed in approximately 1947 and is a one-story, stuccoed Masonry Vernacular house. The building plan is rectangular and it is constructed of concrete blocks. It sits on a concrete slab foundation. The roof is side gabled with a front gabled projection on the north façade and sheathed in composition shingles.

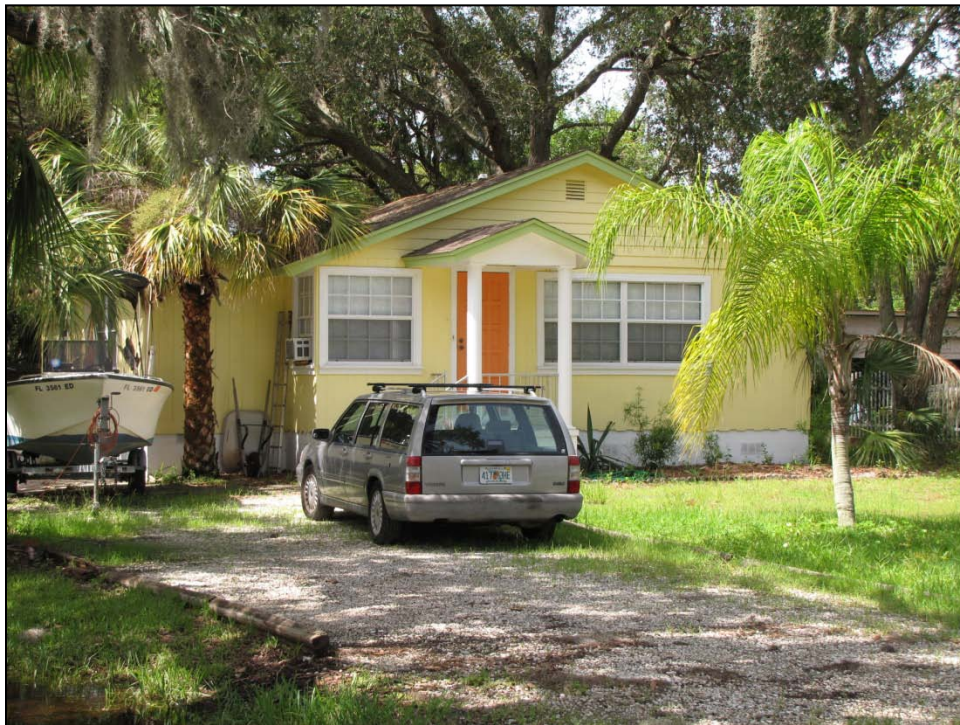
11.2.2.2 8PI12068 (425 Doric Court)

Figure 11.8 – 425 Doric Court (8PI12068) in Pinellas County, facing southwest

425 Doric Court (Figure 11.8) is located to the north of Riverside Drive at the end of Doric Court, Township 27 South, Range 15 East, Section 11 (USGS Quadrangle Tarpon Springs 1973, Photorevised 1987) in Pinellas County, Florida. The building was constructed in approximately 1954 and is a one-story Frame Vernacular house clad in vertical plank and vinyl siding. The building plan is irregular and the building is wood framed. It sits on a continuous concrete block foundation. The roof is front gabled and sheathed in composition shingles. Windows are wood one-over-one and eight-over-eight double-hung sash. Vents are a notable feature of this building

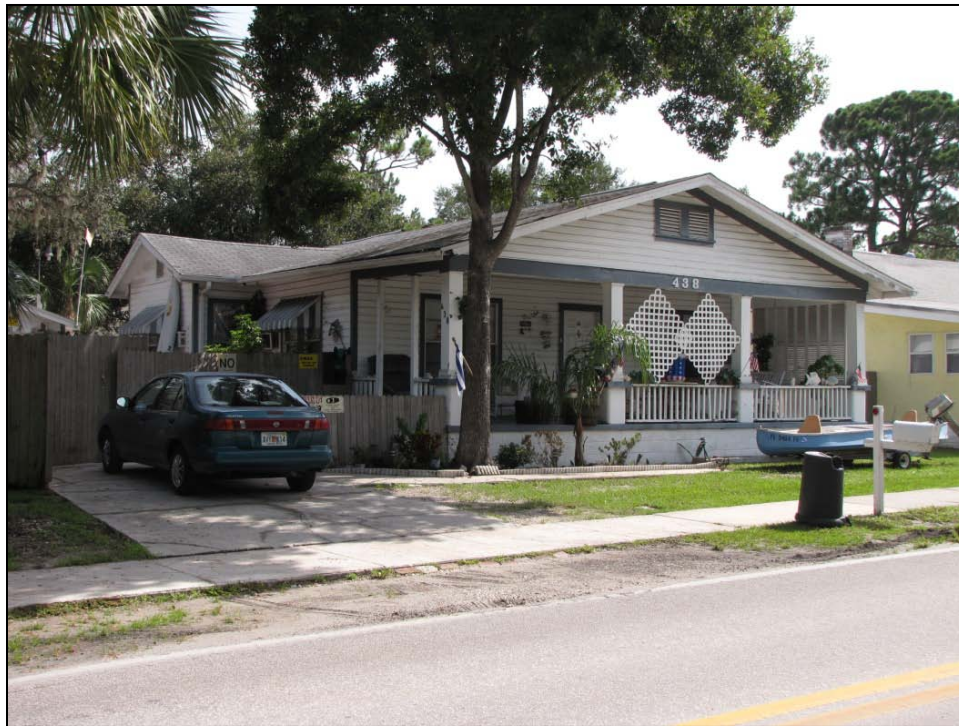
11.2.2.3 8PI12043 (438 Riverside Drive)

Figure 11.9 – 438 Riverside Drive (8PI12043) in Pinellas County, facing northeast

438 Riverside Drive (Figure 11.9) is located on the north side of Riverside Drive between Chesapeake Drive and the Beckett Bridge, Township 27 South, Range 15 East, Section 11 (USGS Quadrangle Tarpon Springs 1973, Photorevised 1987), in Pinellas County, Florida. The building was constructed in approximately 1925 and is a one-story Craftsman house with wood siding. The building plan is irregular and construction is wood frame. It sits on a concrete foundation, but has an incorporated pier system. A front gable roof is present with a cross-gable intersecting to the back of the house. The roof is composition shingle. The porch is full width and includes wooden supports on brick piers with a railing situated between supports, except for an open portion at the front facade. Windows are metal two-over-two single hung sash.

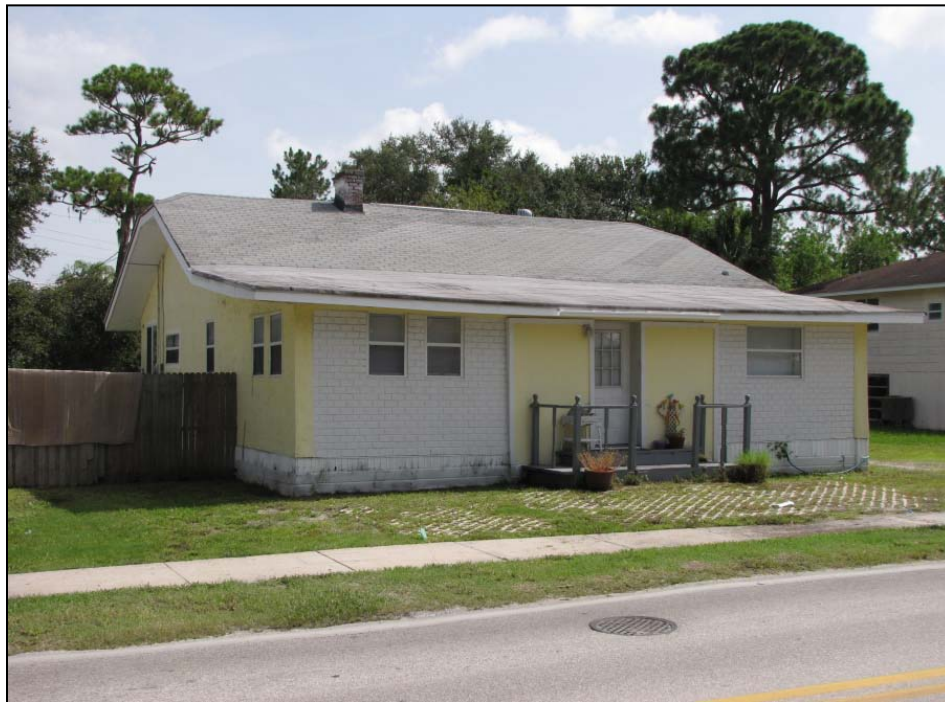
11.2.2.4 8PI12044 (434 Riverside Drive)

Figure 11.10 – 434 Riverside Drive (8PI12044) in Pinellas County, facing northeast

434 Riverside Drive (Figure 11.10) is located to the north of Riverside Drive between Chesapeake Drive and the Beckett Bridge, Township 27 South, Range 15 East, Section 11 (USGS Quadrangle Tarpon Springs 1973, Photorevised 1987), in Pinellas County, Florida. The building was constructed circa 1929 and is a one-story Frame Vernacular house that is clad in stucco. The building plan is rectangular and construction is wood frame. The building sits on a pier system and the foundation material is concrete. The roof is a clipped gable with a shed overhang and composition shingle. Windows are metal one-over-one single hung sash. A small

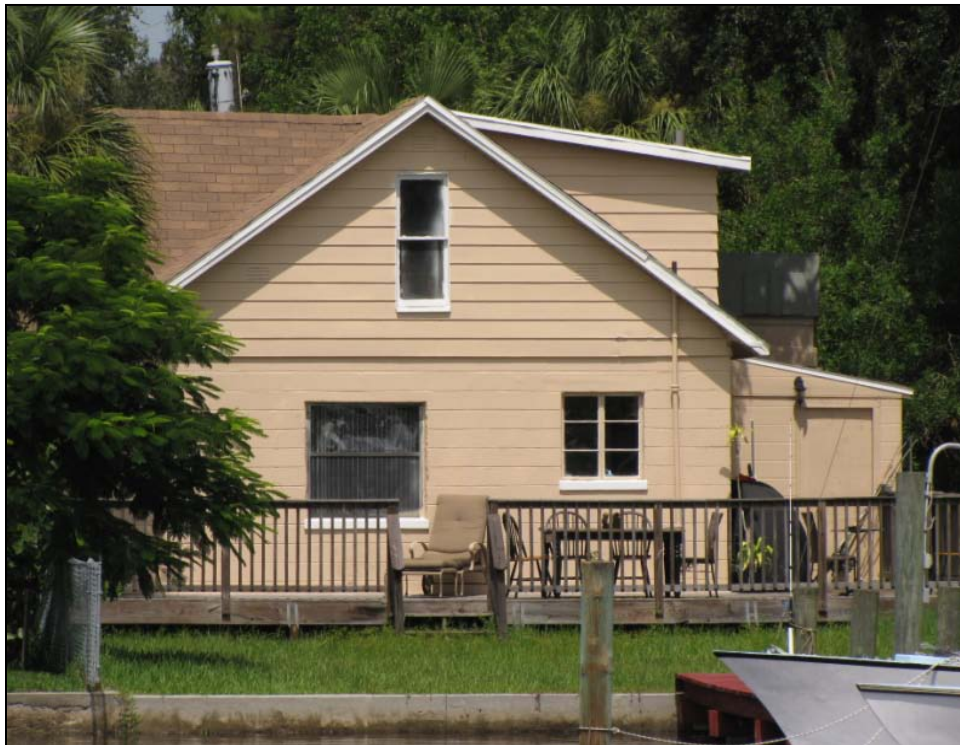
11.2.2.5 8PI12045 (412 Riverside Drive)

Figure 11.11 – 412 Riverside Drive (8PI12045) in Pinellas County, facing west

412 Riverside Drive (Figure 11.11) is located to the north of Riverside Drive between Chesapeake Drive and the Beckett Bridge, Township 27 South, Range 15 East, Section 11 (USGS Quadrangle Tarpon Springs 1973, Photorevised 1987), in Pinellas County, Florida. The building was constructed circa 1946 and is a two-story Masonry Vernacular house. It has an irregular plan and features both concrete block and wood siding. The building sits on a continuous concrete block foundation and has a concrete block structural system. The roof is a cross-gable of composition shingles. Windows are metal one-over-one single hung sash and a six-light louvered window is also observed. The main entrance is likely on the south side of the

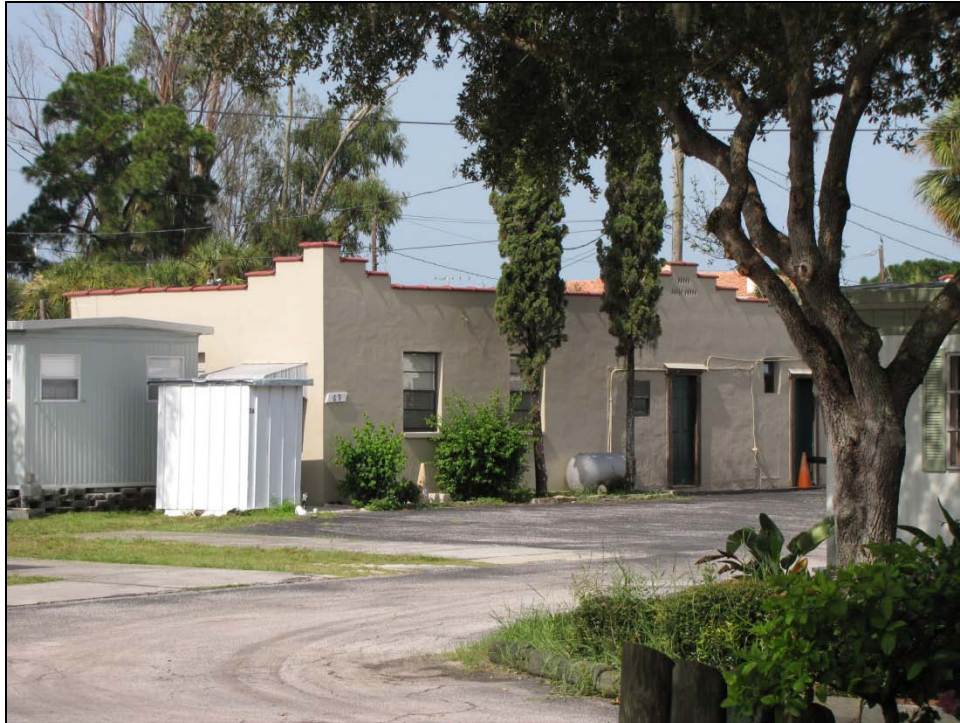
11.2.2.6 8PI12046 (403 Riverside Drive)

Figure 11.12 – 403 Riverside Drive (8PI12046) in Pinellas County, facing south

403 Riverside Drive (Figure 11.12) is located to the south of Riverside Drive between Chesapeake Drive and the Beckett Bridge, Township 27 South, Range 15 East, Section 11 (USGS Quadrangle Tarpon Springs 1973, Photorevised 1987), in Pinellas County, Florida. The building was constructed in approximately 1949 and is a one-story Mission Revival style building that is clad in stucco. The building plan is rectangular and constructed with concrete blocks. It sits on a continuous foundation of concrete blocks. The roof is built-up and flat. Parapets are present on the building and scuppers present within the north façade. Windows are metal one-over-one and two-over-two single hung sash. The building was probably once a residential house, but is now appears to either be offices or storage for the Bayshore MHP. Non-

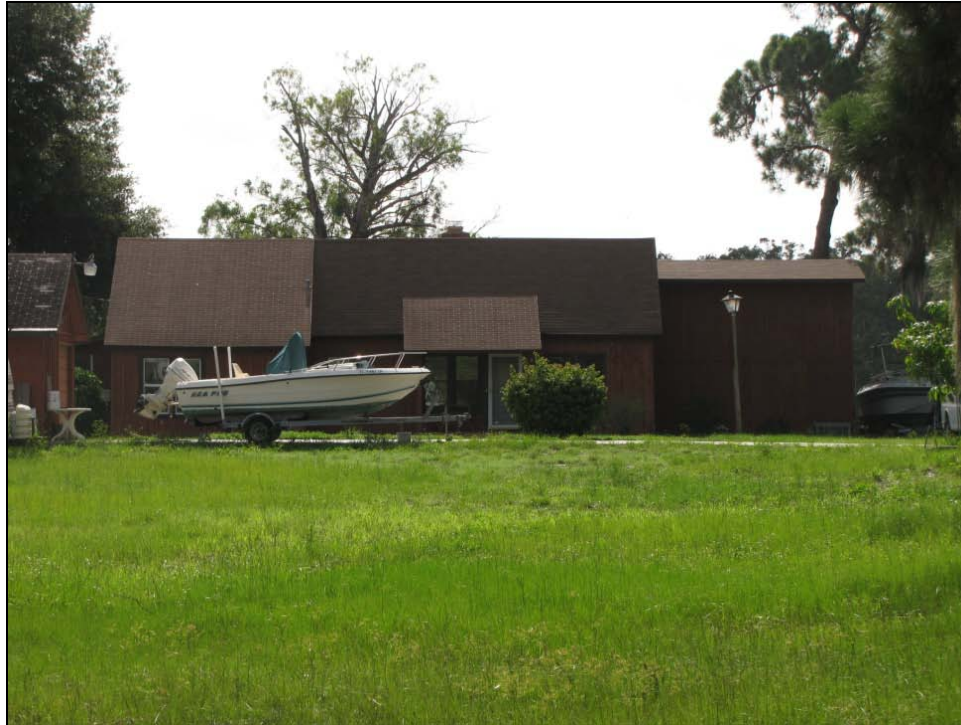
11.2.2.7 8PI12047 (438 Craig Drive)

Figure 11.13 – 438 Craig Drive (8PI12047) in Pinellas County, facing east

438 Craig Drive (Figure 11.13) is located to the south of Riverside Drive at the end of Craig Drive, east of Chesapeake Drive, Township 27 South, Range 15 East, Section 11 (USGS Quadrangle Tarpon Springs 1973, Photorevised 1987), in Pinellas County Florida. The building was constructed in approximately 1940 and is a one-story Frame Vernacular house with board and batten siding. It is simple and unadorned. The building has a wood frame, irregular plan, and sits on a concrete slab foundation. The roof consists of three separate gables of composition shingles. The main entrance is on the west side of the building and consists of a glass door under a shed overhang. Windows are one-over-one single hung sash. A one-car garage is present to the northwest of the building. The building is owned by the same company that owns the Bayshore

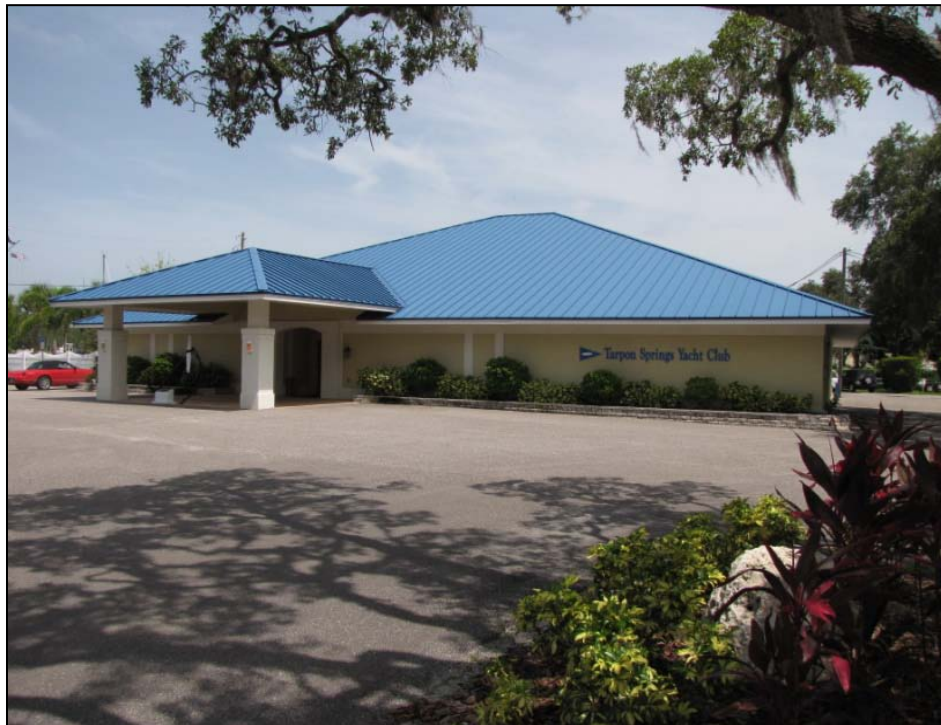
11.2.2.8 8PI12048 (The Tarpon Springs Yacht Club/350 North Spring Boulevard)

Figure 11.14 – The Tarpon Springs Yacht Club/350 North Spring Boulevard (8PI12048), facing north

The Tarpon Springs Yacht Club/350 North Spring Boulevard (Figure 11.14) is located at the intersection of Spring Boulevard and Pampas Avenue, Township 27 South, 15 East, Section 12 (USGS Quadrangle Tarpon Springs 1973, Photorevised 1987), in Pinellas County, Florida. The building was constructed in 1954 after a group of Tarpon Springs boaters founded the Yacht Club in 1949. It is a one-story Masonry Vernacular building that is clad in stucco. The building has a concrete block structural system, a rectangular plan, and the foundation is slab on grade. The building features a hip roof with an added hip roof extension entrance way set on square

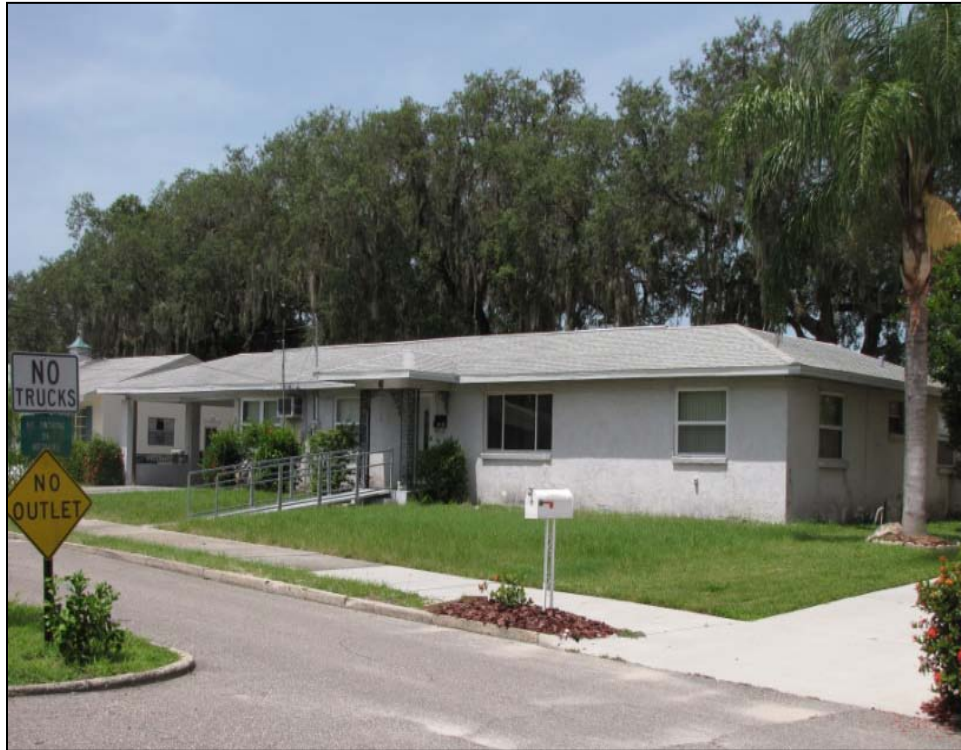
Figure 11.15 – 6 Venetian Court (8PI12049) in Pinellas County, facing southwest

6 Venetian Court (Figure 11.15) is located to on the west side of Venetian Court between Spring Boulevard and the dead end of Venetian Court, Township 27 South, Range 15 East, Section 12 (USGS Quadrangle Tarpon Springs 1973, Photorevised 1987), in Pinellas County, Florida. The building was constructed in approximately 1952 and is an example of a one-story Ranch house that is clad in stucco. The building is simple and unadorned. It has a rectangular plan, concrete block construction, and sits on a continuous concrete block foundation. The roof is hip and a small hip roof extension is located over the front door. This hip roof extension is supported by what appears to be arched decorative wrought iron supports. The stoop porch has a wheel chair access ramp leading up to it. Windows are metal one-over-one single hung sash and a tripartite window unit on the front façade in also present. Below the windows are concrete sills. A carport is incorporated into the main building.

This building does not possess sufficient significance for inclusion in the National Register, individually or as part of a district.

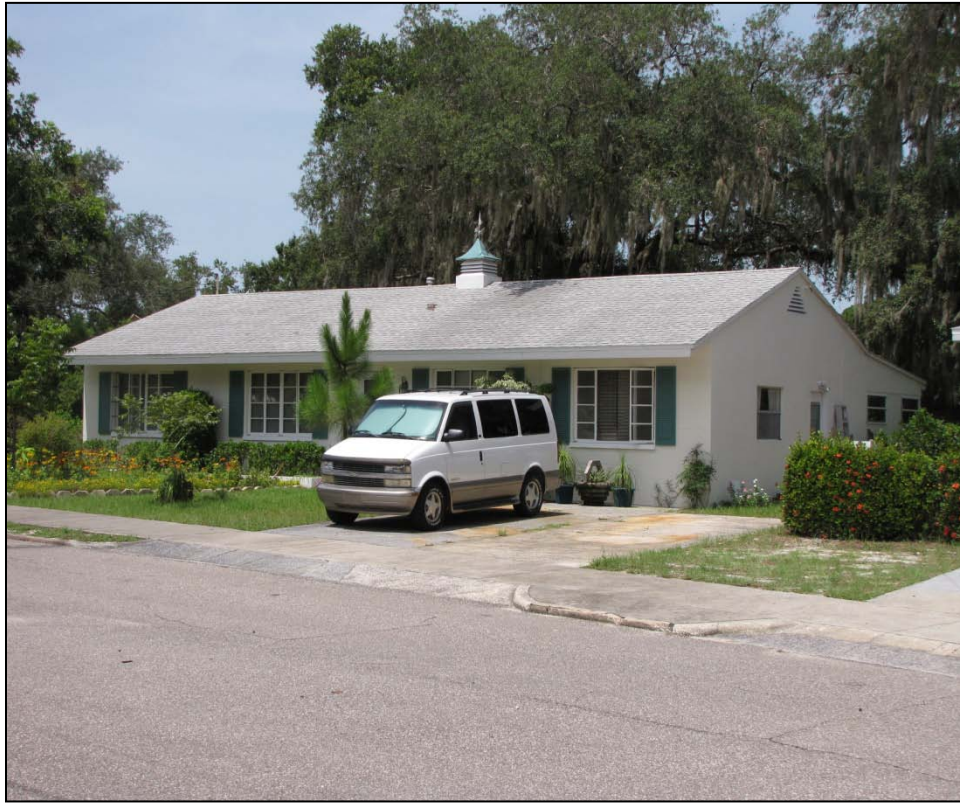
Figure 11.16 – 8 Venetian Court (8PI12050) in Pinellas County, facing southwest

8 Venetian Court (Figure 11.16) is located to the west of Venetian Court between Spring Boulevard and the dead end of Venetian Court, Township 27 South, Range 15 East, Section 12 (USGS Quadrangle Tarpon Springs 1973, Photorevised 1987), in Pinellas County, Florida. The building was constructed in approximately 1954 and is an example of a one-story, stucco clad Ranch house. It is simple and unadorned with a rectangular plan. The building is constructed of concrete blocks and is on a continuous concrete block foundation. The roof is a side facing gable of composition shingles. A small cupola is positioned on the center of the roof ridgeline. The door is set flush with the building. Multiple types of metal windows are present on the building and they include; a tripartite window unit with 4-lights to the right and left of the main picture window, one-over-one single hung sash, two-light awning windows, 8-light casement windows, and 4-light casement windows. Concrete sills are positioned beneath the windows.

Faux shutters have been added to the building as well as replacement windows and doors. The house appears to have been restuccoed and there is a possible garage or carport enclosure at the north end of the building. Due to these modifications and that the building does not possess sufficient significance, it is not considered eligible for inclusion in the National Register, individually or as part of a district.

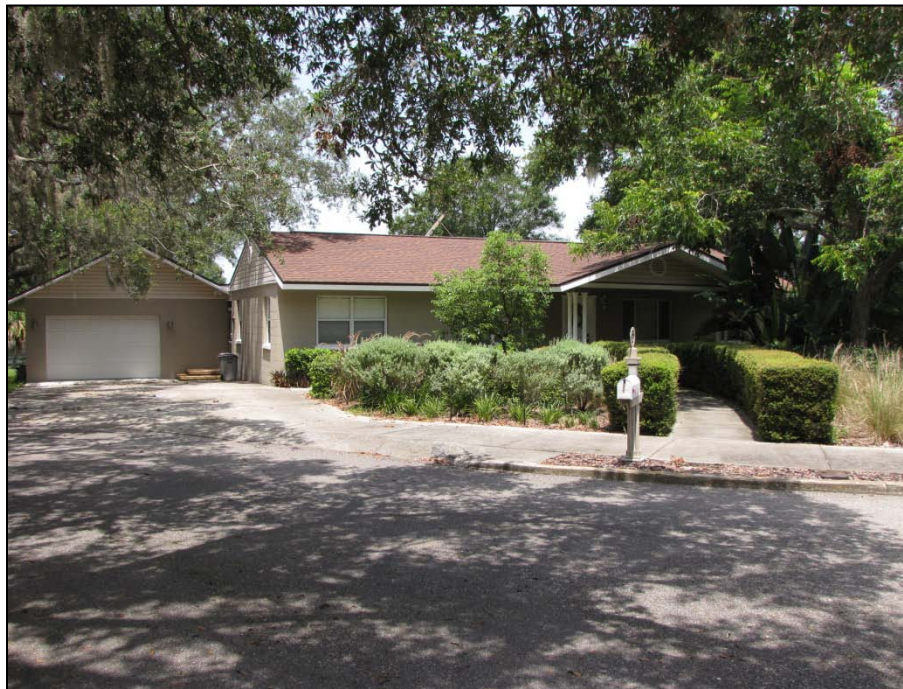
Figure 11.17 – 12 Venetian Court (8PI12051) in Pinellas County, facing west

12 Venetian Court (Figure 11.17) is located to the west of Venetian Court between Spring Boulevard and the dead end of Venetian Court, Township 27 South, Range 15 East, Section 12 (USGS Quadrangle Tarpon Springs 1973, Photorevised 1987), in Pinellas County, Florida. The building was constructed in approximately 1953 and is a one-story, concrete block Masonry Vernacular house. The building form is rectangular. Vinyl siding is present at the gable ends. The foundation is continuous concrete block. The roof is a side facing gable with a front gable extension. A porch is present under the gable roof extension on wood faux Craftsman supports to the east. A porch is evident from aerial photographs to the west as well as an in ground pool. Windows are one-over-one single hung sash and a 3-light sliding window is also present. A

This building exhibits modifications and does not possess sufficient significance for inclusion in the National Register, individually or as part of a district.

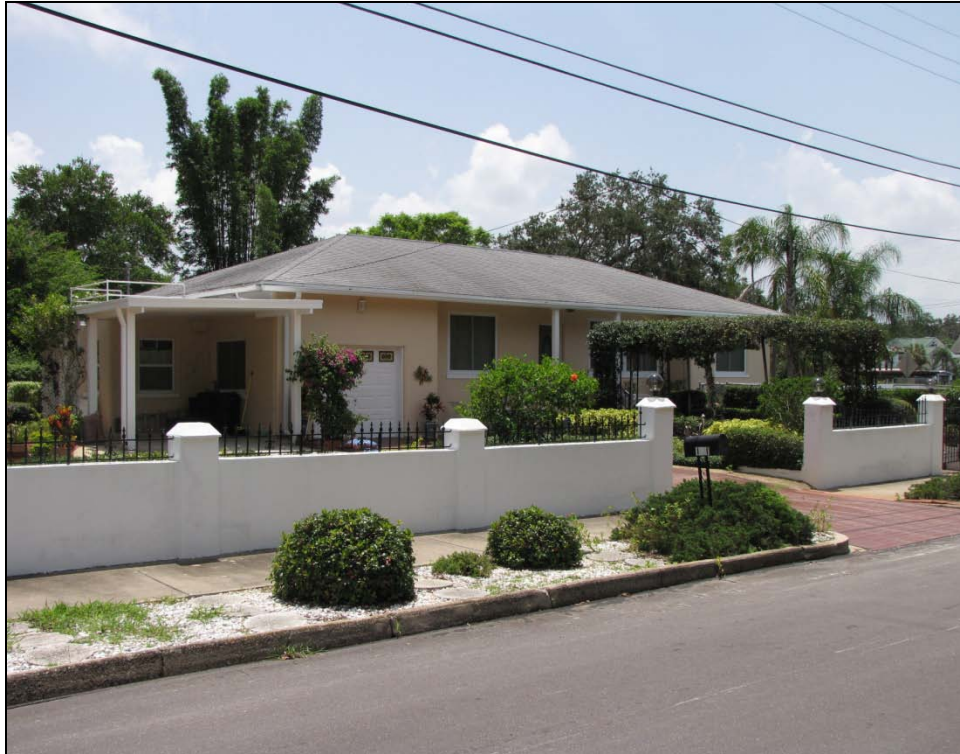
Figure 11.18 – 101 Pampas Avenue (8PI12052) in Pinellas County, facing east

101 Pampas Avenue (Figure 11.18) is located at the northeast corner of Pampas Avenue and Spring Boulevard, Township 27 South, Range 15 East, Section 12 (USGS Quadrangle Tarpon Springs 1973, Photorevised 1987), in Pinellas County, Florida. The building was constructed in approximately 1954 and is an example of a one-story, stucco clad Masonry Vernacular house. The exterior system is composed of concrete blocks and the foundation is a continuous concrete block. The plan of the building is irregular. The hip roof has a flat roof carport addition to the north of the building and consists of composition shingles. The porch is attached with decorative wood supports. Windows are metal one-over-one single hung sash and 2-light sliding with concrete sills. Windows and doors have been replaced. A garage is also present with a modern

This building exhibits modifications and does not possess sufficient significance for inclusion in the National Register, individually or as part of a district.

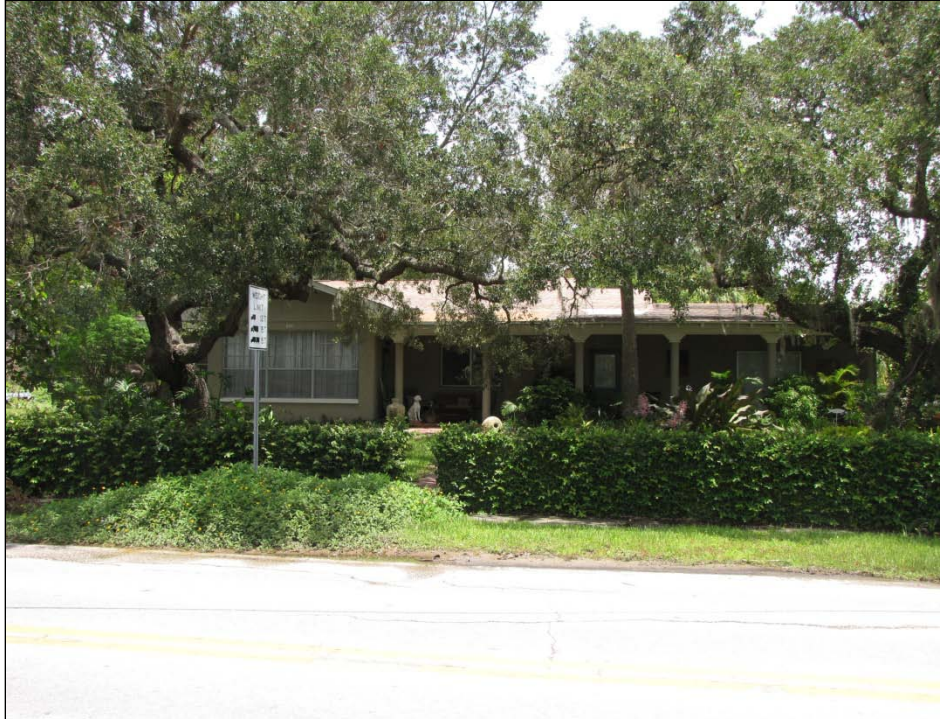
Figure 11.19 – 330 North Spring Boulevard (8PI12053) in Pinellas County, facing north

330 North Spring Boulevard (Figure 11.19) is located on the north side of Spring Boulevard between Pampas Avenue and Forest Avenue, Township 27 South, Range 15 East, Section 11 (USGS Quadrangle Tarpon Springs 1973, Photorevised 1987), in Pinellas County, Florida. The building was constructed in approximately 1956 and is an example of a one-story, stucco clad Masonry Vernacular house. The building is composed of concrete blocks and is on a continuous concrete block foundation. The roof is a side facing gable with a front gable extension and is composition shingle. The porch encompasses much of the front façade and is supported by non-historic columns. Windows have been replaced and are metal one-over-one single hung sash, 2-

This building exhibits modifications and does not possess sufficient significance for inclusion in the National Register, individually or as part of a district.

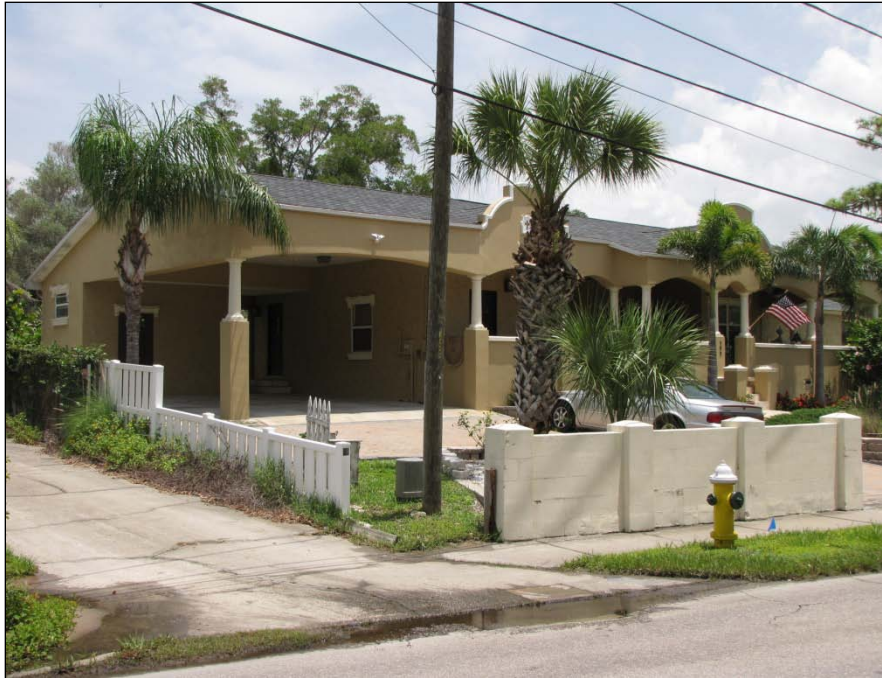
Figure 11.20 – 302 North Spring Boulevard (8PI12054) in Pinellas County, facing northeast

302 North Spring Boulevard (Figure 11.20) is located on the northwest corner of North Spring Boulevard and Forest Avenue, Township 27 South, Range 15 East, Section 12 (USGS Quadrangle Tarpon Springs 1973, Photorevised 1987), in Pinellas County, Florida. The building was constructed in approximately 1950 and is an example of a one-story, stucco clad Masonry Vernacular house. The walls are composed of concrete blocks and the building sits on a continuous concrete block foundation. The roof is a side facing gable with composition shingles. The porch features wood supports set on stuccoed piers. Windows are metal one-over-one single hung sash and a glass block window is also present. Numerous alterations have taken place on the building and no historic fabric remains. The façade was completely redone, windows and doors replaced, new supports were added, and the building was restuccoed and decoratively

This building exhibits modifications and does not possess sufficient significance for inclusion in the National Register, individually or as part of a district.

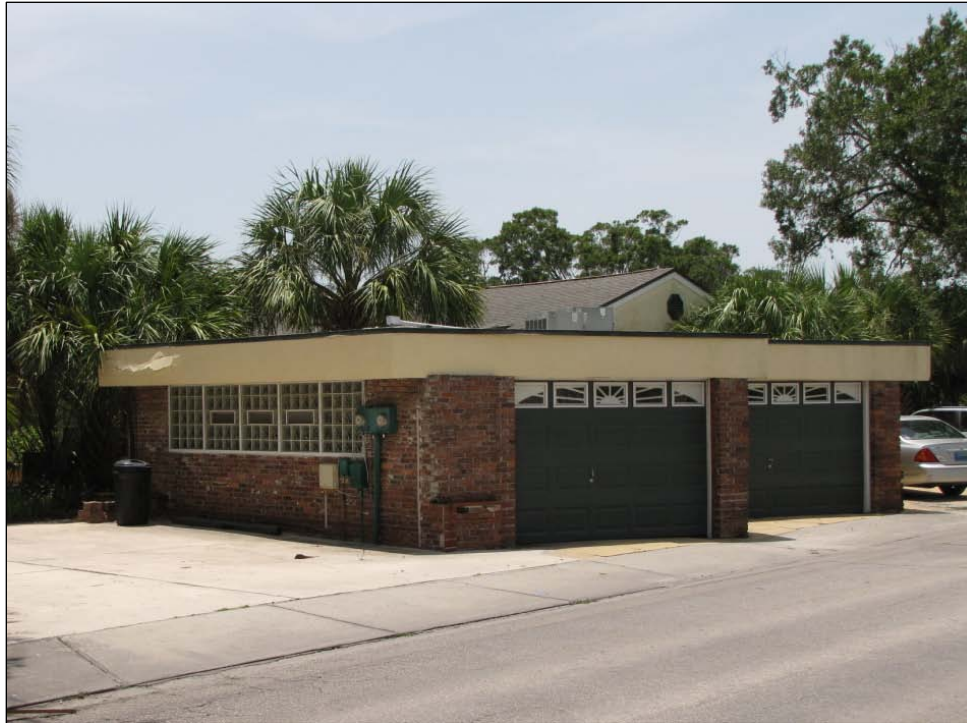
Figure 11.21 – 301 North Spring Boulevard (8PI12055) in Pinellas County, facing southwest

301 North Spring Boulevard (Figure 11.21) is located on the south side of North Spring Boulevard across from Forest Avenue, Township 27 South, Range 15 East, Section 12 (USGS Quadrangle Tarpon Springs 1973, Photorevised 1987), in Pinellas County, Florida. The building was constructed in approximately 1953 and is an example of a one-story Frame Vernacular house with wood siding. It has an irregular form and sits on a continuous concrete foundation. The roof is a front gable with composition shingles. A stucco clad chimney is present at the interior slope of the roof. Two large garages have been added to the northeast side of the building. These additions have a flat roof and brick veneer. The porch is on the southwest side of

This building exhibits modifications and does not possess sufficient significance for inclusion in the National Register, individually or as part of a district.

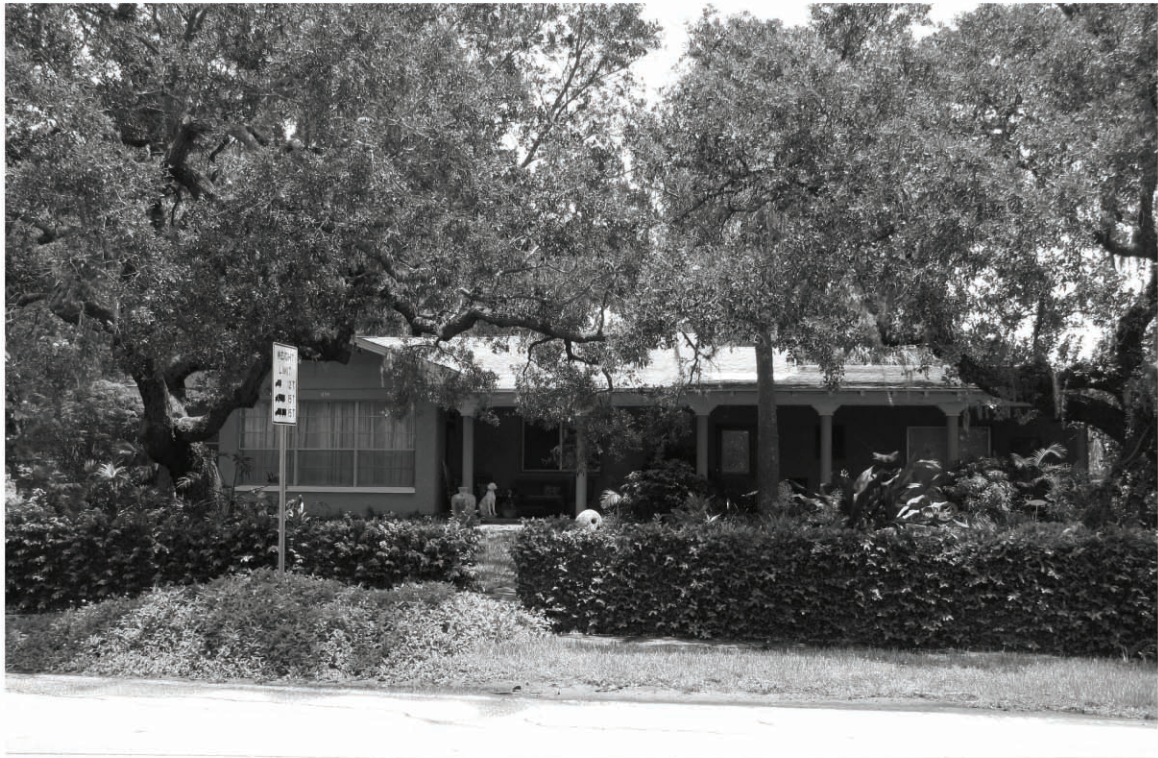
PHOTOGRAPH

Narrative Description of Resource The building is Masonry Vernacular on a continuous concrete block foundation. The building features scored stucco and multiple types of windows. The roof is gabled with a front gable extension. The porch spans much of the building façade.

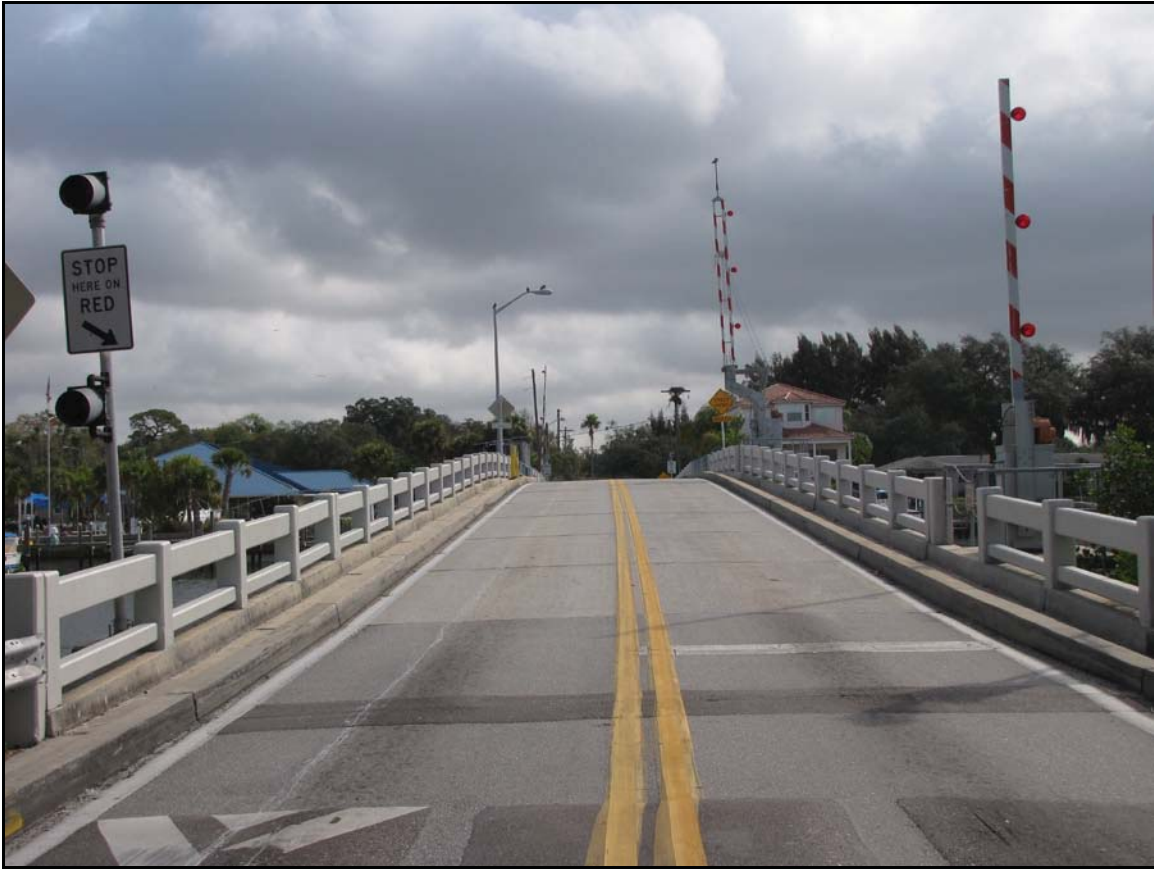
Figure 2
Bridge Roadway, Facing East

The Beckett Bridge has an overall bridge length of approximately 360 feet. The bridge width is approximately 28 feet, including the road and sidewalks (Figures 2-3). The bridge carries two lanes of traffic, one eastbound and one westbound. The existing typical section of the bridge consists of two vehicular lanes measuring 20.21 feet and a sidewalk measuring approximately 3 feet, with concrete railing on both sides. There are nine approach spans and one main span. The main span of the bridge is a steel structure with a cast concrete deck. The bridge railings, which flank the bridge approaches and the bascule span, are simple concrete guardrail with concrete posts, which according to a historic photograph appear to be part of the 1956 rehabilitation project (Figures 4-5). The date "1956" is inscribed in the concrete posts at each end of the bridge (Figure 6). The bridge is a steel, single-leaf, bottom counterweight, Scherzer rolling lift bascule. The length of the bascule span is approximately 40 feet (Figures 7-8). The substructure of the bridge includes the supporting elements under the superstructure. Concrete piers support the prestressed concrete girder spans of
