Beckett Bridge

Project Development & Environment (PD&E) Study

Pinellas County Project ID: PID2161
FDOT Financial Project ID: 424385-1-28-01
Bridge No: 154000

Final Cultural Resource Assessment Survey Report

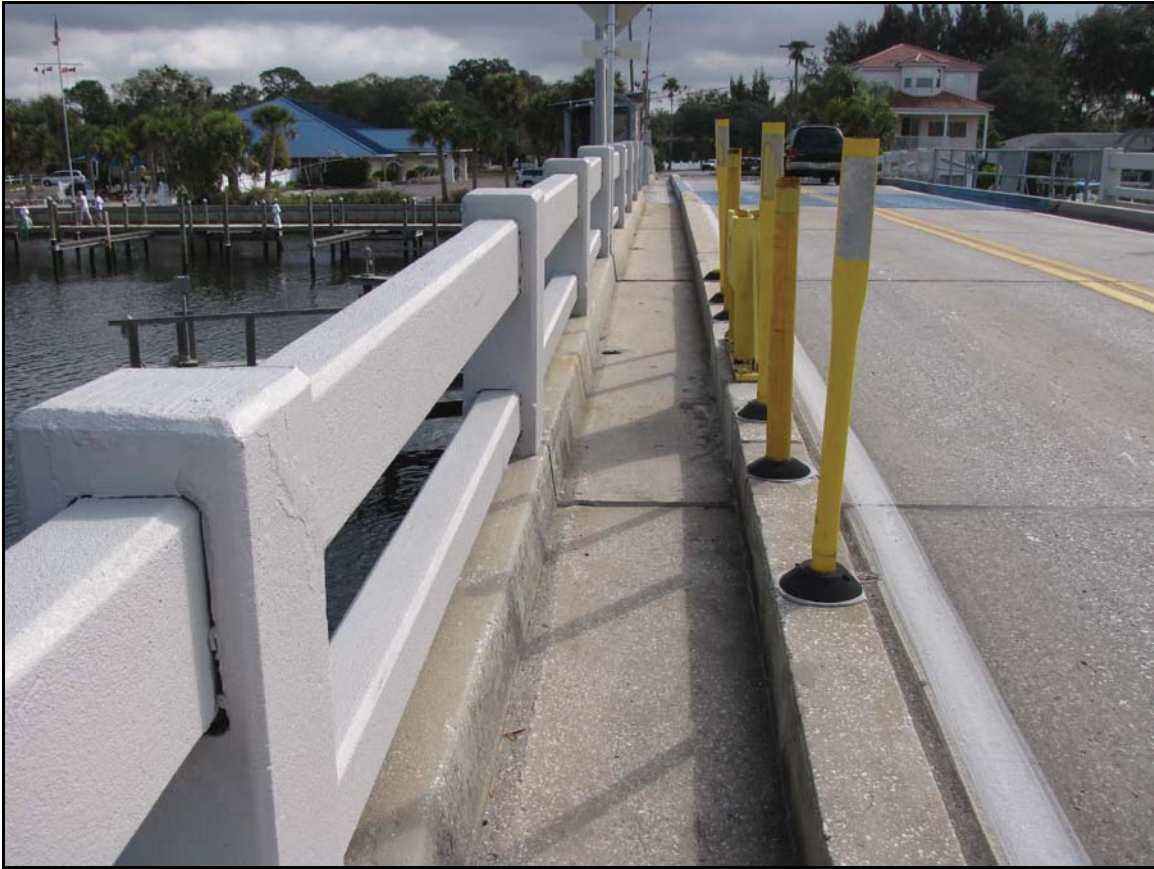
Figure 3
Sidewalk, Facing East

The Beckett Bridge has an overall bridge length of approximately 360 feet. The bridge width is approximately 28 feet, including the road and sidewalks (Figures 2-3). The bridge carries two lanes of traffic, one eastbound and one westbound. The existing typical section of the bridge consists of two vehicular lanes measuring 20.21 feet and a sidewalk measuring approximately 3 feet, with concrete railing on both sides. There are nine approach spans and one main span. The main span of the bridge is a steel structure with a cast concrete deck. The bridge railings, which flank the bridge approaches and the bascule span, are simple concrete guardrail with concrete posts, which according to a historic photograph appear to be part of the 1956 rehabilitation project (Figures 4-5). The date "1956" is inscribed in the concrete posts at each end of the bridge (Figure 6). The bridge is a steel, single-leaf, bottom counterweight, Scherzer rolling lift bascule. The length of the bascule span is approximately 40 feet (Figures 7-8). The substructure of the bridge includes the supporting elements under the superstructure. Concrete piers support the prestressed concrete girder spans of

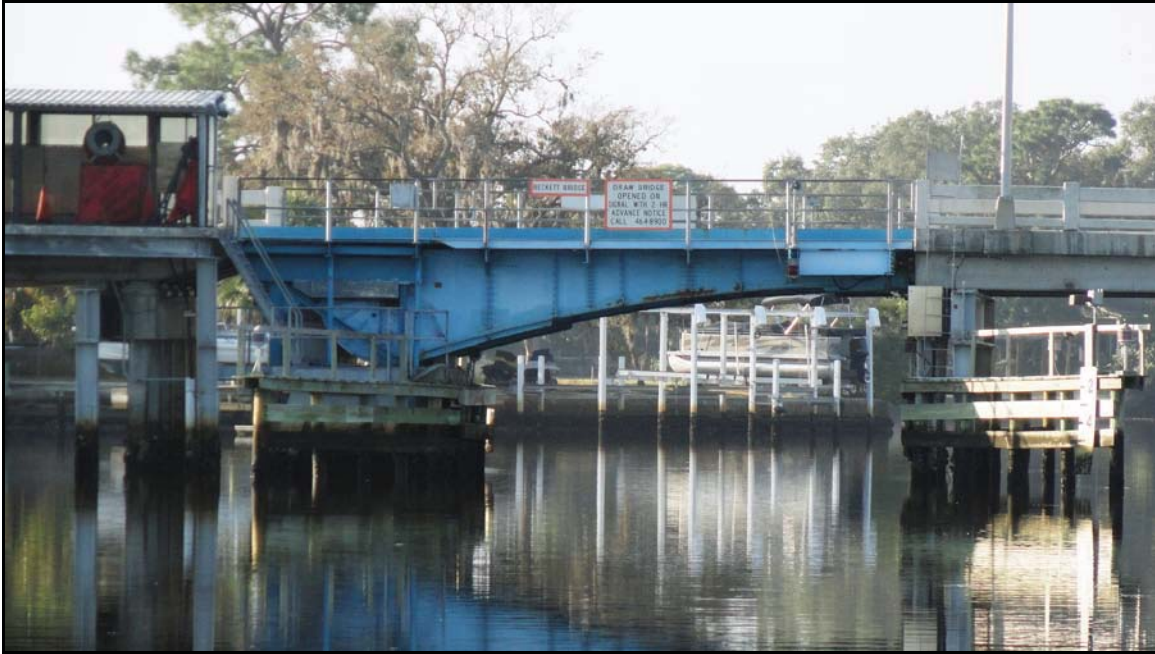
Figure 7
Bascule Span, Facing South

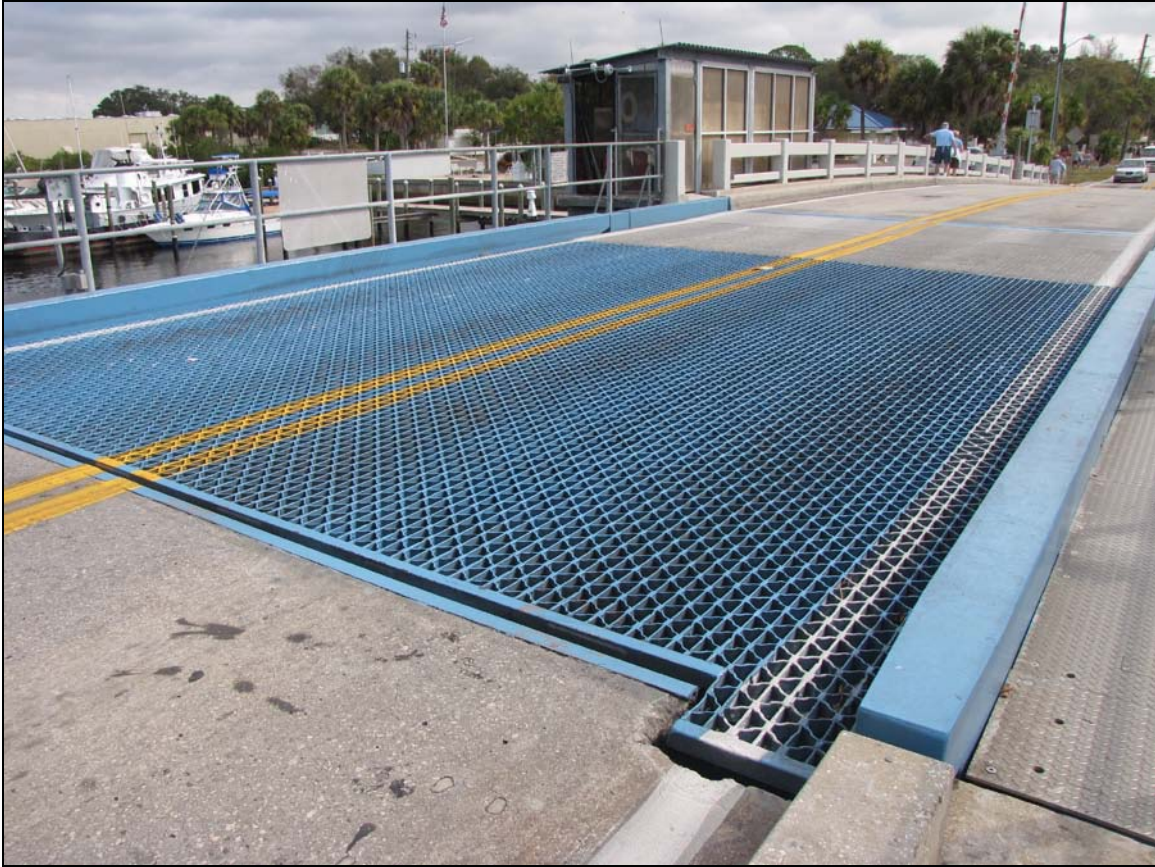
Figure 8
Bascule Span Detail, Facing Southwest

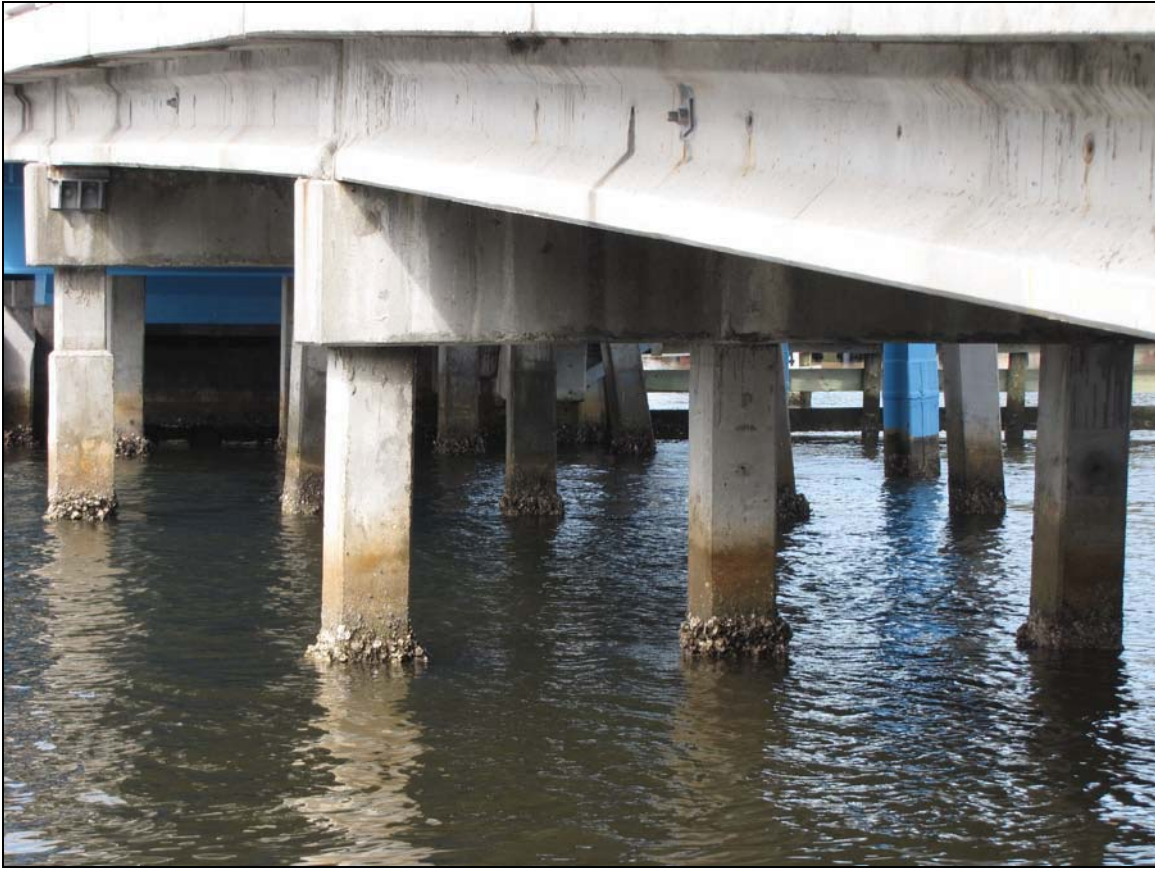
Figure 9
Bridge Substructure, Facing Northeast

this bridge, which replaced the original timber approach spans in 1956 (Figure 9). A galvanized pipe staircase with handrails leads to the bridge substructure from the base of the bridge tender's station. The bridge tender's station is situated on the north side of the bridge. This one-story station is a simple rectangular building without architectural ornamentation (Figure 10). The tender station was constructed with a galvanized steel frame and Plexiglas windows. It features a shed roof sheathed in 22-gage, wide rib galvanized steel. Adjacent to the tender's station is a metal plaque signifying the original date of construction and engineer for the bridge (Figure 11). The station dates from the 1996 repairs to the bridge, and is utilitarian in construction and form. It is considered a non-contributing structure. A bridge tender is only present when required to open the drawbridge for a vessel, there are no full-time bridge tenders. US Coast Guard drawbridge opening regulations (33CFR117.341) states that "the draw of the Beckett Bridge, mile 0.5, at Tarpon Springs, Florida shall open on signal if at least two hours notice is given."

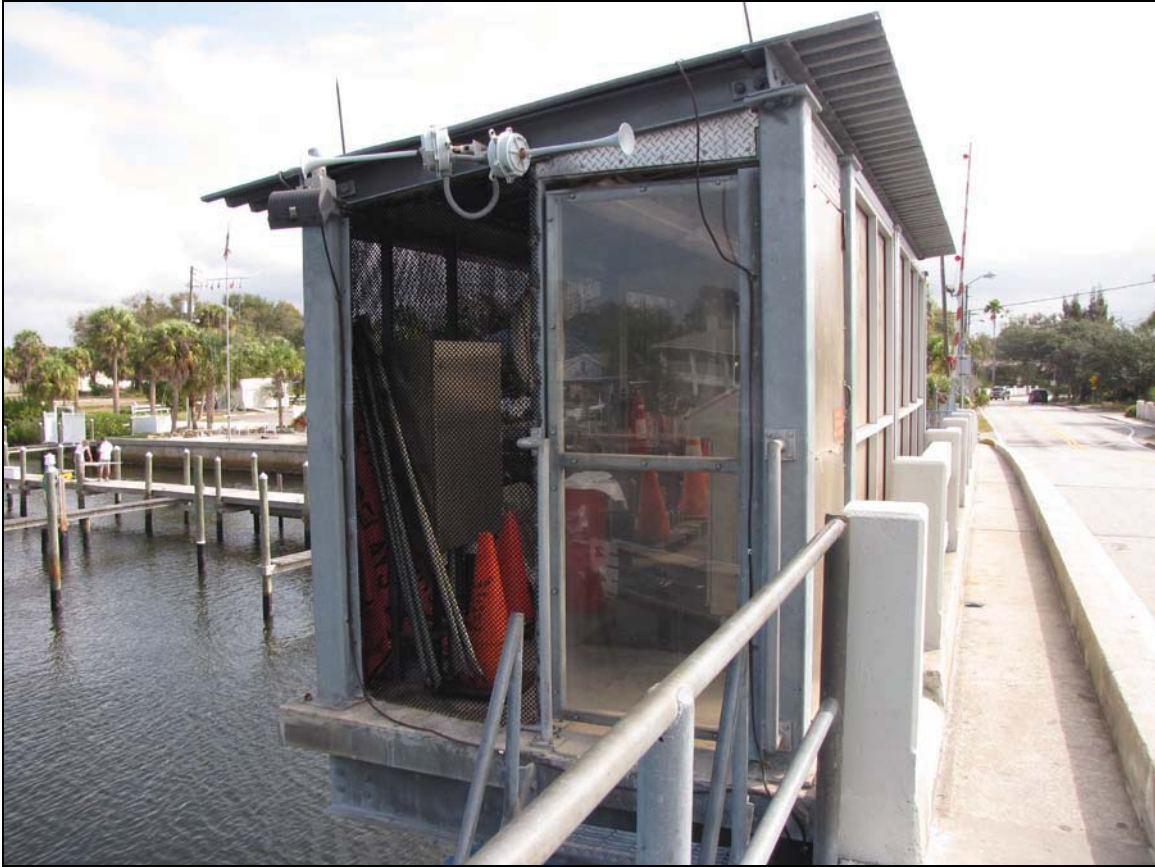
Figure 10
Bridge Tender Station, Built in 1996, Facing Northeast

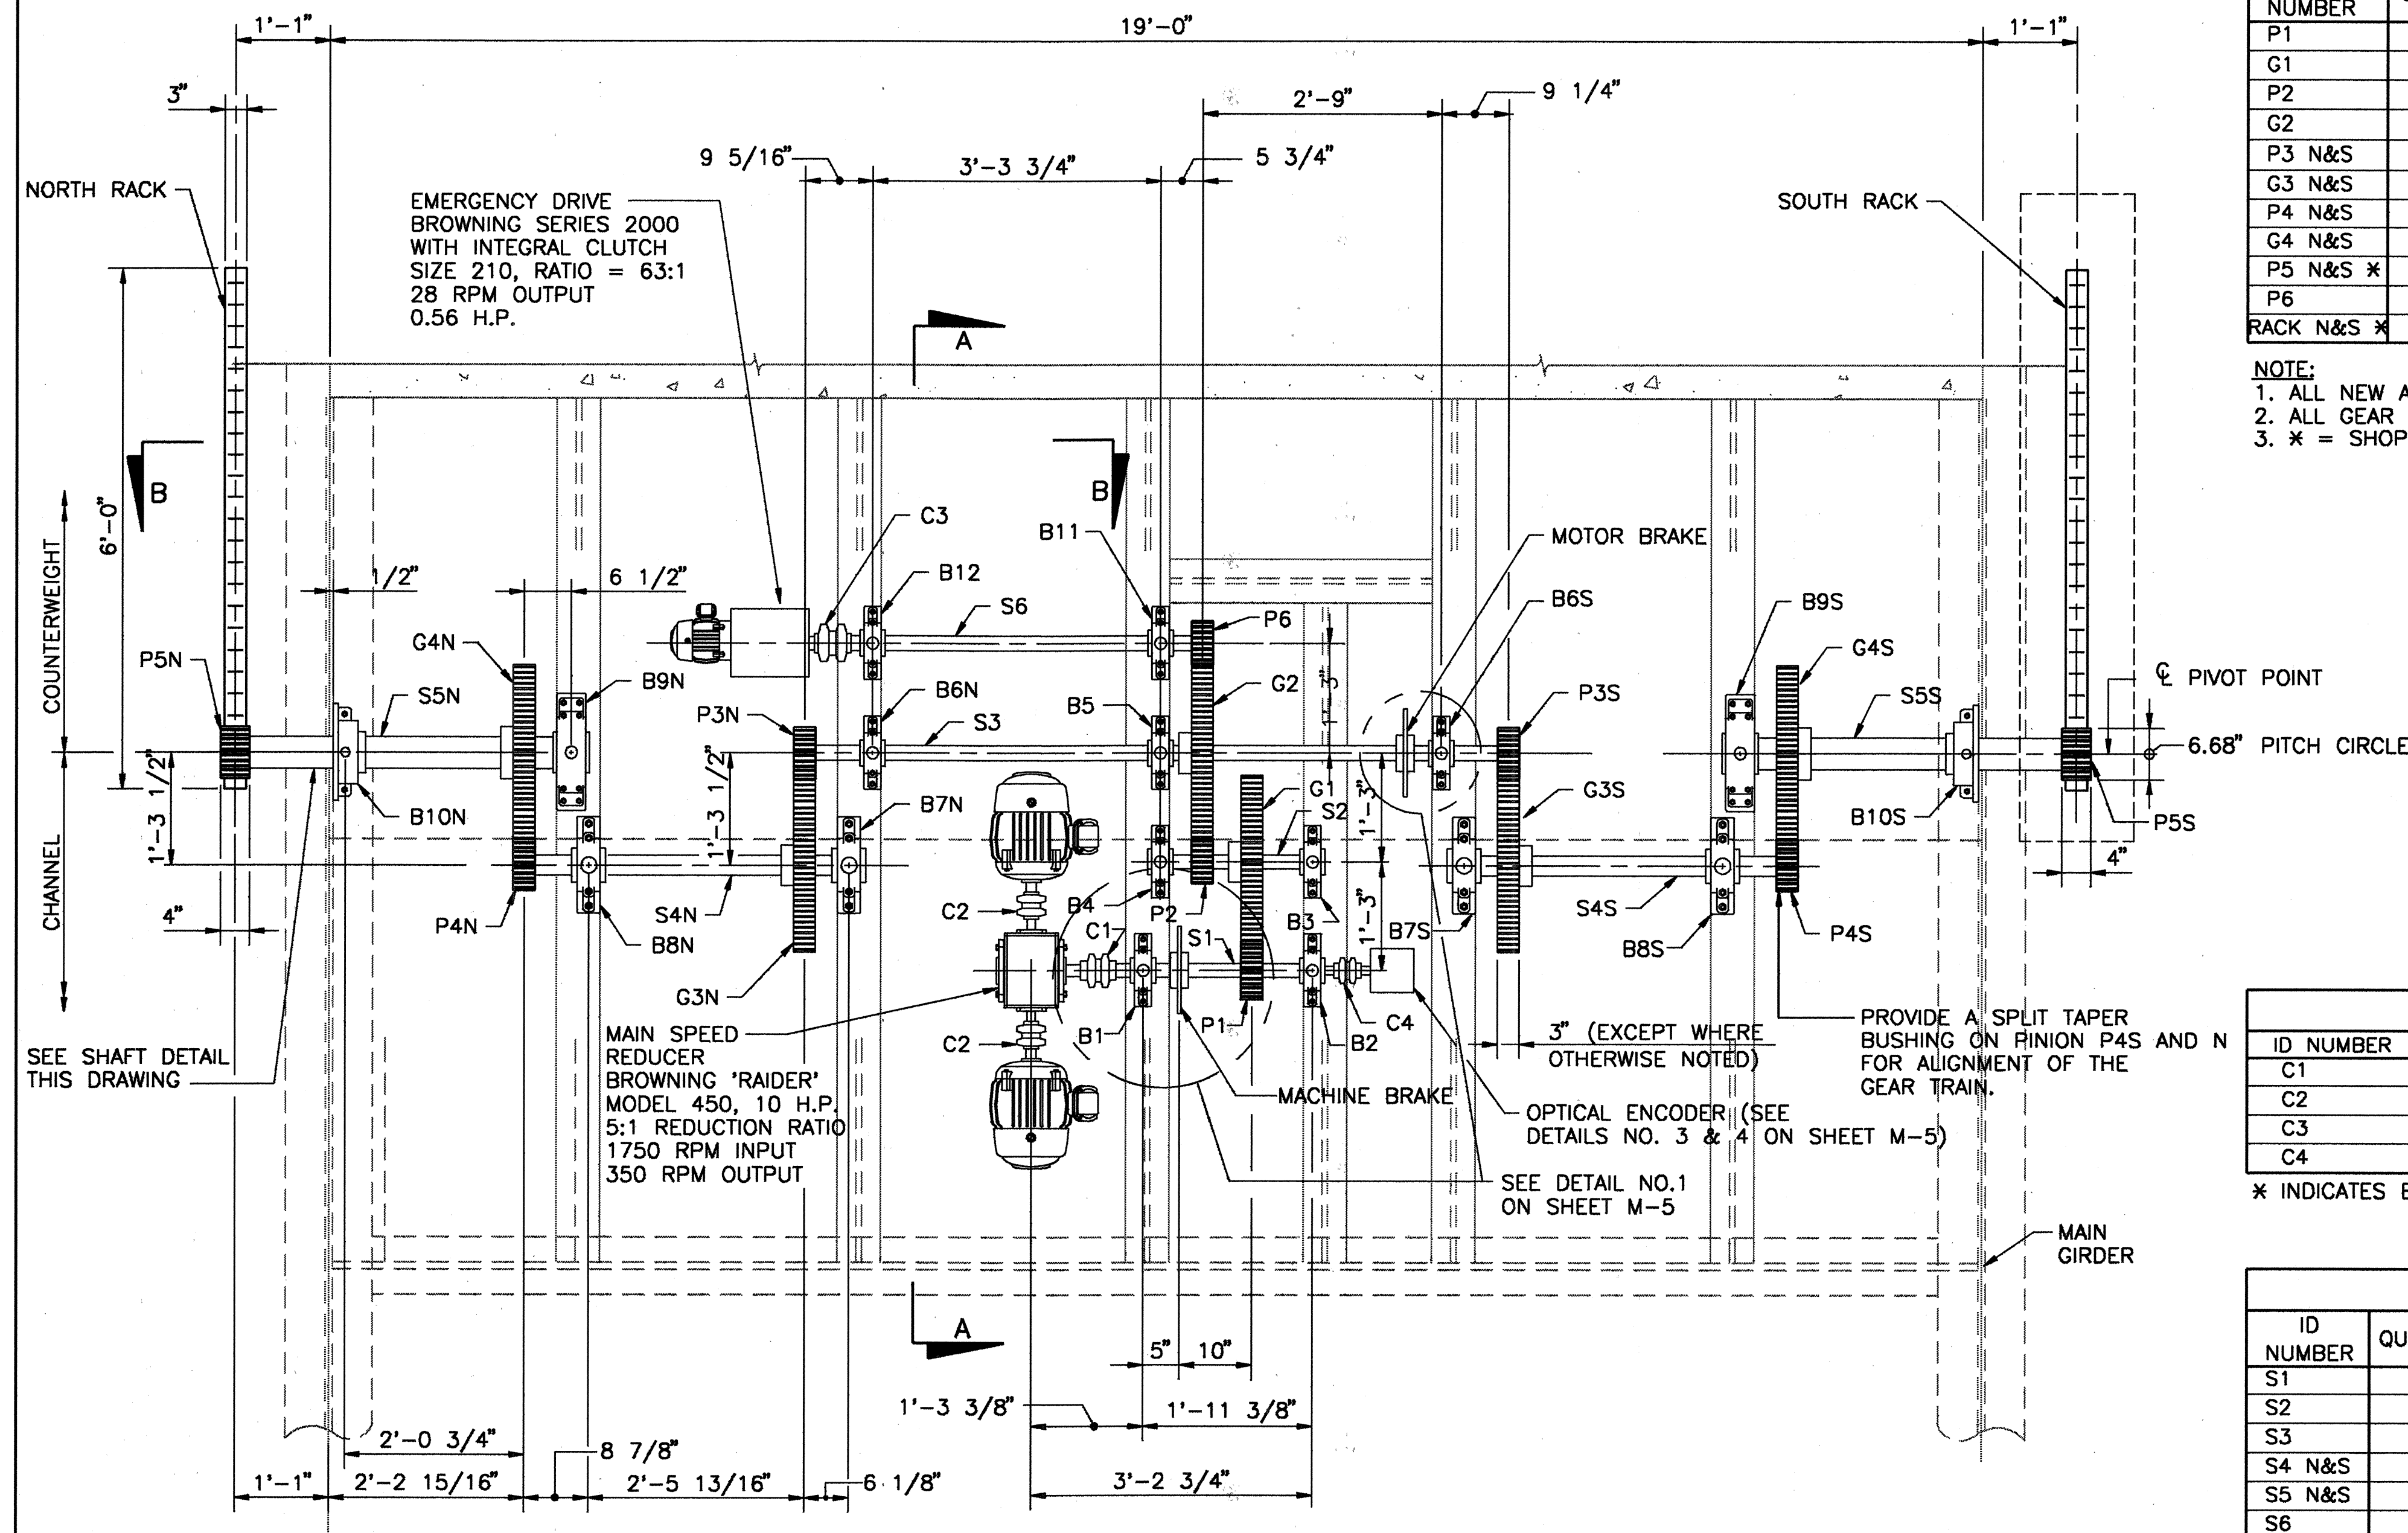
PLAN OF MACHINERY BAY
