Tornado Protection

Selecting Safe Areas in Buildings

Florida Department of Community Affairs
Tallahassee, Florida

March 2002

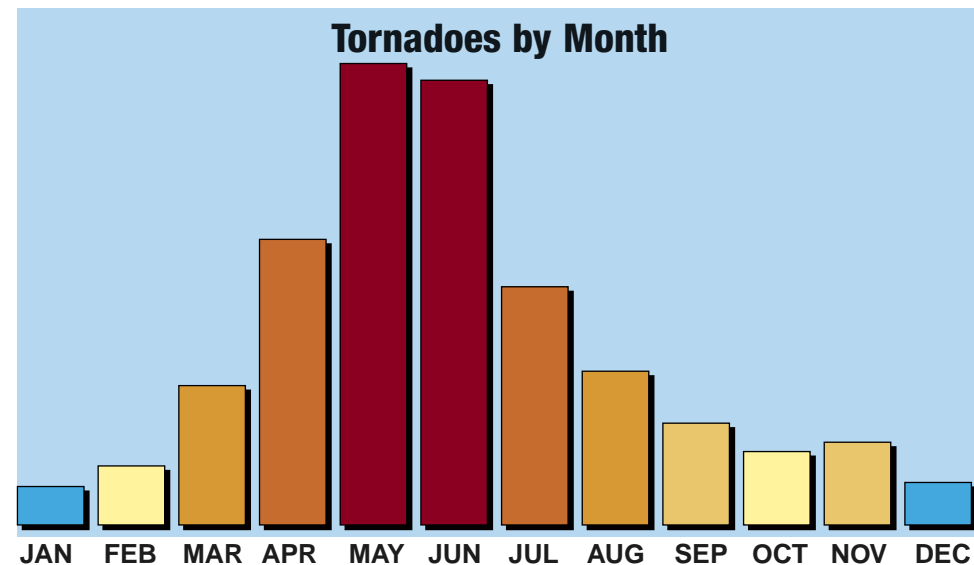
Figure 1-1 Tornado occurrence by month in the United States.

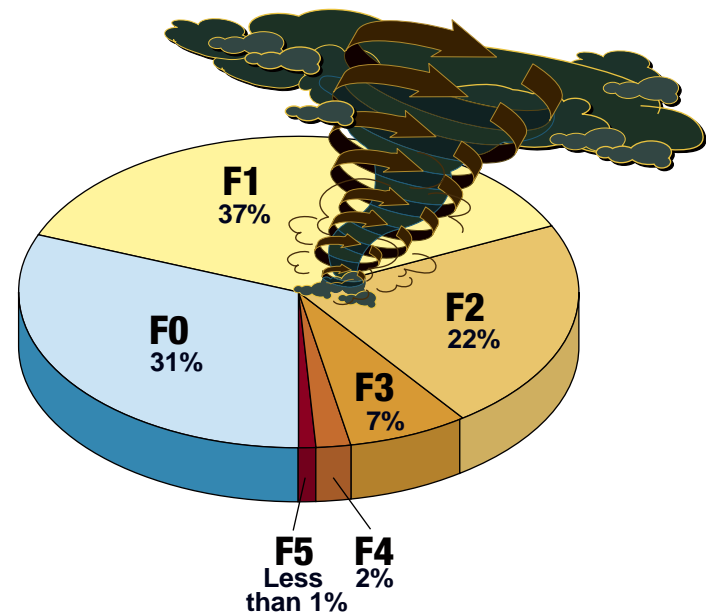
Figure 1-5 Percentage of recorded tornadoes by Fujita Tornado Damage Scale ranking.

Tornadoes are rated by the National Weather Service according to the tornado damage scale developed by Dr. Theodore Fujita, a professor of meteorology. Ratings vary from F0, for light damage, to F5, for total destruction of a building (Figure 1-4). Ninety percent of the tornadoes recorded over the past 45 years have been categorized as F0, F1, or F2 (Figure 1-5).

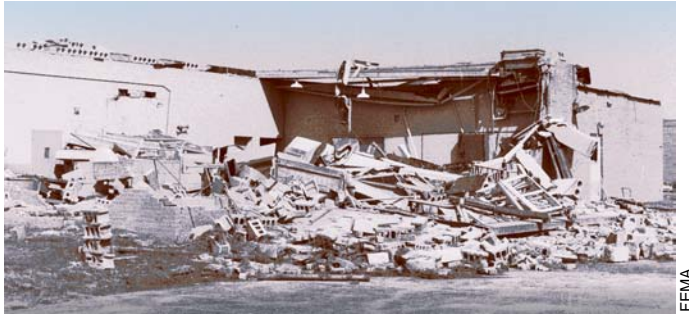
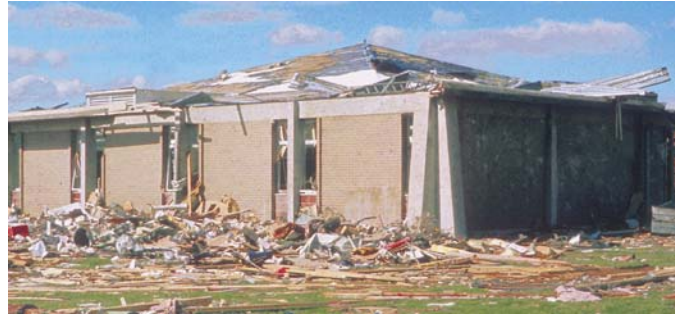
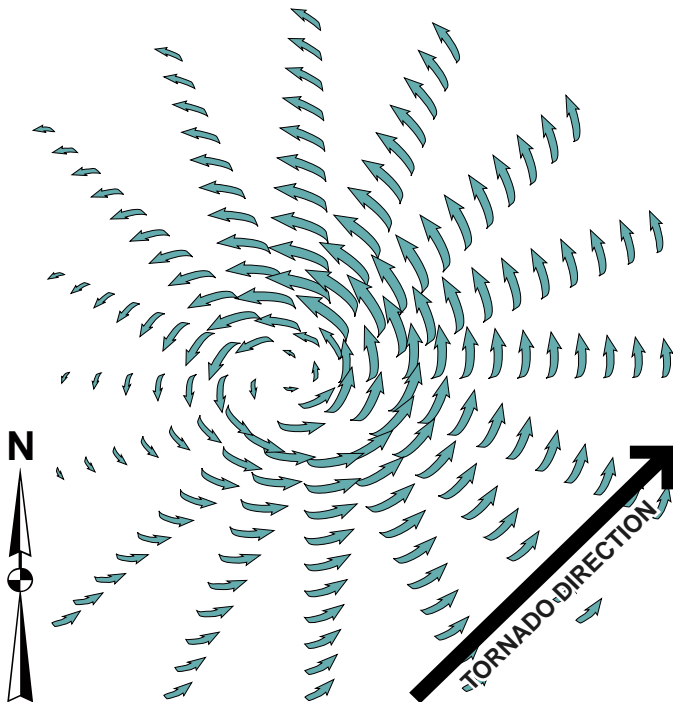
Figure 1-6 Typical tornado rotation.

Rotation is generally counterclockwise in the northern hemisphere (Figure 1-6). About 10 percent of tornadoes have been known to rotate clockwise.

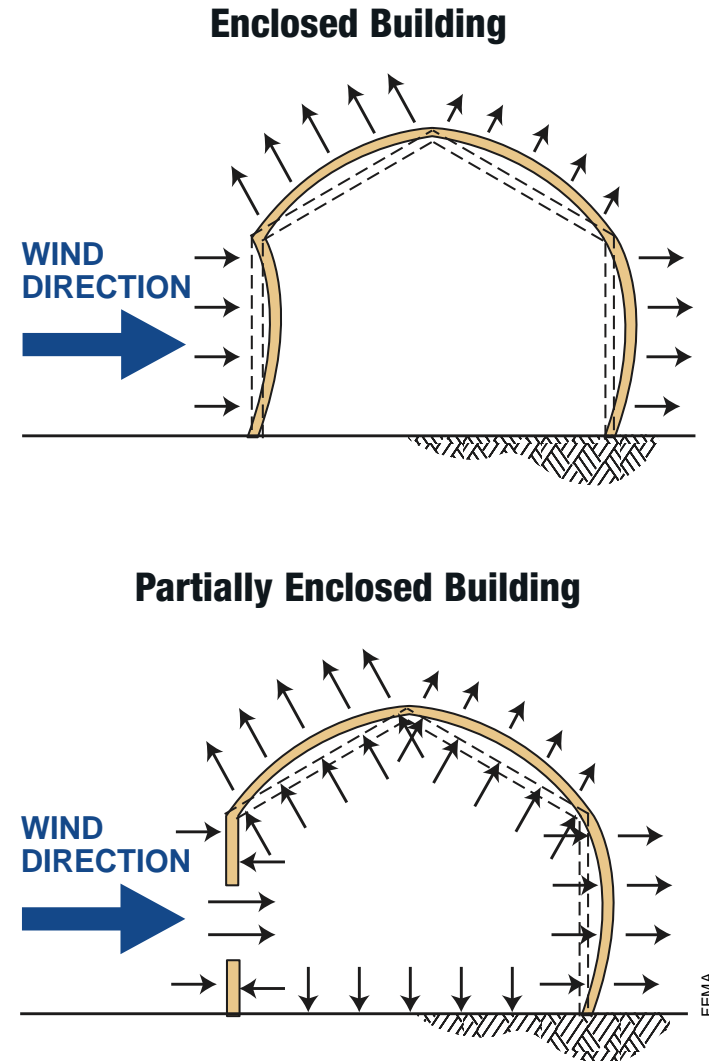
Figure 2-1 Effects of wind on a fully enclosed building and on a building with openings.

The explosion of buildings during a tornado due to atmospheric pressure differences is a myth. In reality, the combination of internal pressure and outward pull on the building from suction pressure has caused building failures that have forced the walls outward and given the building the appearance of having exploded. Doors and windows should remain closed on all sides of the building during an event in order to minimize the amount of wind that can enter the building.

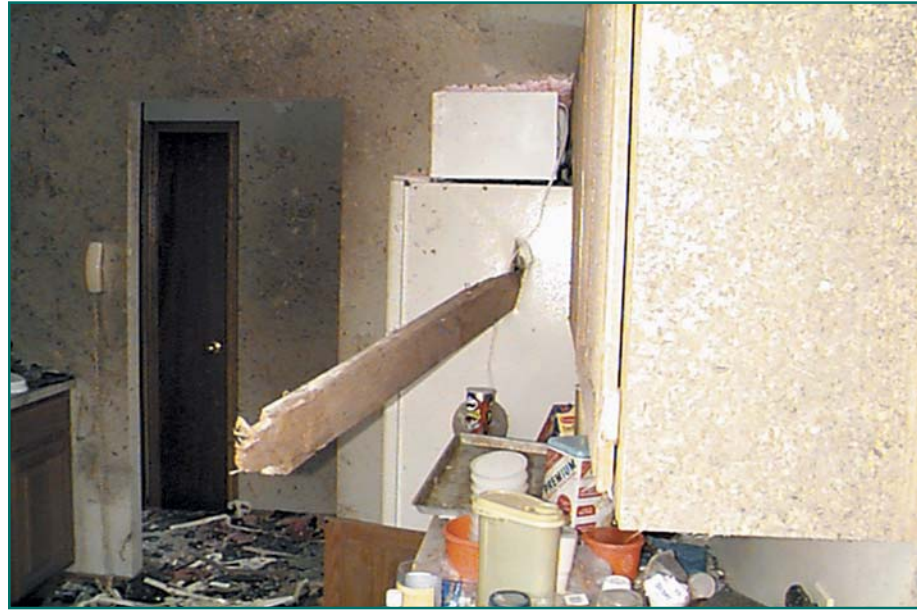
Figure 2-2 Example of damage from windborne missile. A 2-inch by 6-inch board penetrated a refrigerator.

The extreme winds in tornadoes pick up and carry debris from damaged buildings and objects located in the path of the winds (see Figures 2-2 and 2-3). Even heavy, massive objects such as cars, tractor trailers, and buses can become windborne debris capable of causing collateral damage to buildings. Light objects become flying missiles that can penetrate doors, walls, and roofs; heavier objects usually roll and cause crushing-type damage.

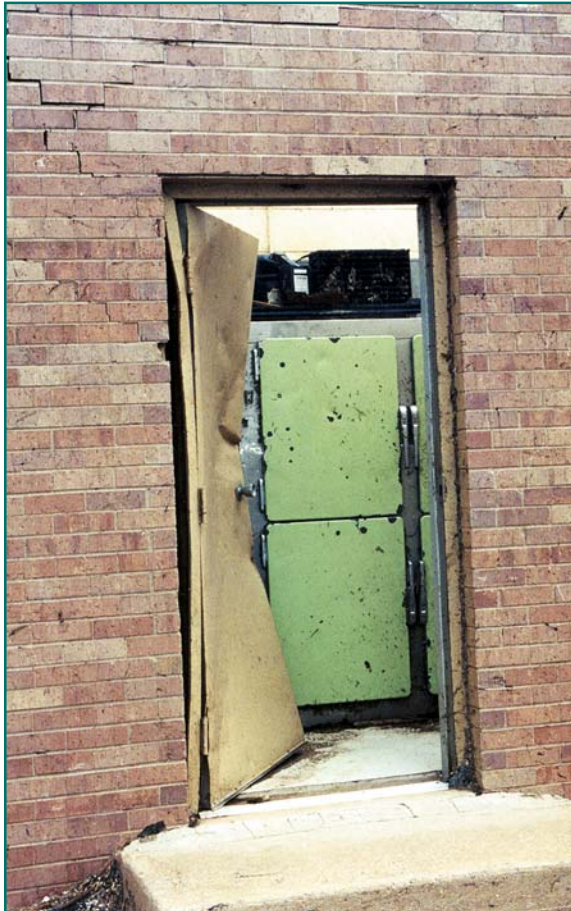
Figure 2-3 Example of damage from windborne missile. Metal door pushed inward by impact of heavy object.

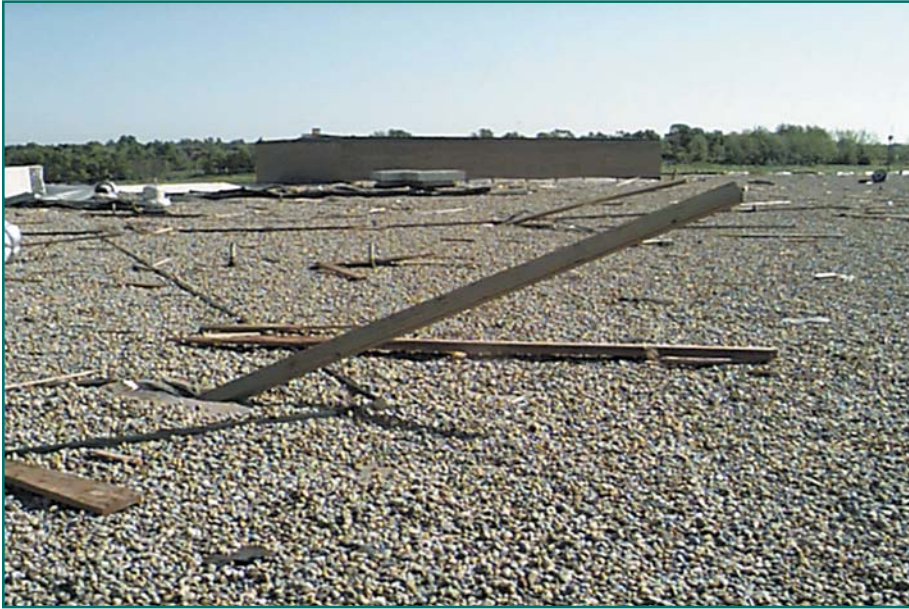
Figure 2-4 Example of damage from windborne missile. Medium and small missiles penetrating through the roof of a high school.

Missiles can travel vertically as well as horizontally (see Figure 2-4). For the safety of shelter occupants, protection must be provided overhead as well as on the sides of the shelter. Building walls and roofs can be designed to withstand the impacts of these missiles. Protection can be provided at the exterior building wall, or interior barriers can be constructed to provide protection for a smaller area within the building.

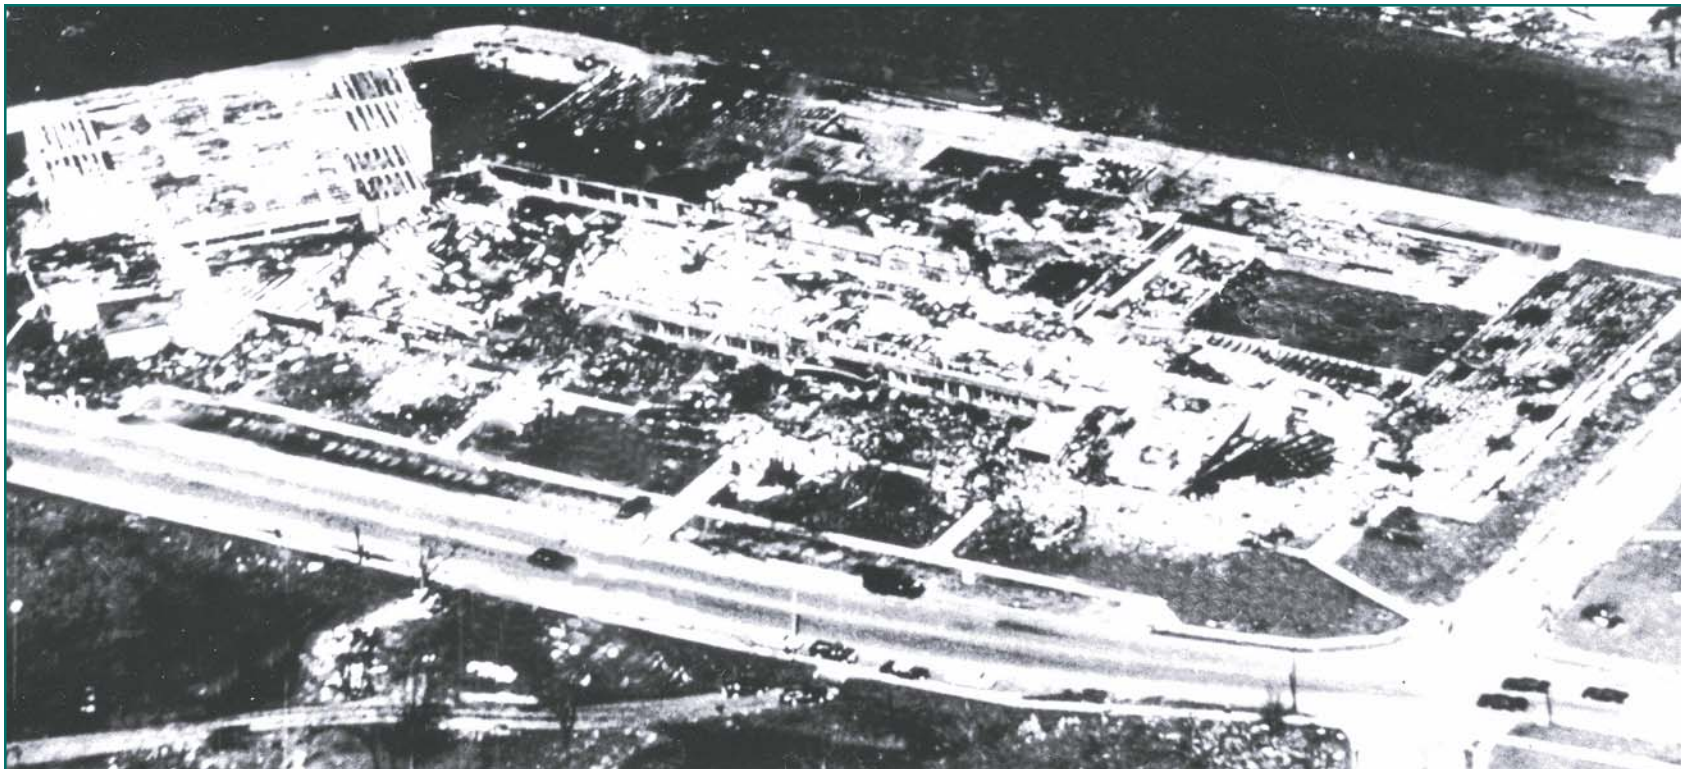
Figure 3-2 *Xenia Senior High School, Xenia, Ohio.*

The tornado passed directly over the school, engulfing the entire building and the adjacent fieldhouse to the south (Figure 3-2).

The enclosure walls failed on the west and south sides, allowing the winds to enter the building. The roofs collapsed over the three large spans—the auditorium, the boys' gym, and the girls' gym. The lightweight roof over the original two-story building was torn off by the extreme winds.

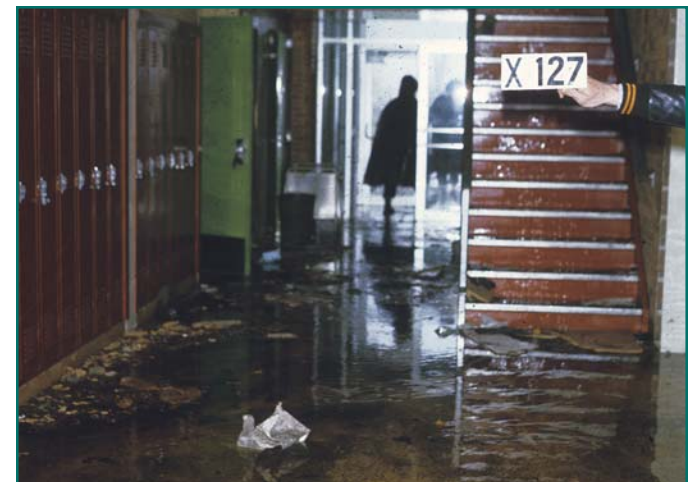
Figure 3-3 *Surviving interior hallway. This is an example of the type of area that can provide refuge for building occupants during a tornado.*

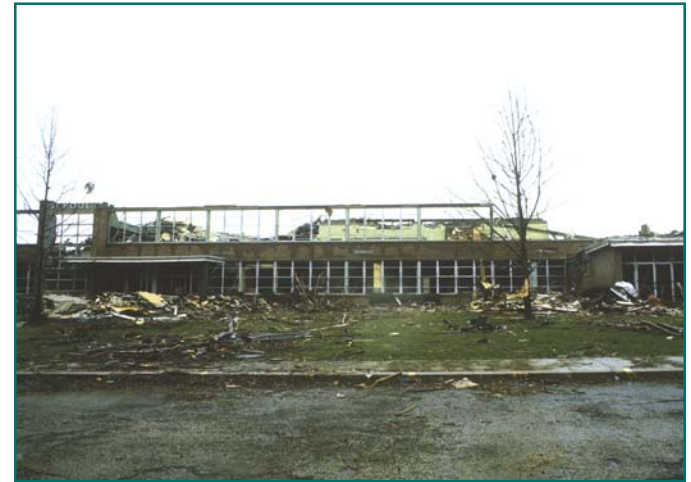
Figure 3-5 Loss of lightweight roof over the original two-story building.

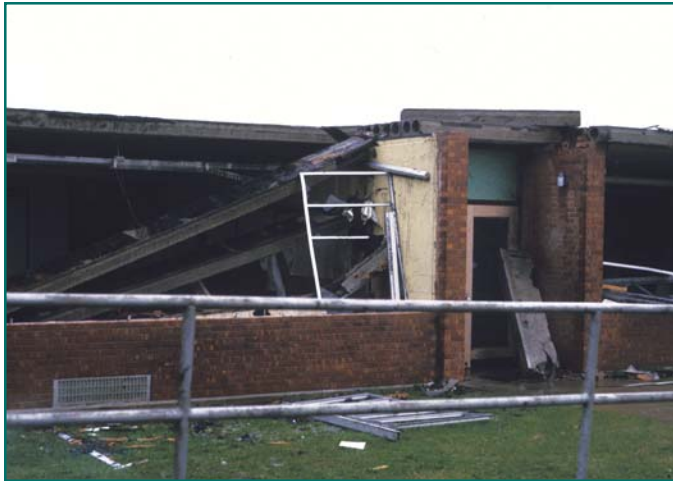
Figure 3-6 Collapsed hollow-core precast roof panels in the classroom area.

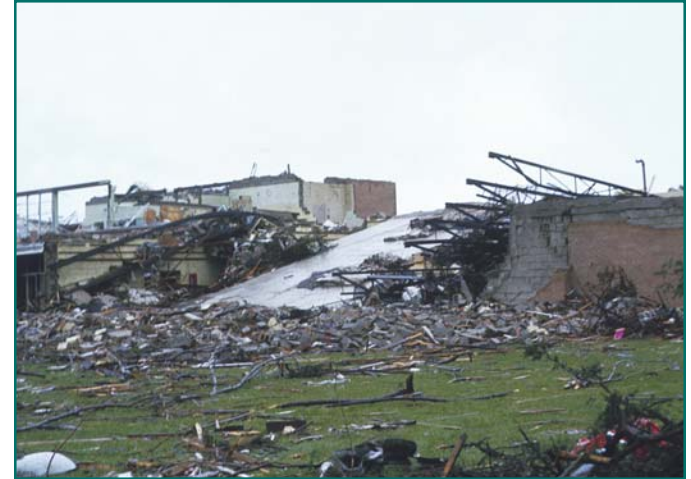
Figure 3-7 Collapsed gymnasium walls and roof, where open-web roof joists were supported on unreinforced masonry walls.

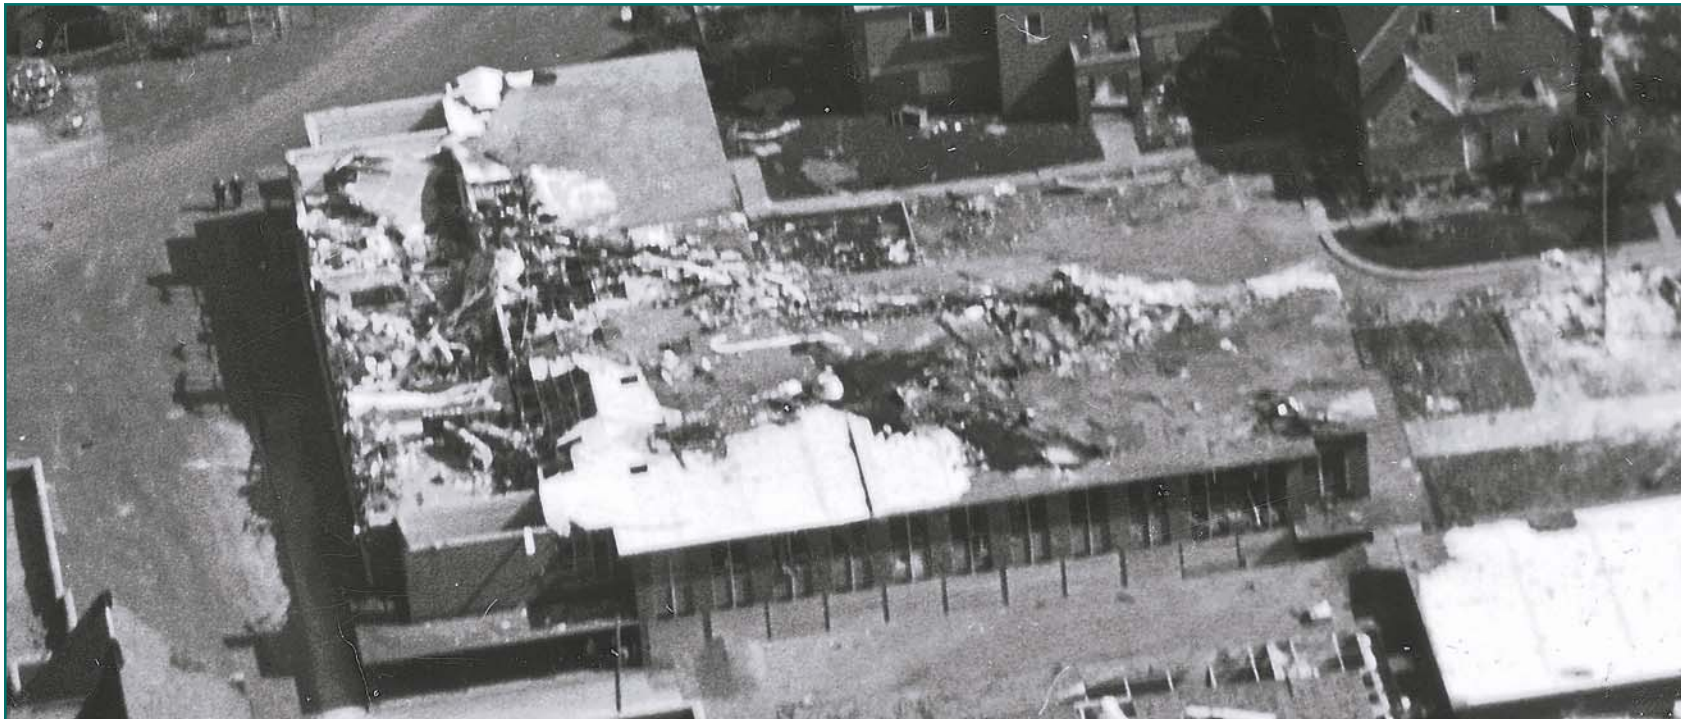
Figure 3-8 St. Augustine Elementary School, Kalamazoo, Michigan.

The tornado winds lifted part of the roof and collapsed the second-floor piers in one wing of the school building (Figures 3-8, 3-9, and 3-10). The wind and windborne debris blew in most of the windows, and windborne debris was found in the classrooms (Figure 3-11). The exterior solid-core wood doors remained in place and kept the debris out. Wired glass windows near the exterior doors remained intact. The interior doors to the classrooms remained in place although the hinges were damaged. The school was damaged to an extent where demolition was required.

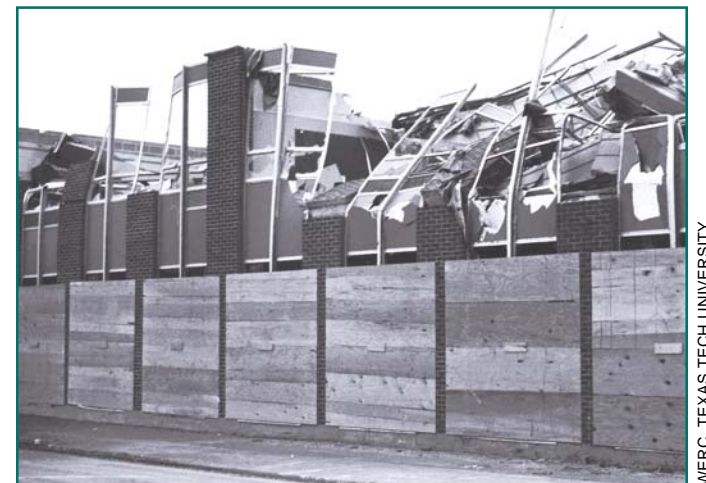
Figure 3-9 Collapsed second floor of St. Augustine Elementary School building.

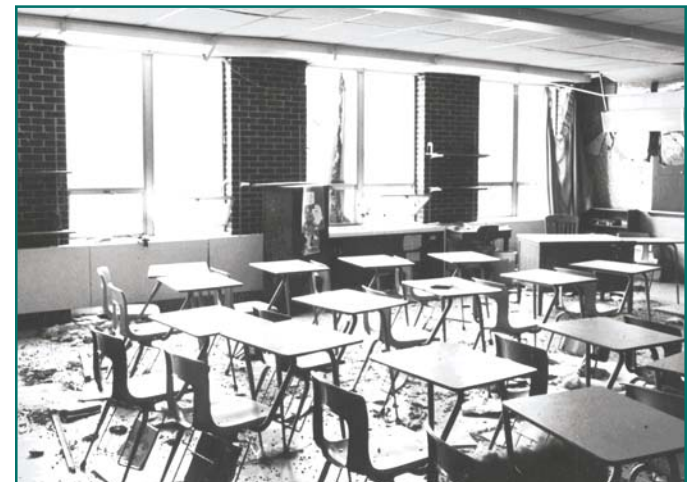
Figure 3-11 Broken windows and debris in classroom of St. Augustine Elementary School building.

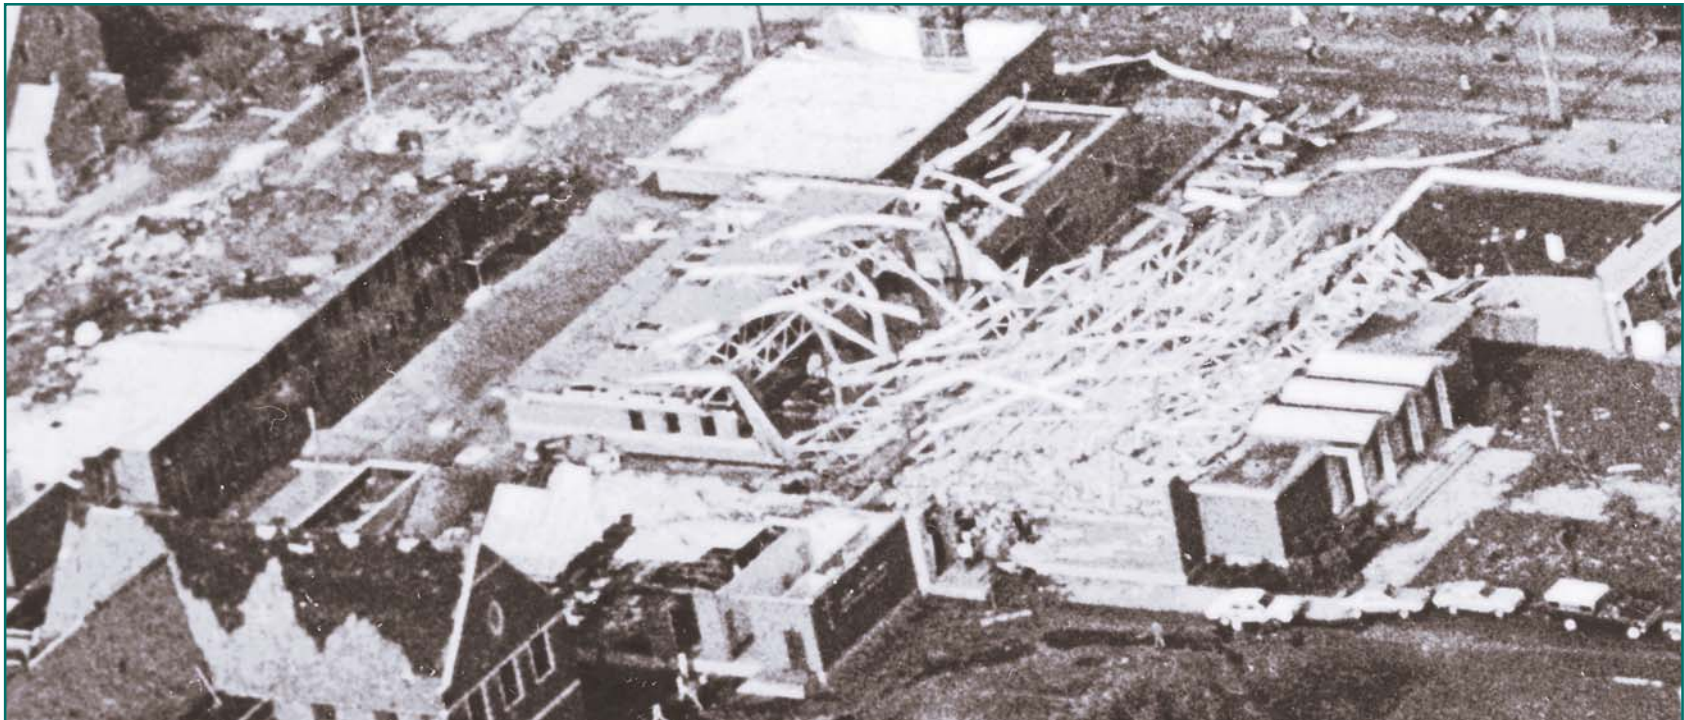
Figure 3-13 St. Augustine Elementary School Gymnasium, Kalamazoo, Michigan.

The structural system consisted of loadbearing masonry walls of 12-inch concrete block and 4-inch face brick. The walls were not reinforced in the vertical direction. The roof structure consisted of long-span steel joists spanning 80 feet between the walls and spaced 6 feet apart. The corrugated steel roof deck was connected to joists with puddle welds.

The building was destroyed (Figures 3-13 and 3-14). The loadbearing west wall collapsed inward, and the east wall fell outward. The roof fell in the building when the walls collapsed.

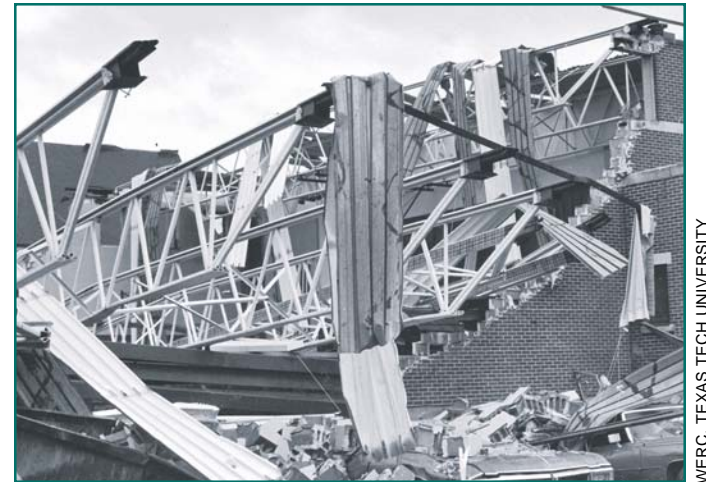
Figure 3-14 Collapsed St. Augustine Elementary School Gymnasium building.

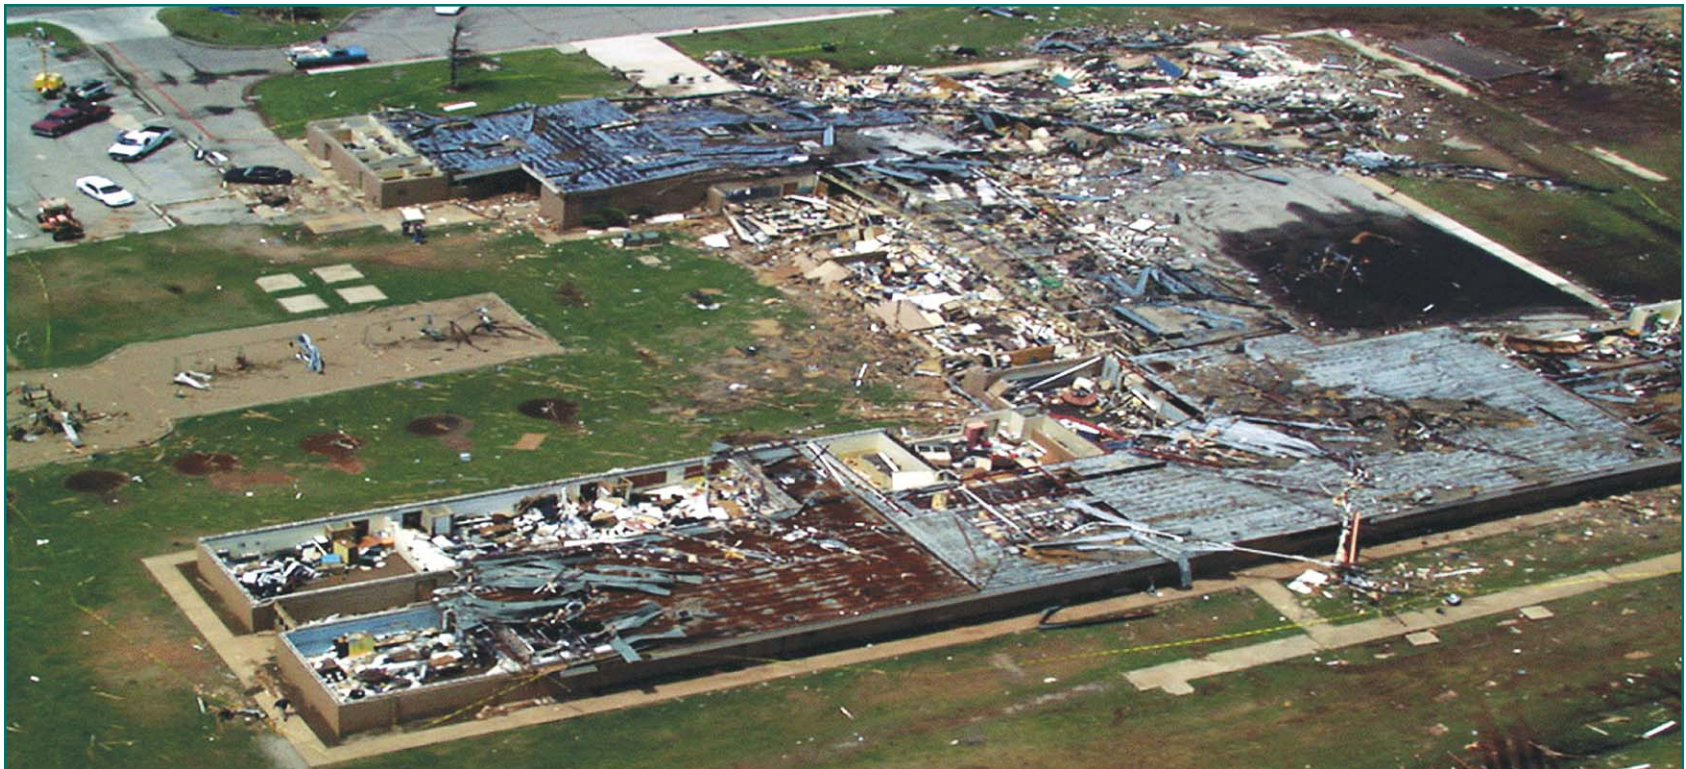
Figure 3-15 Kelly Elementary School, Moore, Oklahoma.

The tornado hit after school hours and passed just to the north of the site. Damage to the school building was both severe and extensive (Figure 3-15). As discussed in the Lessons Learned section in this case study, the remaining structure was demolished and the school was rebuilt. The new school includes structural elements designed to provide increased wind resistance.

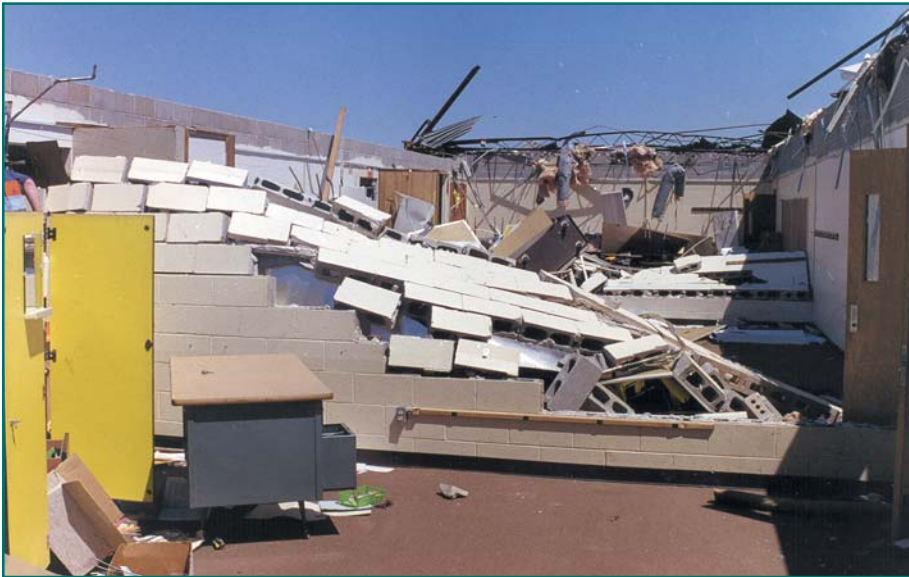
Figure 3-17 Interior and exterior unreinforced masonry walls were damaged when reinforced bond beams failed.

Unreinforced masonry walls failed when the roof system was lifted or removed by tornado winds (Figures 3-17, 3-18, and 3-19). Figures 3-17 and 3-19 show failed interior and exterior walls, respectively. Figure 3-18 shows the separation of the reinforced bond beam (indicated by circles) from the upper part of a corridor wall. The inclusion of clerestory windows in some corridor walls contributed to their failure under loads imposed by tornado winds (Figure 3-20).

The improvements discussed here are designed to prevent the types of damage to interior corridor walls and roofs shown previously in Figures 3-17, 3-18, 3-20, and 3-21. The reconstruction of the Kelly Elementary School is a good example of how shelter areas can be incorporated into new construction.

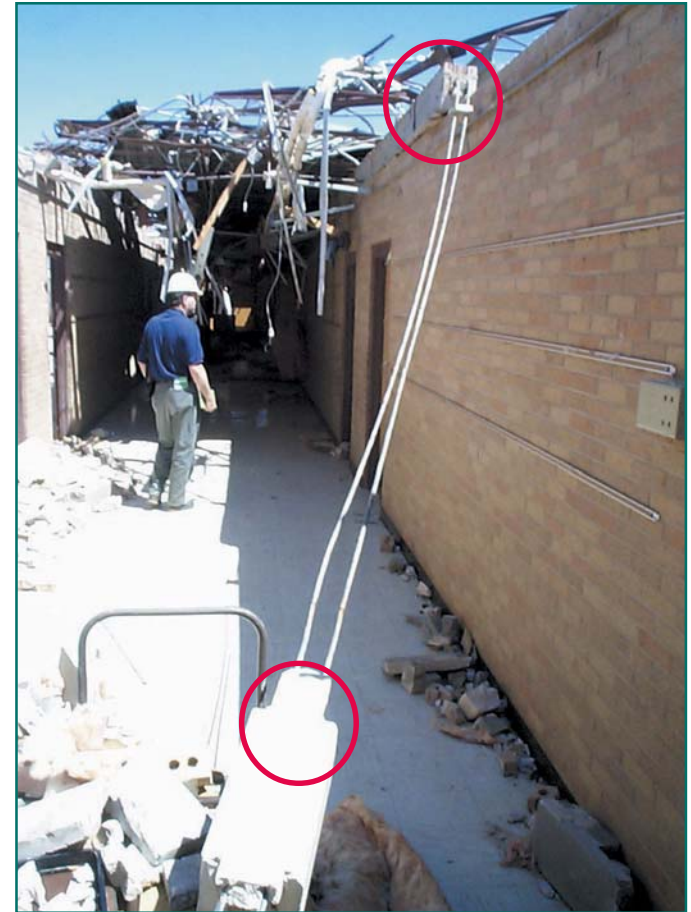
Figure 3-18 Corridor area. Separation of reinforced bond beam (indicated by circles) from supporting wall.

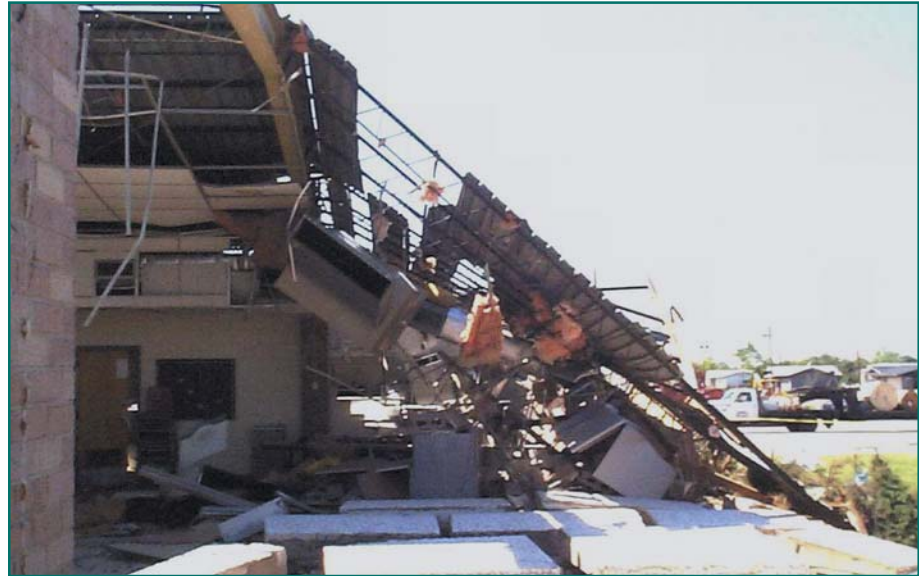
Figure 3-19 Collapsed roof structure and exterior wall.

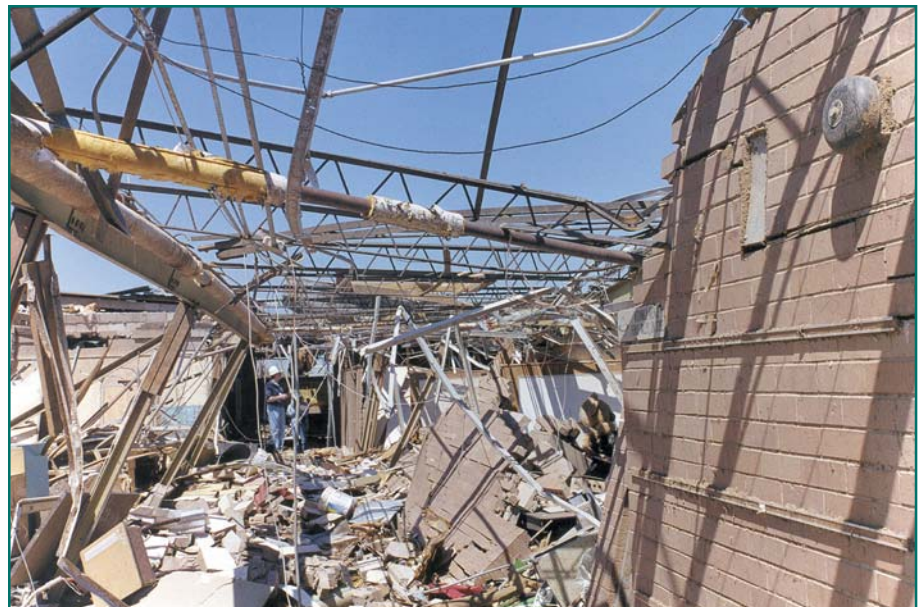
Figure 3-20 Failed interior corridor walls. These walls consisted of unreinforced brick masonry infill between steel-frame members. The brick masonry extended to a height of approximately 7 feet. Clerestory windows extended from the top of the masonry to the tops of the walls.

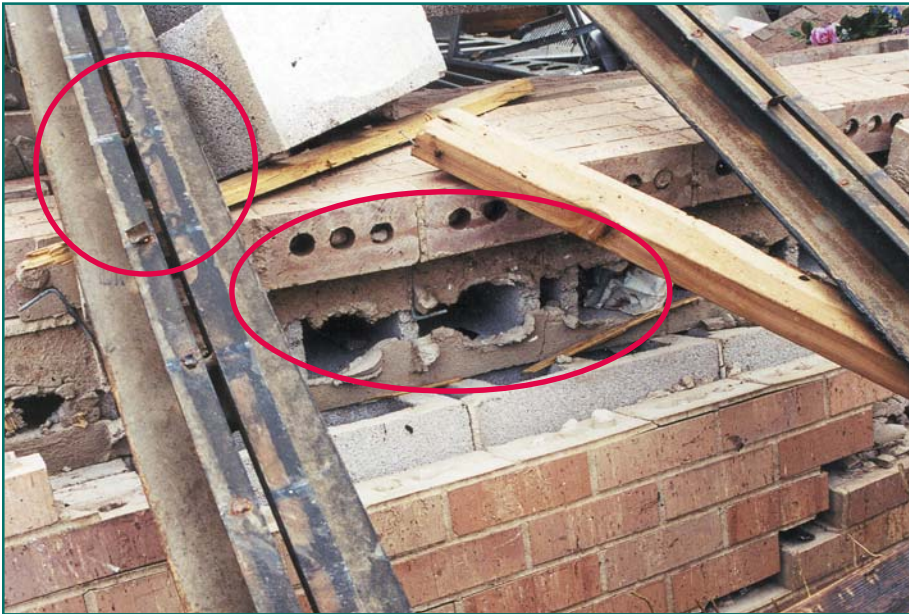
Figure 3-21 Failed roof structure showing broken welds between metal roof deck and tops of joists (upper circle) and lack of vertical reinforcement (bottom circle).

Inspection of the roof damage revealed that the roof decking failed at the points where it was welded to the tops of the steel trusses. Although the spacing of the welds appeared to be consistent with standard practice, the welds were not strong enough to resist the wind uplift forces (Figure 3-21).

Welds between the roof decking at the tops of the metal joists failed because they were **not strong enough to resist uplift**.

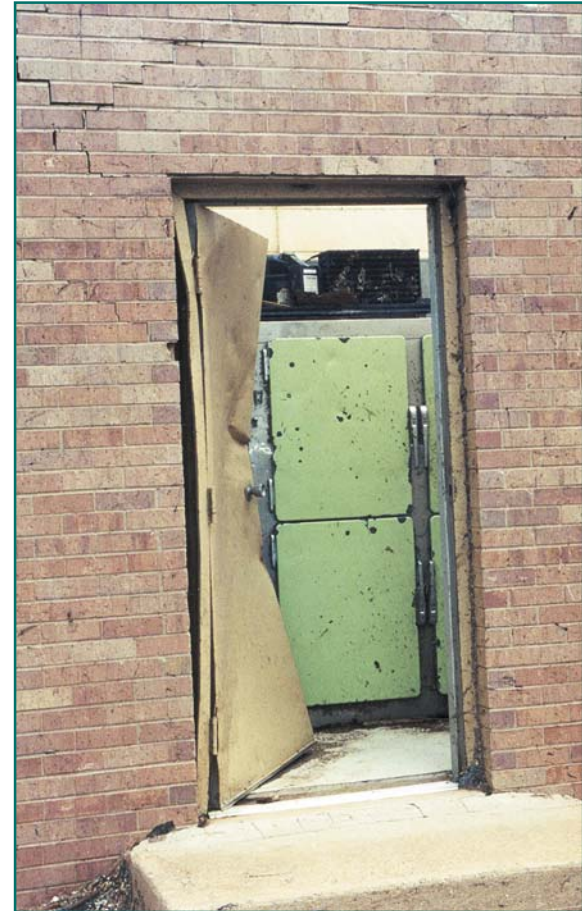
Figure 3-22 Damaged door pushed in by impact of heavy windborne debris.

Damage was also caused by the impact of windborne missiles. Figure 3-22 shows a steel door that appeared to have been opened by the impact of a heavy object. This door led into an area where the roof was missing. The opening created by this breached door may have allowed wind to enter the building and create internal pressure that increased the load on the building envelope.

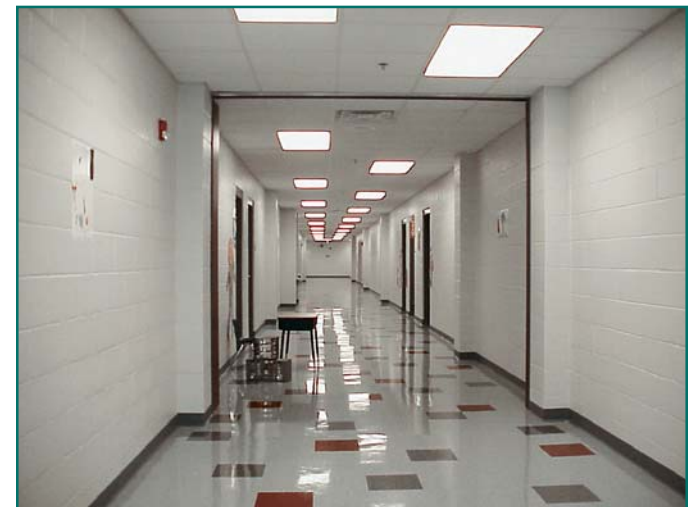
Figure 3-24 Corridor (designated safe area) in reconstructed Kelly Elementary School.

Because the damage to Kelly Elementary School was so great, the school was demolished and completely rebuilt. The new building, although constructed on the same footprint, incorporated several structural improvements specifically designed to provide improved resistance to extreme winds and create shelter areas for the school's occupants. As in the original building, the central corridors of the three wings are the designated shelter areas (Figures 3-23 and 3-24).

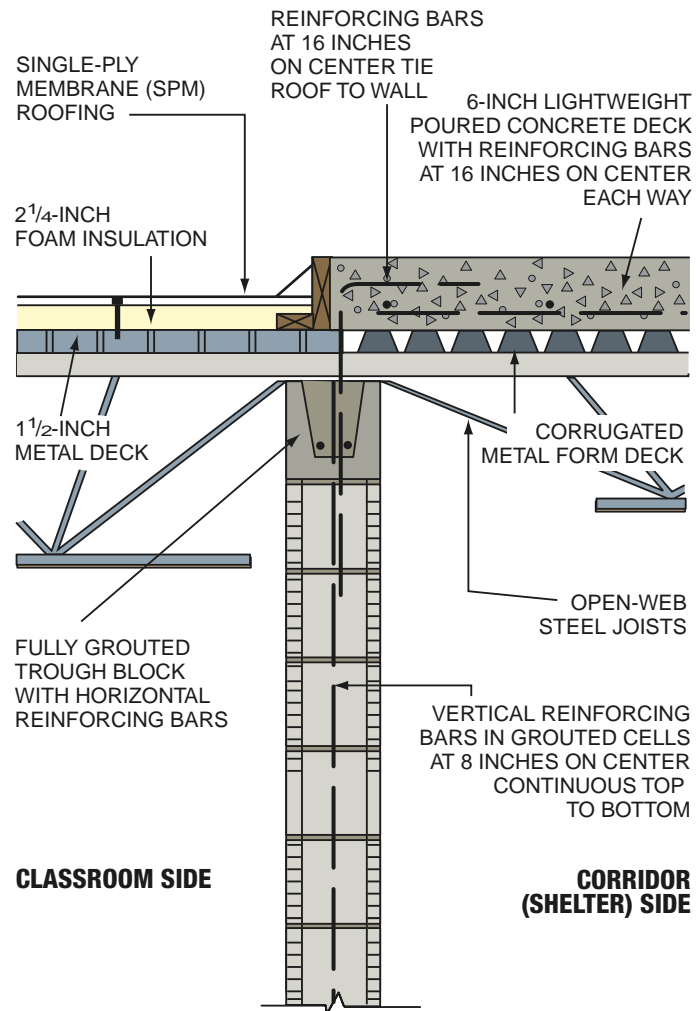
Figure 3-25 Typical cross-section of top of safe area wall in the reconstructed Kelly Elementary School.

The creation of shelter areas in the new school involved, among other improvements, the design and construction of stronger loadbearing walls, roofs, roof-to-wall connections, and wall-to-foundation connections. Figure 3-25 is a typical cross-section of the top of a safe area (corridor) wall in the new school. As shown in this figure, the wall is constructed of reinforced concrete masonry. Note the continuous, closely spaced (8 inches on center) vertical reinforcement bars, fully grouted block cells, 6-inch-thick reinforced concrete

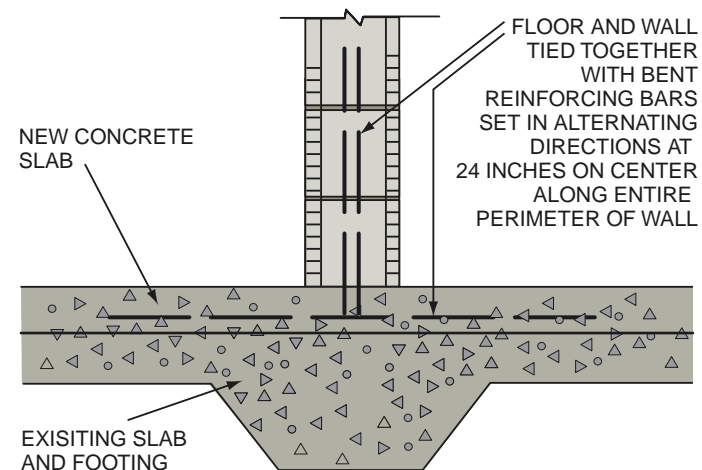
Figure 3-26 Typical cross-section of bottom of safe area wall in the reconstructed Kelly Elementary School.

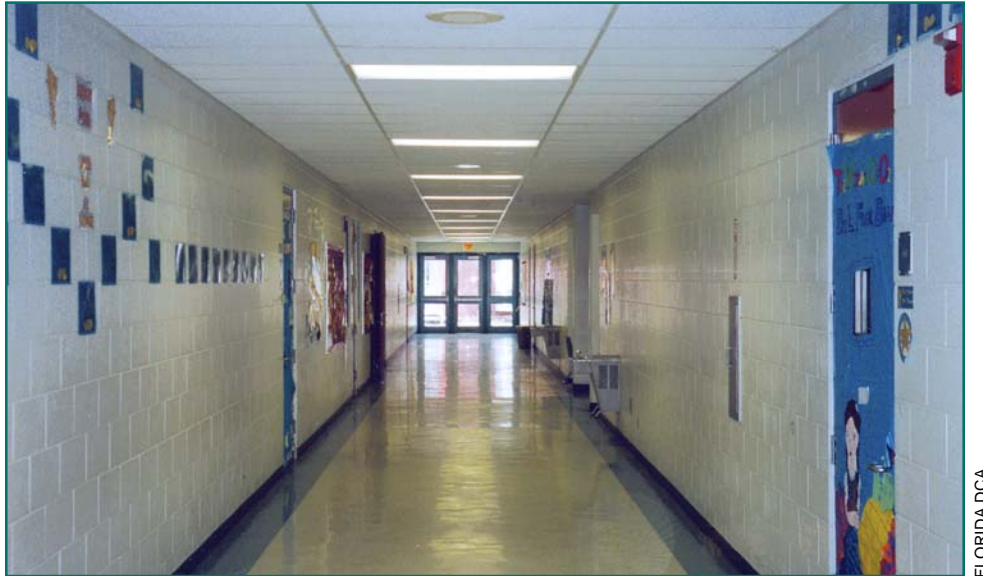
Figure 4-5 Interior central corridor – typical of Buildings 200, 400, 600, and 800.

Buildings 200, 400, 600, and 800 contain typical classrooms. These classrooms are smaller than the library, labs, and large classrooms in Building 500 and, unlike the rooms in Buildings 100, 300, 500, and 700, they are accessed from long, central, interior corridors. Figure 4-4 shows the floor plan of Buildings 200, 400, 600, and 800. One of the central corridors in these buildings is shown in Figure 4-5.

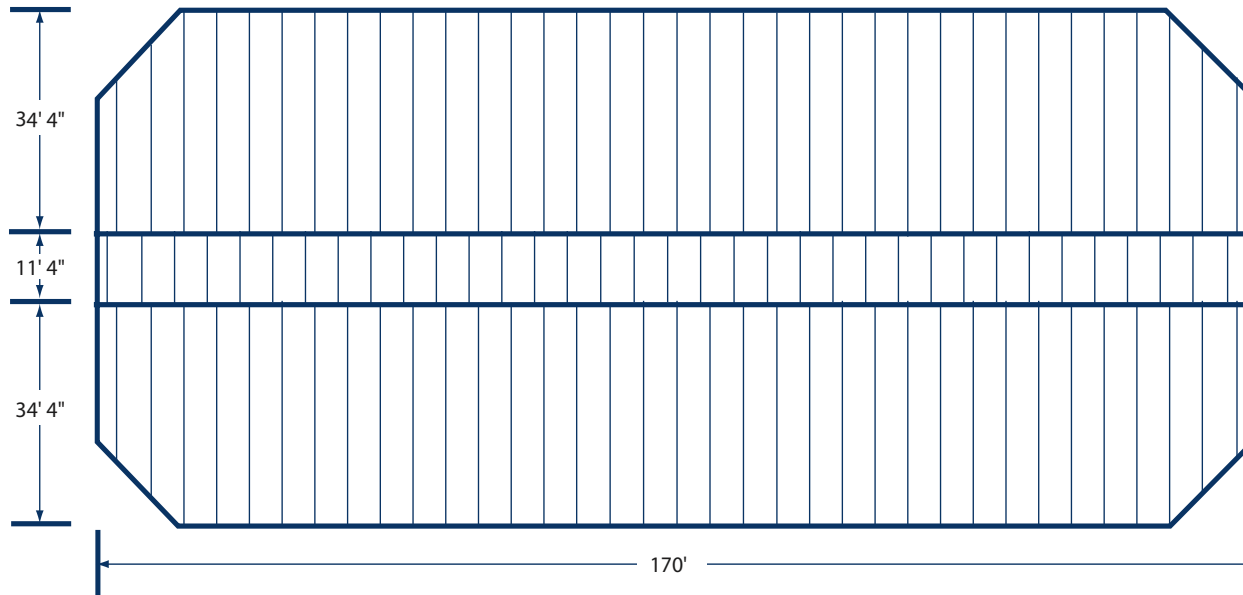
Figure 4-8 Roof framing plan for Buildings 200, 400, 600, and 800.

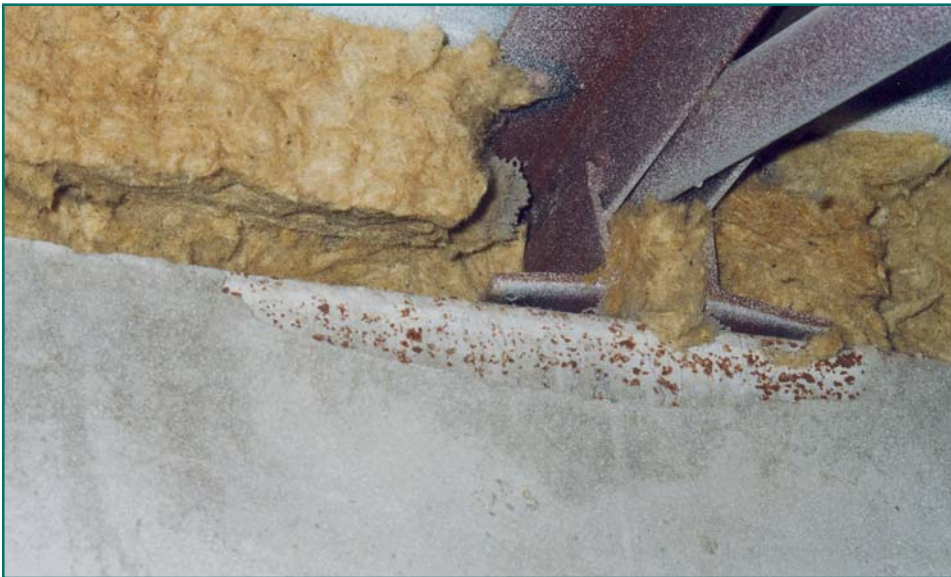
Figure 4-9 Typical roof truss connection to exterior wall in the example school.

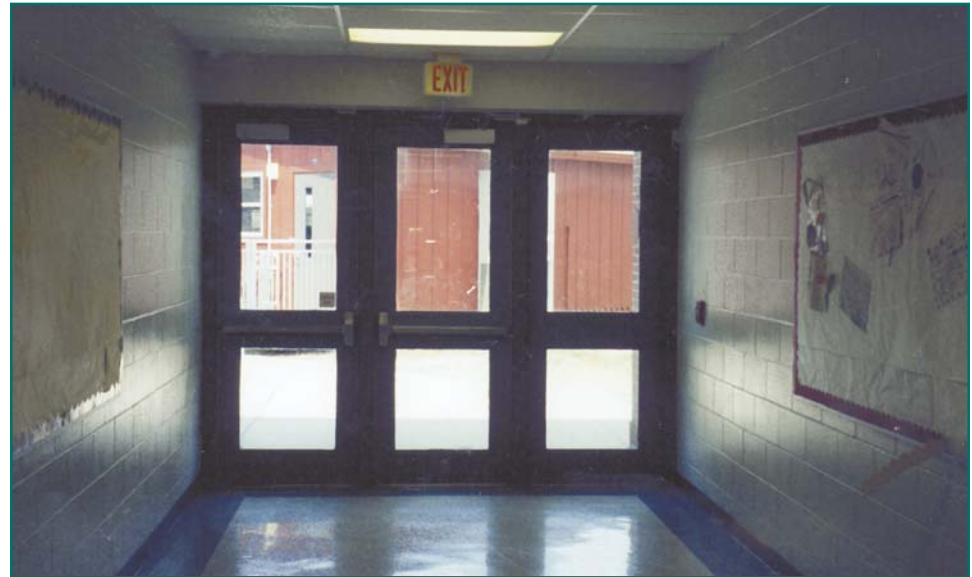
Figure 4-10 Exterior corridor doors in the example school.

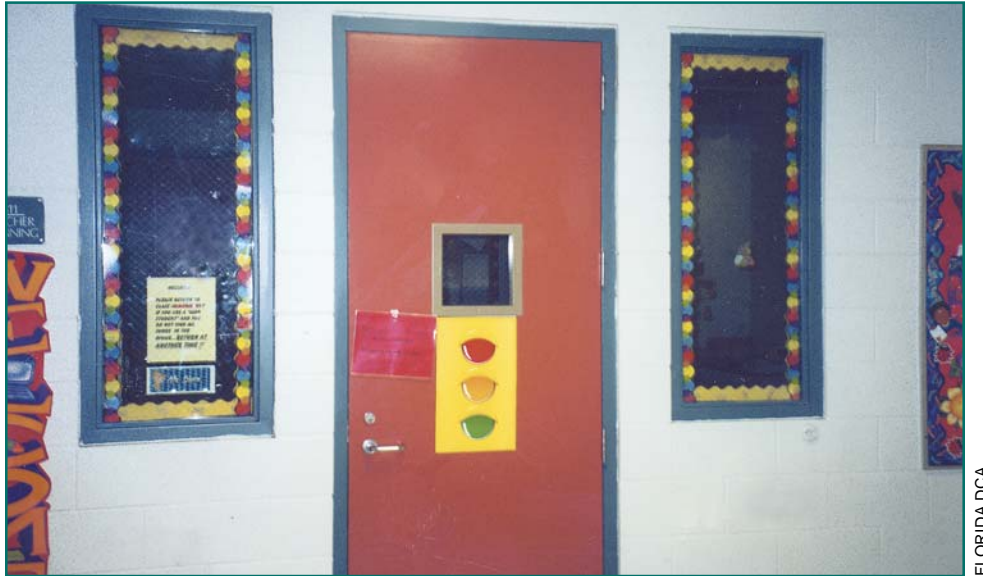
Figure 4-11 Door connecting classroom to corridor – Buildings 200, 400, 600, and 800.

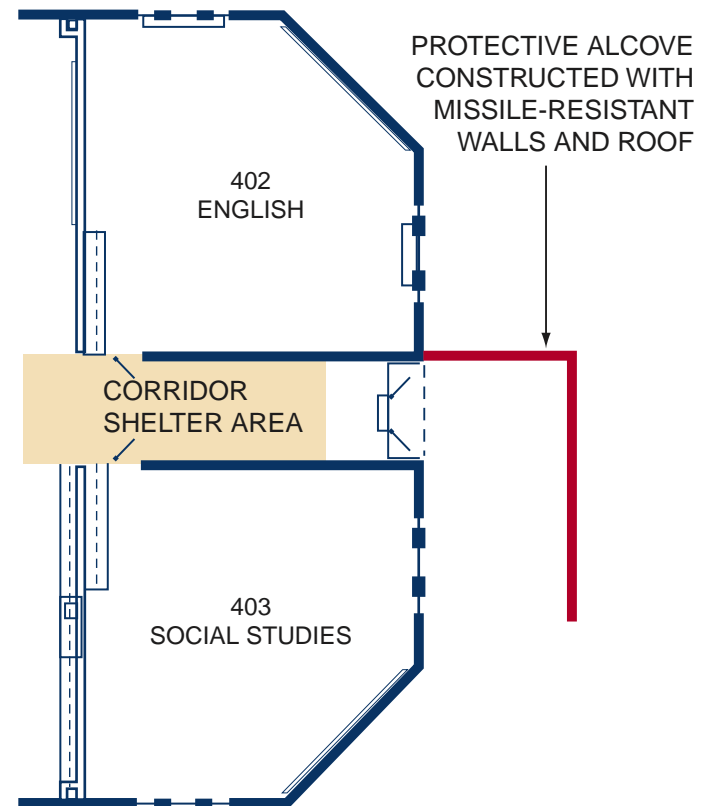
Figure 4-13 Corridor areas with glass exterior doors can be protected from wind and debris through the construction of a wind-resistant alcove.

In many facilities, the size of the most resistant area available will be less than the required size determined according to the guidelines in FEMA publication 361. In such facilities, building occupants will need to be housed in either smaller areas or more vulnerable areas. While there are physical limits to the number of people a space can accommodate, housing more people in less space is preferable to locating them in more vulnerable areas.
