## **Pinellas County Beaches during Tropical Storm Debby, June 25, 2012 and June 26, 2012**

### **Initial Field Observations during the Storm by Ping Wang**

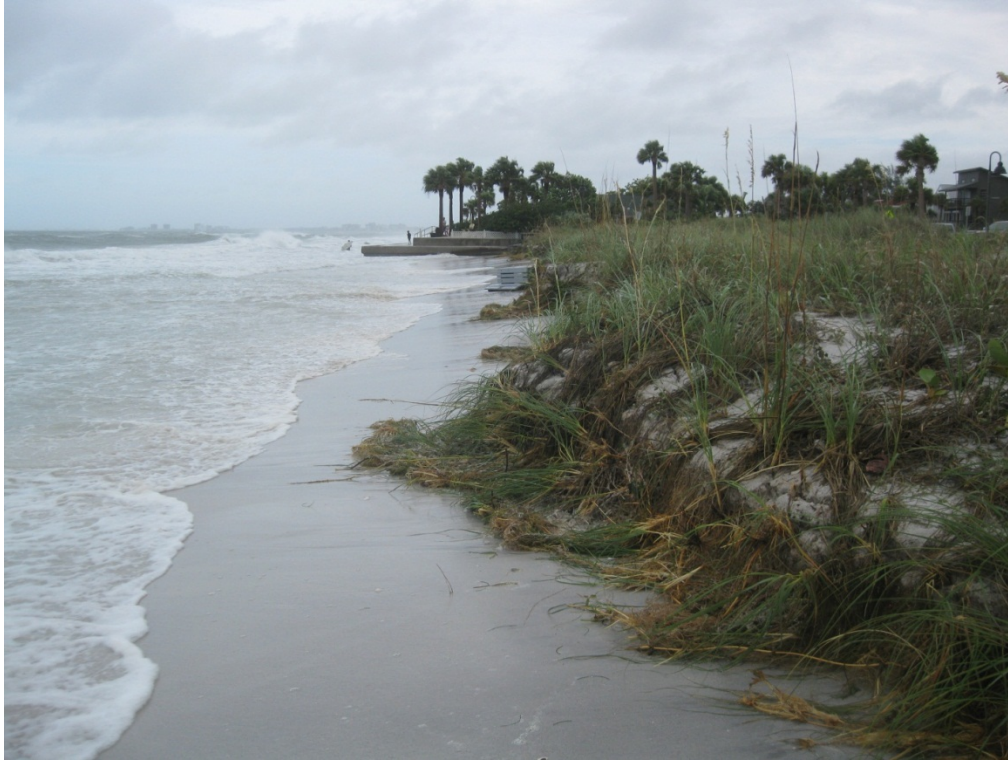
Figure 1a. Pass-A-Grille Beach looking north to the snack bar, June 25<sup>th</sup>, 2012.

**Pass-A-Grille Beach: (R163-R165):** The pre-storm beach was quite narrow. Severe beach erosion occurred on June 25<sup>th</sup> resulting in a continuous dune scarp (Figure 1a). Storm waves are crashing on the seawall in front of the snack bar (Figure 2a). **Considerably more dune erosion occurred along this stretch of the beach on June 26<sup>th</sup>, 2012 as high waves continued to impact the scarp directly.**

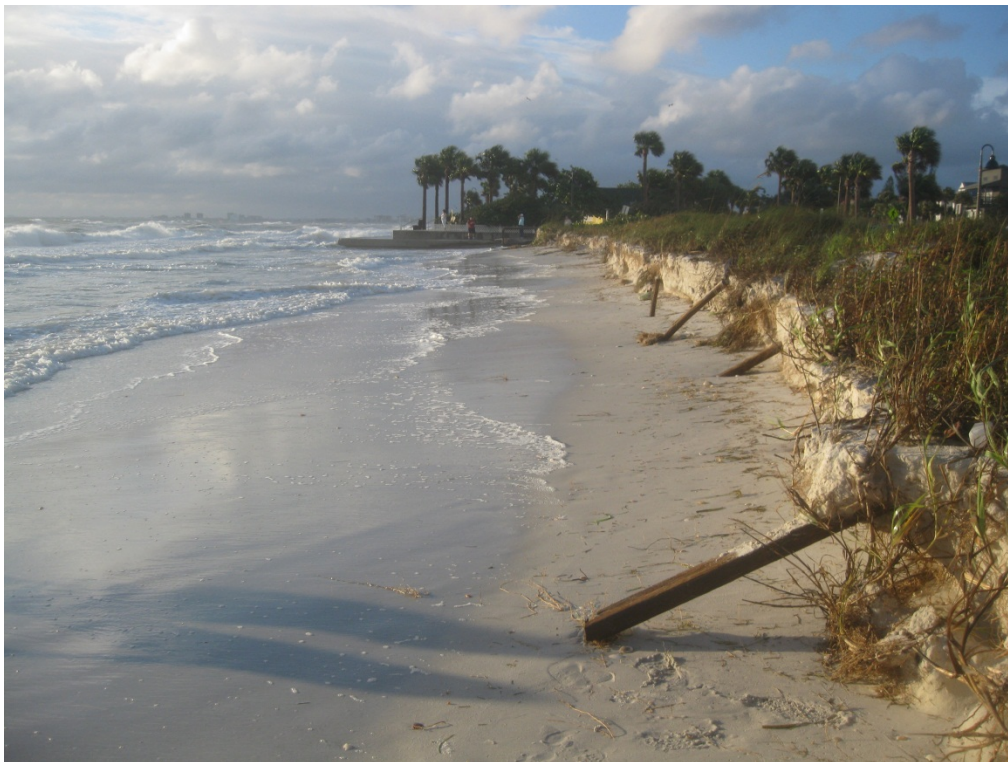
Figure 1b. Pass-A-Grille Beach looking north to the snack bar, June 26<sup>th</sup>, 2012.

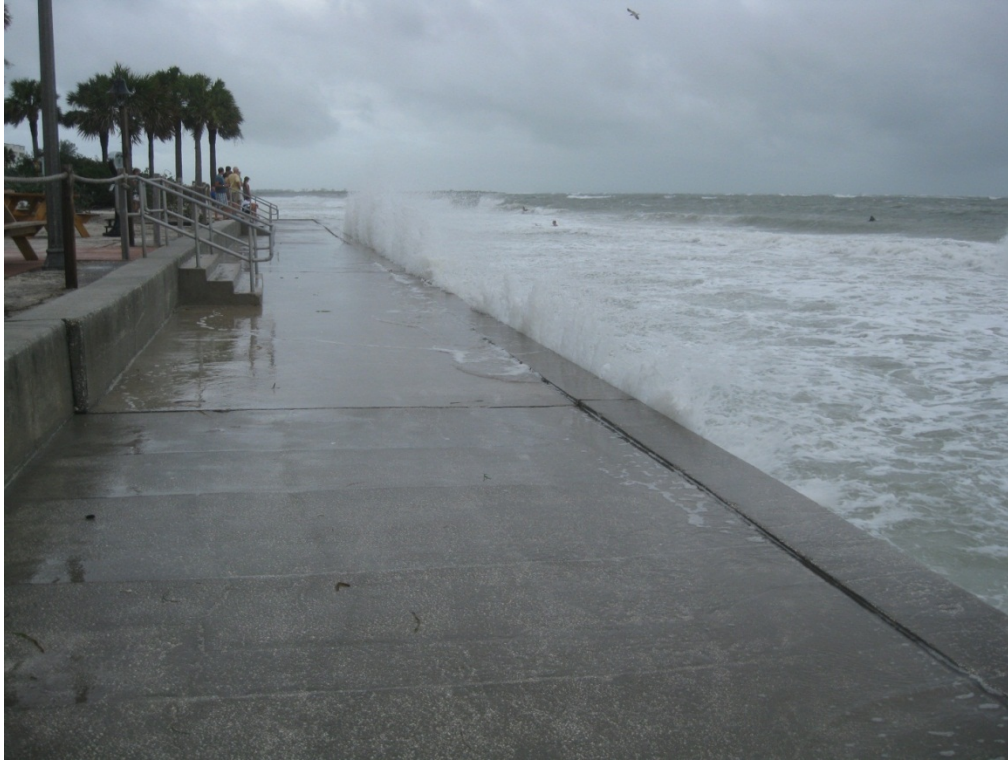
Figure 2a. Pass-A-Grille Beach, seawall in front of the snack bar, June 25<sup>th</sup>, 2012.

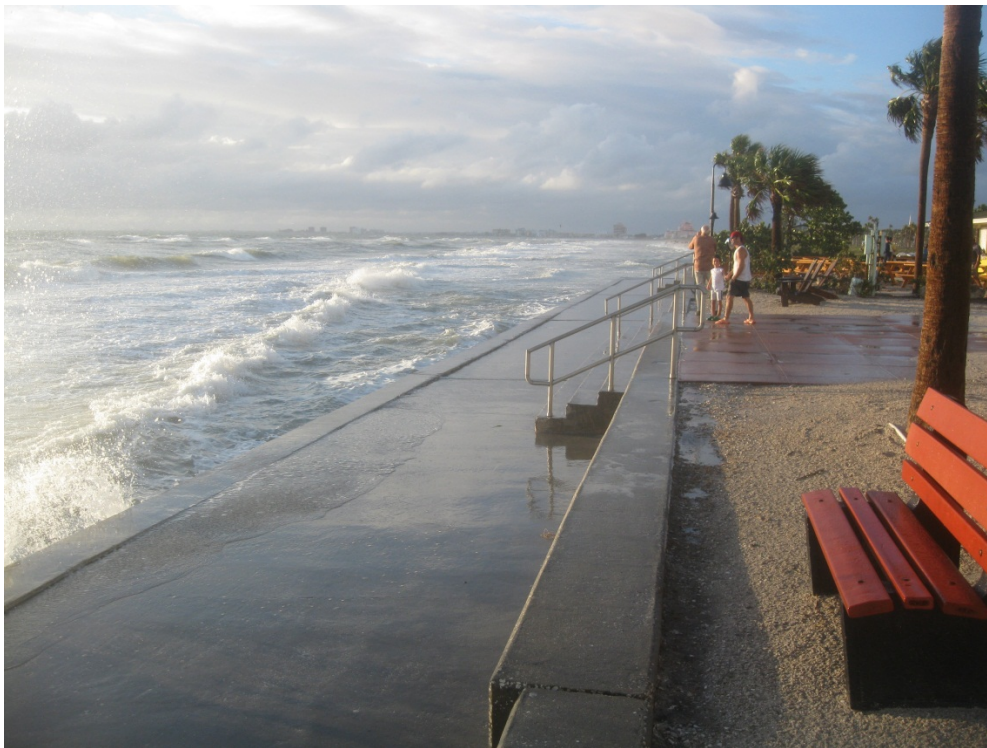
Figure 2b. Pass-A-Grille Beach, seawall in front of the snack bar, June 26<sup>th</sup>, 2012. Water in front of the seawall became deeper.

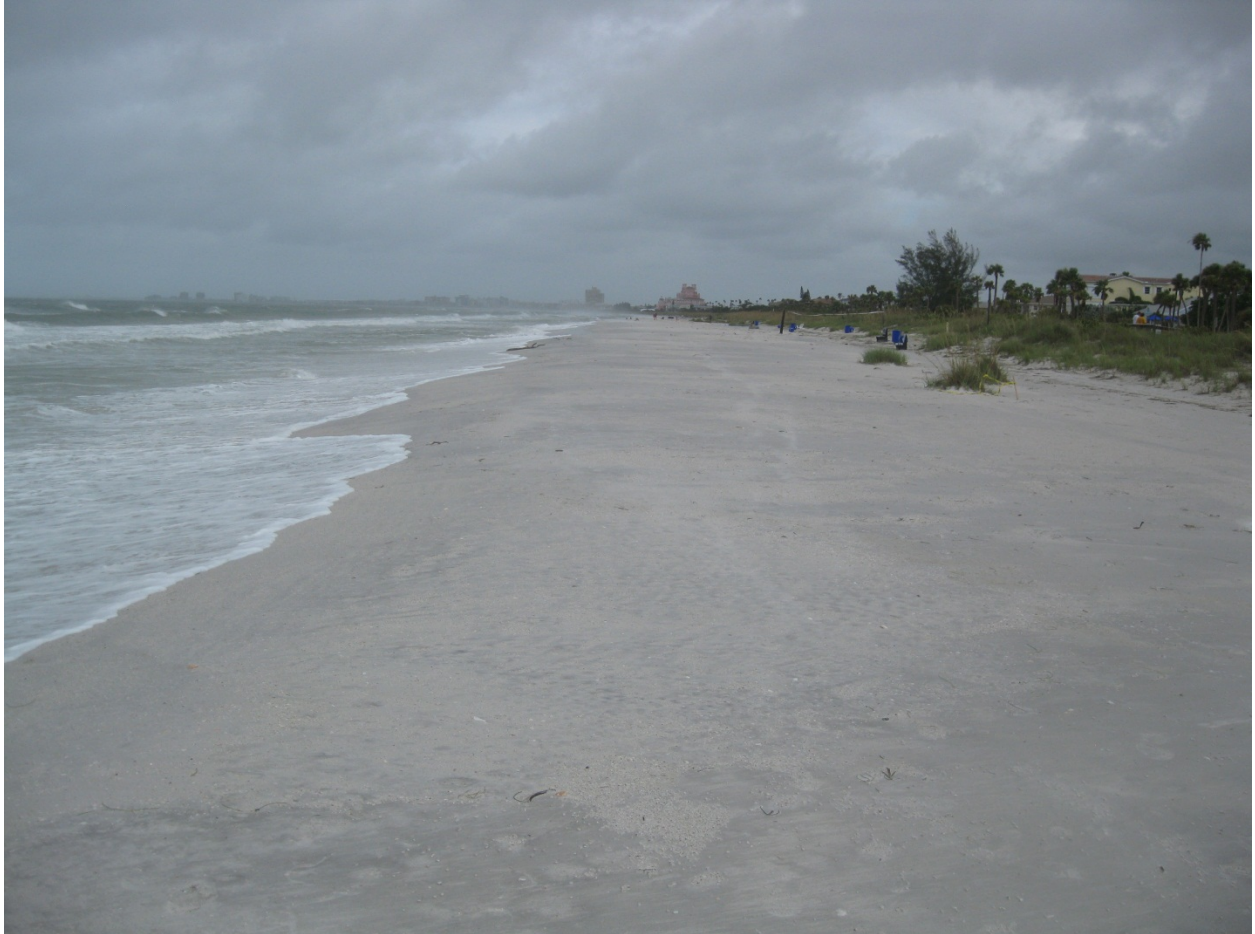
Figure 3: Long Key, looking north from ~R162.

**Middle Section of Long Key (R162-LK6):** The middle section of Long Key still has a flat back beach and a berm (Figure 3). This section of the beach was quite wide pre-storm. Except a section between R159-R155, no significant beach or dune scarp was observed (Figure 4). This section of the beach appeared to be similar on June 26<sup>th</sup>.

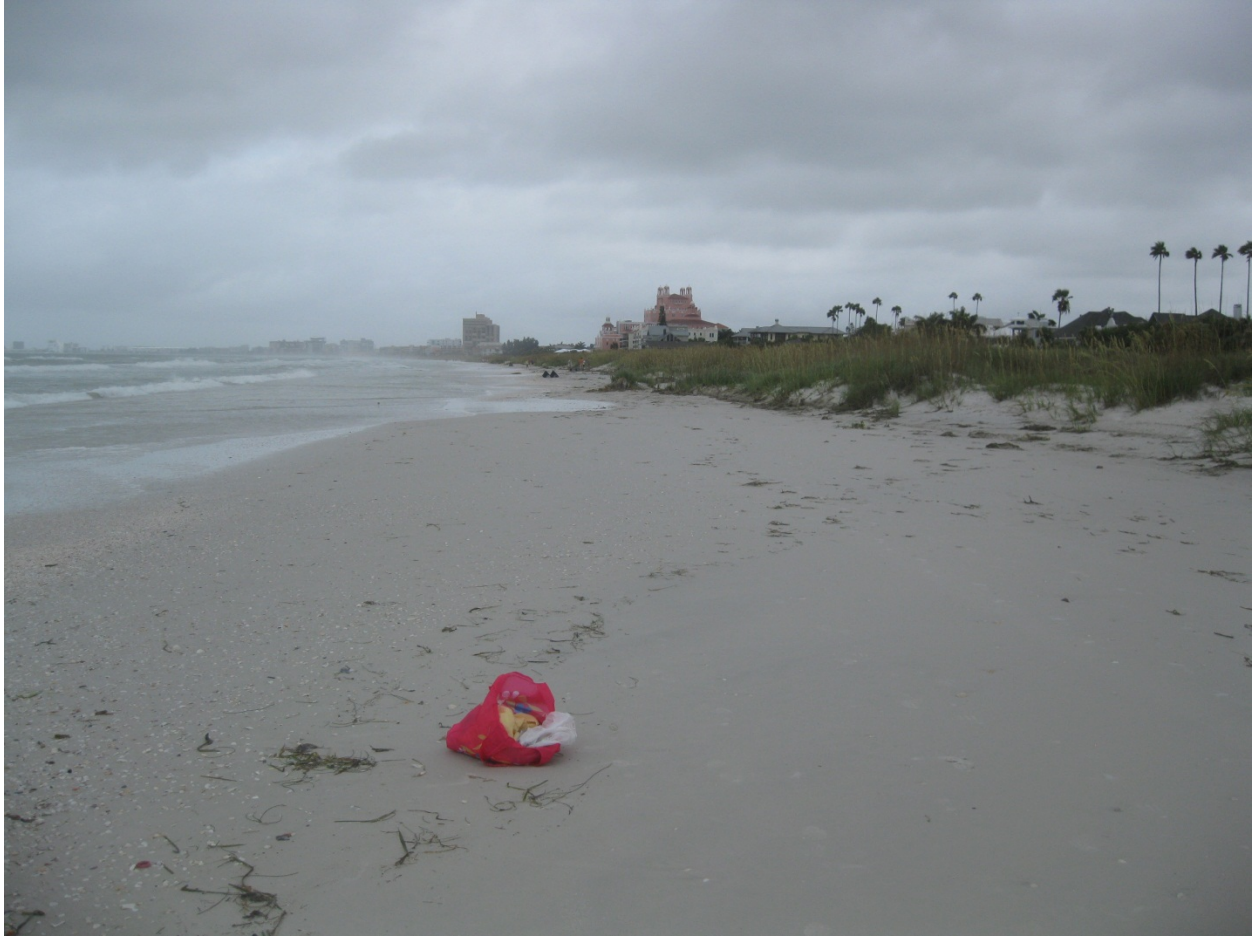
Figure 4. Minor dune scarping , looking north from ~R158.

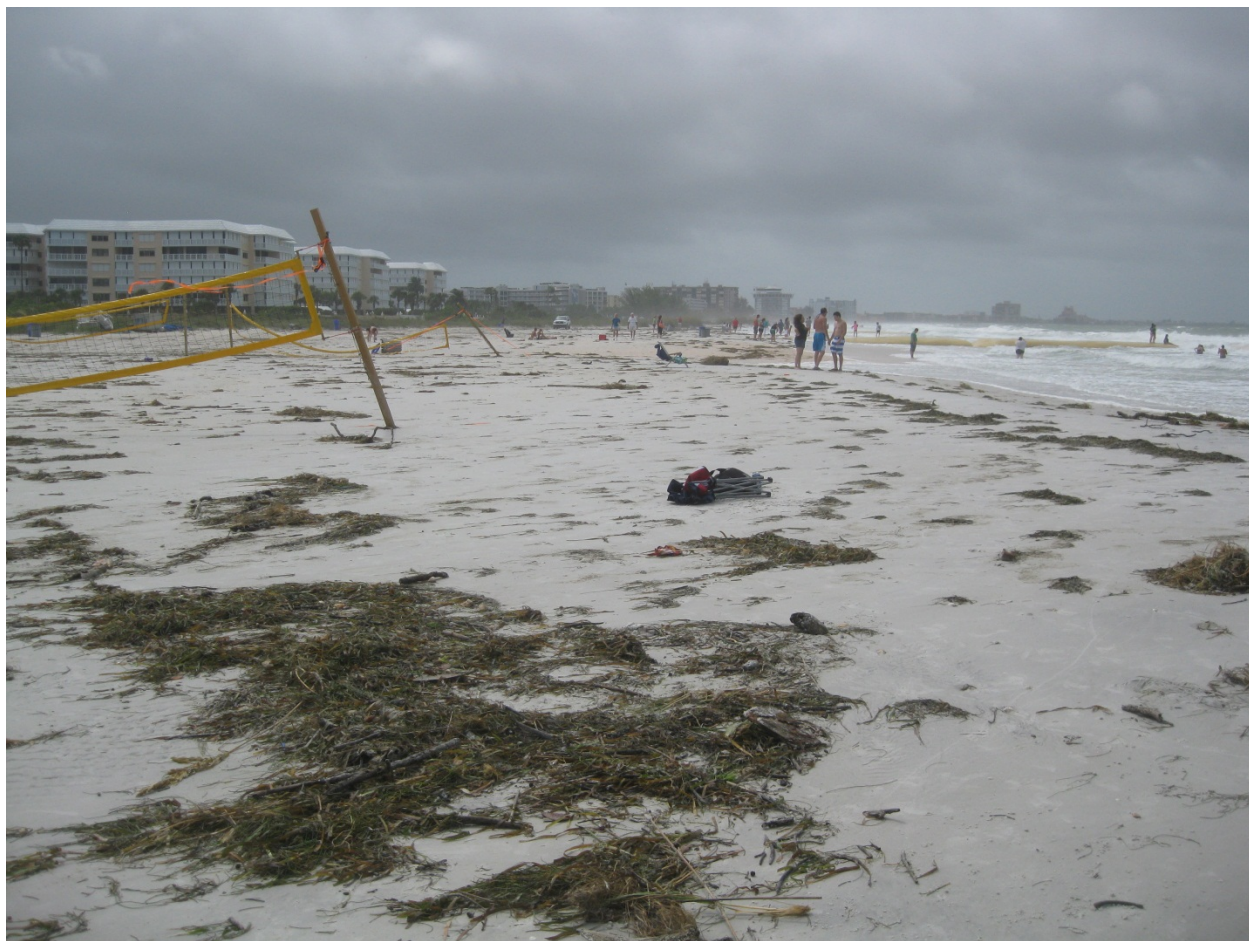
Figure 5. LK3, looking south. No beach scarps.

**Upham Beach:** The southern section of Upham Beach (LK3-LK5A) still has a wide beach with no beach scarping (Figure 5). However, judging from the seawall just north of LK3, the beach is likely eroded back 20-30 ft (Figure 6). The northern section of Upham Beach (LK2A to the Blind Pass south jetty) does not have any dry beach left (Figure 6). The storm waves were crashing onto the seawall. This section of the beach appeared to be similar on June 26<sup>th</sup>, as compared to June 25<sup>th</sup>.

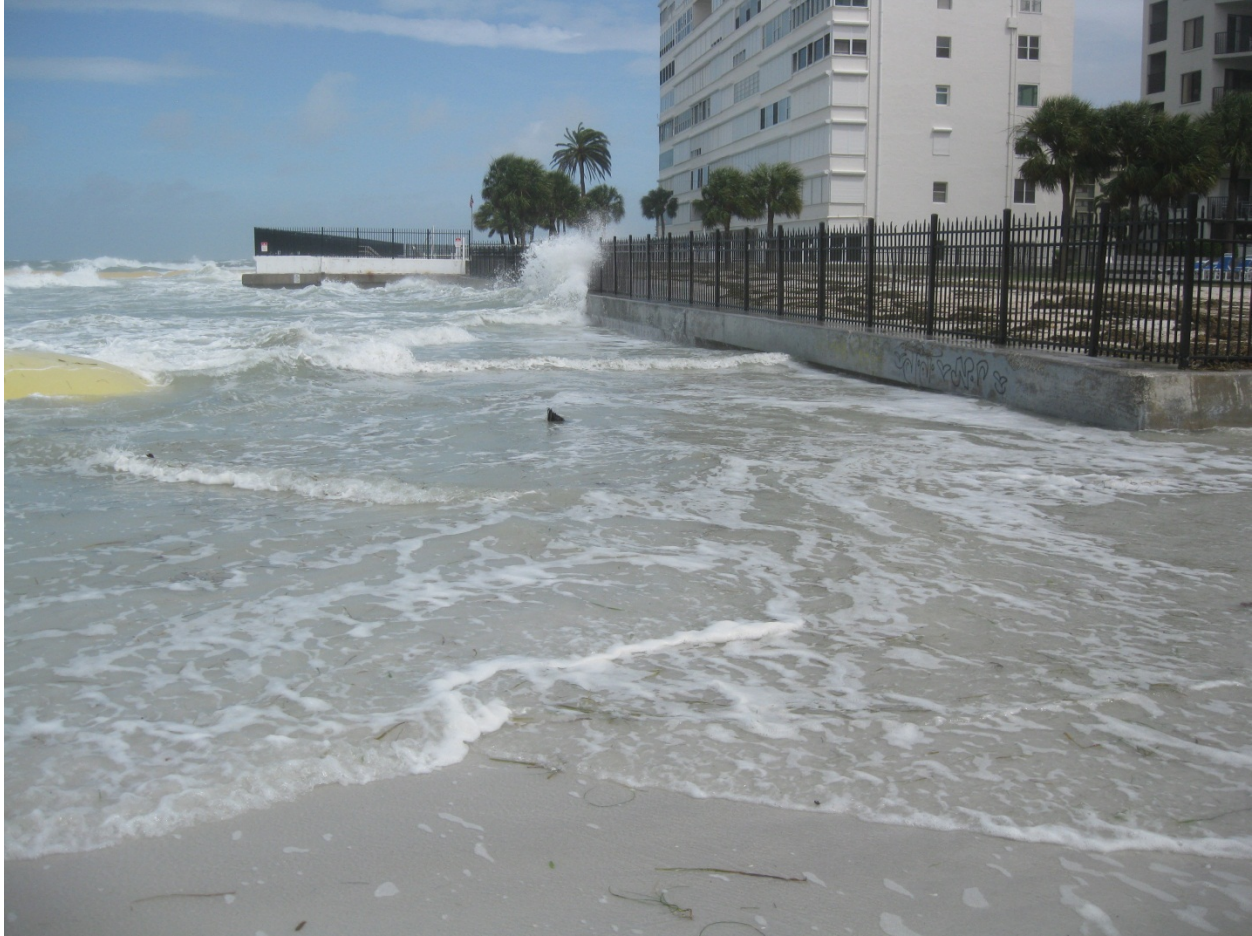
Figure 6. LK3, looking north. Severe beach erosion and overwash into the fence.

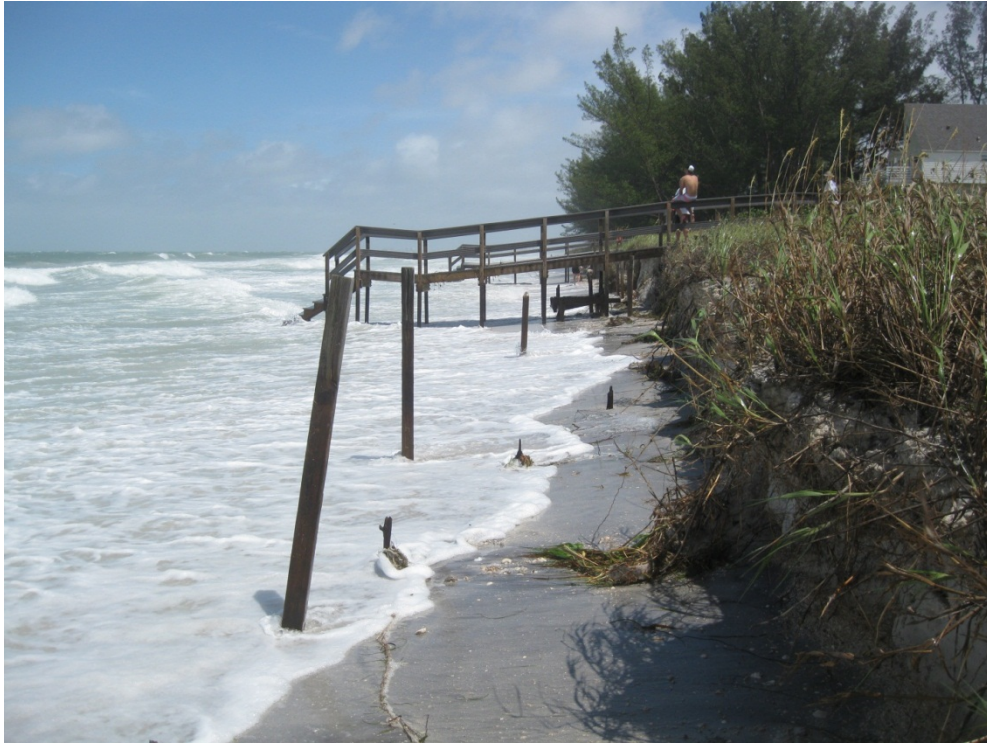
Figure 7a. R140.5 looking north. Continuous dune scarp, June 25<sup>th</sup>, 2012.

**Sunset Beach (R137-R142):** Severe beach erosion along this stretch of the beach. R142 and R141 section is severely eroded but with no dune scarp. **This section of the beach appeared to be similar on June 26<sup>th</sup>.** There was a pre-storm dune scarp there. The scarp was nearly completely eroded. R140-R138 has a continuous dune scarp (Figure 7a). Based on the location of the USF survey benchmarks, the dune line retreated 10-15 ft by June 25<sup>th</sup>, 2012. At R139, the seawall became exposed (Figure 8a). Between R139 and R138, the low dune field became quite narrow (Figure 9). **The scarp along R140-R138 has become much worse on June 26<sup>th</sup>, as compared to June 25<sup>th</sup> (Figure 7b). The seawall at R139 was completely exposed with severe erosion in front of the seawall. The dune scarp between R139-R138 also retreated. Overall, on June 26<sup>th</sup>, the dune scarp along this section of the beach retreated another 5 to 10 ft.**

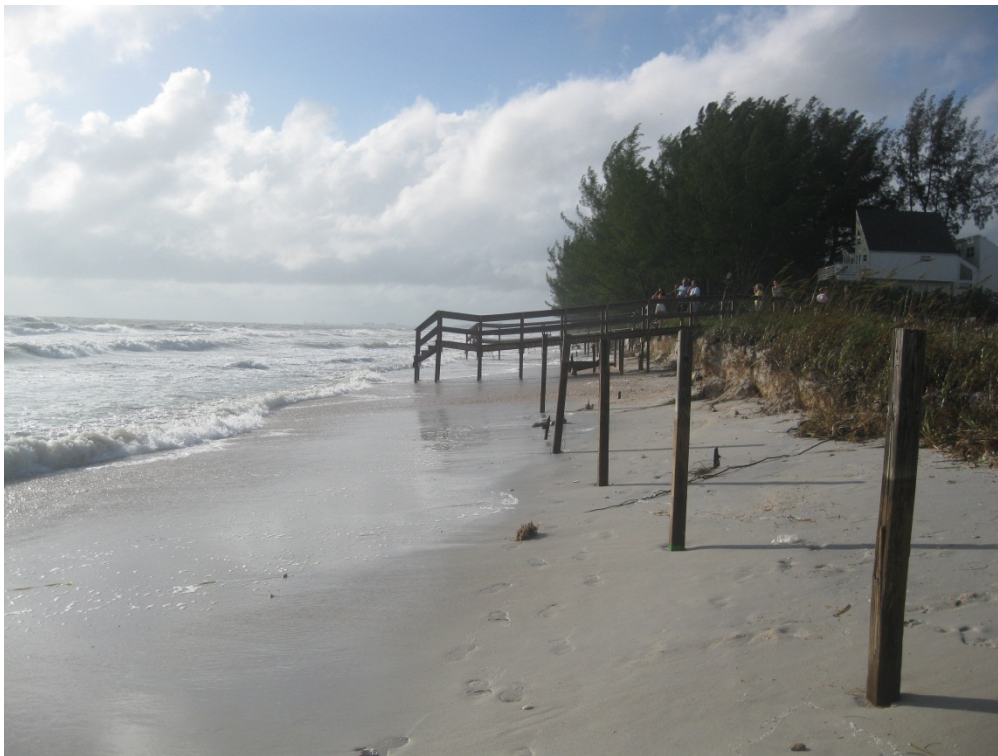
Figure 7b. R140.5 looking north. Continuous dune scarp, June 26<sup>th</sup>, 2012. About 5 ft more landward retreat was observed.

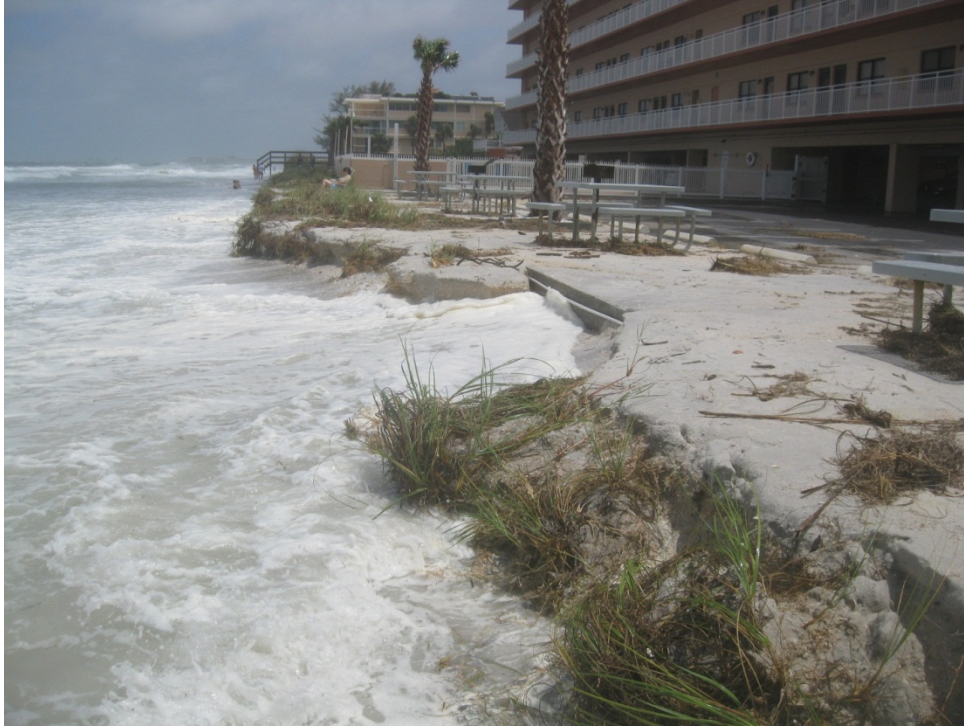
Figure 8a. Seawall became exposed at R139, June 25<sup>th</sup>, 2012.

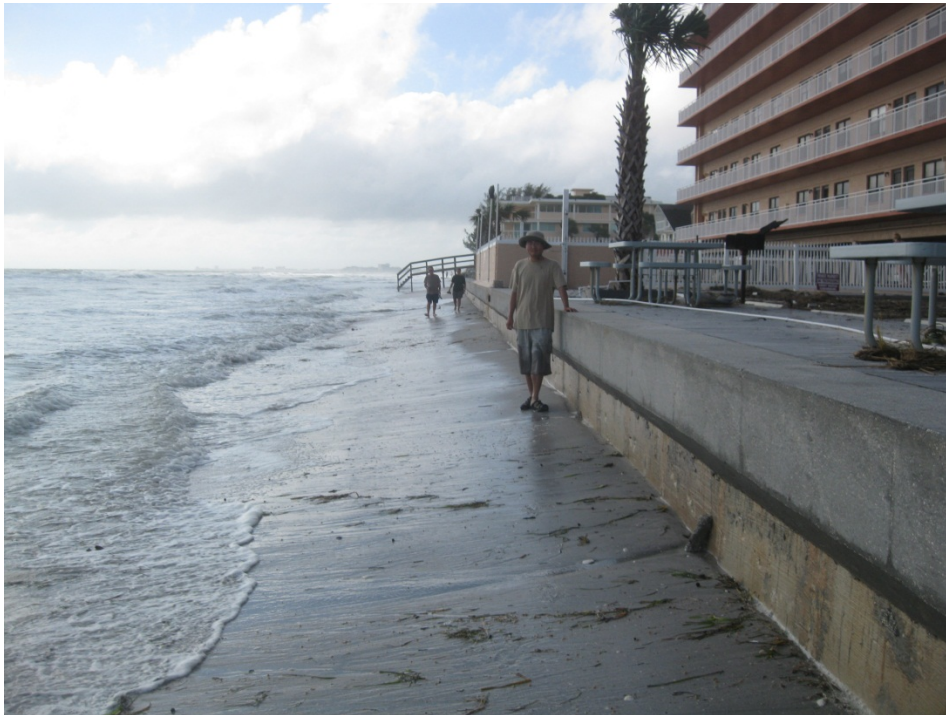
Figure 8b. Seawall became completely exposed at R139, with a nearly 3-ft scour in front of the seawall, June 26<sup>th</sup>, 2012.

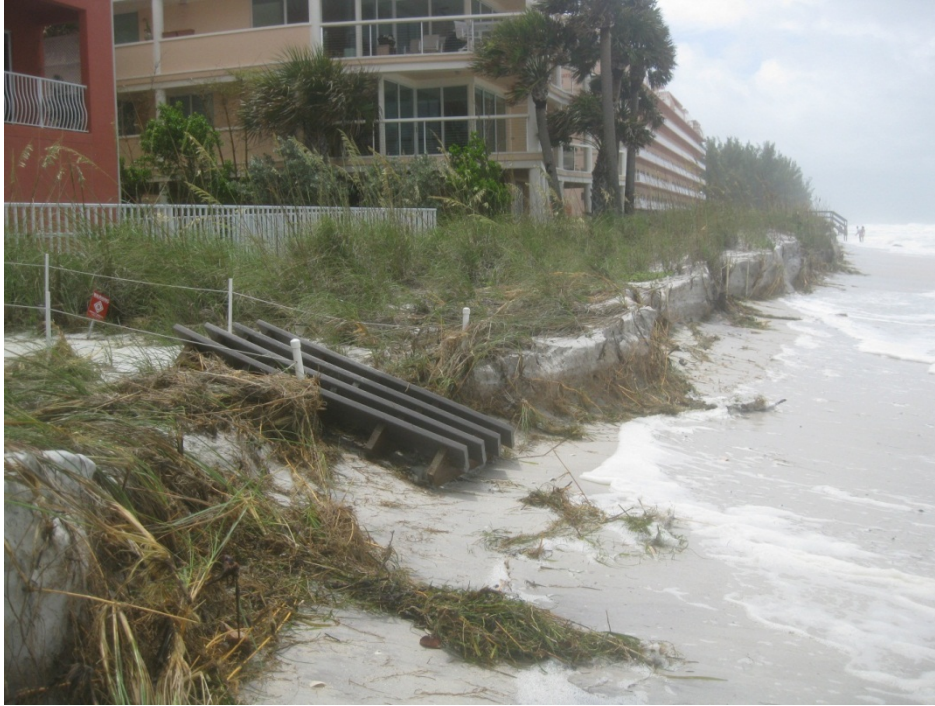
Figure 9a. Between R138 and R139. Severe dune erosion. The stairs in the photo was from the dune overwalk near the top of the photo, June 25<sup>th</sup>, 2012.

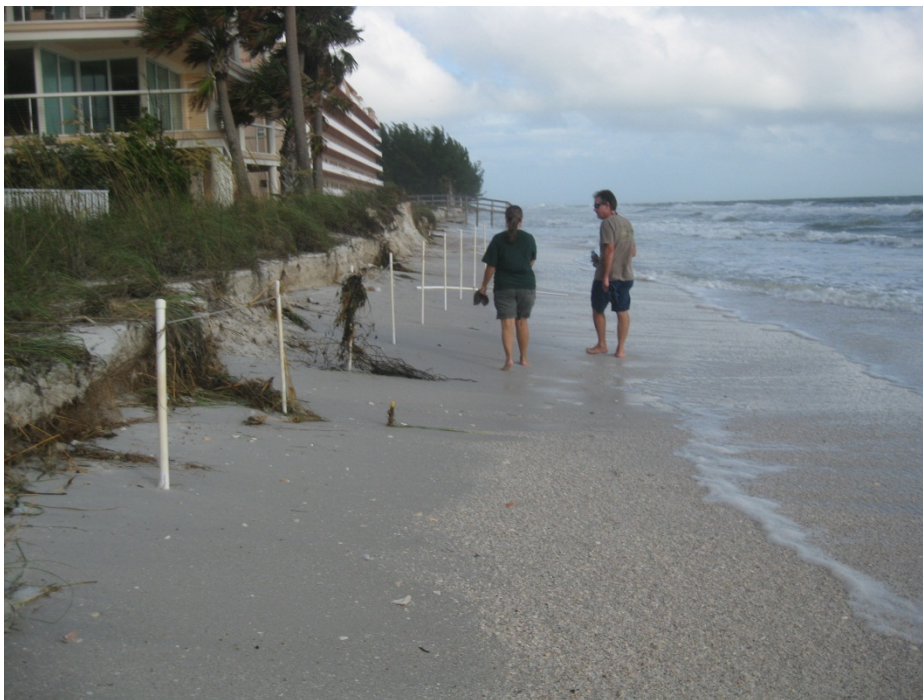
Figure 9a. Between R138 and R139. Severe dune erosion. Note the PVC pipes have become completely exposed due to the ~5-ft additional scarp retreat, June 26<sup>th</sup>, 2012..

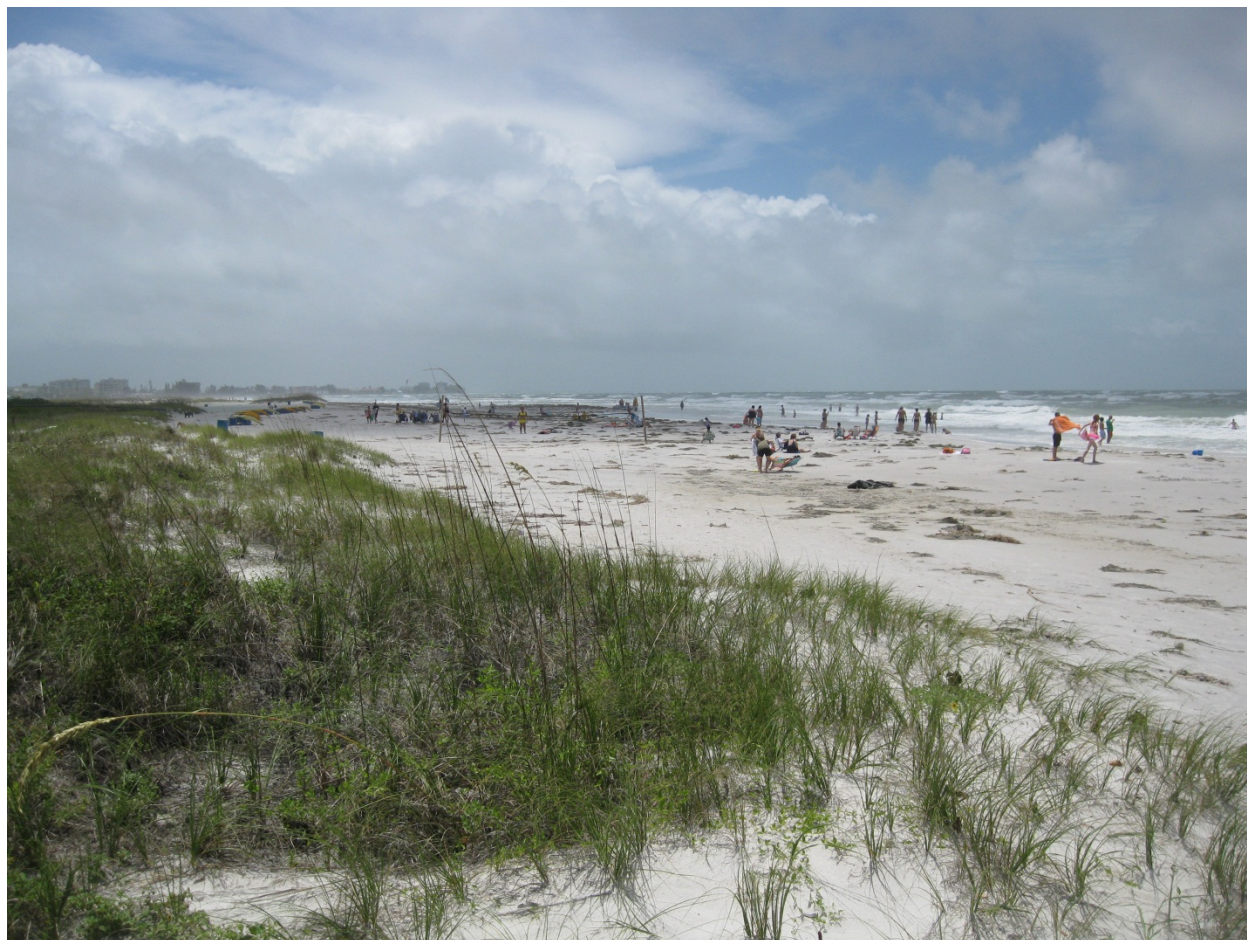
Figure 10. R129 looking south. Wide beach with no beach or dune scarp, June 25<sup>th</sup>, 2012.

**Middle Section of Treasure Island (R136-R129):** The middle section of Treasure Island was very wide pre-storm. This section still has a wide beach with a berm and no significant beach and dune scarps (Figure 10). The beach appeared to be similar on June 26<sup>th</sup>. It is difficult to compare visually.

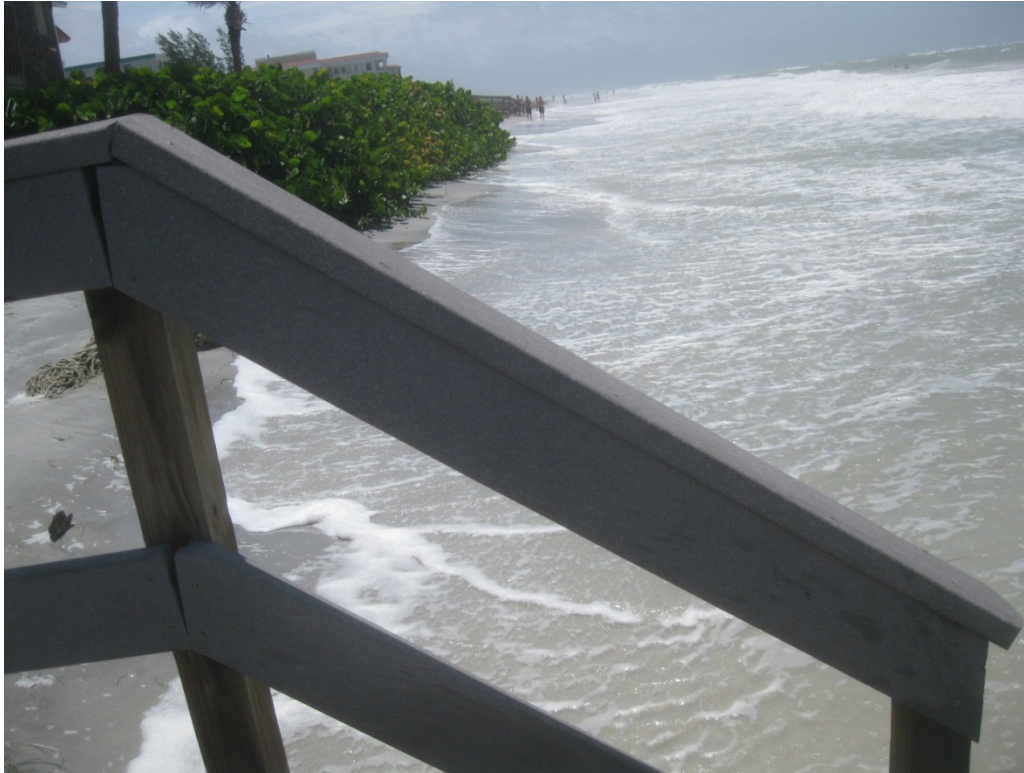
Figure 11a. The northernmost dune overwalk on Treasure Island, looking south, June 25<sup>th</sup>, 2012.

**Sunshine Beach (R128-R127):** This section of the beach was nourished in August 2010. The beach was modestly wide before the storm. Severe beach erosion occurred with dune scarping. The northern-most dune walk is impacted by wave runoff (Figure 11a). Slightly more dune erosion and scour under the dune overwalk occurred on June 26<sup>th</sup>, 2012 (Figure 11b).

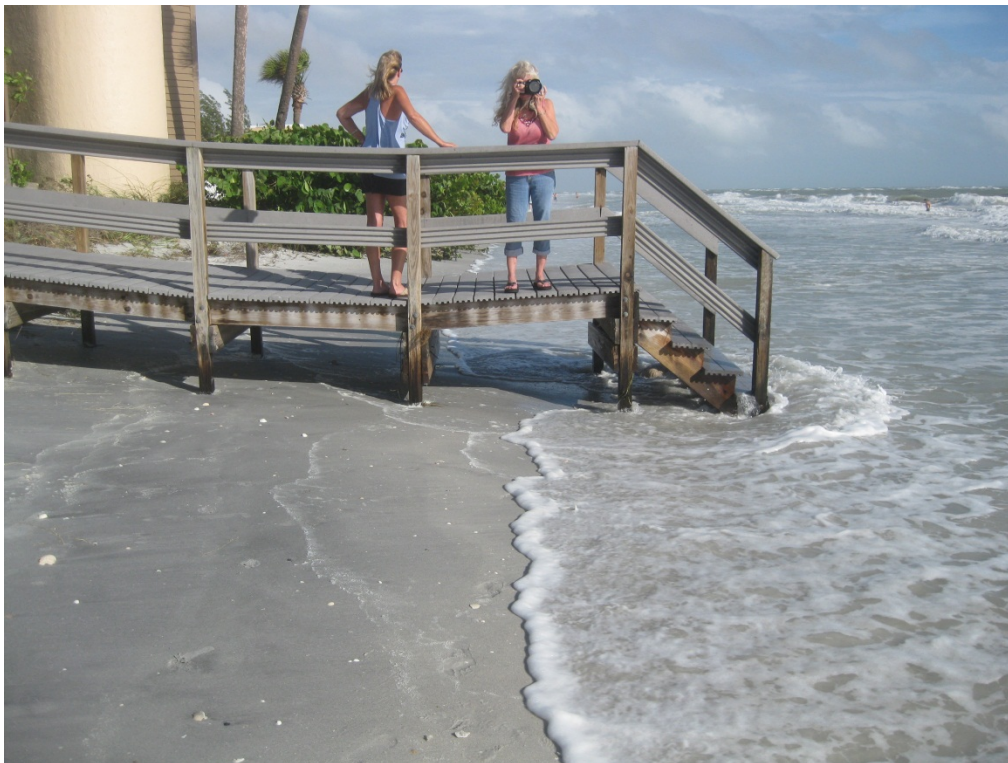
Figure 11a. The northernmost dune overwalk on Treasure Island, looking south, June 26<sup>th</sup>, 2012.

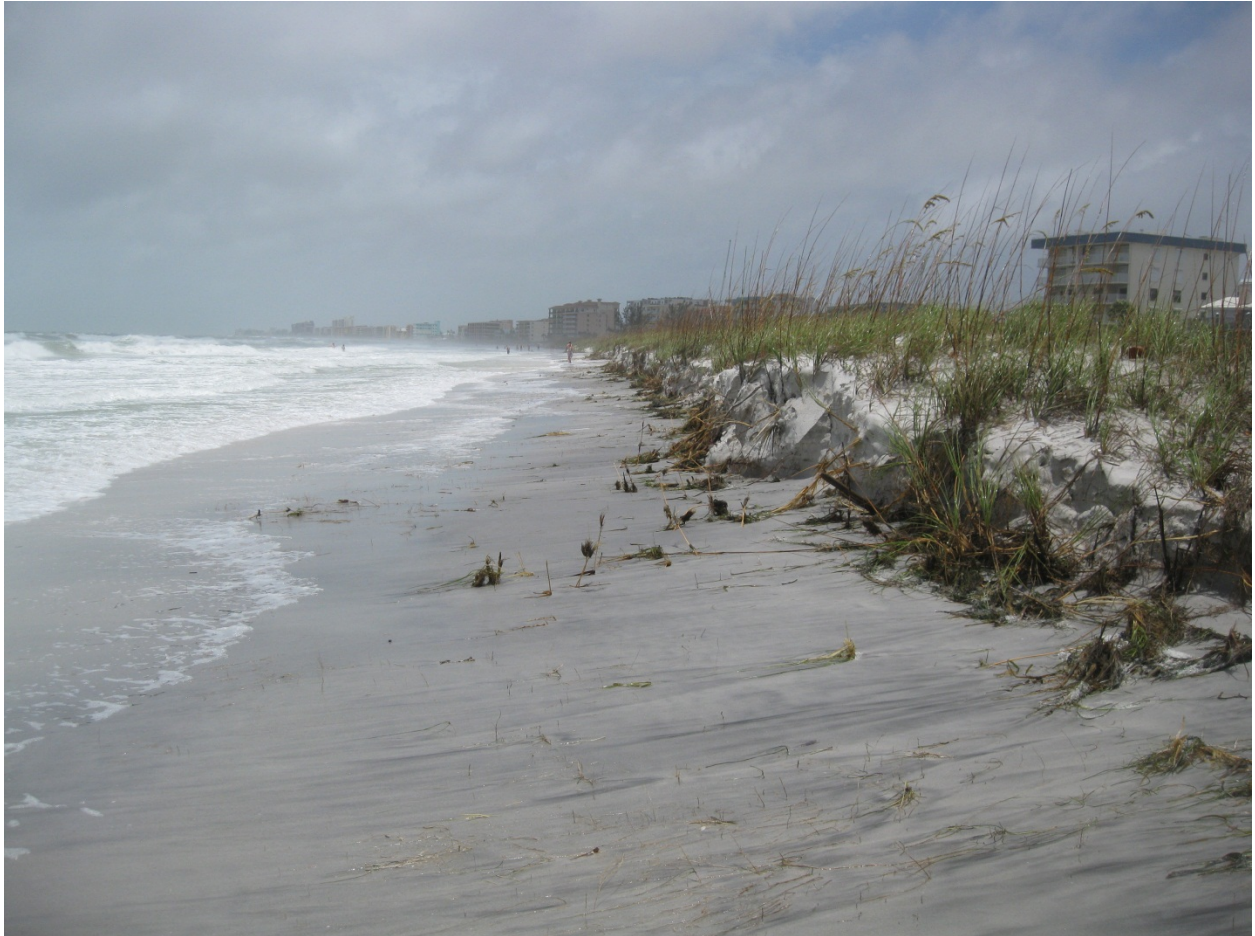
Figure 12. R123 looking north. The dune scarp is not continuous but quite close to being continuous. Exceptions are places with wide beach or no dune (e.g., at R120).

**South Sand Key (R124-R119):** This section of the beach was not nourished recently and has been quite stable over the last 8 years. Severe beach erosion and dune scarping occurred along most of this section of the beach except at locations with relatively wide beach (Figure 12). **This section of the beach appeared to be similar on June 26<sup>th</sup>.**

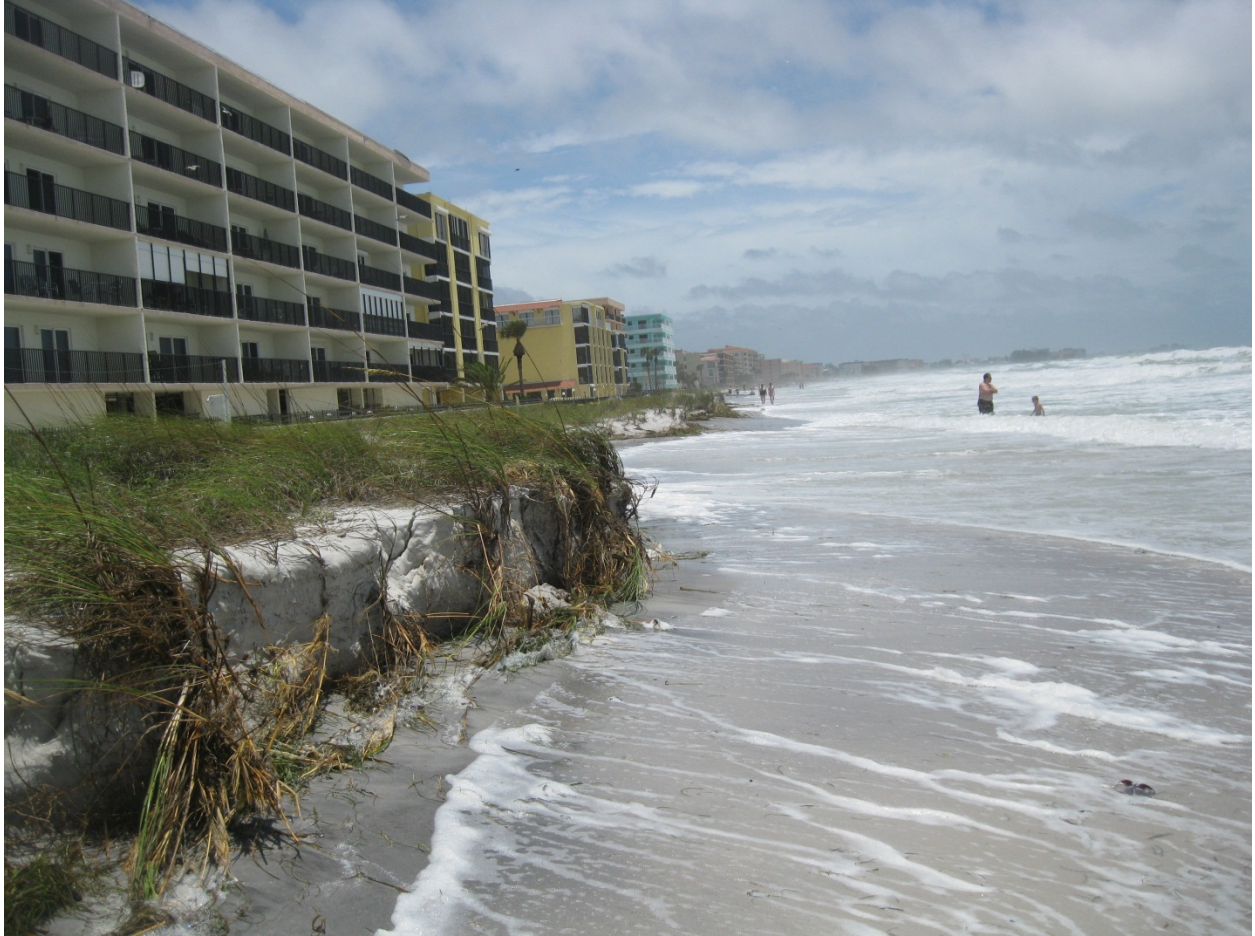
Figure 13. R118 looking south, nearly continuous dune scarping. June 25<sup>th</sup>, 2012.

**The Madeira Beach Groin Field (R118-R110):** The groin field was completely submerged and hardly visible. Severe beach erosion and nearly continuous dune scarp occurred (except at locations without dunes) (Figures 13 and 14). **This section of the beach appeared to be similar on June 26<sup>th</sup>.**

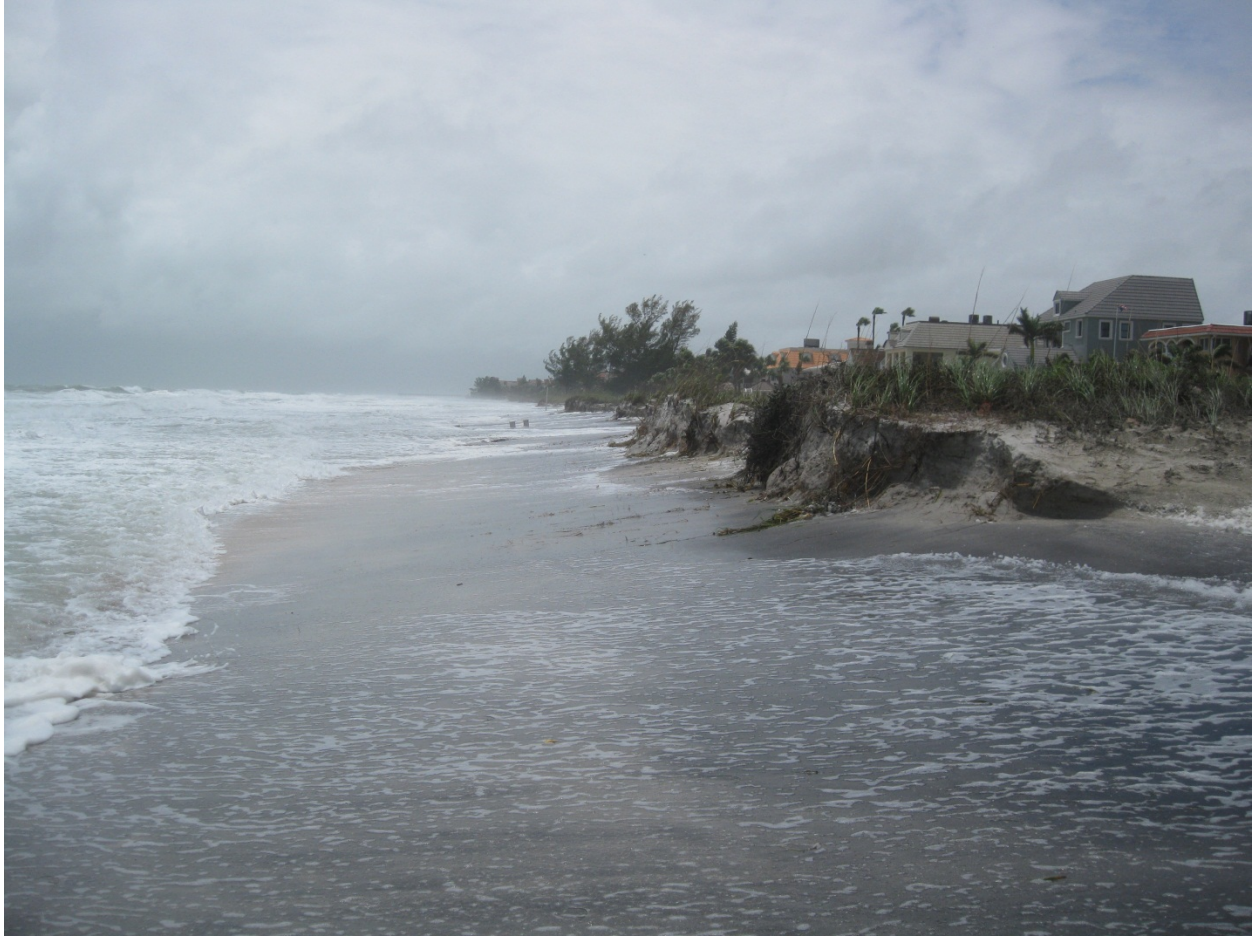
Figure 14. R114 looking north. Nearly continuous dune scarping, except at places without dunes.

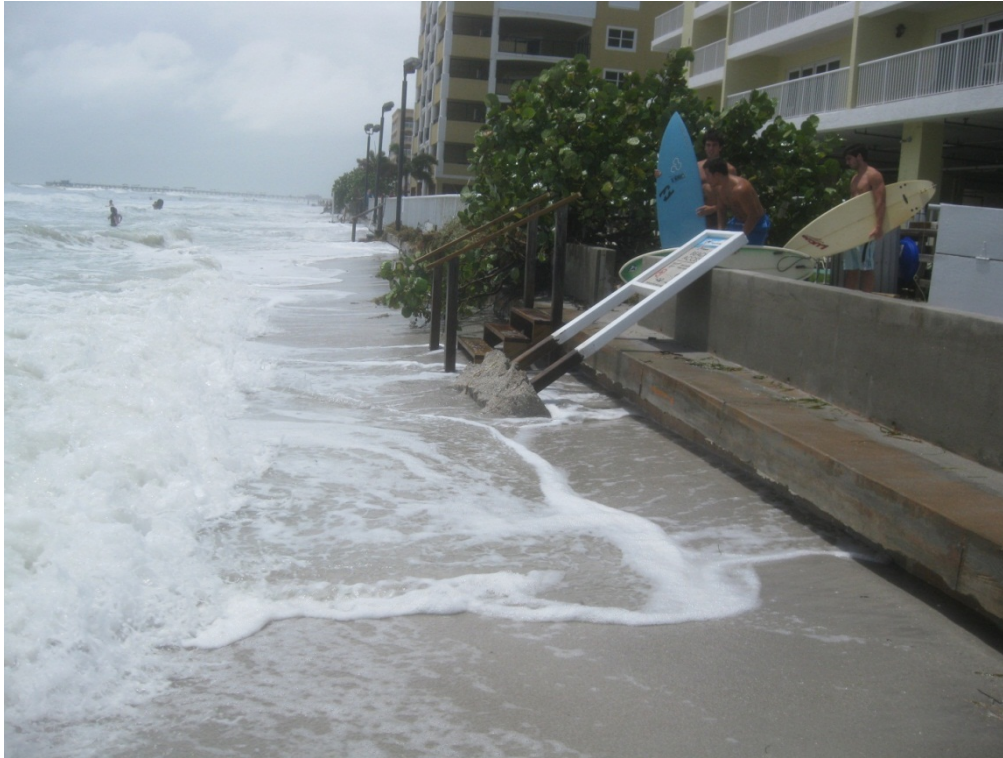
Figure 15a. R107 looking north. Several beach signs were washed down, June 25<sup>th</sup>, 2012.

**End of Sand Key 2006 Nourishment (R109-R106):** This section has very narrow pre-storm beach and very small to no dunes. All the small dunes were nearly completely eroded. The waves were crashing on the seawall on June 25<sup>th</sup>, 2012 (Figure 15a). Considerably more erosion occurred on June 26<sup>th</sup>, 2012 (Figure 15b). The very small amount of sand in front of the seawall has become completely eroded, with over 1 ft additional scour in front of the seawall. At places, rip-raps in front of the seawall became exposed.

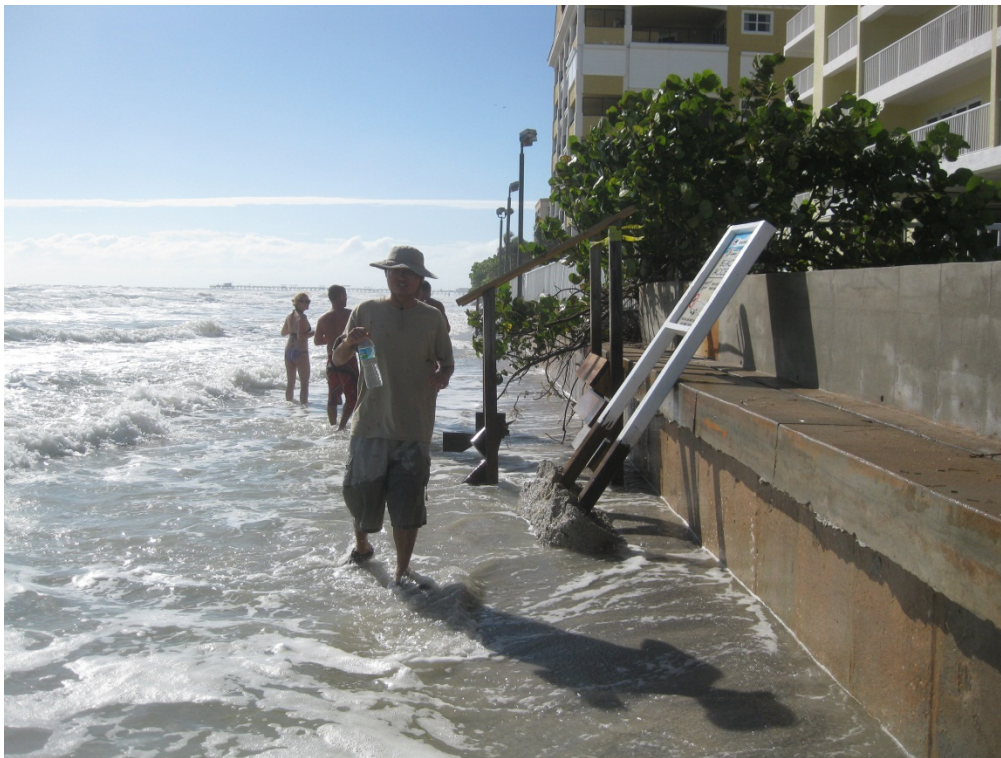
Figure 15b. R107 looking north. Additional erosion occurred along the seawall, June 26<sup>th</sup>.

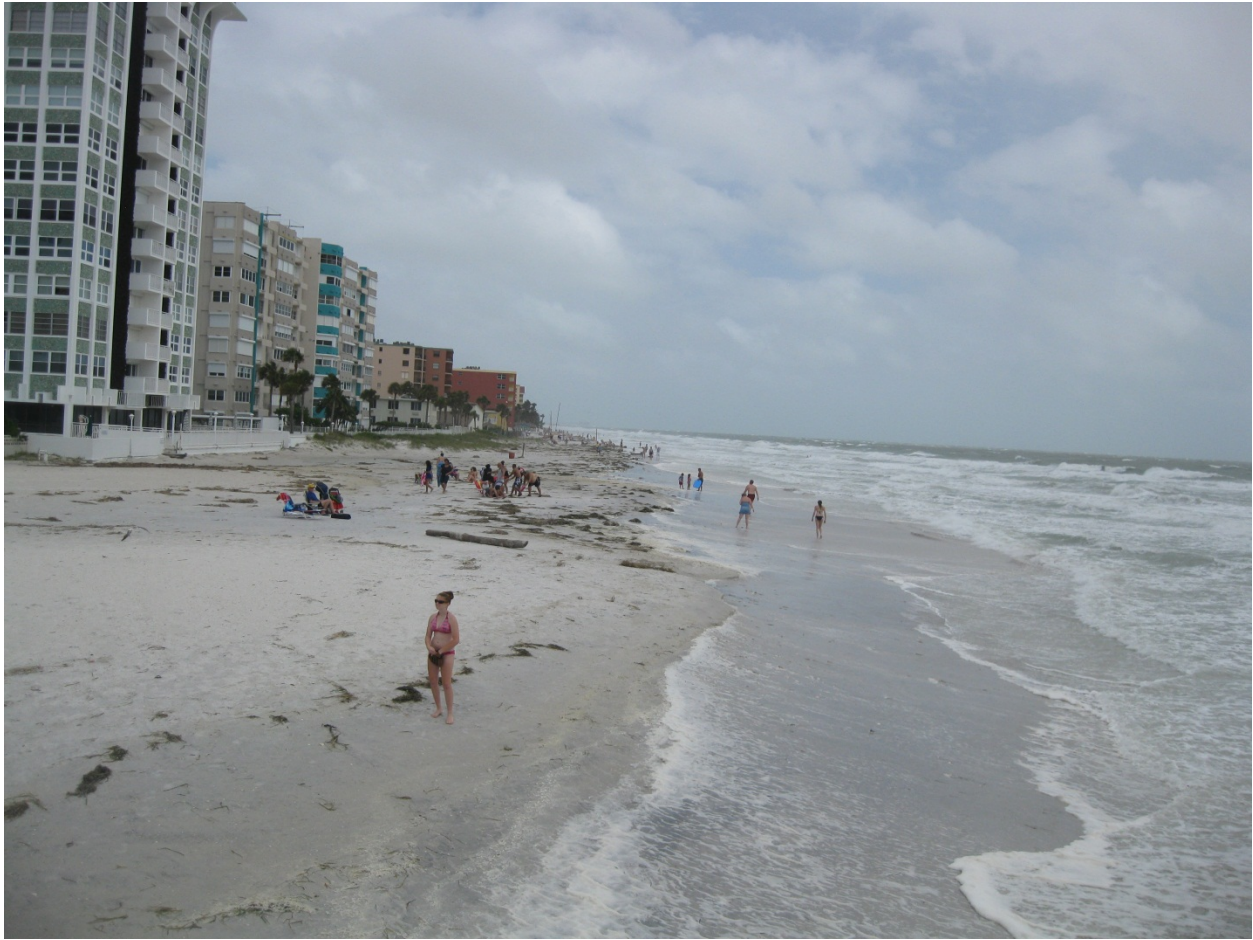
Figure 16. Redington Beach Pier looking south.

**North Redington Beach (R105-R100):** This section of the beach was quite wide before the storm, especially at the breakwater. The beach was still quite wide even with the elevated water level (Figures 16 and 17). Only limited beach and dune scarping was observed. The breakwater is mostly submerged. No apparent erosion was observed landward of the breakwater (Figure 18). This section of the beach appeared to be similar on June 26<sup>th</sup>.
