## **Pinellas County Beaches during Tropical Storm Debby, June 25, 2012 and June 26, 2012**

### **Initial Field Observations during the Storm by Ping Wang**

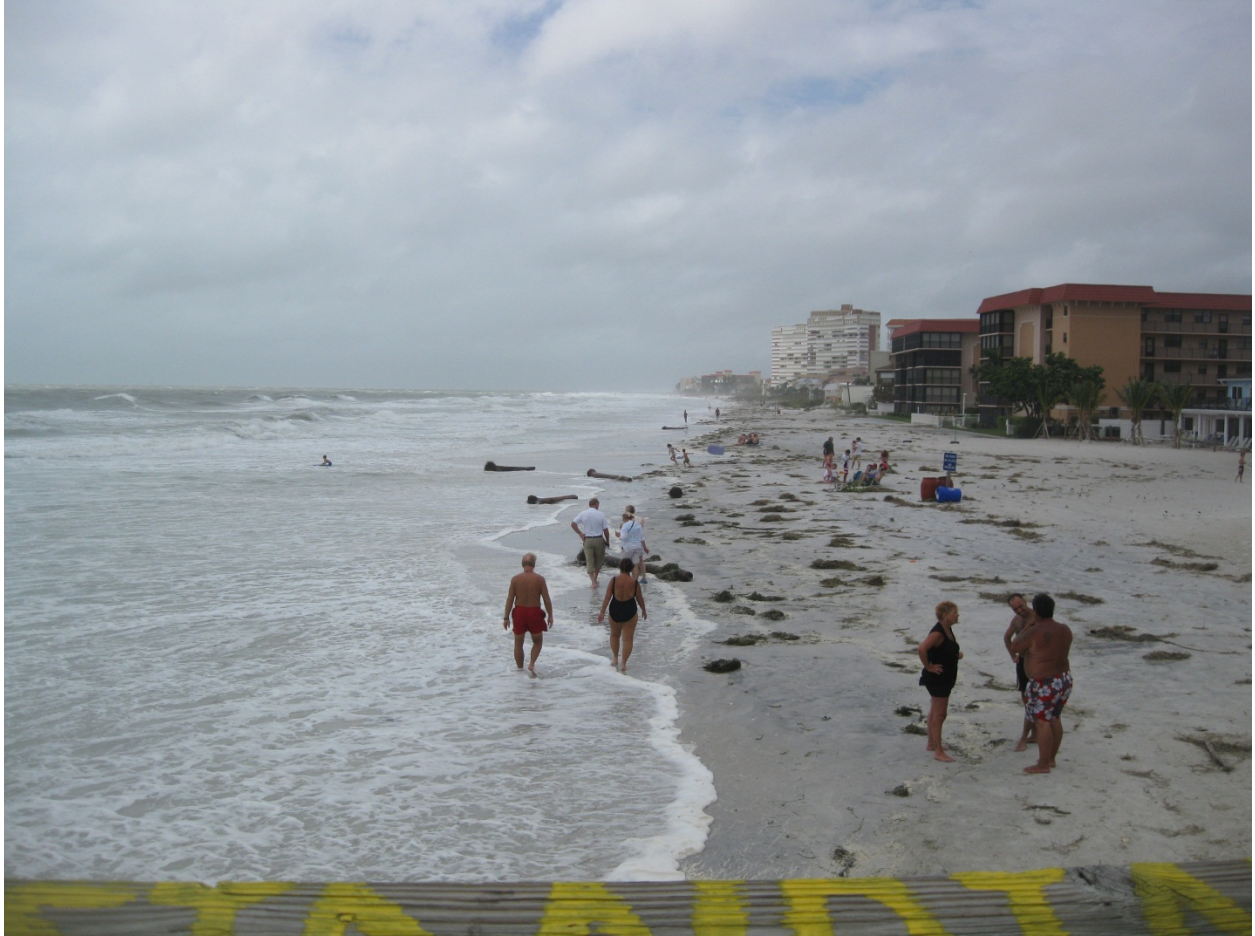
Figure 17. Redington Beach pier looking north.

**North Redington Beach (R105-R100):** This section of the beach was quite wide before the storm, especially at the breakwater. The beach was still quite wide even with the elevated water level (Figures 16 and 17). Only limited beach and dune scarping was observed. The breakwater is mostly submerged. No apparent erosion was observed landward of the breakwater (Figure 18). This section of the beach appeared to be similar on June 26<sup>th</sup>.

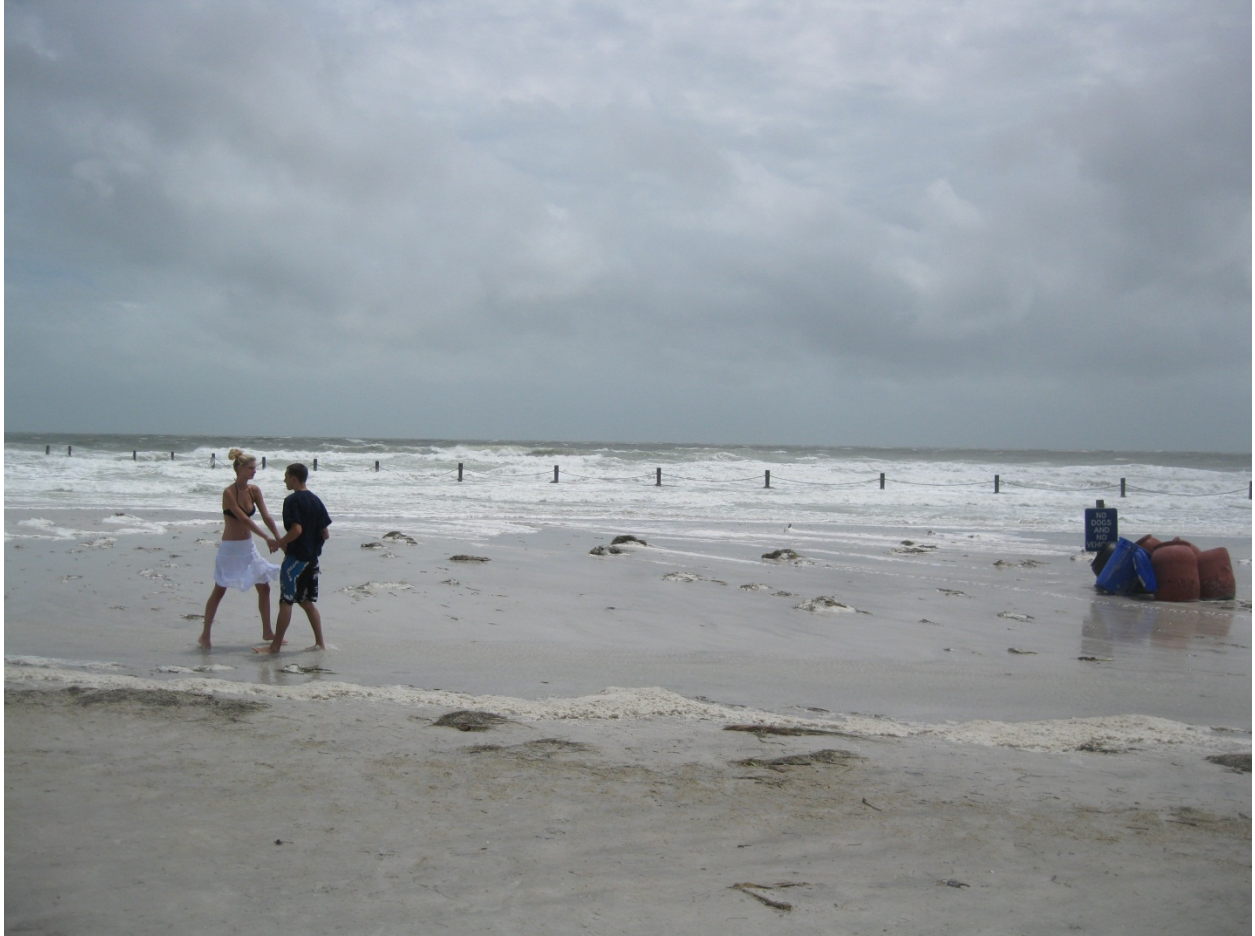
Figure 18. Redington Beach breakwater. The beach seemed to be flat and wide landward of the breakwater.

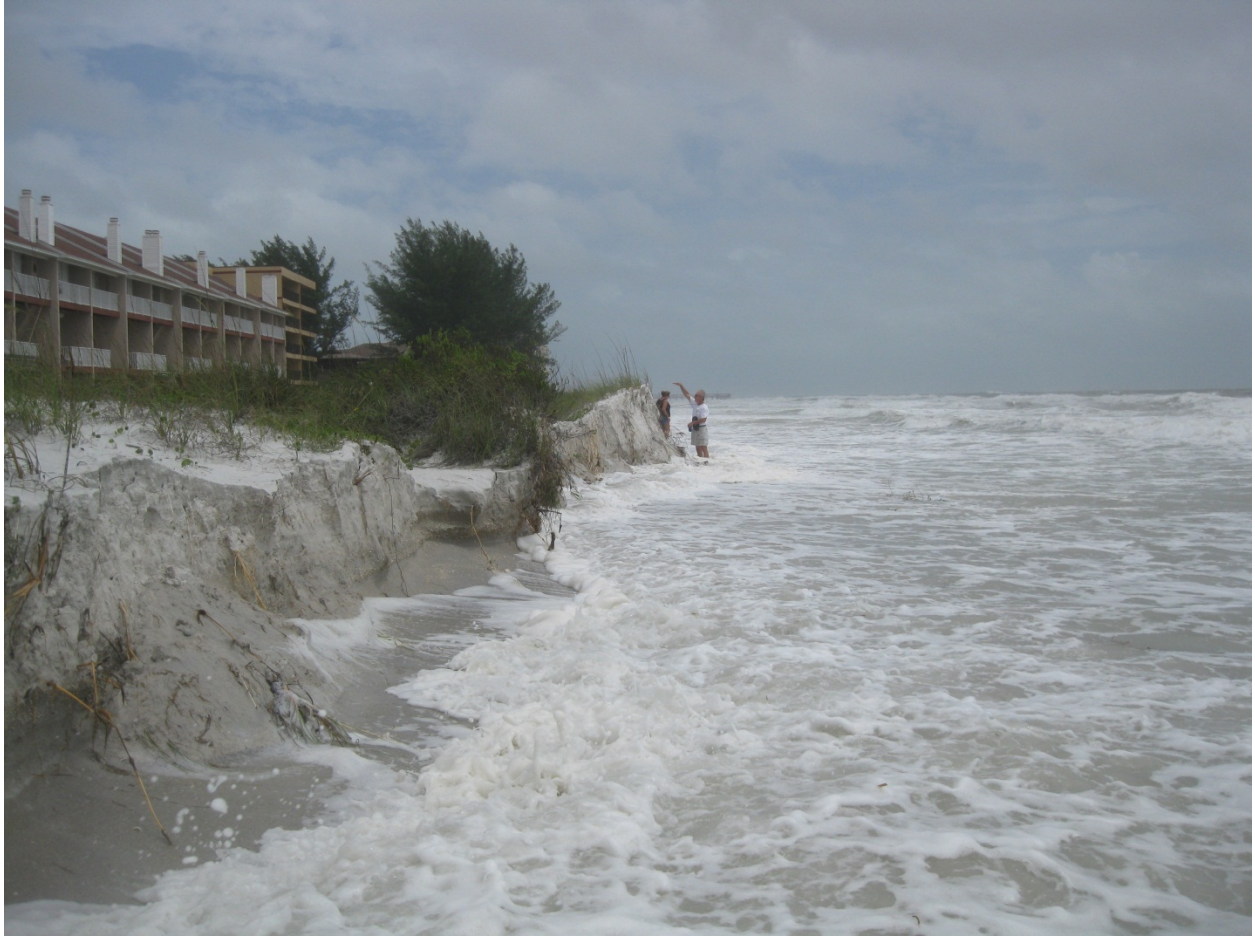
Figure 19. R94 looking south. Active dune scarping. Note the “freshly” fell off sand (lower left), June 25<sup>th</sup>, 2012.

**North Redington Beach (R97-R93):** The section is severely eroded with nearly continuous dune scarp where dunes are present. Some of the dune scarps are very high, up to 6 ft (Figures 19 and 20). Most of this section does not have any back beach. The pre-storm berm was completely eroded. It is difficult to determine if the dune scarp has retreated further landward on June 26<sup>th</sup> due to the lack of fixed reference.

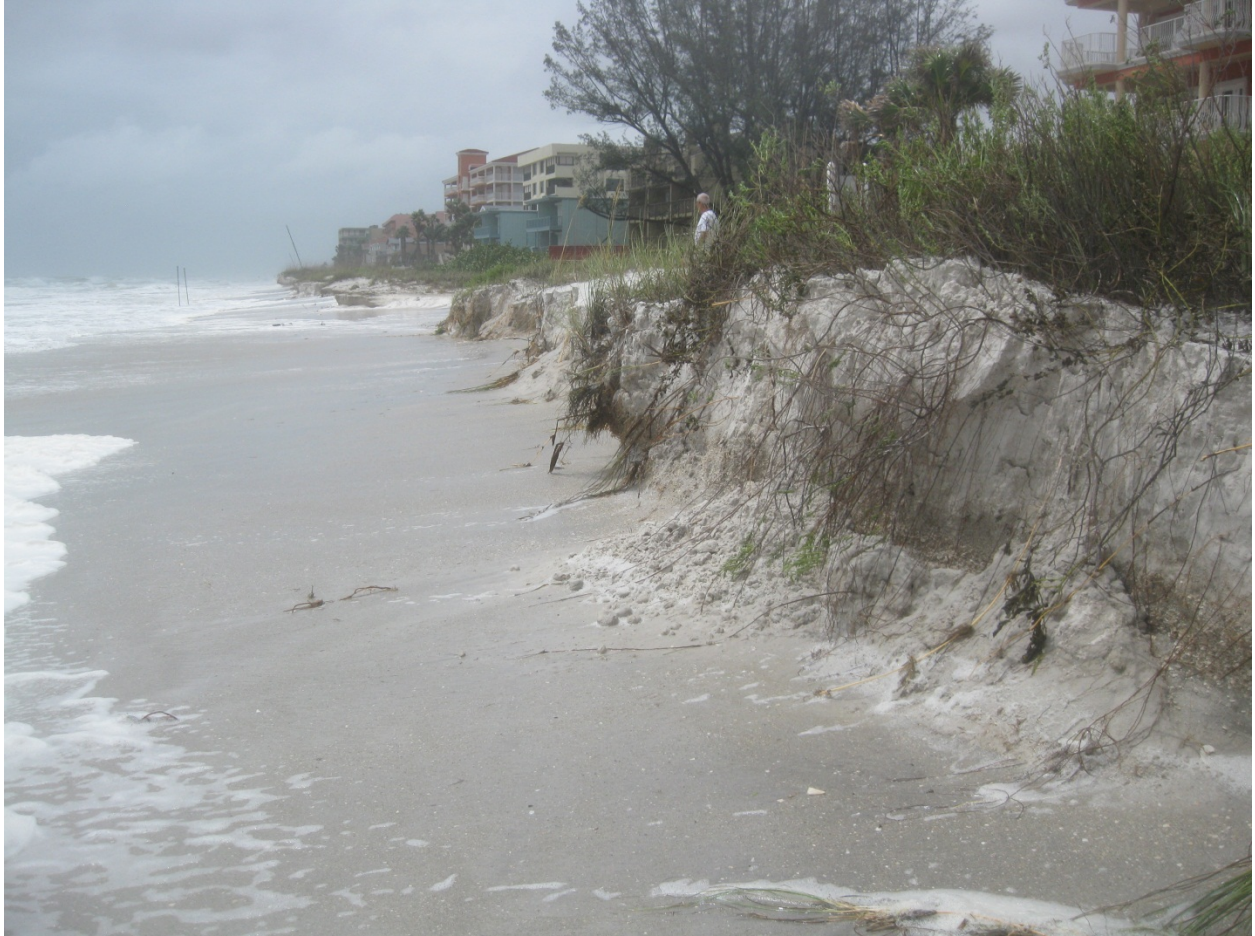
Figure 20. R94 looking north. Nearly continuous beach and dune scarp, June 25<sup>th</sup>, 2012.

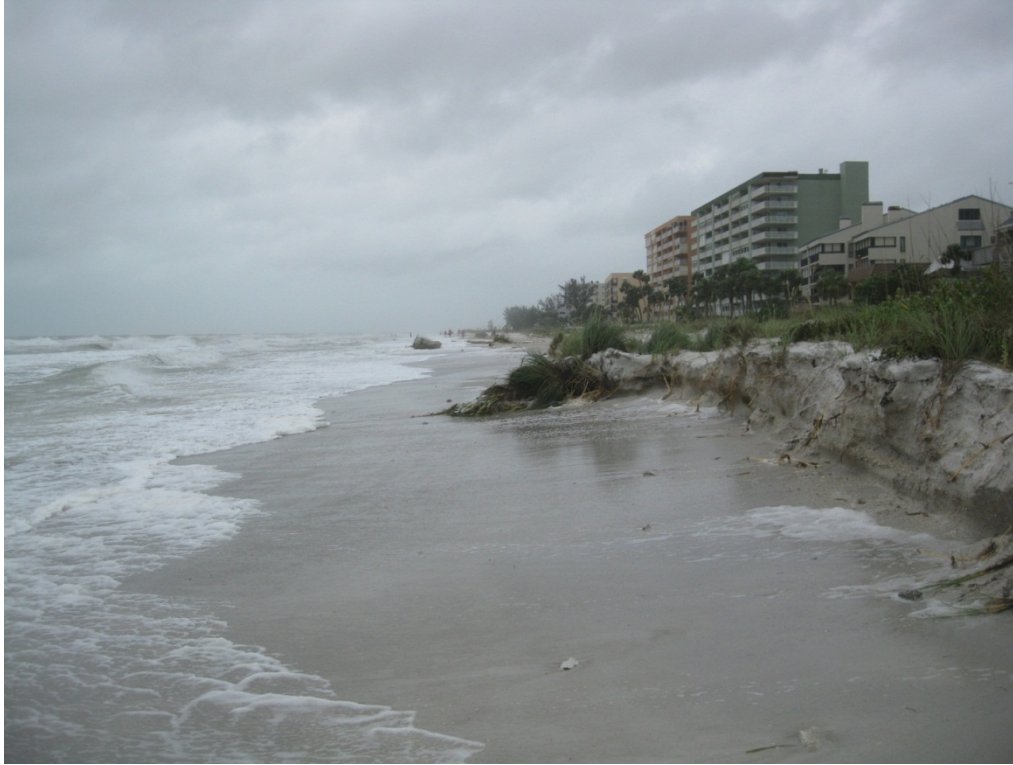
Figure 21a. R88 looking north. Note the “freshly” fell over dune vegetation, June 25<sup>th</sup>, 2012.

**South of Headland (R91-R87):** Similar to the above section, nearly continuous dune scarp. Beach scarp occurred when there is no dune on June 25<sup>th</sup> (Figures 21a, 22, and 23). The surface sediment in local areas has become much coarser with large shell debris on June 26<sup>th</sup> (Figure 21b). At this location, slightly additional dune scarping seems to have happened. The isolated dune feature in Figure 22 has been eroded.

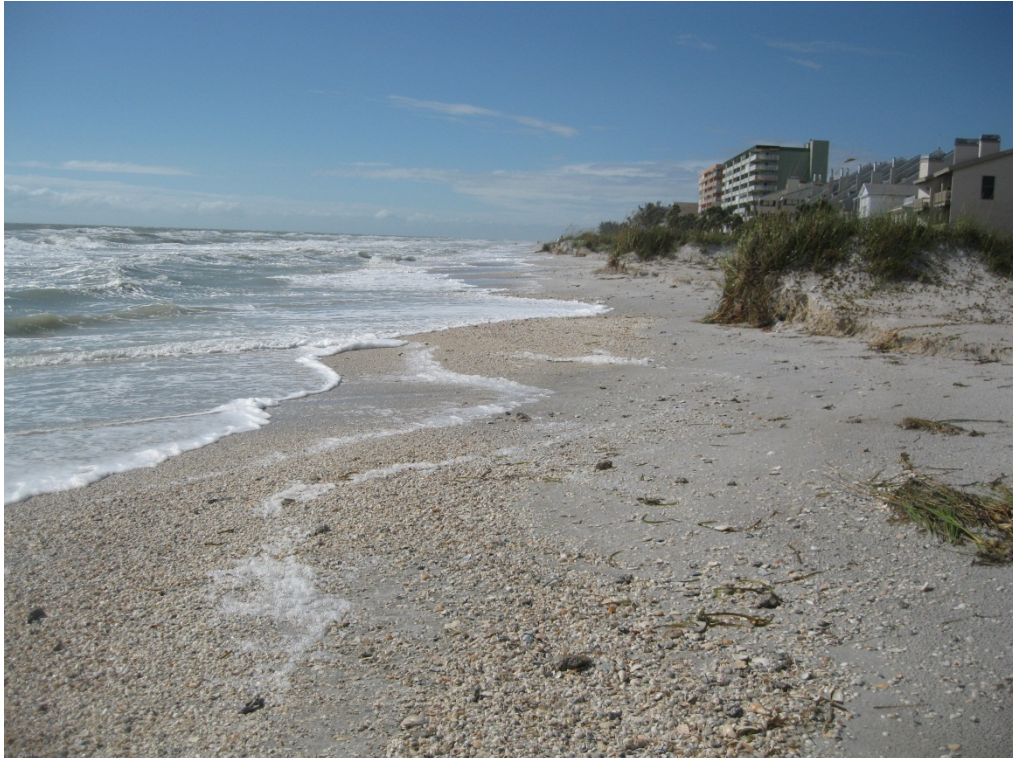
Figure 21b. R88 looking north. Much coarser surface sediments, June 26<sup>th</sup>, 2012.

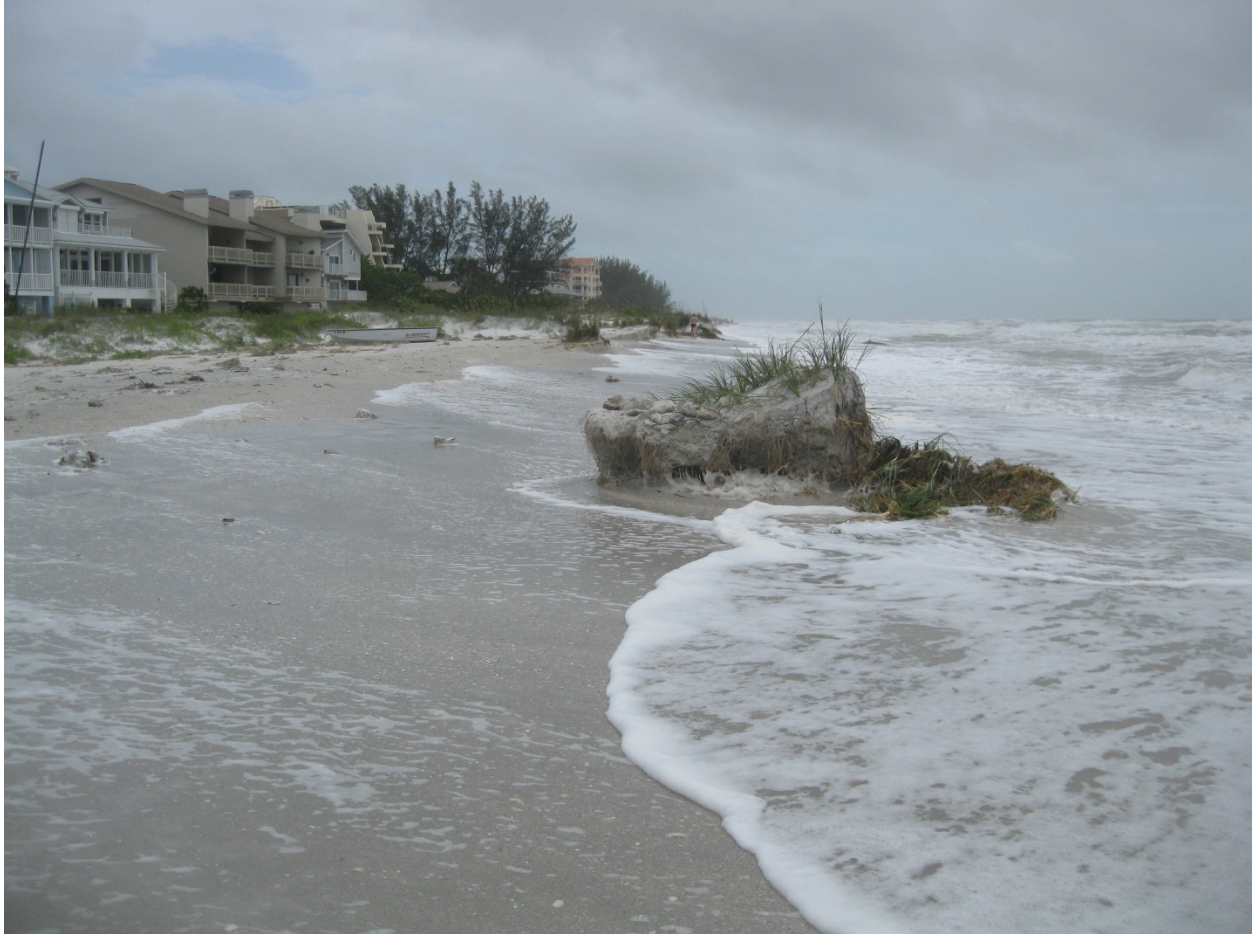
Figure 22. R88 looking south. An isolated dune that is about to be eroded away. A second line of small dunes was establishing along this section of the beach before the storm. That line of dune/vegetation was all eroded, June 25<sup>th</sup>, 2012. This feature was eroded by June 26<sup>th</sup>, 2012.

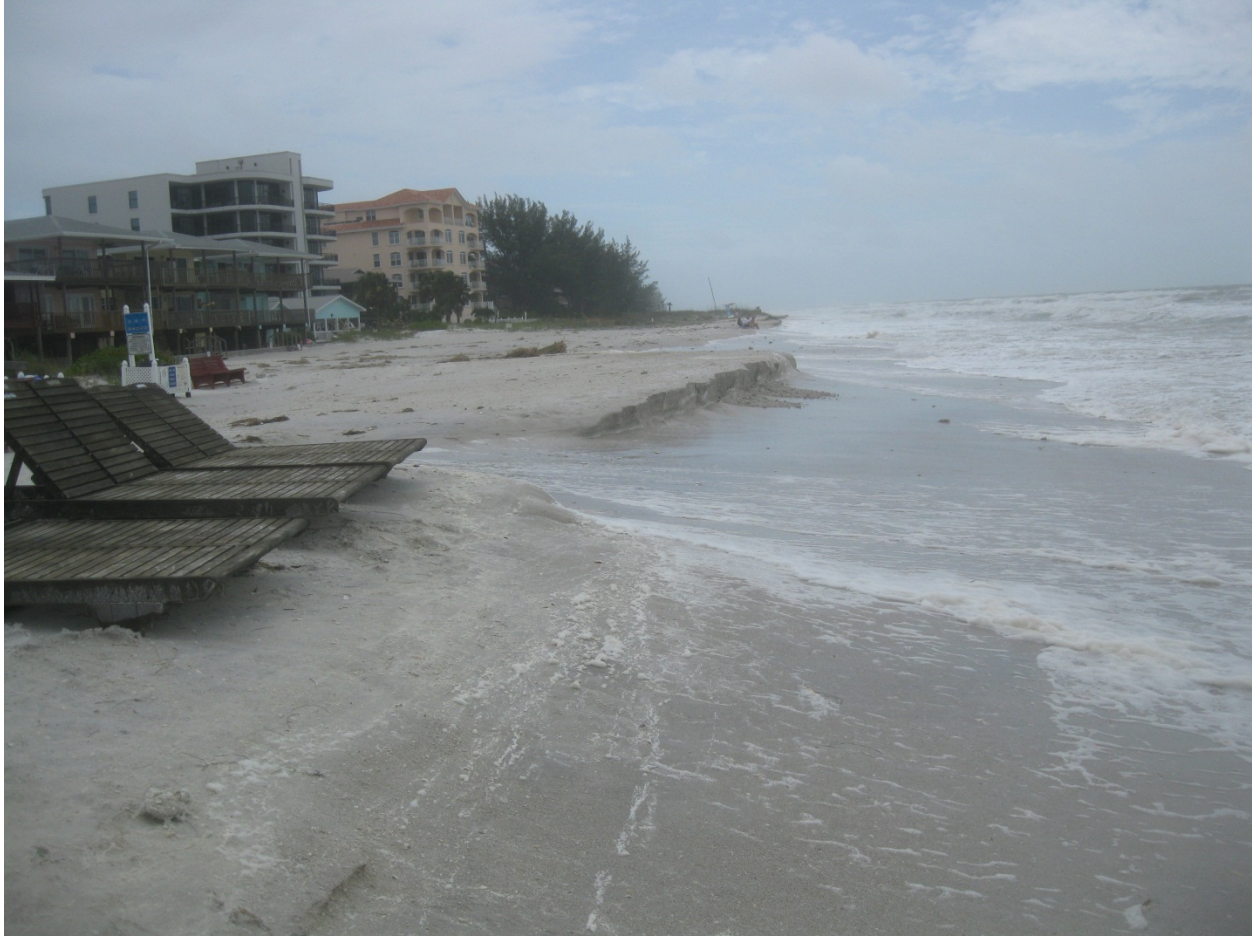
Figure 23. Beach scarp at R89. This section of the beach (~400 ft) does not have any dunes), June 25<sup>th</sup>, 2012.

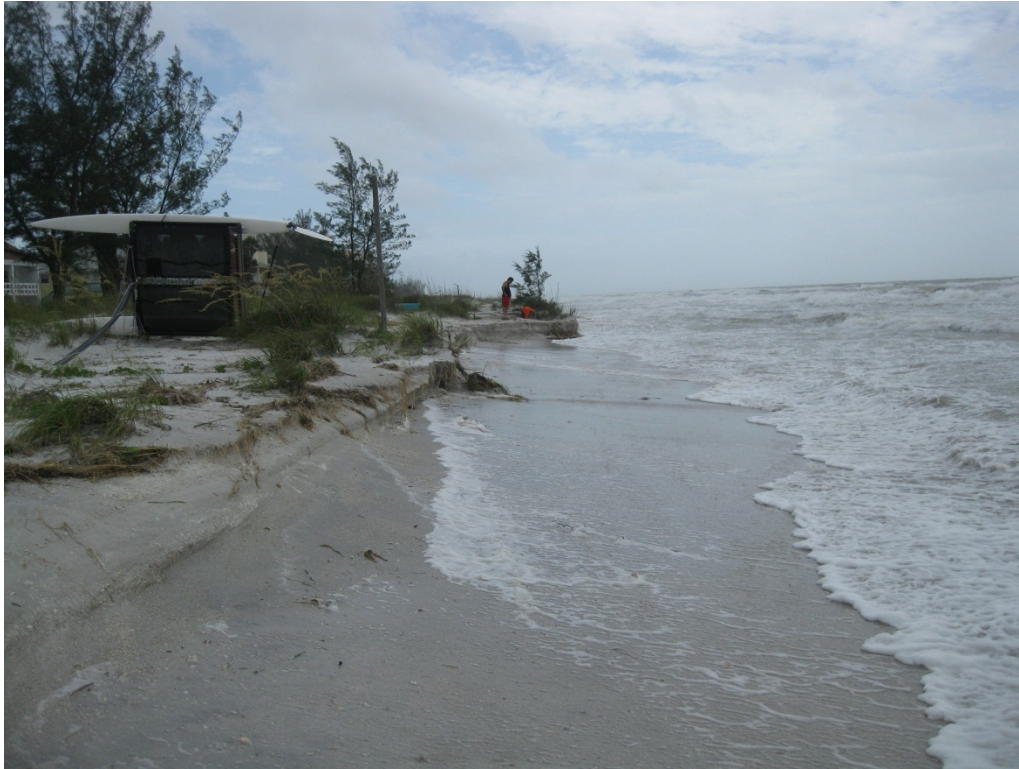
Figure 24a. R85A looking south. June 25<sup>th</sup>, 2012.

**Headland (R86-R83):** This section of the beach was modestly wide (~60-100 ft) before the storm. Severe erosion and continuous dune scarping occurred (Figure 24a, 25a, 26a, and 27a). This is one of the most severely eroded sections with the highest dune scarp at R84. The protruding headland may have sustained higher waves, but this could not be confirmed from the field observations. Continued beach erosion and dune scarping occurred on June 26<sup>th</sup>, 2012 along the headland (Figure 24b, 25b, 26b, and 27b). Additional 3-6 ft dune scarp retreat occurred on June 26<sup>th</sup>.

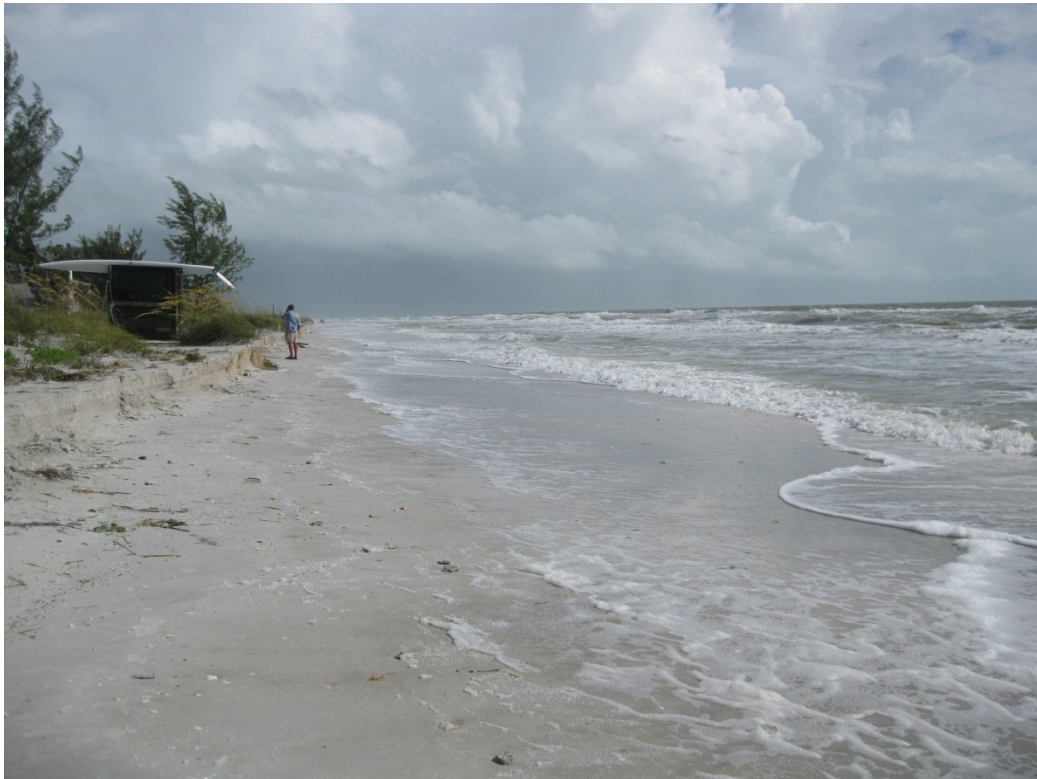
Figure 24b. R85A looking south. June 26<sup>th</sup>, 2012.

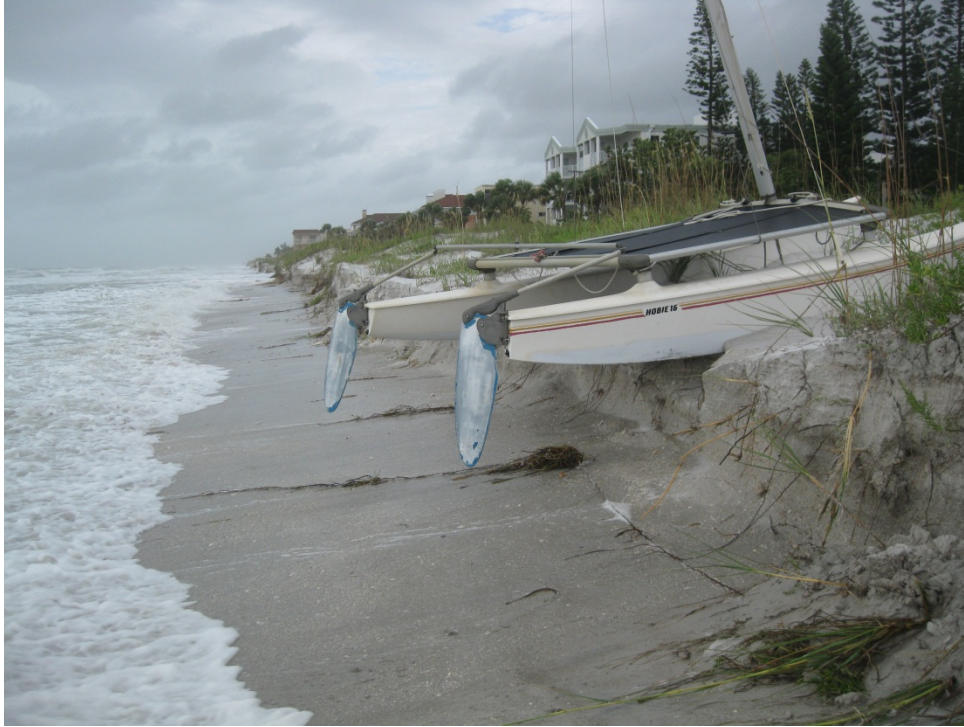
Figure 25a. R85A looking north. Continuous dune scarp, June 25<sup>th</sup>, 2012..

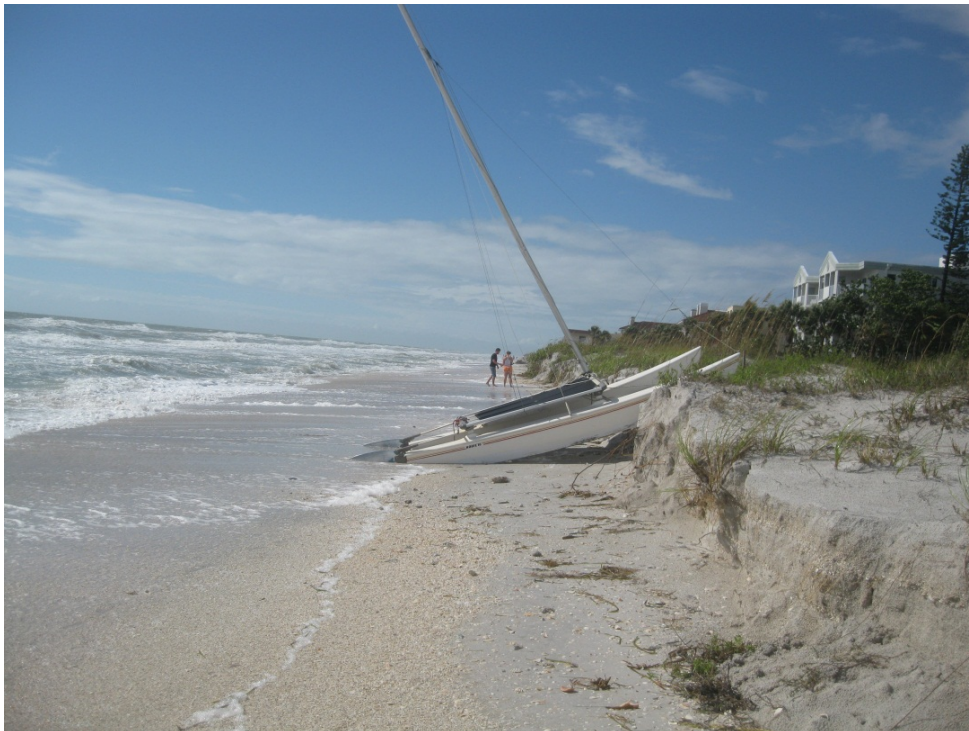
Figure 25b. R85A looking north. Note the sail boat has fallen off due to the additional dune scarping, June 26<sup>th</sup>, 2012.

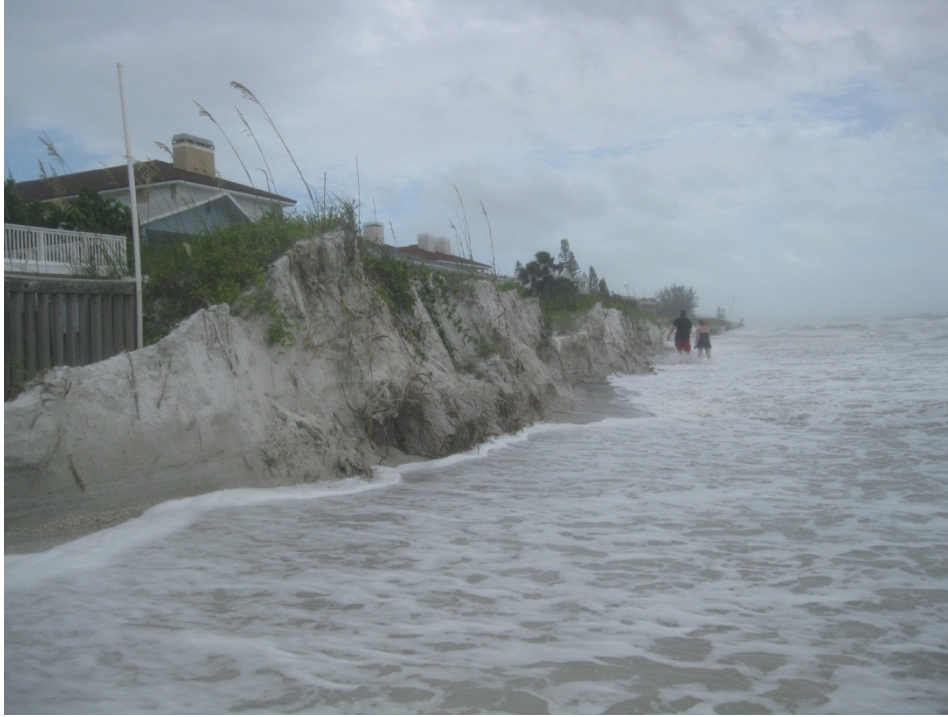
Figure 26a. R84 looking south. About 8 ft dune scarp. Note the sand was still falling of the scarp as the storm waves crashing on the dune scarp, June 25<sup>th</sup>, 2012.

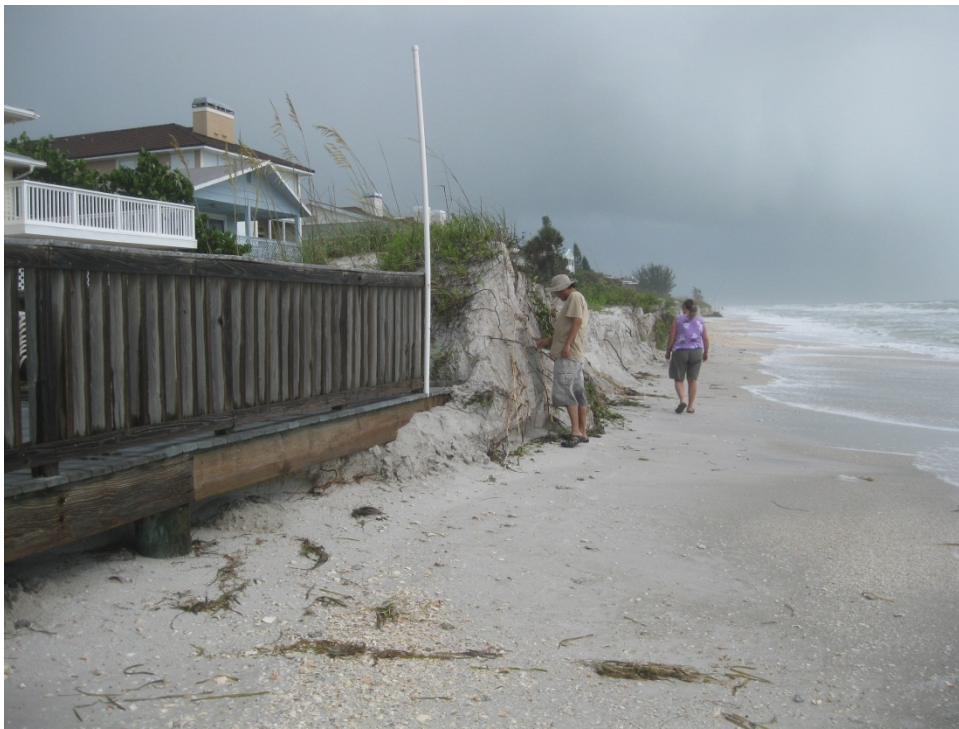
Figure 26b. R84 looking south. Additional erosion occurred, June 26<sup>th</sup>, 2012.

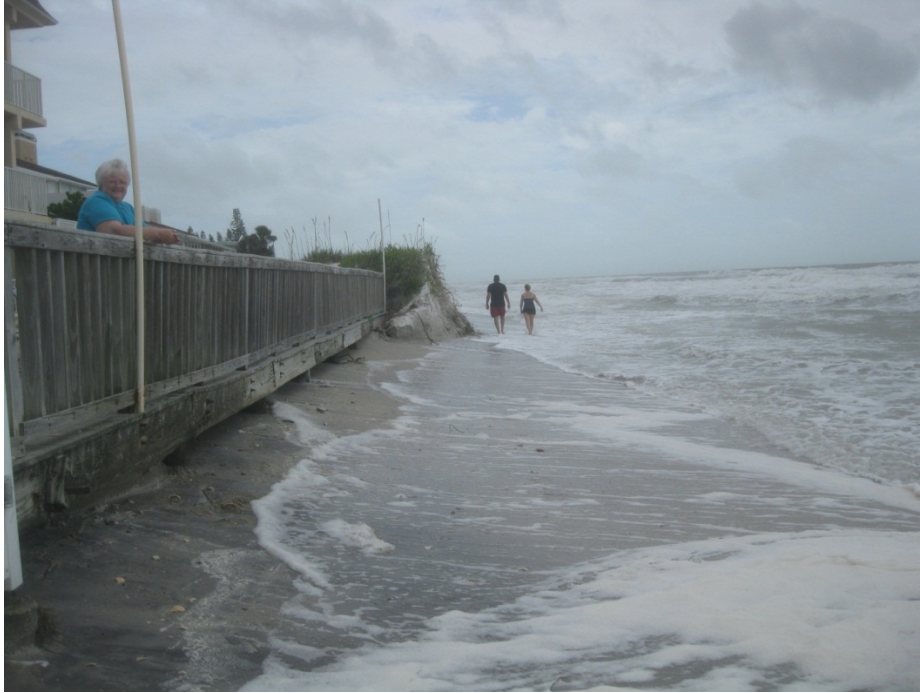
Figure 27a. Fence in front of the hotel at R84. There was a beach and a dune in front of the fence before storm, June 25<sup>th</sup>, 2012.

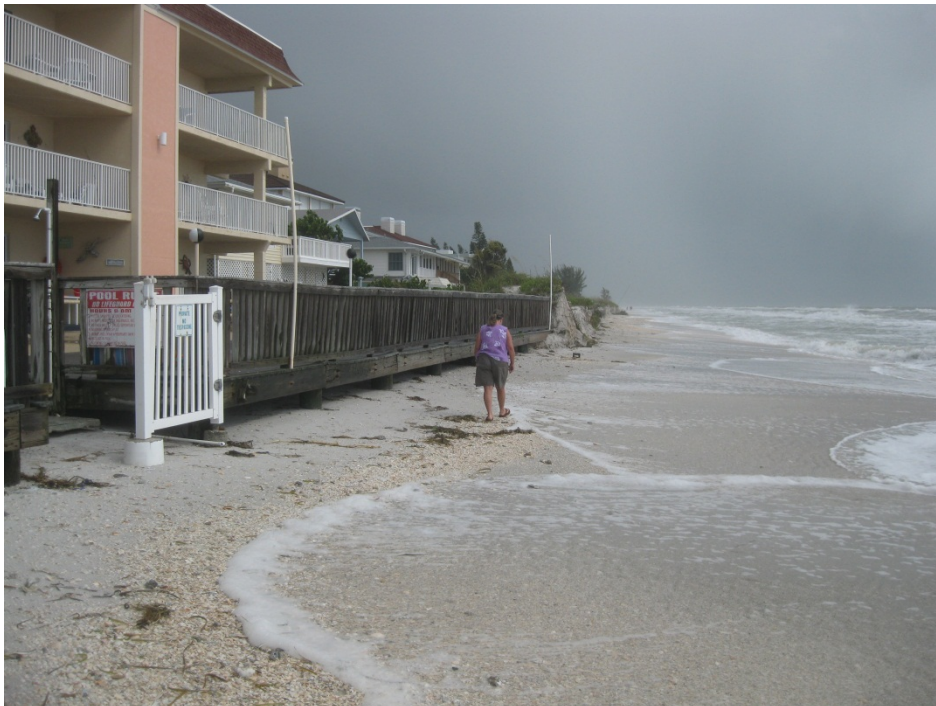
Figure 27b. Fence in front of the hotel at R84. Slightly more beach erosion occurred and the surface sediment has become coarser, June 26<sup>th</sup>, 2012.

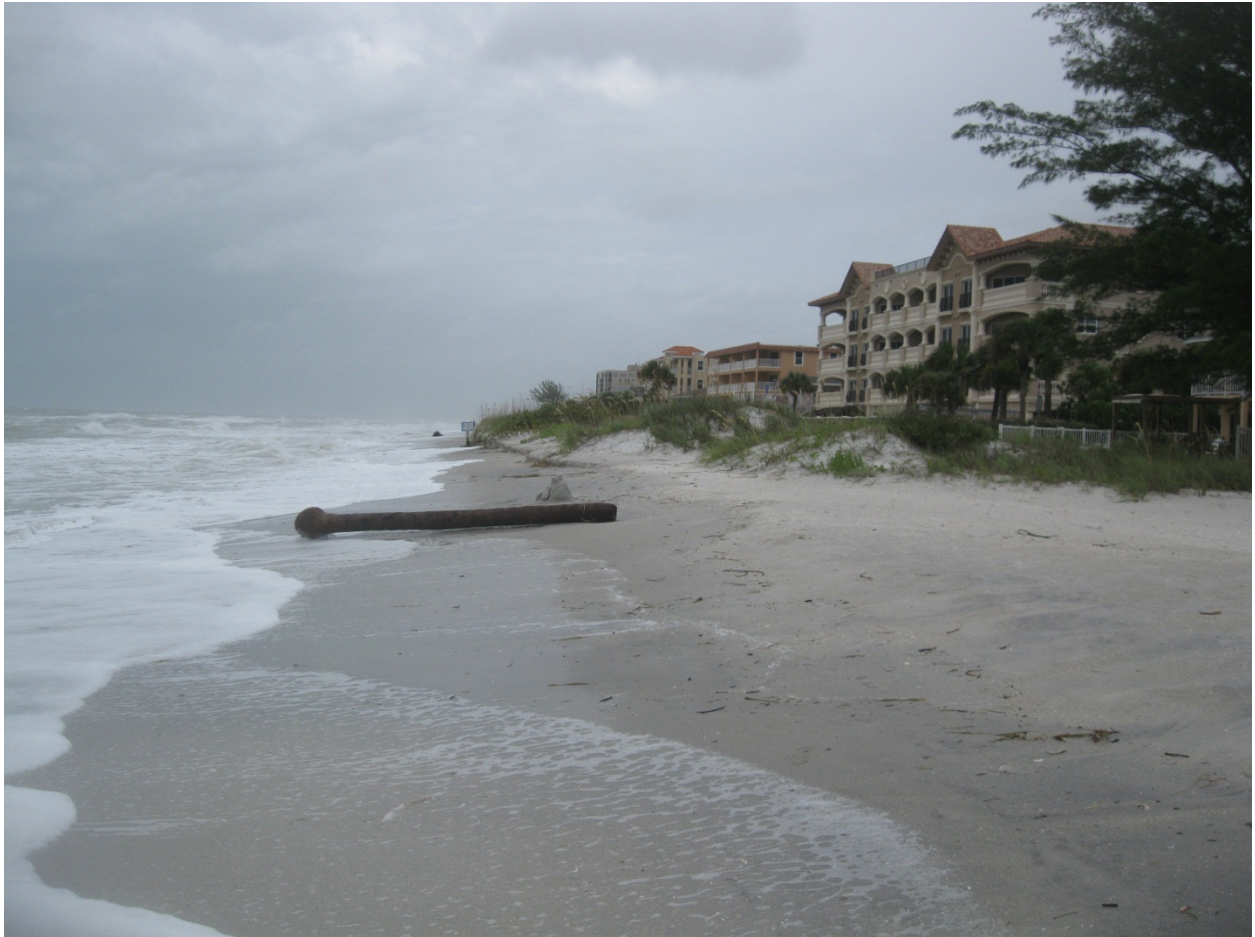
Figure 28. R82 looking north, June 25<sup>th</sup>, 2012.

**Indian Rocks Beach (R81-R74):** This section of the beach was modestly wide (~50-100 ft) before the storm. Continuous beach scarp or dune scarp occurred (Figure 28, 29 and 30). **This section of the beach appeared to be similar on June 26<sup>th</sup>.**

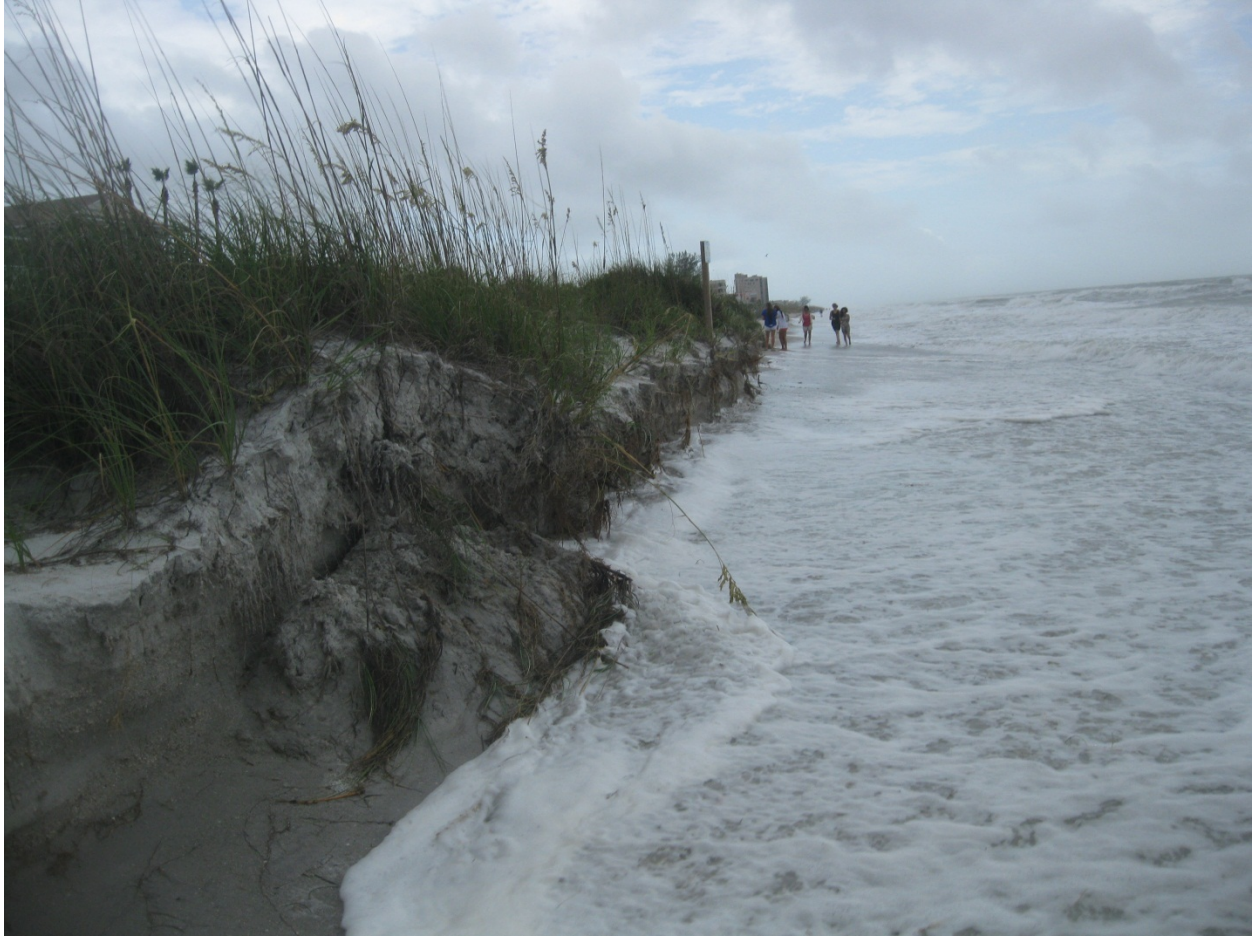
Figure 29. R74 looking south. Active dune scarping. Note that a “fresh” block was falling off the scarp, June 25<sup>th</sup>, 2012.

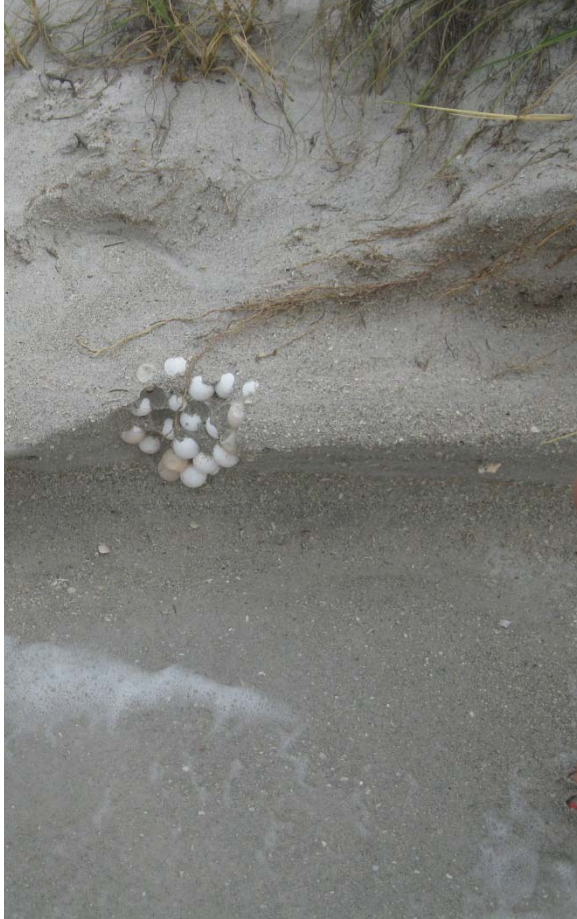
Figure 30. Turtle eggs exposed at R74 dune scarp, June 25<sup>th</sup>, 2012.

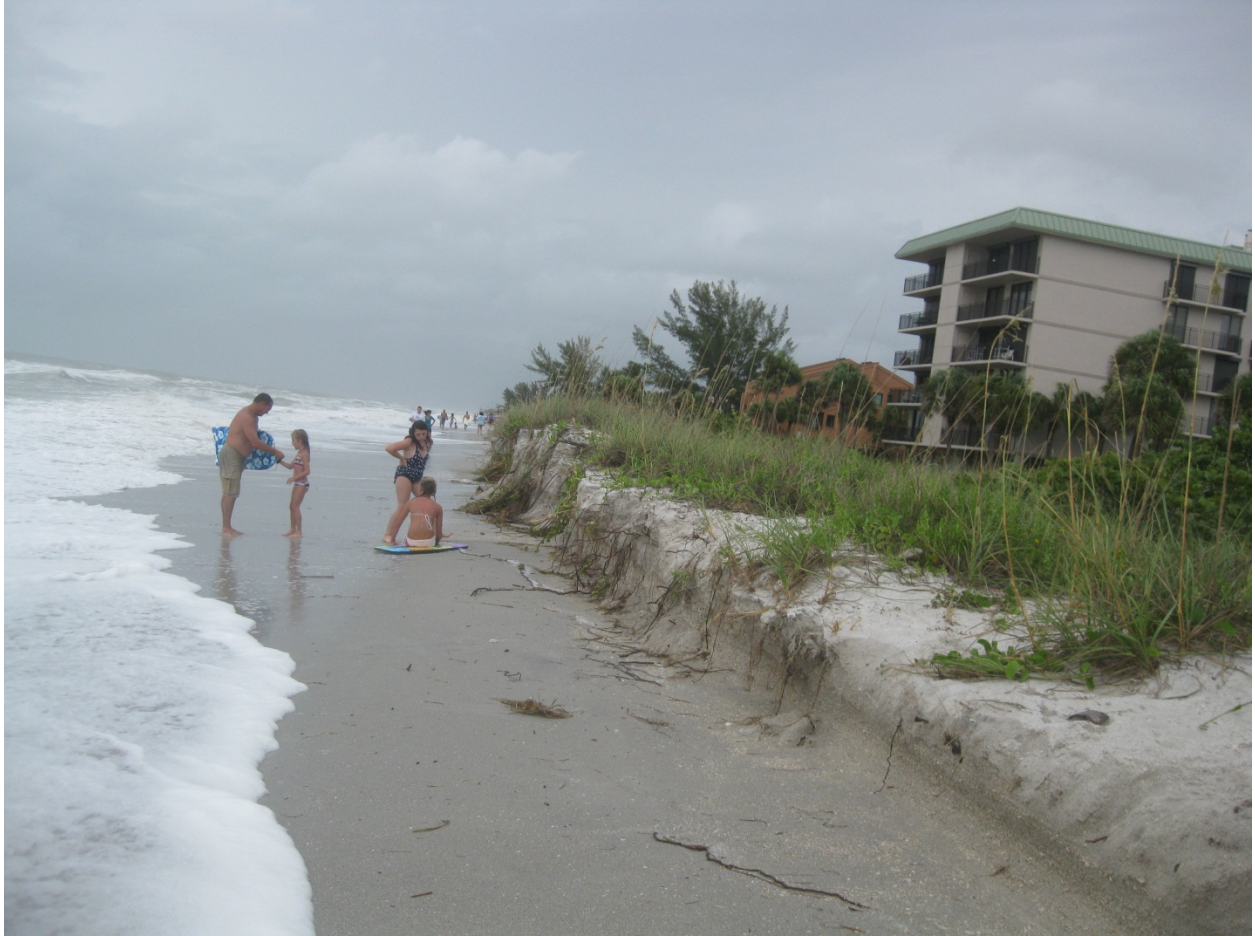
Figure 31. R72.5 looking north. Continuous beach and dune scarp, June 25<sup>th</sup>, 2012.

**2006 Nourishment area Transition R74-R71:** This section of the beach was quite narrow (less than 80 ft) before the storm. Severe beach erosion and nearly continuous beach and dune scarping occurred, except at localized places (Figures 31 and 32). **This section of the beach appeared to be similar on June 26<sup>th</sup>.**

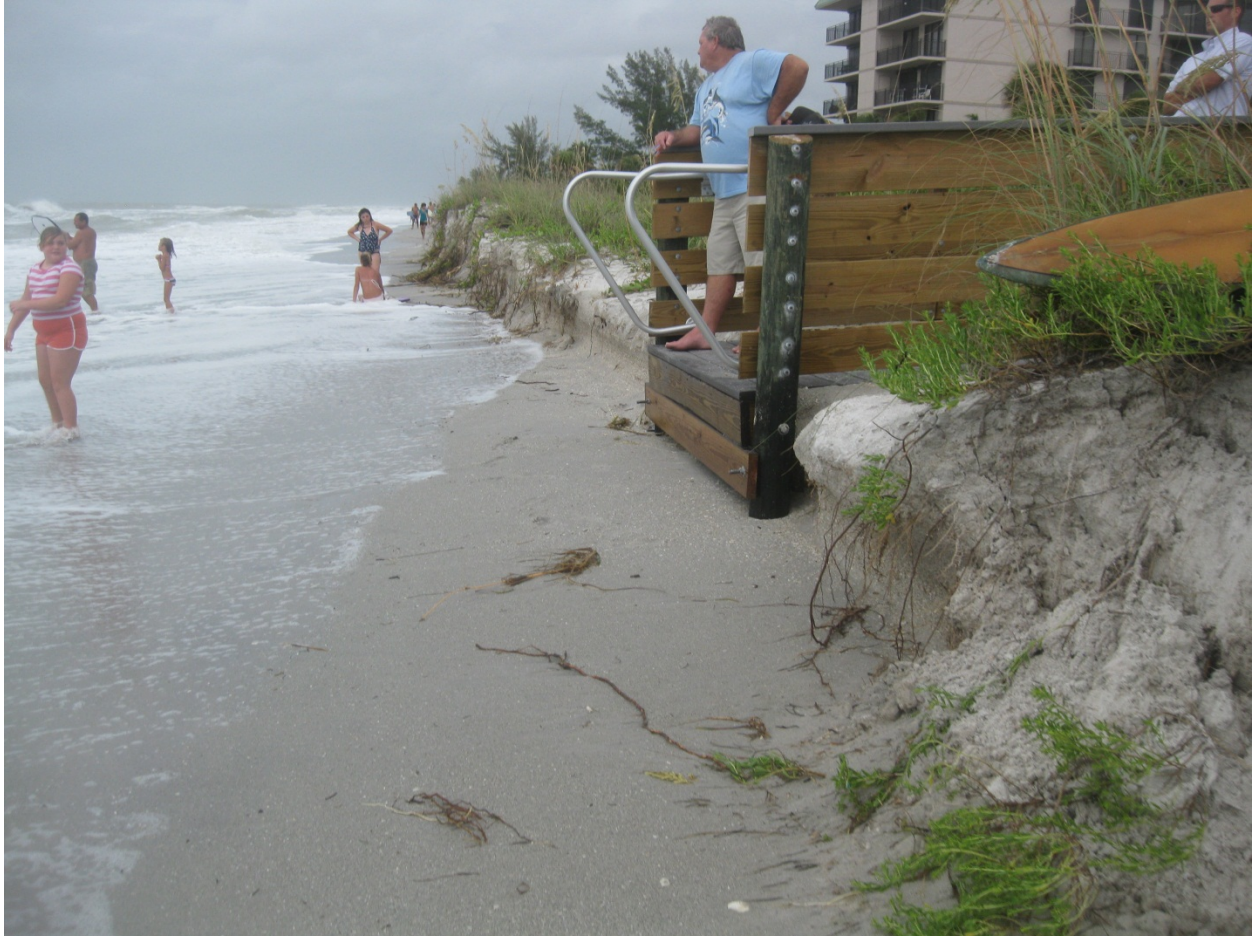
Figure 32. ~R71.5 looking north. Continuous beach and dune scarp, June 25<sup>th</sup>, 2012.

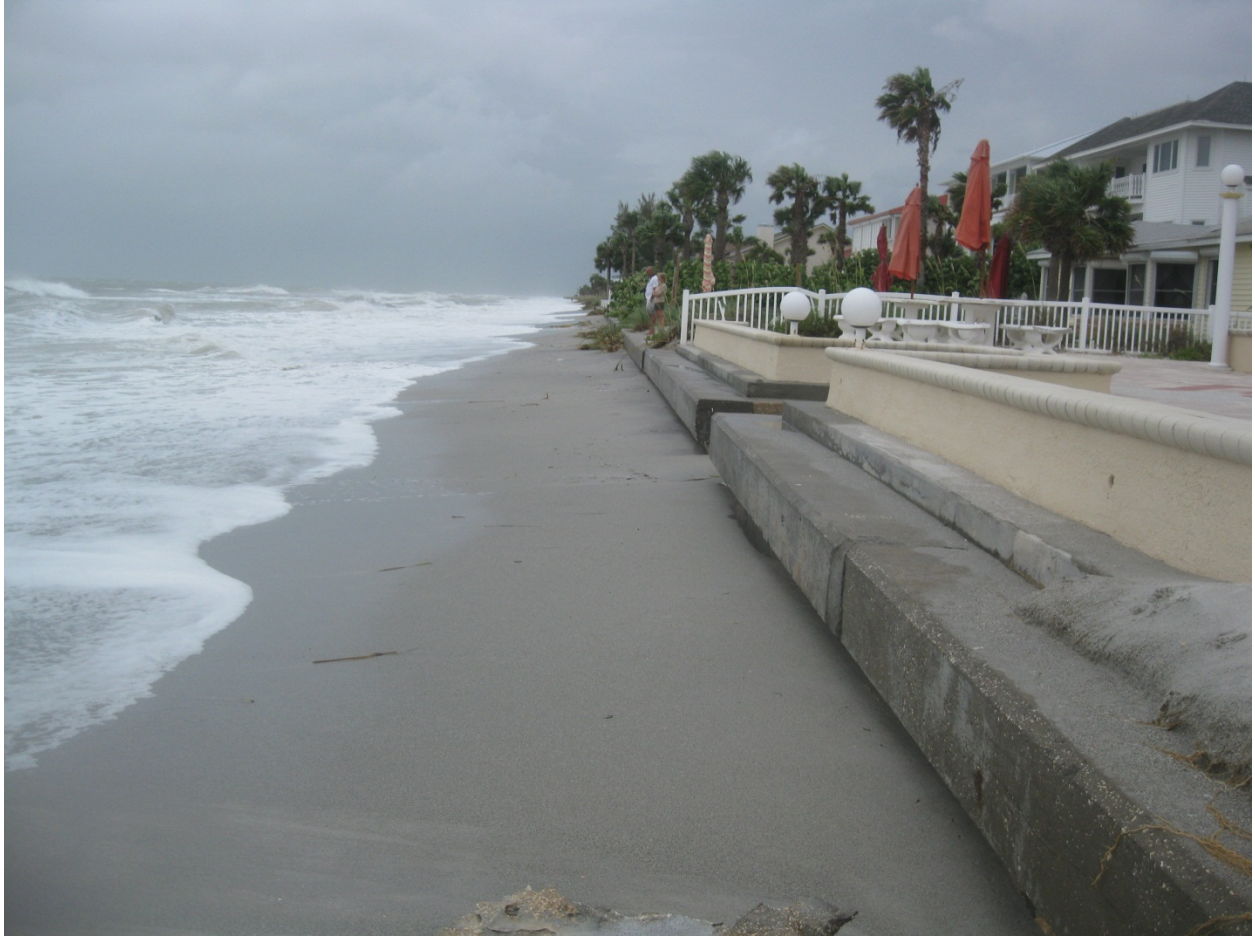
Figure 33. ~R69.5 looking north. The seawall was not overtopped, June 25<sup>th</sup>, 2012.

**Belleair Shores (R70-R66):** This section did not receive beach nourishment during 2006 and before. The beach was very narrow (mostly less than 30 ft) before the storm. The narrow beach was mostly eroded, leaving a rather steep swash zone in front of the seawall. The sea oats and small dunes were largely eroded away. The waves were crashing onto the seawall, but not overtopping the seawall (Figure 33 and 34). This section of the beach appeared to be similar on June 26<sup>th</sup>. It is not clear why no additional scour occurred in front of the seawall here (Figure 33), while severe additional erosion occurred along exposed seawall at Redington Beach and Sunset Beach.
