## **Pinellas County Beaches during Tropical Storm Debby, June 25, 2012 and June 26, 2012**

### **Initial Field Observations during the Storm by Ping Wang**

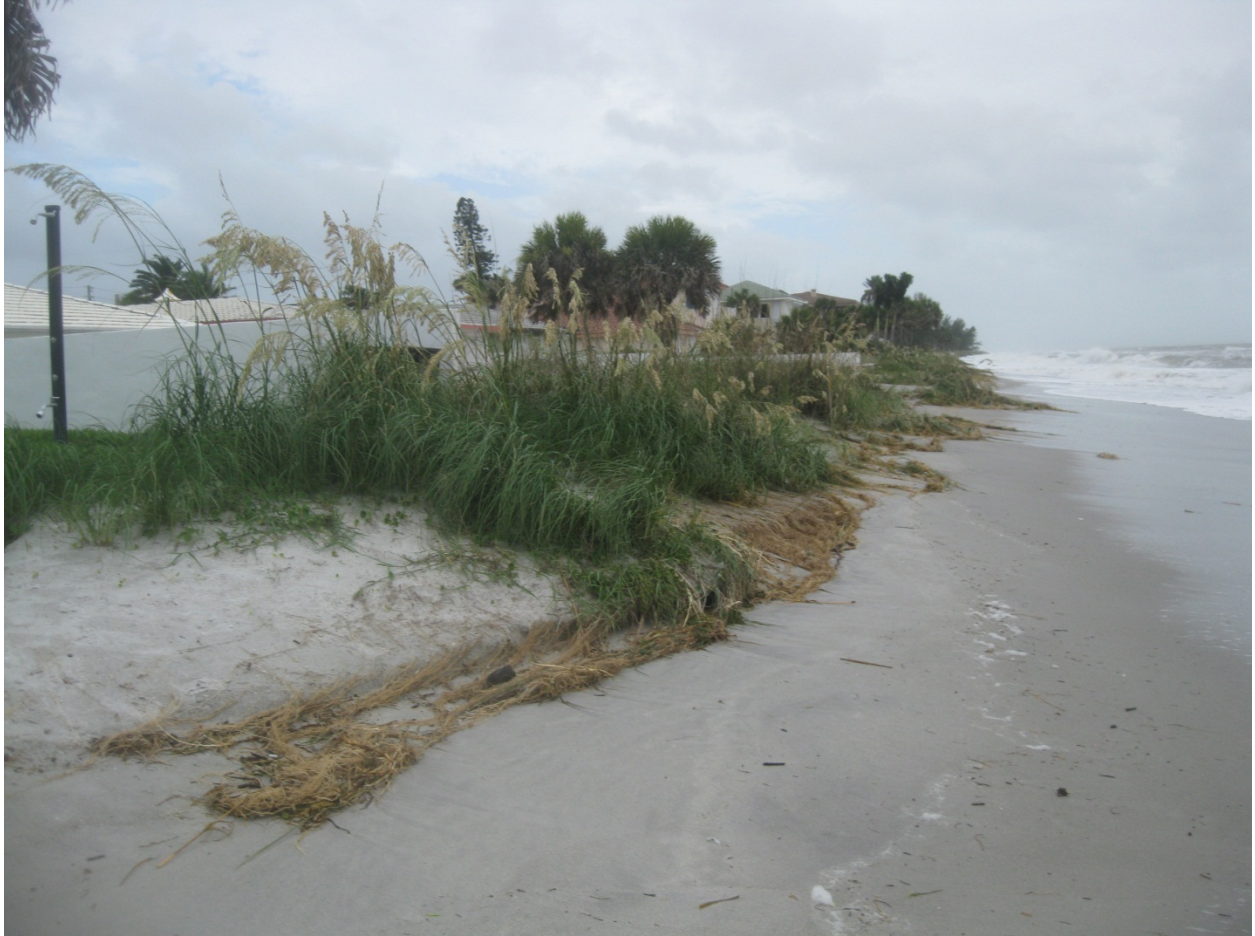
Figure 34. R68 looking north. Some dune vegetation survived at this time, June 25<sup>th</sup>, 2012.

**Belleair Shores (R70-R66):** This section did not receive beach nourishment during 2006 and before. The beach was very narrow (mostly less than 30 ft) before the storm. The narrow beach was mostly eroded, leaving a rather steep swash zone in front of the seawall. The sea oats and small dunes were largely eroded away. The waves were crashing onto the seawall, but not overtopping the seawall (Figure 33 and 34). This section of the beach appeared to be similar on June 26<sup>th</sup>. It is not clear why no additional scour occurred in front of the seawall here (Figure 33), while severe additional erosion occurred along exposed seawall at Redington Beach and Sunset Beach.

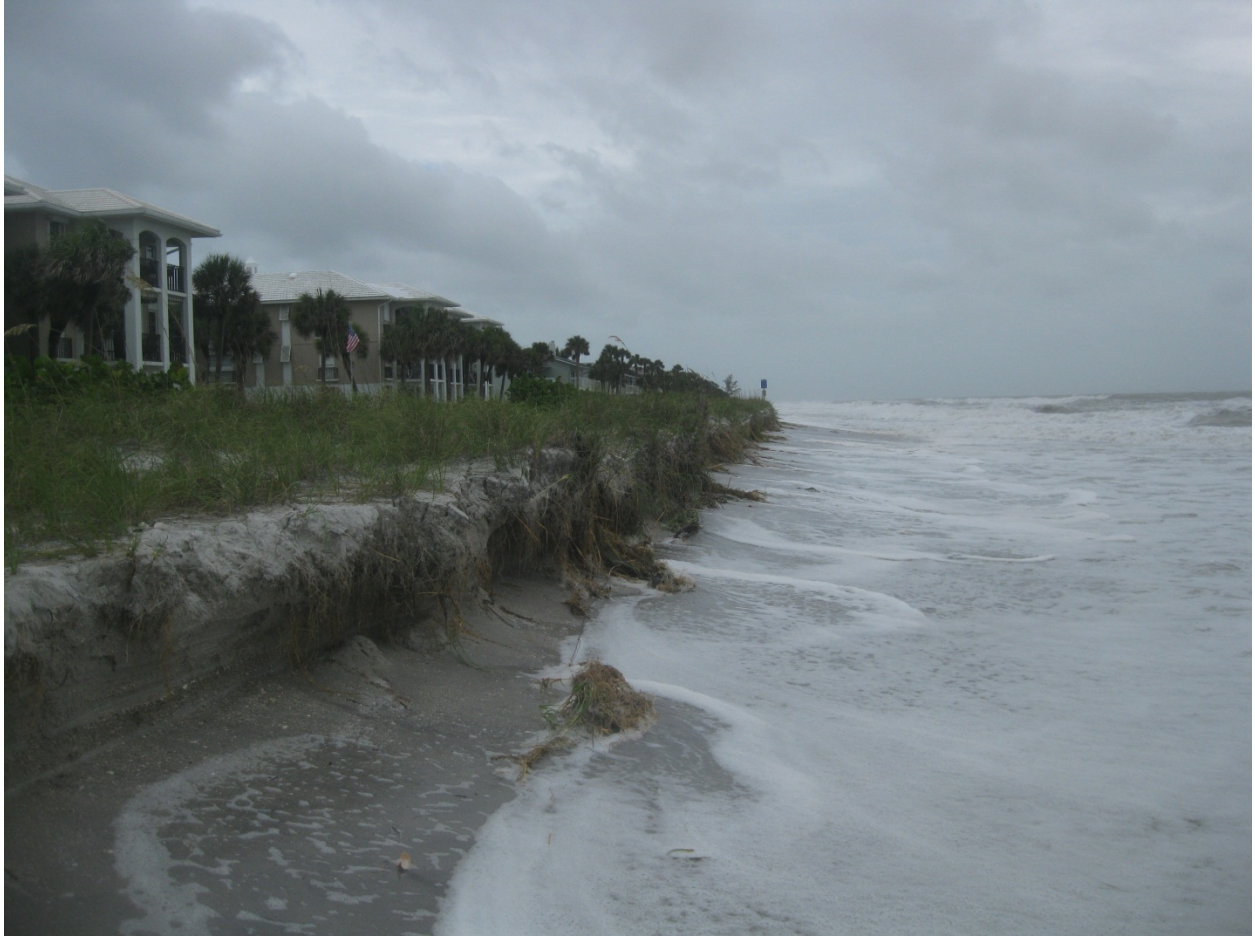
Figure 35. R64 looking south. Note the dune vegetation was being washed away by the high waves, June 25<sup>th</sup>, 2012.

**2006 Nourishment End Zone R65.5 – R62:** This section of the beach was narrow (~50 ft) before the storm. Severe beach erosion and continuous dune scarping occurred (Figures 35, 36, and 37). **This section of the beach appeared to be similar on June 26<sup>th</sup>.**

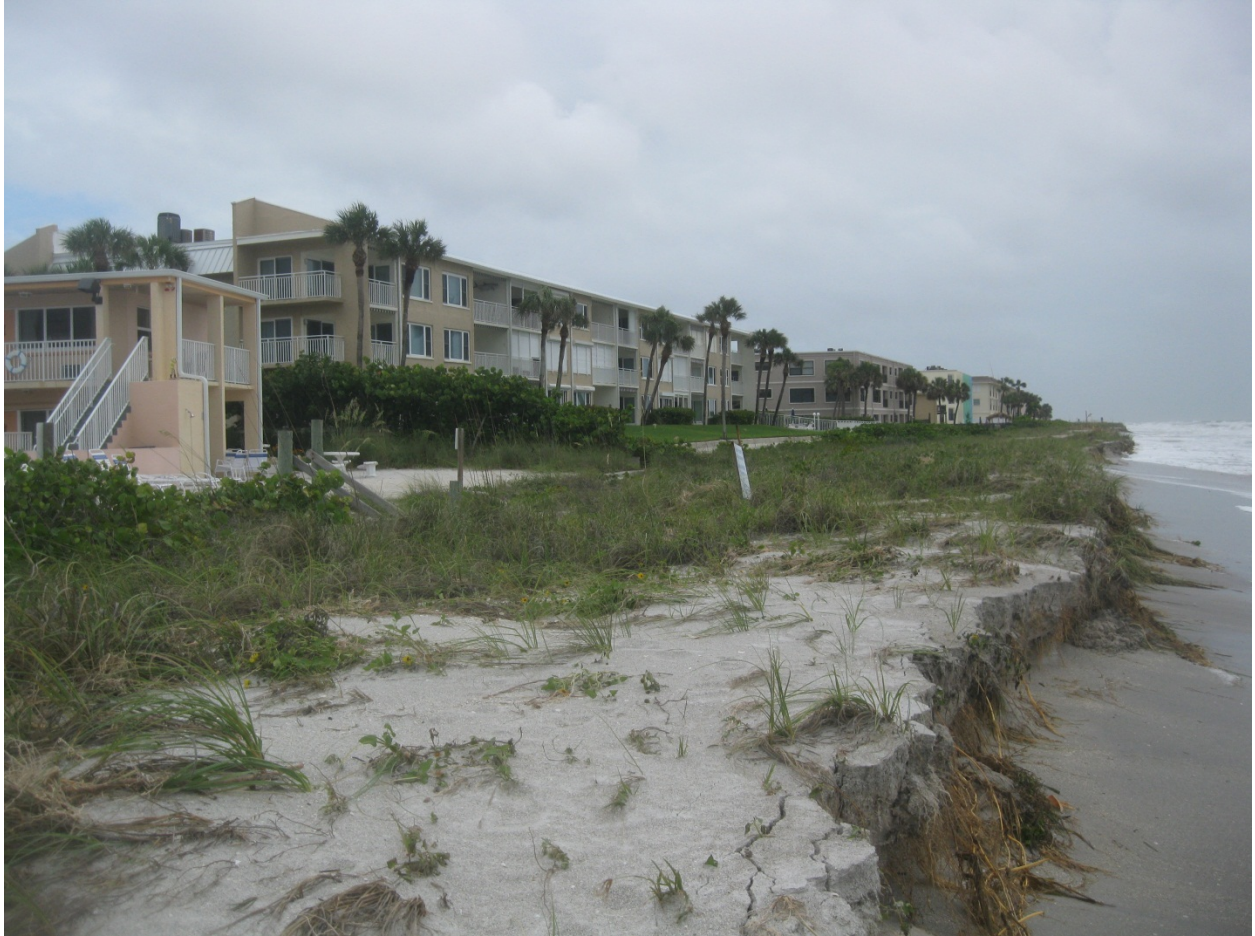
Figure 36. R62 looking south, continuous dune scarping, note the crack in the sand at the bottom of the photo, June 25<sup>th</sup>, 2012.

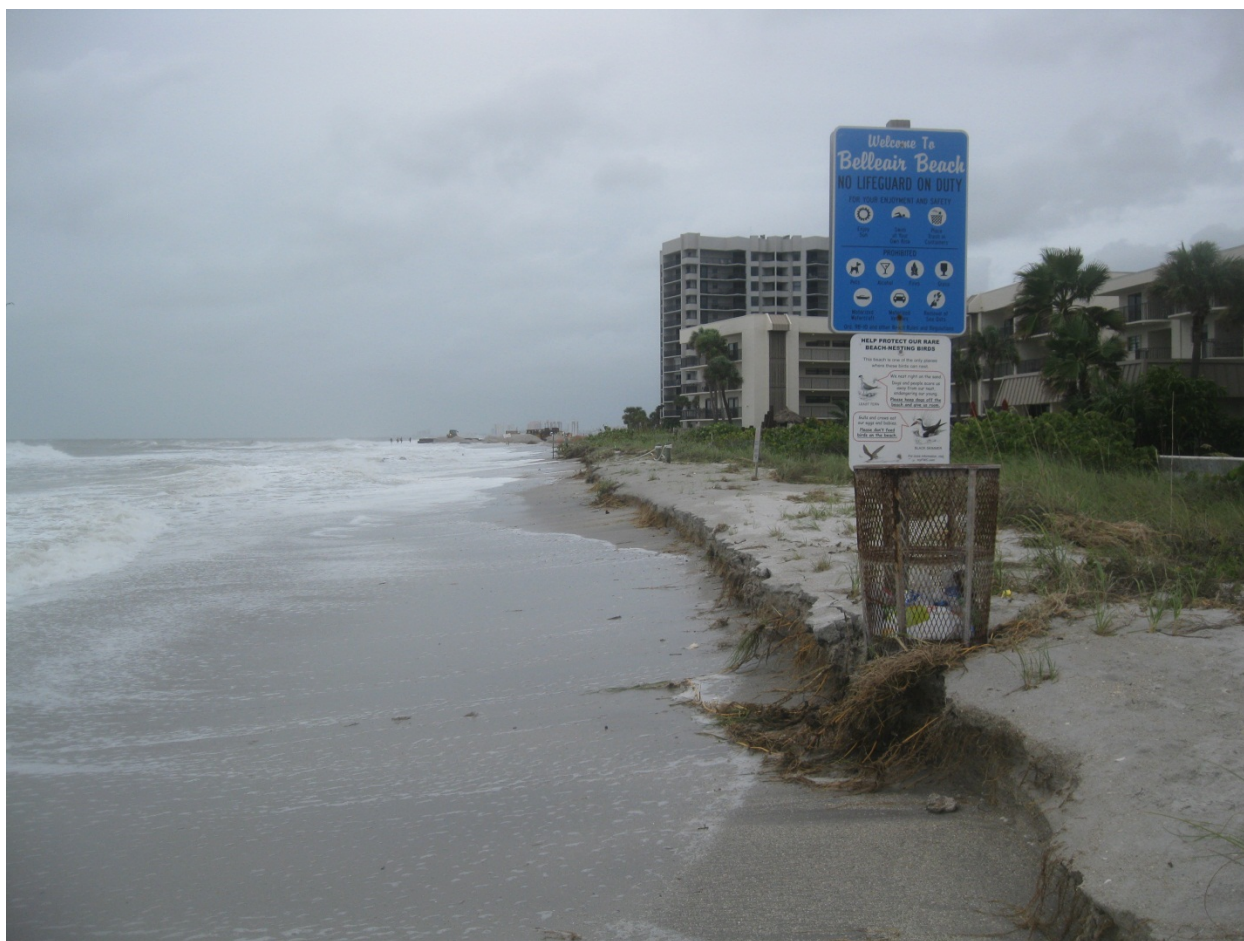
Figure 37. R62 looking north, June 25<sup>th</sup>, 2012. The 2012 beach nourishment area in the distance.

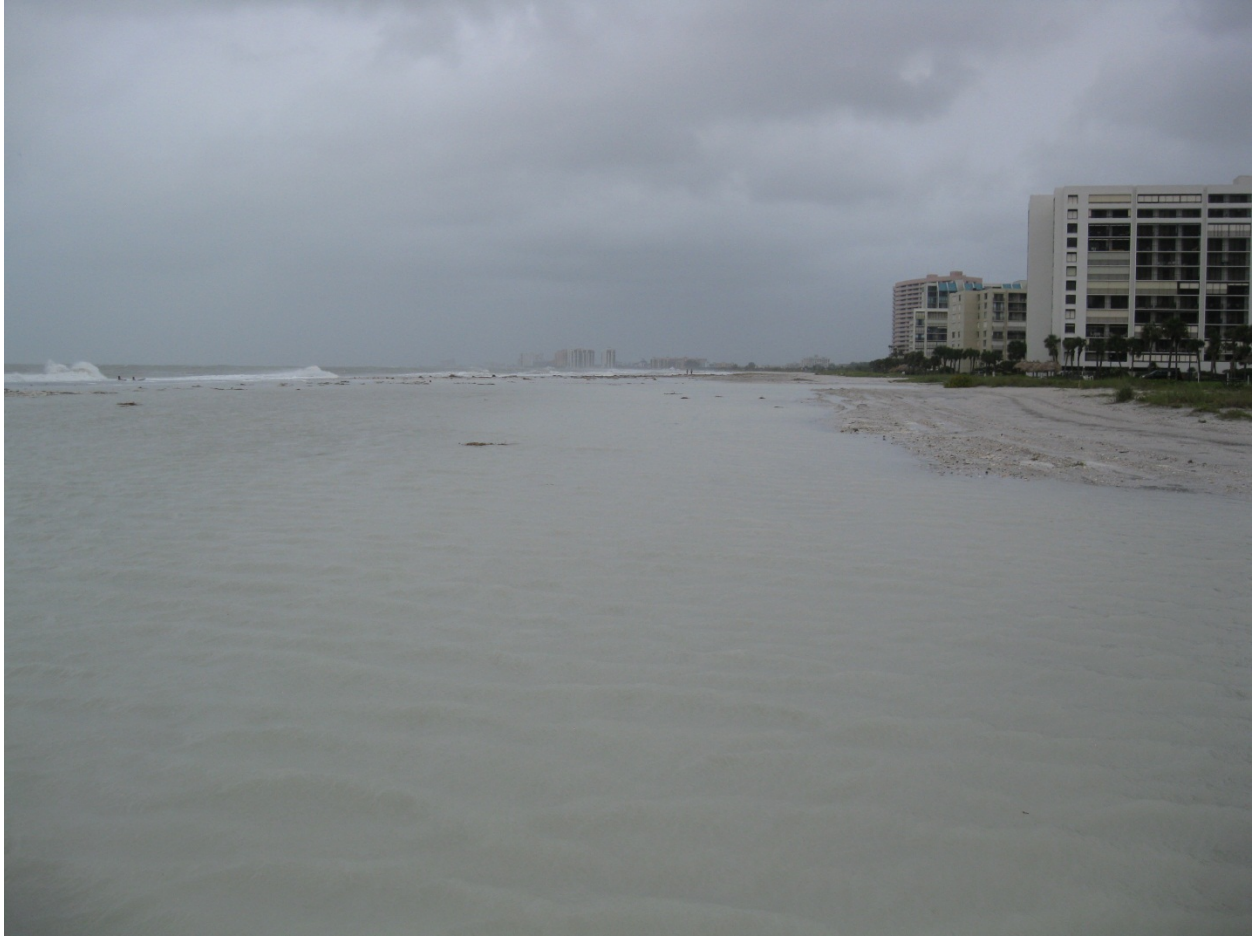
Figure 38. R59 looking north with on-going beach nourishment, June 25<sup>th</sup>, 2012.

**2012 Beach Nourishment Area (R61-R57):** The freshly nourished beach appears to be holding up reasonably well. Serious ponding on the back beach occurred on the beach, partly related to the not yet completed construction. No significant amount of gravel was found in the surf zone (landward edge of the surf zone) and on the surface.
