## Blind Pass Coastal Management History

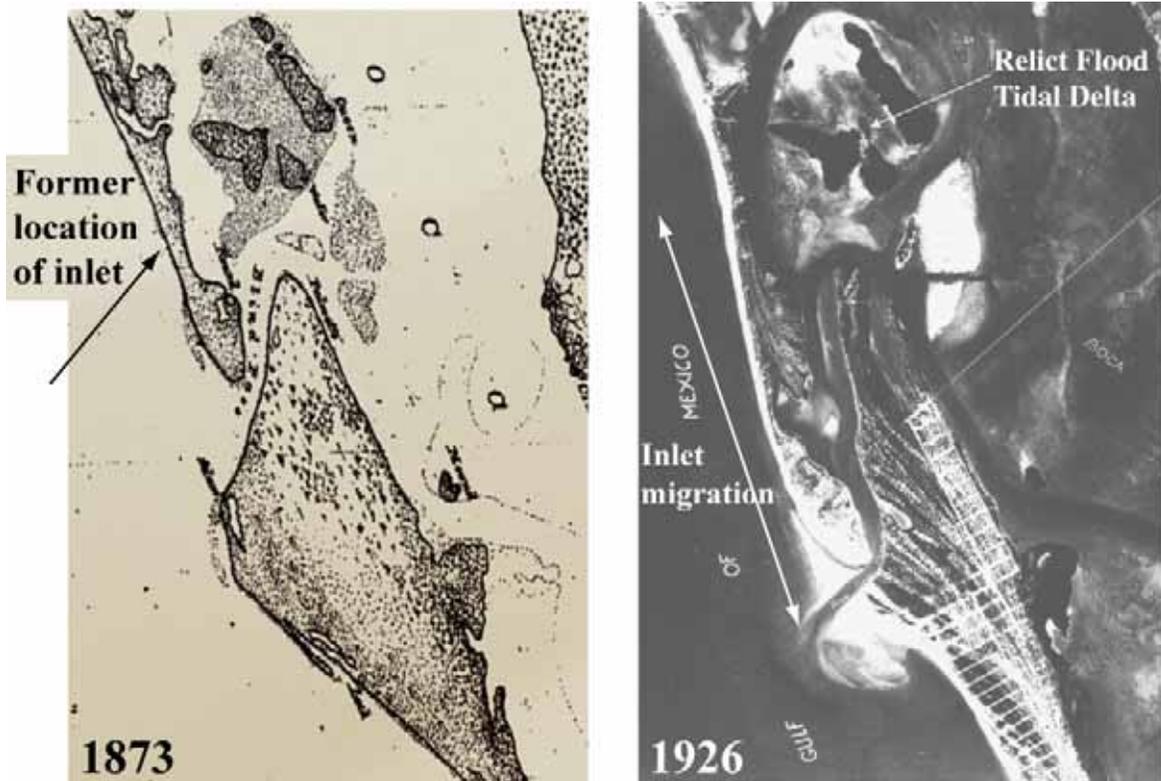
In the 1800's, **Blind Pass** was a well-established tidal inlet with prominent ebb- and flood-tidal deltas. The relict flood tidal delta is shown above. Blind Pass deteriorated due to a lack of tidal flow caused by several factors (namely the opening of John's Pass and dredge-and-fill activities in Boca Ciega Bay).

In 1873, Blind Pass was located 2 km north of its present location (see above). The opening of John's Pass in 1848 initiated the destabilization of Blind Pass. When John's Pass opened, it captured a portion of the tidal prism of Blind Pass, causing instability. In response to longshore sediment transport to the south, the inlet began to migrate to the south and erode the wide north end of Long Key. By the location of the flood tidal delta, it is evident that the southerly migration had already begun in 1873.

By 1926 (see above), Blind Pass had been migrating to the south, eroding the beach ridges on the north end of Long Key for 75 years. The inlet migrated over 1 km during this time. The ebb delta of Blind Pass had been forced onshore by wave energy as a result of reduced tidal flows.

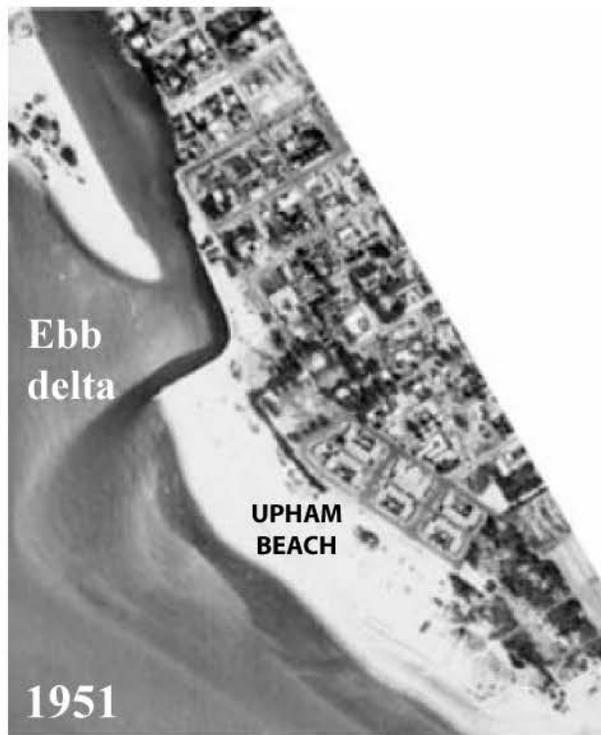
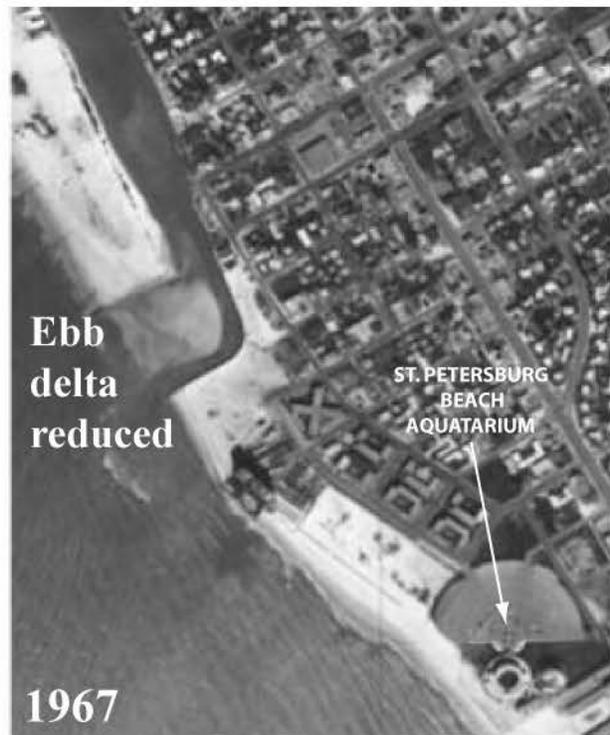
These photos illustrate final collapse of the ebb shoal of Blind Pass and the poorly-located construction that occurred during the 1960's. In 1951, the ebb delta is visible, but by 1967 it had been significantly reduced. During this time, Upham Beach was wide and stable due to onshore sediment transport as the ebb delta collapsed and migrated onshore. No coastal construction control line building regulations existed at the time and condos were built on the beach. Due to this poorly-located construction, erosion problems were imminent. Once the sediment source from the collapsing ebb shoal disappeared, erosion began to plague this region.

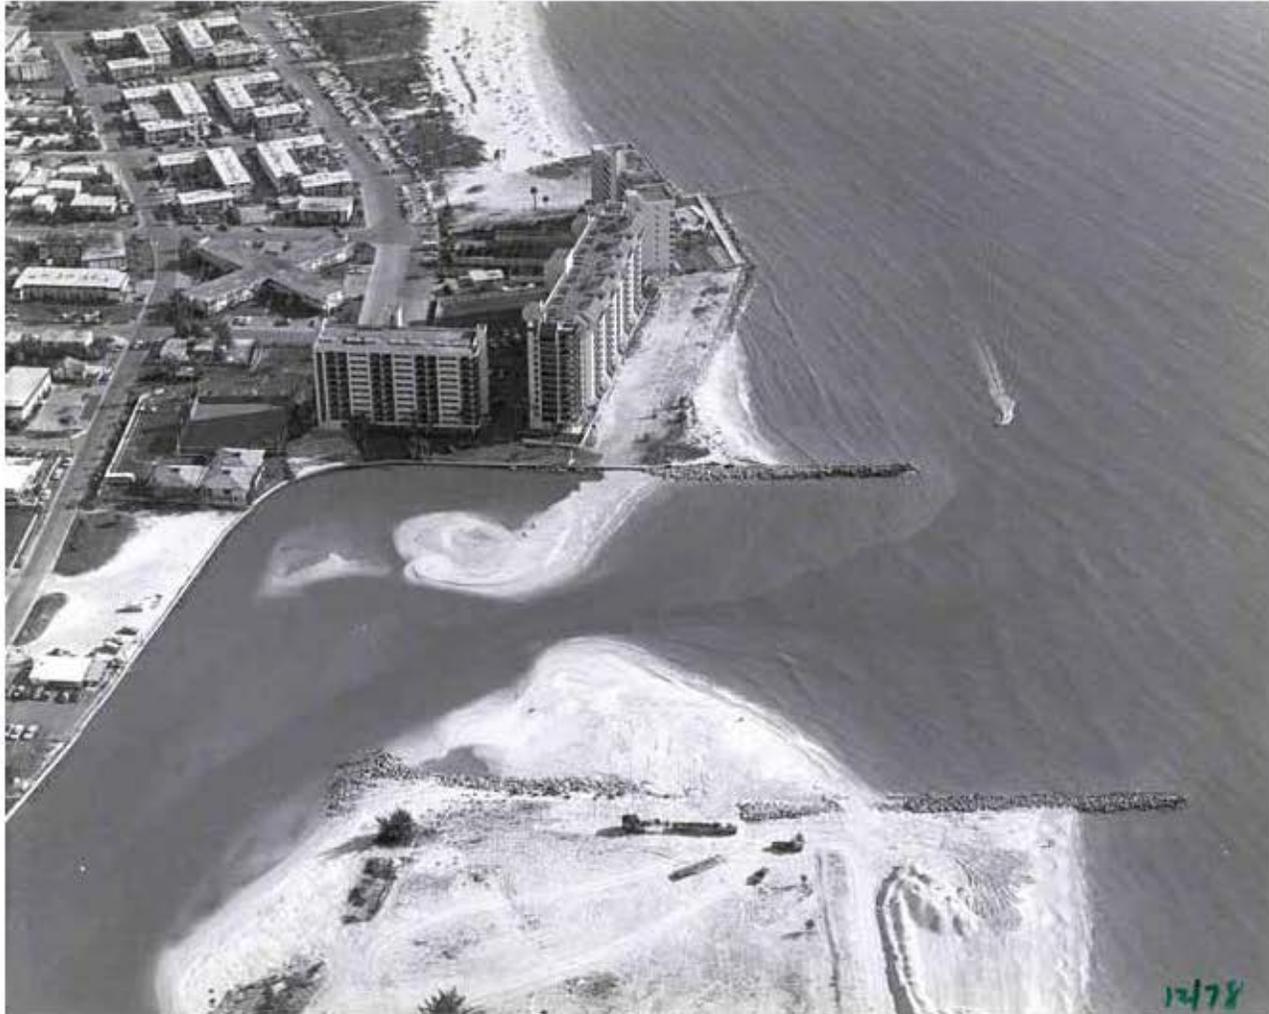
The U.S. Army Corps of Engineers began dredging Blind Pass in 1969. Jetty construction on both sides of the inlet continued. Despite these efforts, Blind Pass closed in 1978 due to shoaling (below).

After this shoaling, the jetties were raised, lengthened, and sand tightened. A detached breakwater was added to the south jetty in 1986. During the 1960's, 70's, and 80's, Blind Pass was dredged nearly every 2 ½ years. By the 1990's, the downdrift erosion at Upham Beach was seemingly unstoppable. Due to the large volumes of sand trapped by Blind Pass, the only sediment source for the downdrift beach was nourishment. Blind Pass was last dredged in 2000 and the next dredging is planned for 2009.

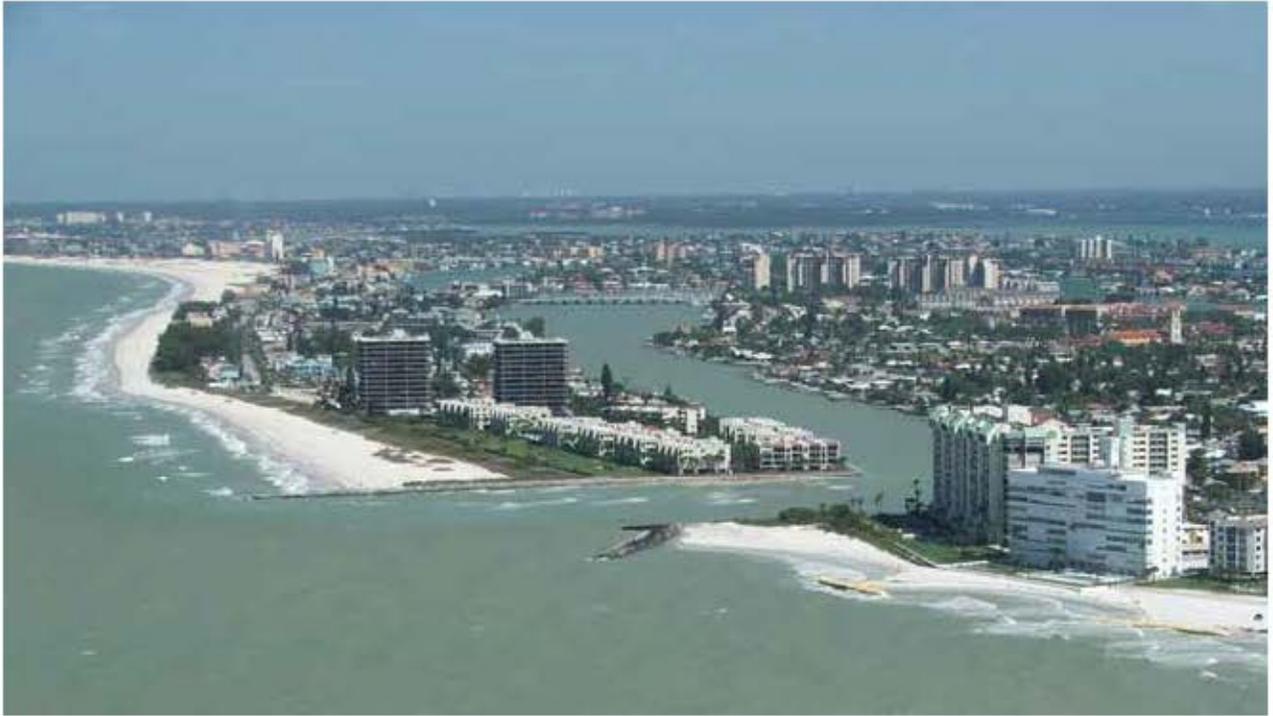
Since 1990, Blind Pass has only been dredged every 9 years. As a result, Blind Pass shoals considerably between dredging events, but remains navigable. Note the breaking waves in the inlet, which indicates shallow water, in the photo below. Hydrographic surveys conducted by the University of South Florida's Coastal Research Laboratory indicate that the ebb shoal has actually reformed. The ebb shoal serves to better protect Upham Beach from wave energy and should eventually allow for sediment bypassing around Blind Pass. This ebb shoal come-back suggests that reducing the dredging interval improved the morphology and functionality of Blind Pass.
