## Clearwater Beach Island Coastal Management History

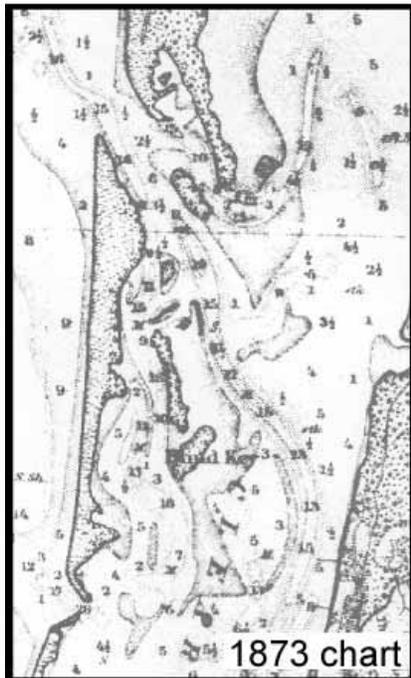
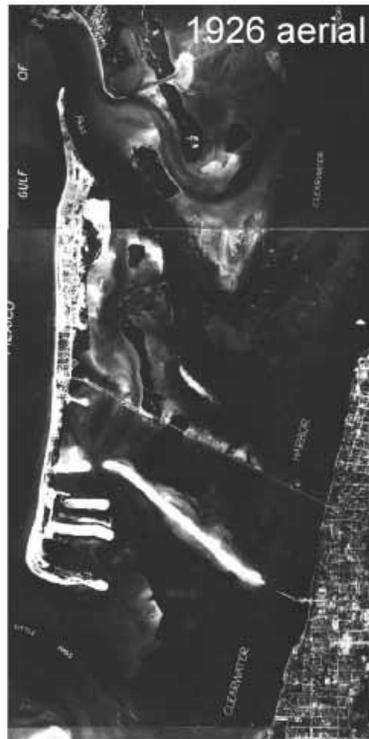
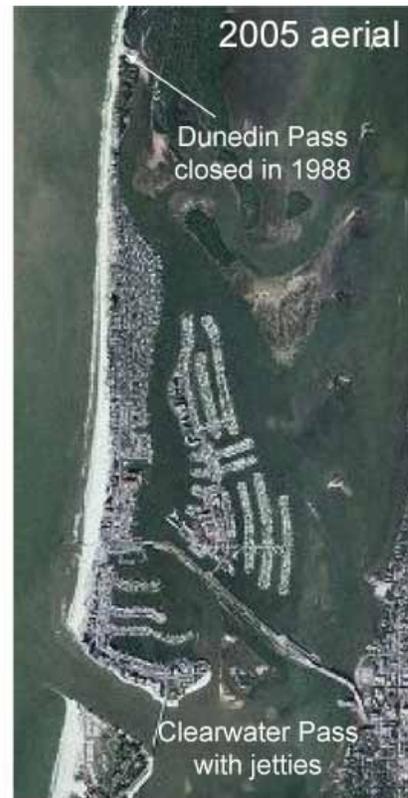
**Clearwater Beach** Island is now a highly developed barrier island that is a popular tourist destination. The photo sequence above illustrates the island's morphologic transformation over the last century. The morphologic changes were a result of closure of Dunedin Pass, the dramatic increase in width and subsequent stabilization of Clearwater Pass, and significant dredge-and-fill construction landward of the island.

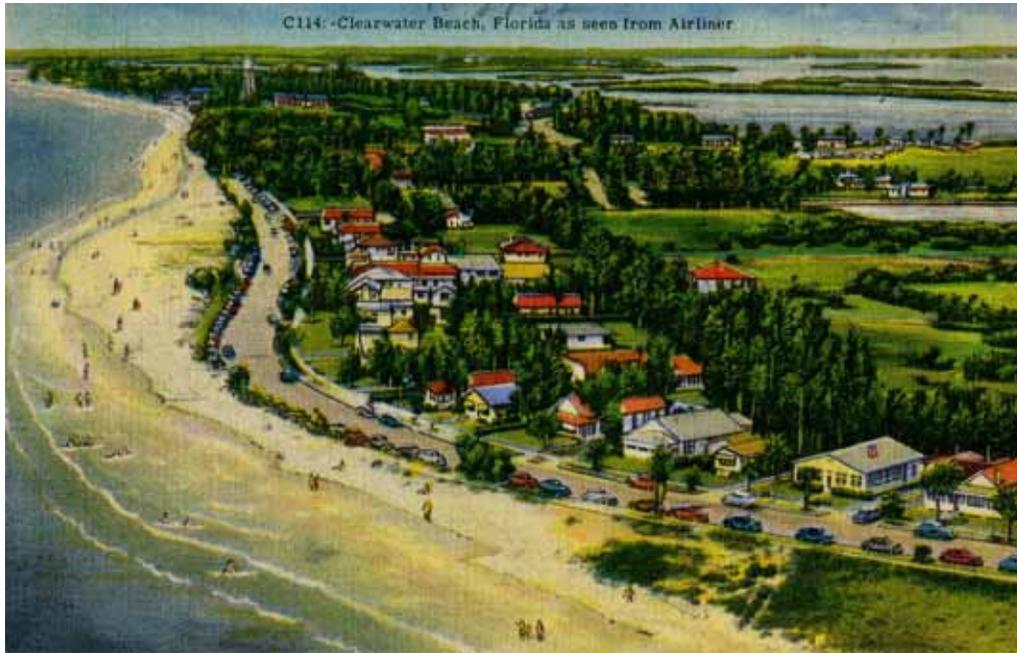
C114: -Clearwater Beach, Florida as seen from Airliner

Like many other coastal communities in the state of Florida, Clearwater Beach Island began to experience significant beach erosion in the 1950s. Unregulated coastal development, which included dredge-and-fill construction in the back barrier bays, led to this erosion. In 1950, the City of Clearwater restored the south beach and constructed two groins, as shown in this 1952 postcard.

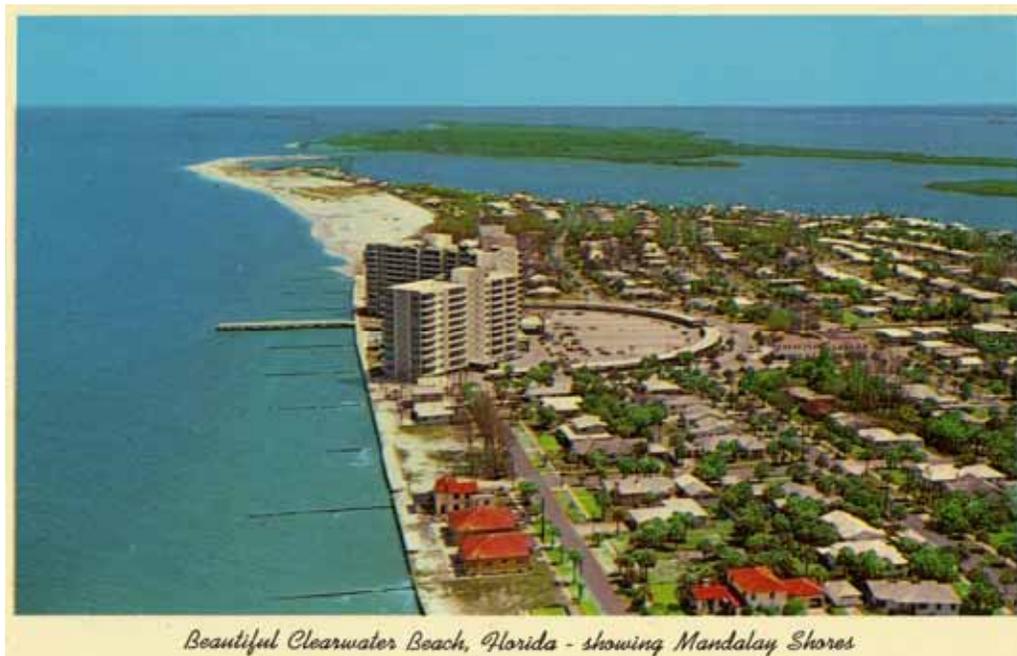
*Beautiful Clearwater Beach, Florida - showing Mandalay Shores*

By 1961, the city had built a total of 25 groins along the island including a short terminal groin at the south end of the island. The city also built two concrete-slab baffle piers, one of which fronts the Mandalay Condos, shown in this 1960 postcard image. Most of the length of the beach was lined with seawalls.

The photo below was taken at the end of September 2004, after the worst hurricanes in at least a decade. It illustrates that the beaches are significantly wider than in the 1960's, compare to this 1960 postcard above (same condo).

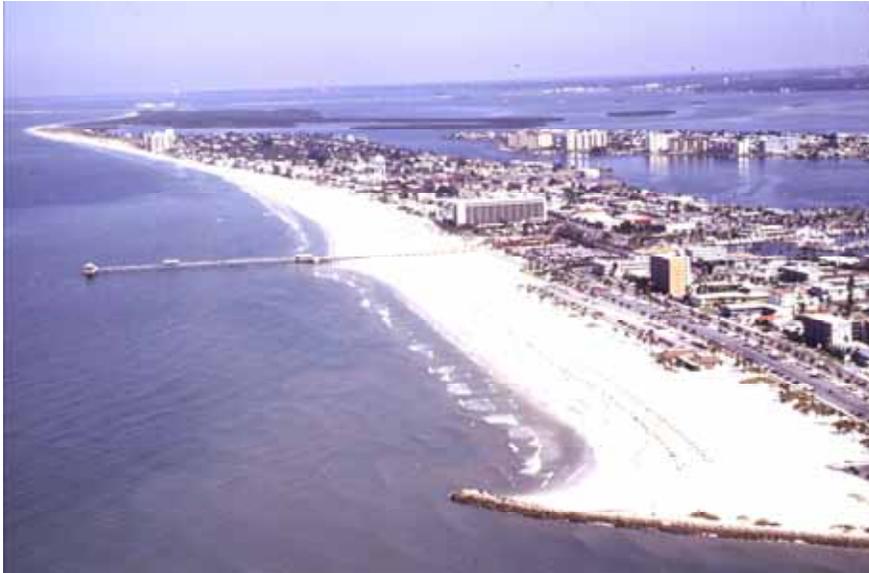
In the early 1980's, the city owned and operated its own small dredge. In 1982, the city extended the south groin into an 800-ft long curved jetty and nourished the south beach.

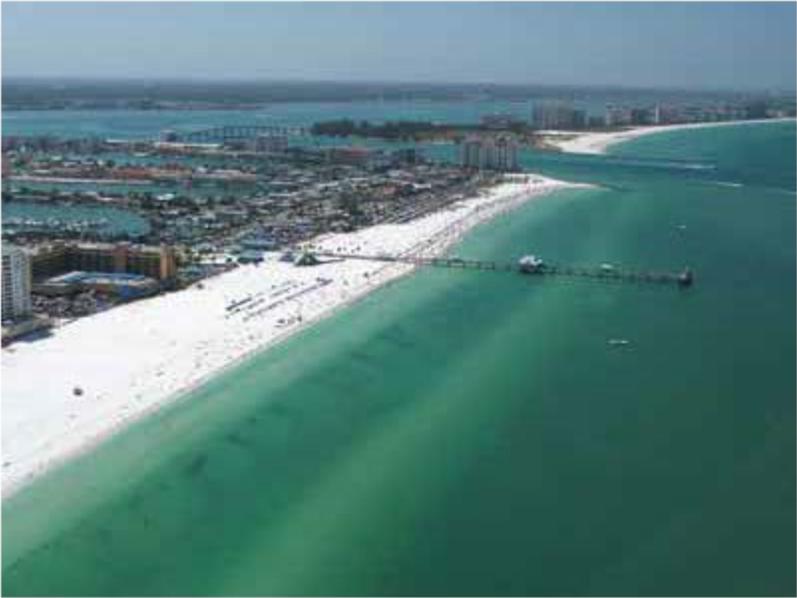
Thanks to the erosion control measures taken by the city, Clearwater Beach is now a beautiful fine white native sand beach that does not require nourishment. The photo below looks south along Clearwater Beach during the spring of 2006.
