## Clearwater Pass Coastal Management History

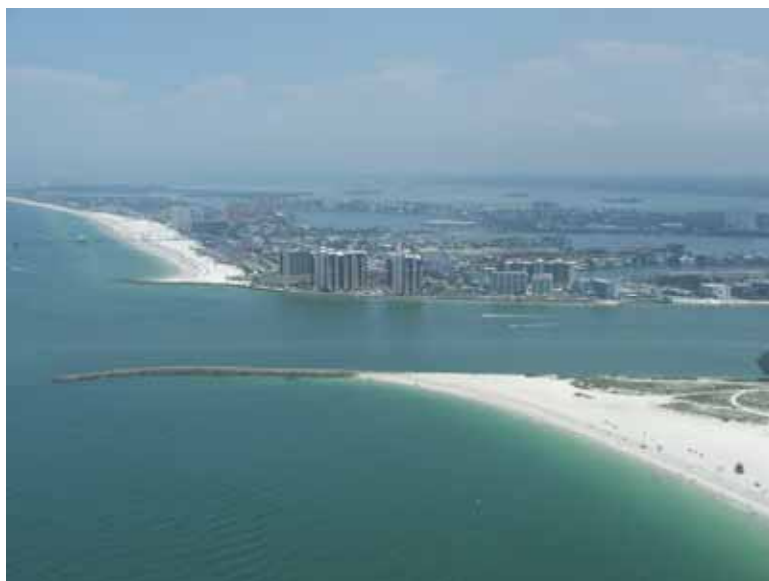
The photo below looks north at Clearwater Pass during the spring of 2005.

Known as Little Pass in the late 1800's, **Clearwater Pass** was only about 100 m wide. As a result of the hurricane of 1921, "Little Pass" increased to over ½ mile wide (see [Clearwater Beach Island](#)). From the 1930's to the 70's, the channel narrowed as it came back into equilibrium with the tidal prism. Clearwater Pass was being constricted by sediment input from the south as Sand Key extended to the north. As a result of this narrowing, the channel deepened to carry its large tidal prism. Between 1962 and 1973, the channel's depth increased from 10 to 20 ft. The existing bridge pilings began to scour at the base, threatening the structure. To stop further constriction, the ½ mile-long south jetty was completed in 1975 and successfully stabilized Clearwater Pass.
