# Management of a Beach Nourishment Project during the 2004 Hurricane Season

Nicole A. Elko

*Pinellas County, Department of Environmental Management  
512 S. Ft. Harrison Ave., Clearwater, FL 33756  
nelko@pinellascounty.org*

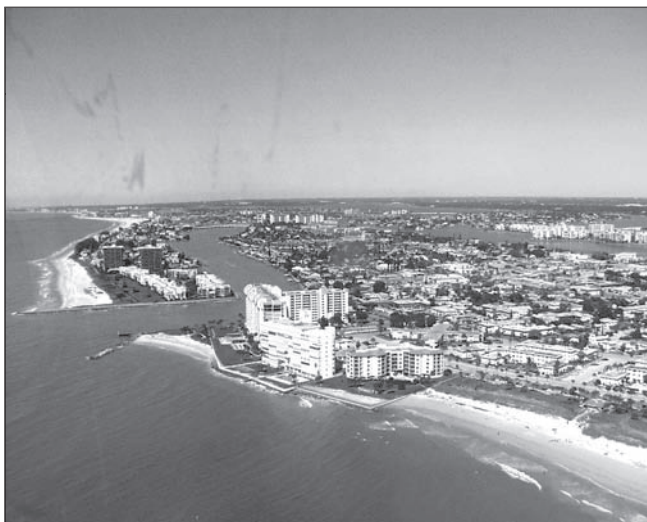
**Figure 2.** Aerial photo of Upham Beach in November 2003 prior to nourishment. Blind Pass is the tidal inlet with the most structural modifications on the west coast of Florida. Sunset Beach is in the background on the south end of Treasure Island.

Sunset Beach and Upham Beach are separated by Blind Pass (Figure 1). This wave-dominated tidal inlet has been stabilized with bulkhead-type seawalls and a weir jetty (Figure 2), resulting in the most structured inlet along Florida's west-central coast (Davis and Barnard, 2000). Blind Pass alternates as a borrow area for this nourishment project with other nearby sand sources, such as Pass-a-Grille Channel, the tidal inlet on the south end of Long Key, which was the borrow area for the 2004 project. Blind Pass was utilized as the borrow area in 1980, 1991, and 2000. Pass-a-Grille Channel and the ebb-tidal delta were last used as a borrow area in 1986 (USACE, 1999). Pass-a-Grille Beach is located at the south

collapsing and migrating onshore, creating an abnormally wide beach. Once Upham Beach was no longer protected from wave energy by the ebb delta, erosion began to dominate this region. Upham Beach now forms a headland with the condos and seawall in an advanced seaward position (Figure 2).

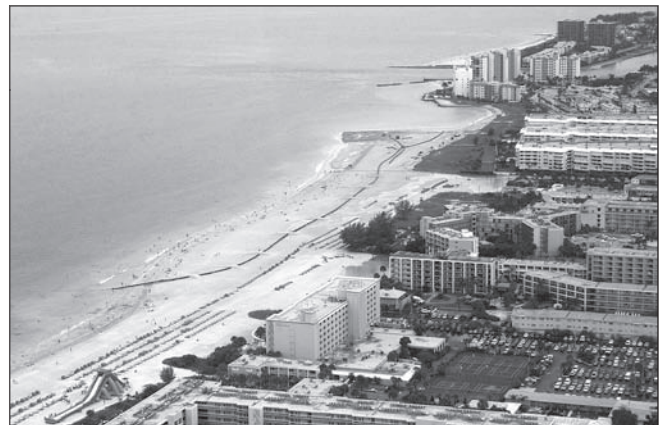
**Figure 3.** Photo of Upham Beach nourishment on July 28, 2004, looking north, illustrating the direction of fill placement from south to north.

An ambitious field-monitoring program was initiated prior to the 2004 nourishment construction with the goal of understanding and quantifying the processes governing immediate post-nourishment project performance. The field study was also intended to support future management decisions. Of course, the impact of four hurricanes was not anticipated, but was an interesting addition to the field study. Beach profiles were surveyed before, during, and immediately after construction such that the "post-nourishment" surveys for profiles on the south end of the project (where fill placement began) were measured on a different date than those for the northern profiles (Figure 3).

The Long Key (Upham Beach) portion of the federal nourishment project began on July 7 and was completed on Sept. 1, 2004. The project supplied an unprecedented amount of material, approximately 280,000 cubic meters of sediment (40 percent more than the previous nourishment in 2000), to the northernmost 1 kilometer of the 7-kilometer-long barrier island. Sediment was excavated from the Pass-a-Grille Channel borrow area, 6 kilometers to the south, with a cutterhead suction dredge. The sand was pumped to the nourishment areas through a submerged pipeline located approximately 600 meters offshore. The contractor, Norfolk Dredging Company, placed the fill from south to north, in the opposite direction of littoral drift (Figure 3).

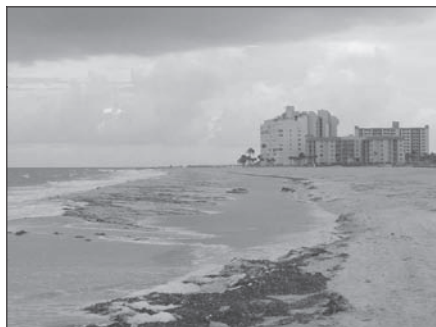
**Figure 5. Photo of Upham Beach on Aug. 15, 2004, looking north, illustrating a spit that formed to the south from the widest portion of the nourished planform. The spit is outlined with a dashed line.**

Several weeks after project construction began, weekly survey data indicated the formation of a large inter- to supra-tidal spit in the center of the nourishment project. The feature extended over 300 meters and resembled a spit elongating from the taper of the widest portion of the planform. The shoreline advanced 8 meters on average as the spit developed to a maximum elevation of 1.4 meters. The spit was first surveyed on Aug. 11, 2004, it persisted through the passage of Hurricane Charley, and then it was dispersed during the passage of Hurricane Frances in early September. The spit was composed primarily of coarse, shelly sand (Figure 5). This spit was likely the product of longshore transport of the nourished sediment, which had a mean grain size of 0.5 millimeters. Then, a selective transport process transported the coarse, shelly fraction onshore and the fine fraction offshore.

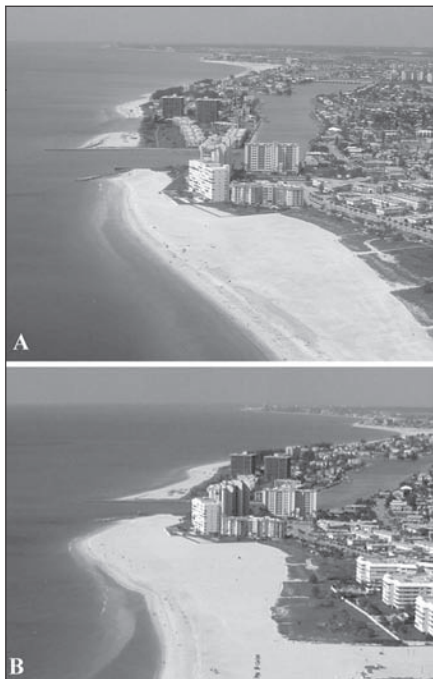
**Figure 6. Aerial photos of Upham Beach (A) on Oct. 6, 2004, after the passage of Jeanne and (B) on Nov. 16, 2004, after the hurricane repair nourishment was complete. Comparison to Figure 4 illustrates that the post-nourishment shoreline (Sept. 1, 2004) extended from the north jetty.**

The fill on Upham Beach lost an additional 20 meters of shoreline (Figure 4, Figure 6A), for a remarkable total of 60 meters during the month of September. The recently placed fill on the south end of Sunset Beach also lost up to 20 meters of shoreline during the passage of Jeanne. Dune erosion exposed walkovers and sprinkler systems along the northern segment of this project, which had no fill in place prior to the storm (Figure 7A). A slightly higher intensity or longer duration storm would have likely undermined some of the infrastructure along the Sunset Beach portion of the project. In addition, Pass-a-Grille Beach continued to erode, enduring up to 20 meters of shoreline and dune recession during the hurricane season (Figure 8A, B).

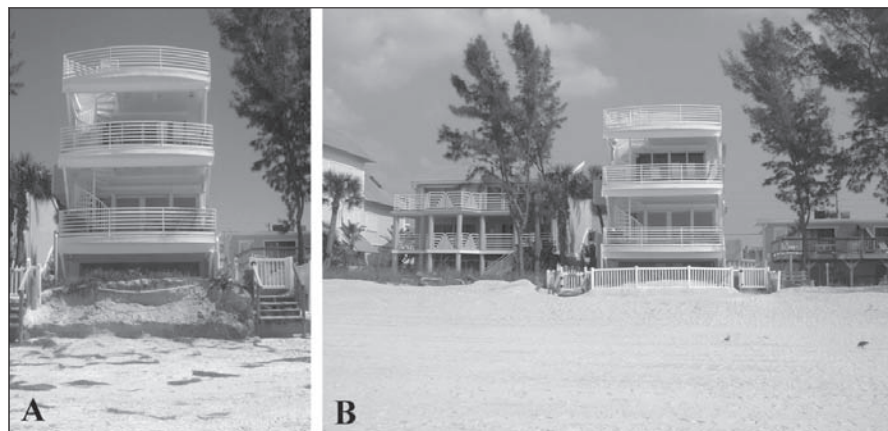
**Figure 7. The north segment of the Sunset Beach nourishment project (A) on Oct. 2, 2004, after the passage of Jeanne and (B) on Oct. 29, 2004, after nourishment.**

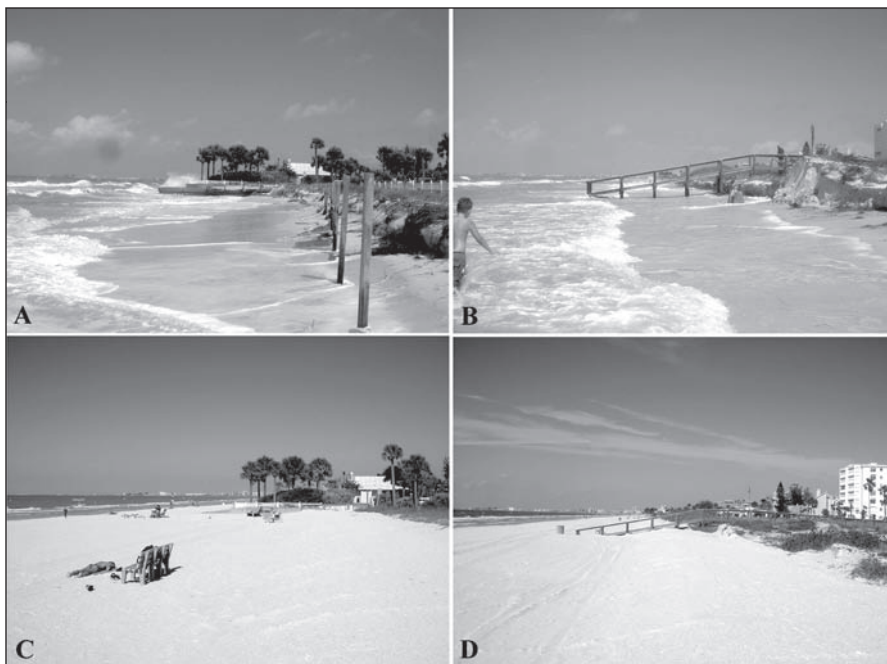
**Figure 8. Pass-a-Grille Beach (A) and (B) on Sept. 27, 2004 after the passage of Jeanne and (C) and (D) the same locations on Dec. 19, 2004, after emergency nourishment.**
