Implementation of Geotextile T-Groins in Pinellas County, Florida

Nicole A. Elko, Ph.D.

Douglas W. Mann, P.E.

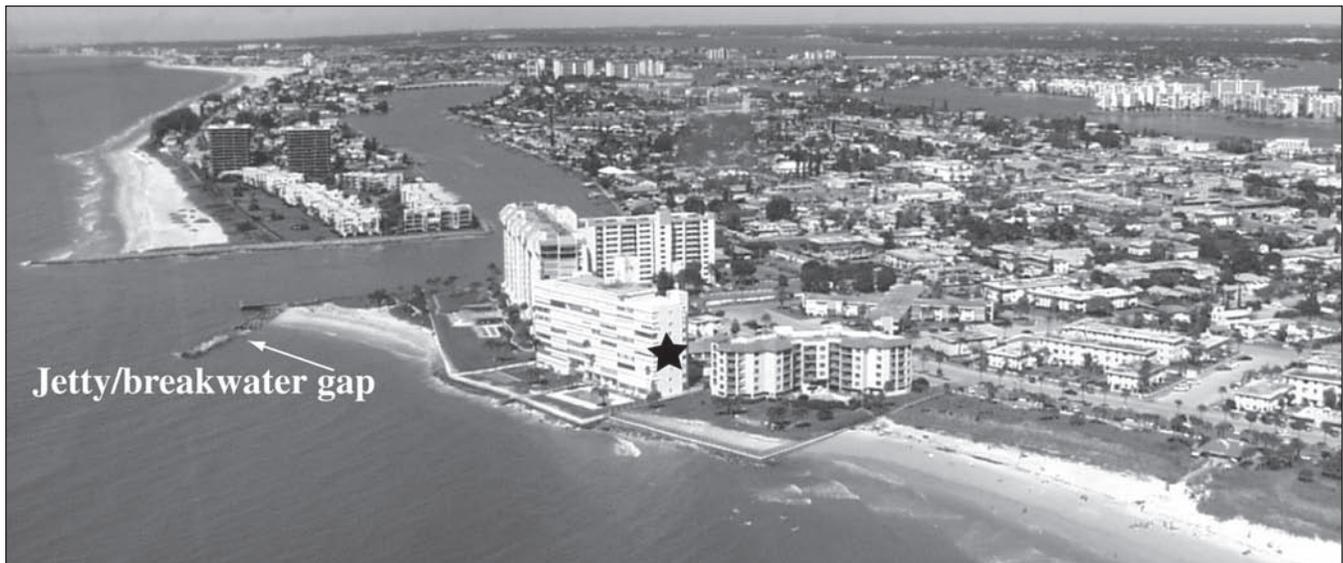
Figure 2. Oblique aerial photo looking north at Upham Beach and Blind Pass in October 2003, illustrates the typical condition of the project area prior to T-groin installation. Note the gap between the southern Blind Pass jetty and the detached breakwater. The condominium with the star housed the Argus video camera on its roof.

and is bordered on the north by Blind Pass. In the project area, net annual littoral drift is from north to south. Figure 2 illustrates the former, typical condition of Upham Beach and Blind Pass. Upham Beach is sediment starved due to the combined effect of sediment trapping by the Blind Pass jetties, a minimal ebb shoal, and periodic dredging of the inlet. Thus, sediment bypassing around Blind Pass to Upham Beach has been largely eliminated (Davis 1989; CPE 1992). The only sediment supplied to Upham Beach is via beach nourishment. If nourishment did not occur, the sand deficit in the littoral system at the project site would result in an unstable downdrift shoreline that would threaten development and public infrastructure.

After construction of the 1996 Upham Beach nourishment project, an early model of an Argus video station (Aarninkhof and Holman 1999) was installed on the roof of a high-rise condominium on the north end of the island (Figure 2). Due to the rapid post-nourishment erosion rates, the site was chosen as a proof-of-concept test of video for monitoring nourishment project evolution. This unique methodology provided nearly continuous high-resolution video images of the relatively short project area. By comparing video- and survey-derived shorelines, video methodology was verified as a worthy complement to traditional beach profiles for post-nourishment monitoring (Elko *et al.* 2005). Viewing to the south, snapshot images were taken hourly for 18 months, from 10 October 1996 to 13 April 1998 (Figure 3).

Continued nourishment of Upham Beach will be required for the foreseeable future. Closure of Blind Pass would likely achieve natural, continual bypassing, but pass closure is not an option. Interference with the feeder beach could threaten the stability of the downdrift shoreline which is an unarmored, commercial area. Understandably, the property owners on the north end of Long Key were concerned that no beach existed seaward of their property for the majority of the duration between nourishment projects. This is due, in part, to the advanced-seaward position of the condominiums relative to the line of construction to the south (Figure 2).

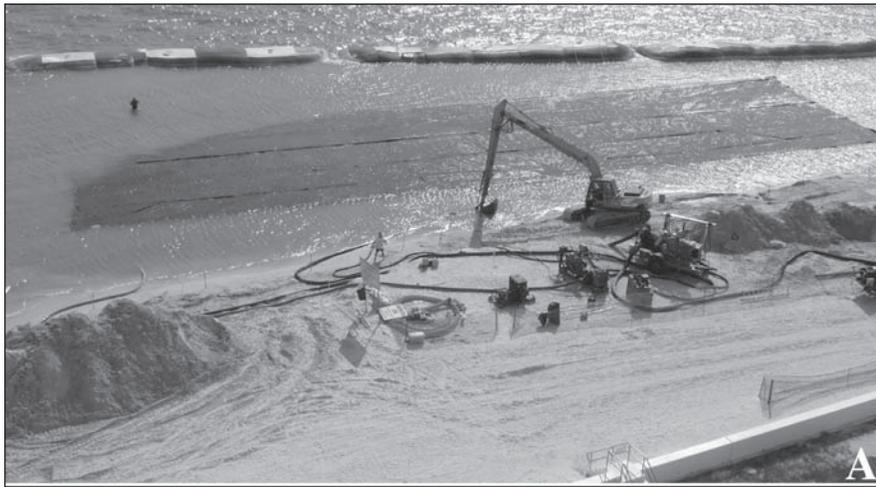
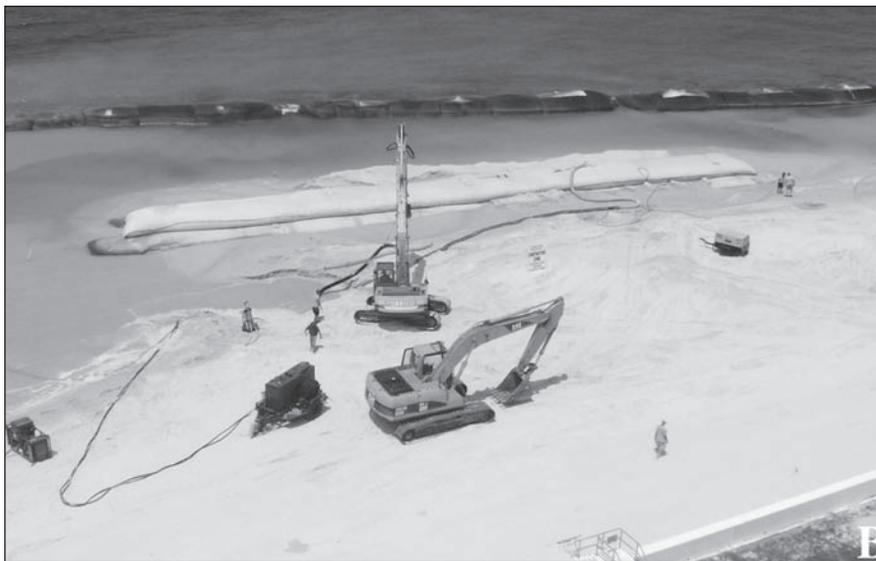
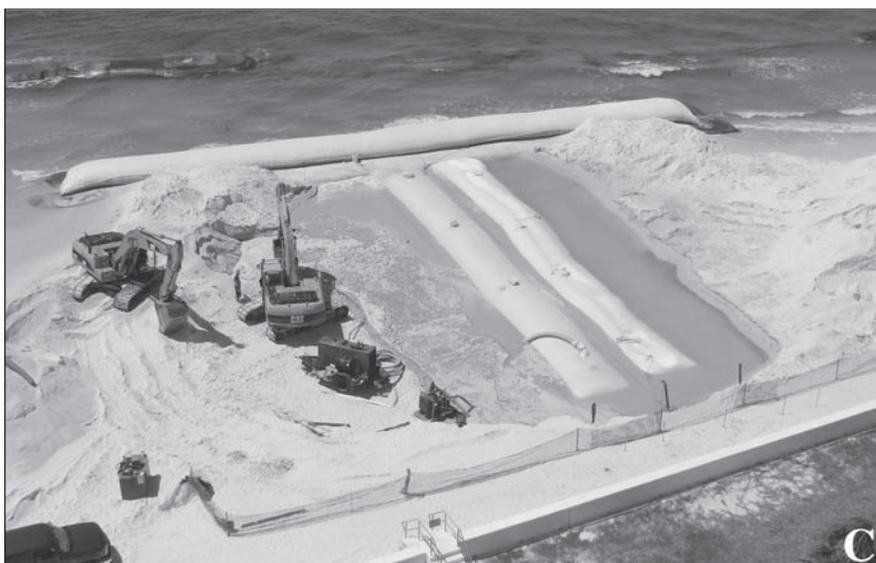
Figure 7. Construction of the first T-head on: A) 19 April 2005, B) 16 June 2005, and C) 13 September 2005.

tion of the highest wave energy in Pinellas County. Rapid erosion following the 2004 nourishment reduced the beach width at the northernmost T-groin location. When placing geotubes or the base “scour apron” layers (Figure 7A), calm water conditions are desired. A set of black, temporary geotubes were installed seaward of the work area, to act as a cofferdam or breakwater, in an attempt to achieve calm water conditions. The temporary geotubes were slashed and deflated by vandals in February 2005. After this vandalism incident, the cofferdam could not be rebuilt in the correct configuration. Consequently, excavation of this single section took four months and the scour apron was not installed until April 2005. The cofferdam was continuously overtopped by wave energy, carrying sand into the work area. This was a problem both during excavation and during geotube placement. Sand that washed into the work area had to be removed by hand in order to place the next geotube. The last geotube of the first T-head structure was finally installed in June 2005 (Figure 7B).

successful construction method. With the northern section of beach shored up, the contractor installed the remaining T-groins before returning to complete the shore-perpendicular portion of the first T-groin in September 2005 (Figure 7C).

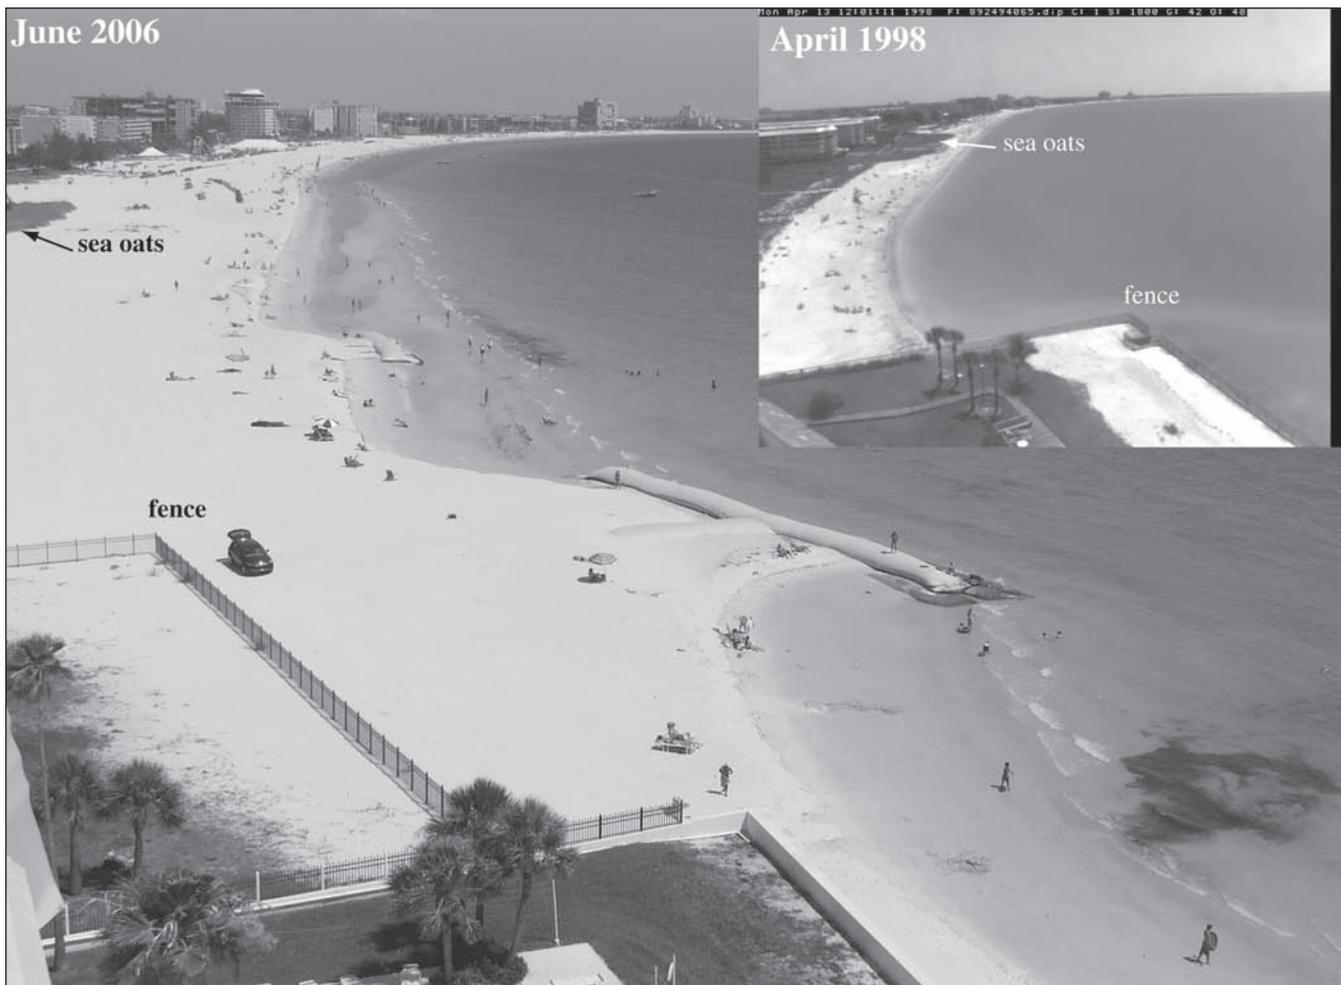
Figure 8. Photos taken from the roof of one of the condominiums 22 months after the 1996 and 2004 nourishment projects. Note the wide beach stabilized by the T-groins in front of the fence and sea oats in 2006 as compared to 1998.

tative results are promising as illustrated by photos taken 22 months after the 1996 and 2004 nourishment projects (Figure 8). The inset is the last image from the sequence in Figure 3. Twenty-two months after the 1996 nourishment, 83 percent of the fill had eroded (Elko *et al.* 2005). Twenty-two months after the 2004 nourishment, the T-groins were maintaining a substantial beach in front of the fence as compared to 1998. The fifth T-groin is not yet exposed and the sea oats and buried seawall are fronted by a wide beach as a result of the advance downdrift mitigation.

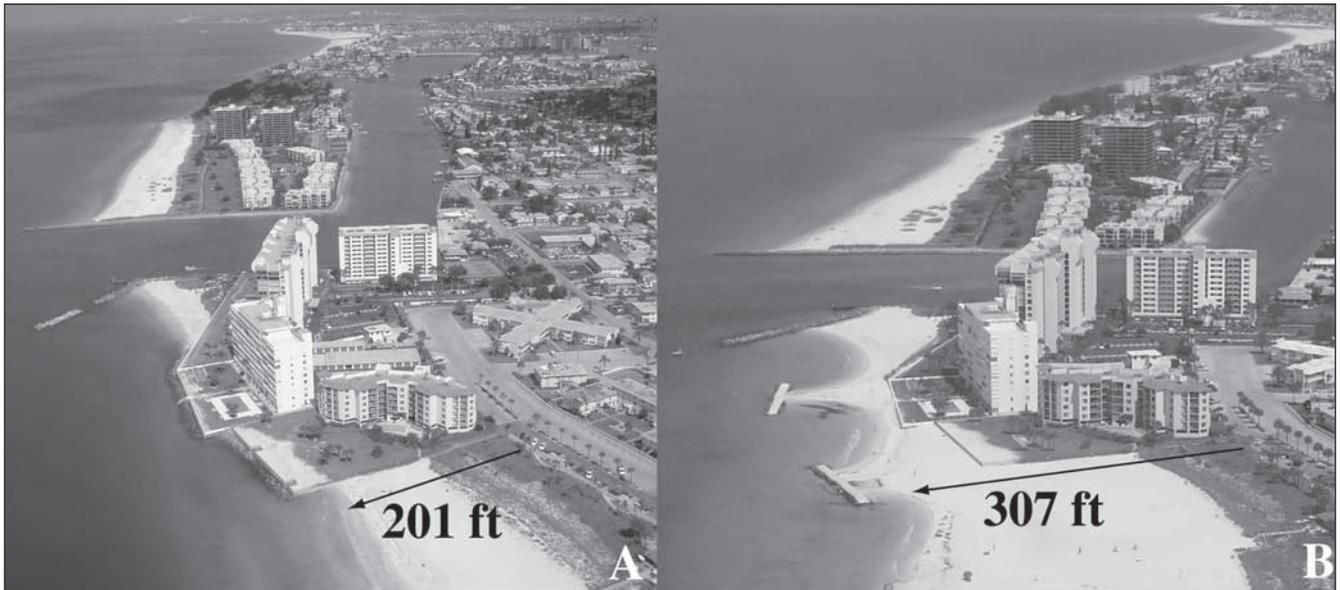
Figure 9. Aerial photos taken two years after the 2000 and 2004 nourishment projects in: A) October 2002 and B) August 2006. Survey data indicate that the beach is now over 100 ft wider than it was two years after the 2000 project.

Aerial photos comparing Upham Beach two years after the 2000 and 2004 projects also show positive qualitative results (Figure 9). Two years after nourishment, all of the fill would normally erode from in front of the northern seawall. Presently, the T-groins have stabilized this beach. Beach widths measured from survey data indicate that in 2006 the beach at the public park is over 100 ft wider than it was in 2002.

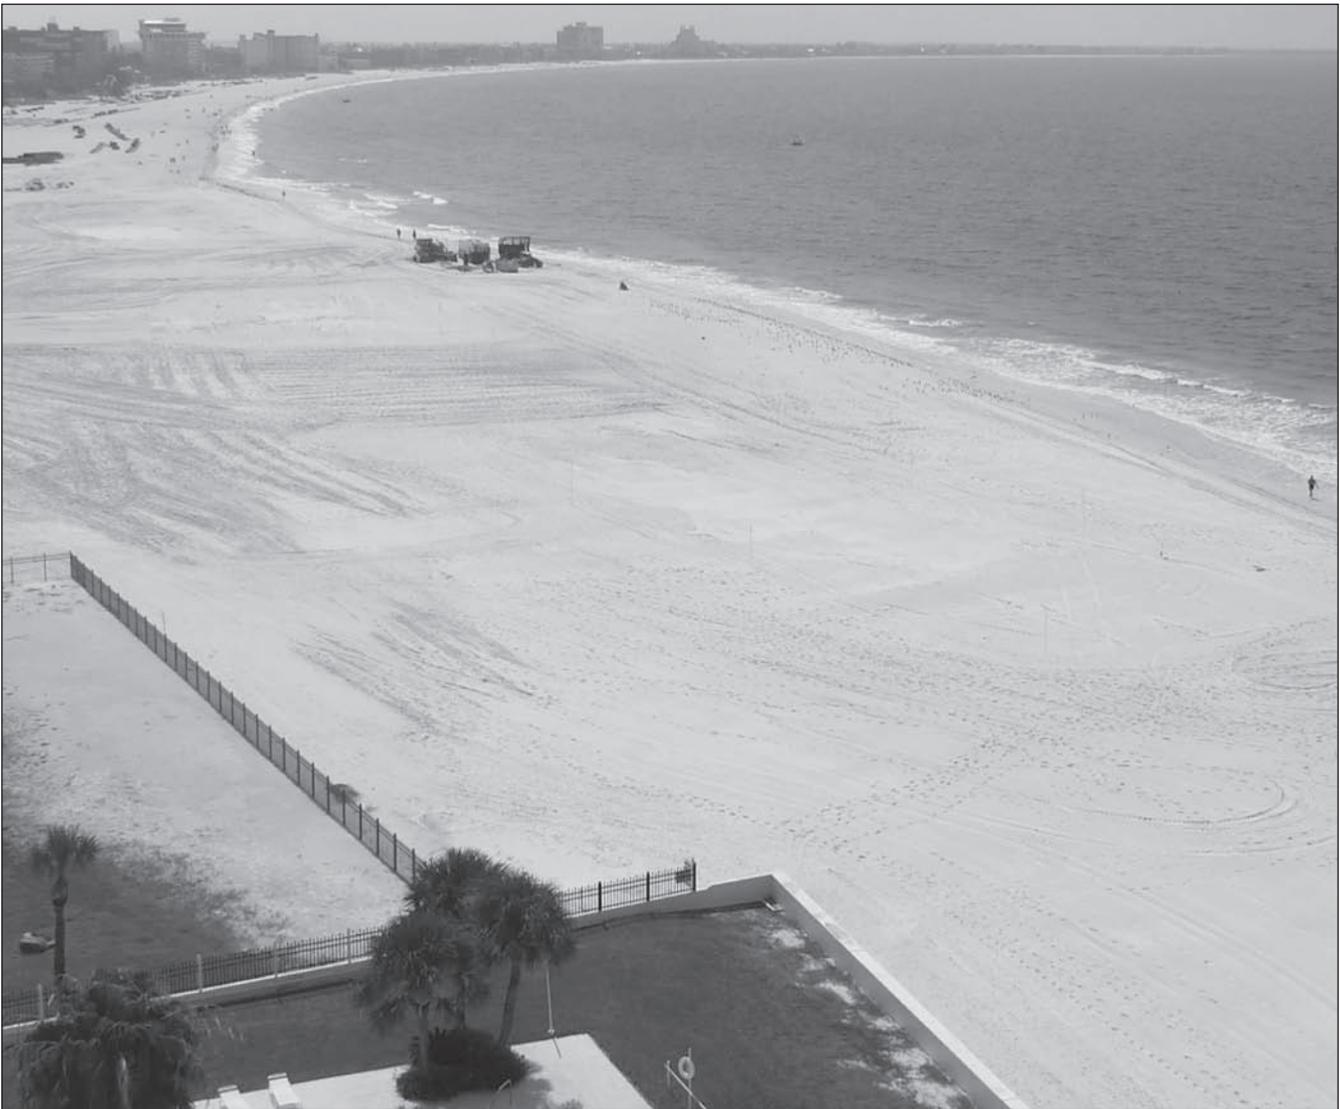
Figure 10. Recently renourished beach in September 2006 (compare to Figure 8). The T-groins are buried and are expected to become exposed gradually as the feeder beach erodes.

Upham Beach qualified for federal emergency rehabilitation funding due to damage that occurred during the 2005 hurricane season. Sediment that eroded during 2005 was replaced in September 2006. This interim nourishment was conducted independent of the T-groin project. At the time of publication, the T-groins were completely buried within the recently-placed fill (Figure 10). Detailed physical monitoring will continue as the beach erodes and the structures eventually become exposed again. Pinellas County is planning for the structures to remain intact throughout this nourishment interval and to be covered again during the upcoming 2009 project. Depending on the performance, another permit application for similar rock structures may be submitted in the future.
