**UPHAM BEACH STABILIZATION PROJECT**  
**STRUCTURAL ALTERNATIVES DEVELOPMENT AND ANALYSIS REPORT**

**Coastal Planning & Engineering, Inc.**

**January 2010**

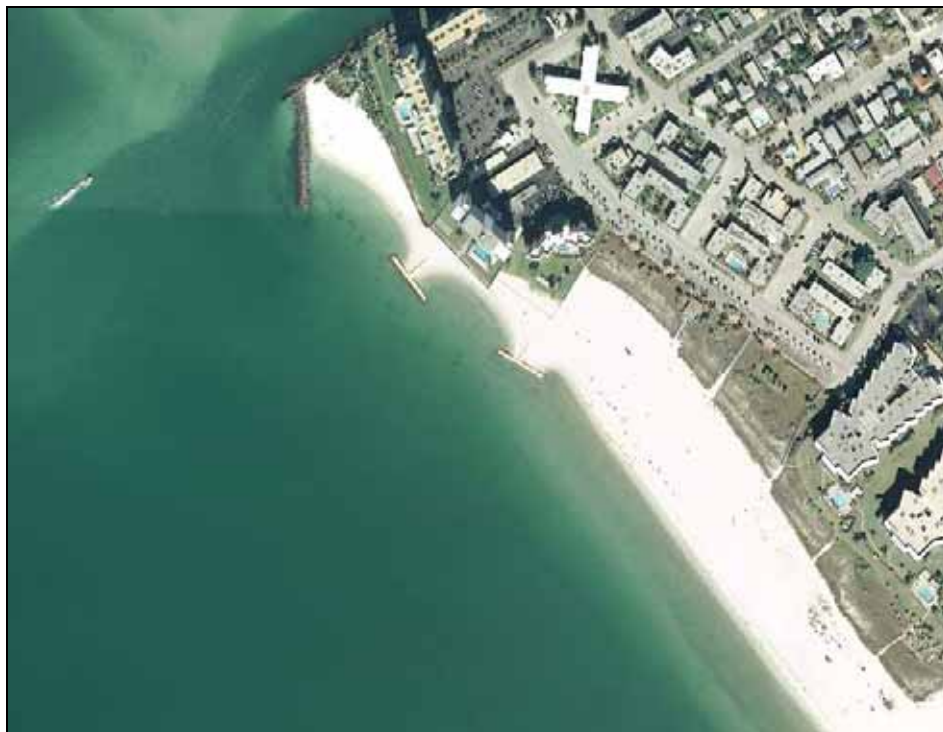
Five experimental geotextile groins (geotubes) were installed along the Upham Beach shoreline in 2005/06 to mitigate for the rapid and persistent erosion. The temporary groins were used to test the stabilization of Upham Beach and the reduction of nourishment needs and to evaluate the potential for adverse downdrift impacts. They were generally spaced evenly alongshore from benchmark LK1B south to benchmark LK5 and were buried by beach fill in September 2006. The existing structures exposed as of January 2008 are shown in Figure 2.

**Figure 2. January 2008 aerial photograph of Upham Beach.**

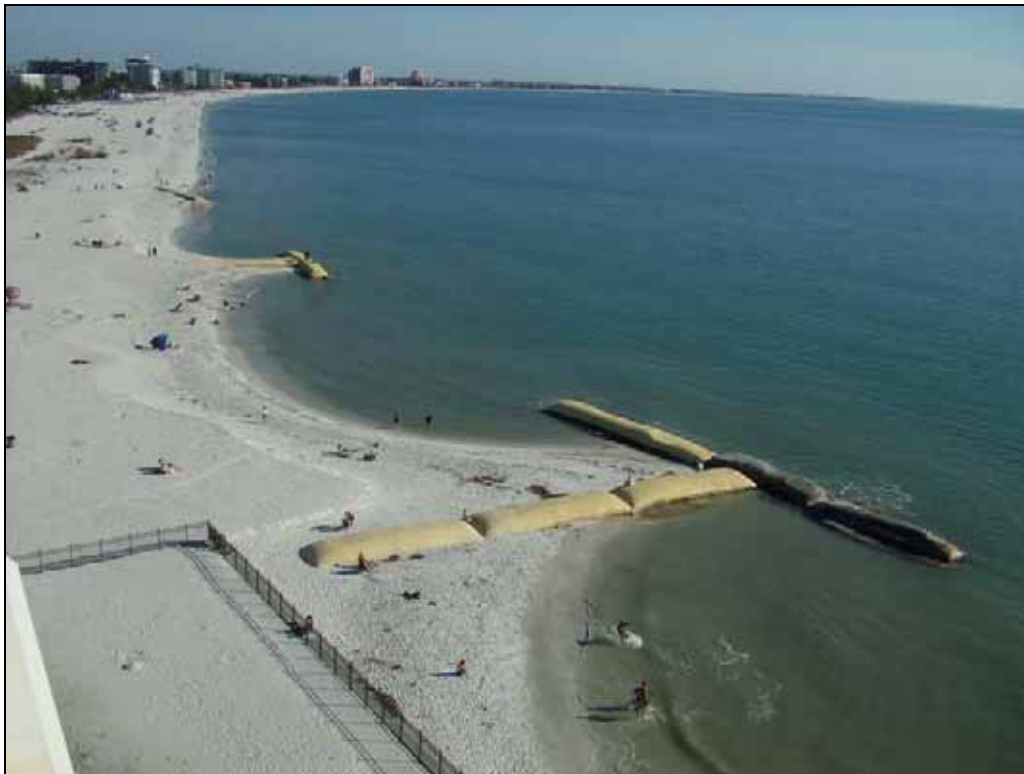
Performance monitoring by USF and observations of local upland property owners concur that the temporary structures have been beneficial to slowing erosion and maintaining a wide beach. A photograph of the beach taken in February 2009 is shown in Figure 3 looking south from atop of the Starlight Tower condominium near the north end of the project area. The photograph illustrates the local shoreline response between the structures and shows the lack of downdrift erosion, which evidenced by the straight shoreline of the beaches to the south.

**Figure 3. Experimental geotube T-groins in February 2009.**

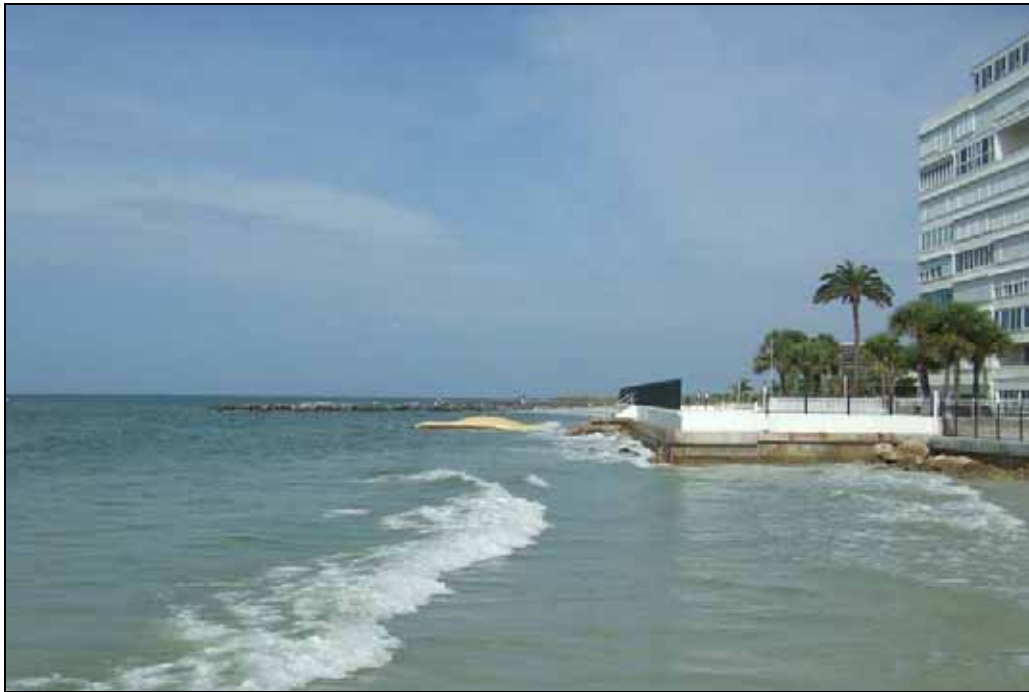
The northernmost T-groin has sustained significant damage since its installation due to vandalism and/or natural forces and is not longer holding sand as originally designed (Figure 4). However, in areas where the experimental geotubes remain intact, the beach is wide and stable as shown in Figure 5. The stability of the beach is further evidenced by the growth of pioneer vegetation that would not have occurred without installation of the structures. The existing experimental design is shown in Figure 6, with the groins labeled T1 through T5 for reference. The alternatives developed for the study are shown in Figures 7-10 and are described below.

**Figure 4. Damaged northernmost T-groin in October 2009.**

It is also recommended that the existing geotubes be repaired in conjunction with the upcoming nourishment project to retain sand until the permanent structures can be installed. In doing so, the County may wish to modify the existing permit to test a new configuration as part of the selected alternative. Currently, T1 and T2 are damaged and could be repaired with the modifications developed for Alternative 2. Including all the changes of Alternative 2 would require complete removal of T3 and T4 with the re-installation of one structure in the modified location, which has additional cost implications associated with moving/replacing the geotubes.

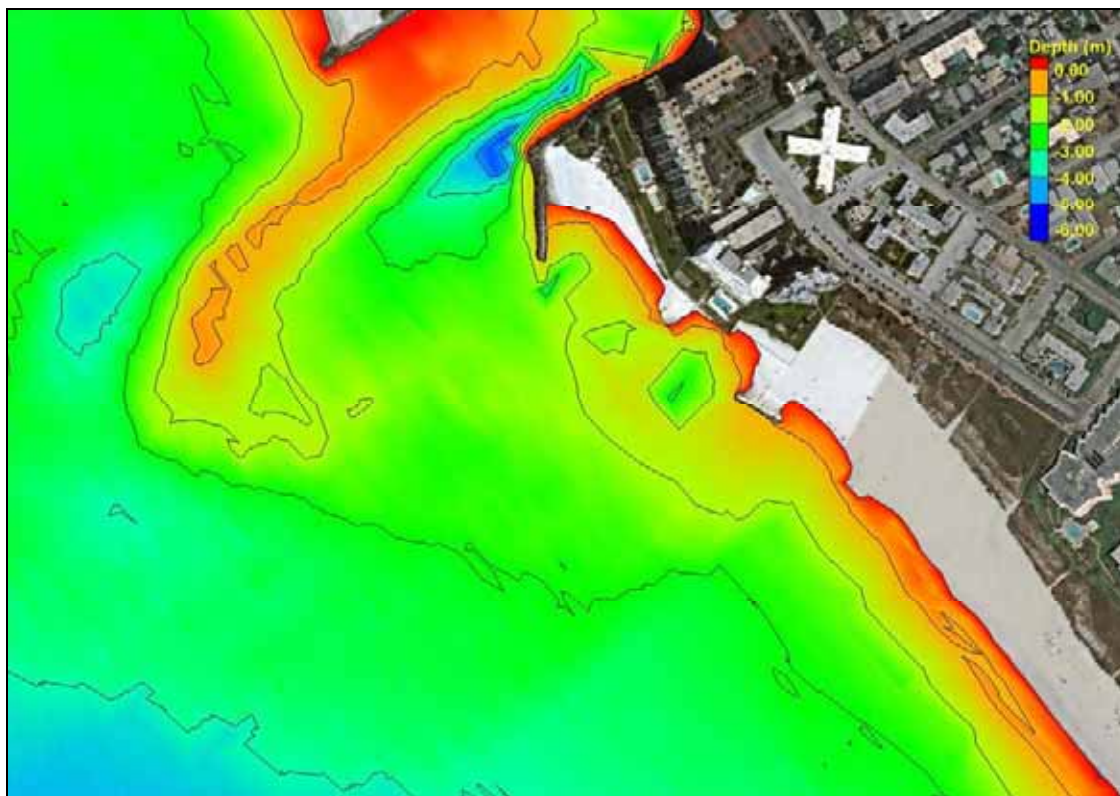
Various sources of bathymetric data were compiled for use in the model. For the verification analysis, the USACE 2004 LIDAR data were used to represent the pre-project condition. The Post-Wilma 2006 LIDAR data were used to represent the conditions after installation of the geotube groins. For production runs, bathymetries were compiled by merging different data sets to create “Existing Conditions” bathymetry. The goal was to obtain recent conditions that represent 2008/2009 bathymetric features. The final bathymetry was composed from 2009 USF profiles, USACE October 2008 data sets, supplemented with the 2006 Post Wilma LIDAR data. The data sets were merged in chronological order and priority. Figure 11 shows the final bathymetry in the project area. Additional details on the bathymetric data can be found in Appendix B.

**Figure 11. 2009 bathymetry for numerical model.**

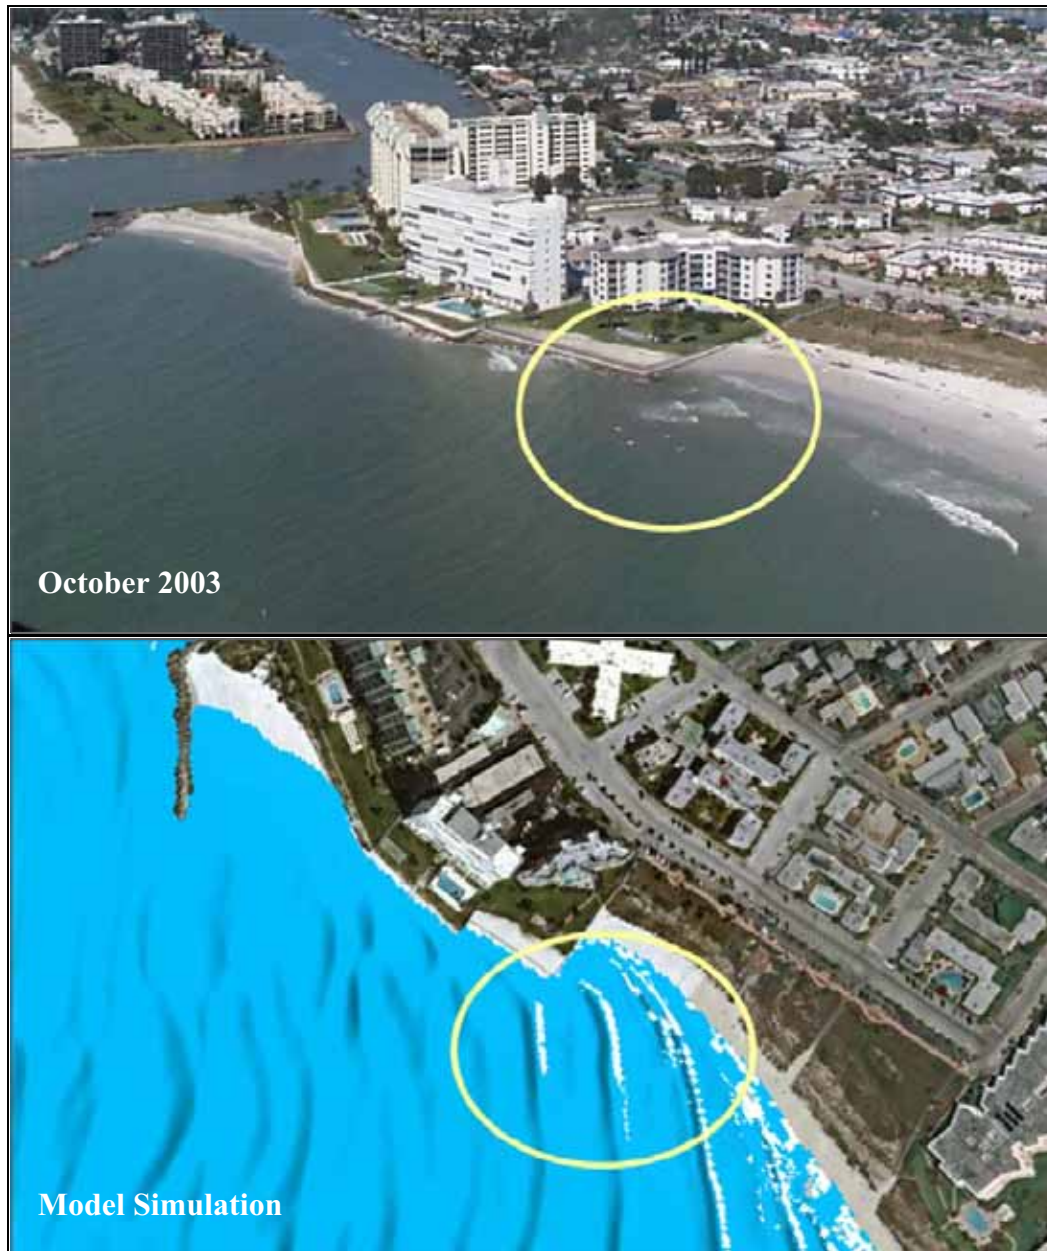
The results showed that the model closely simulated the observed breaking wave patterns and features. Model results compared to conditions observed in an October 2003 aerial are shown in Figure 12. In addition, the 2006 condition after installation of the geotubes was also well

**Figure 12. Comparison of simulated and observed breaking wave conditions.**

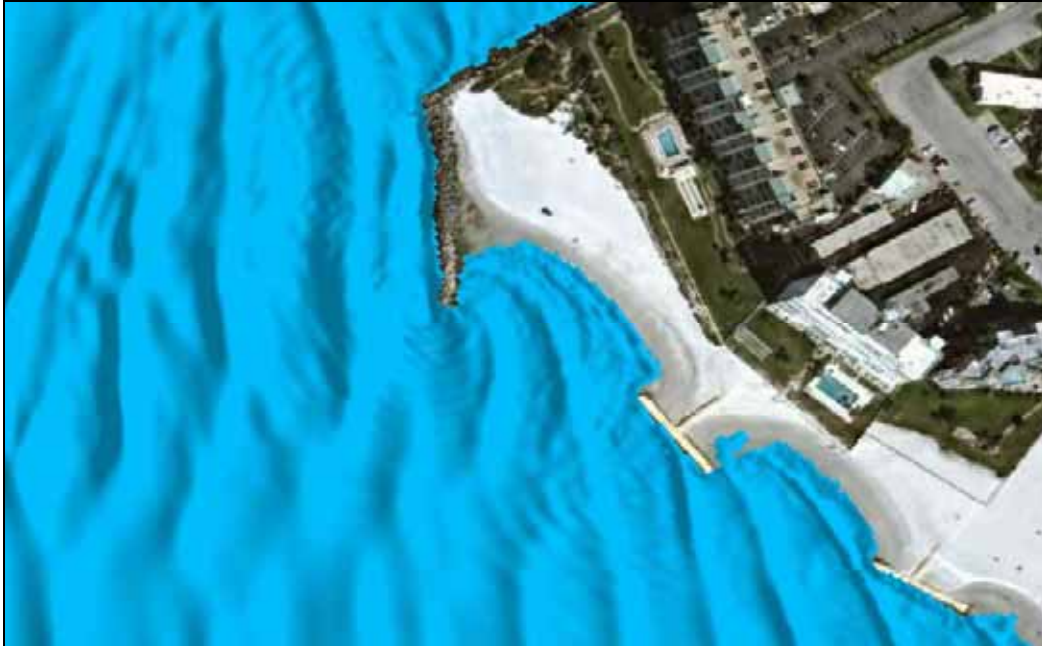
represented and reproduced the reported effects of the structures, such as wave reflection shown in Figure 13. Further discussion on the verification is provided in the appendices to this report.

**Figure 13. Observed wave refraction from structures represented in model results.**

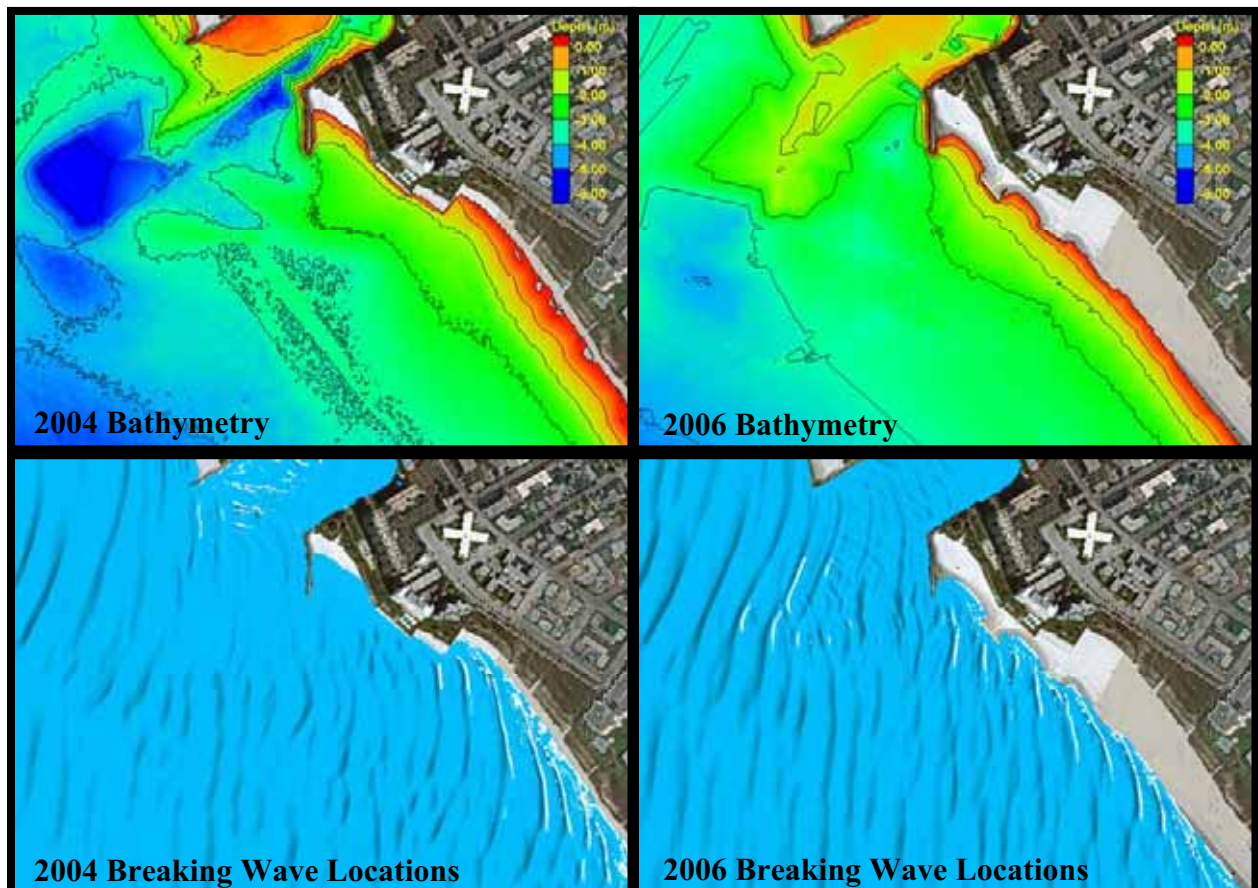
In comparing the 2004 and 2006 bathymetries, the ebb shoal development was shown to affect wave quality at Upham Beach. In 2004, waves were able to propagate to the beach without breaking due to the lack of a developed ebb shoal. With the re-growth of the shoal by 2006, waves were found to be influenced to the point of breaking further offshore than the preferred surfing location shown in Figure 12. The comparisons of the 2004 vs. 2006 bathymetry and breaking wave conditions are shown in Figure 14.

**Figure 14. Comparisons of the 2004 vs. 2006 bathymetry and breaking wave locations.**

2. The ebb shoal offshore of Blind Pass affects wave energy and surfing conditions at Upham Beach. Wave height and surface elevation simulations from the numerical model show that wave breaking and refraction occurs in response to the shoal. Bathymetric surveys show that shoal has been reforming since at least 2006, which has resulted in reduced wave energy and less organized waves reaching the beach. It is also evident from the model that waves reaching the nearshore surfzone are further affected by the presence of the existing geotubes.

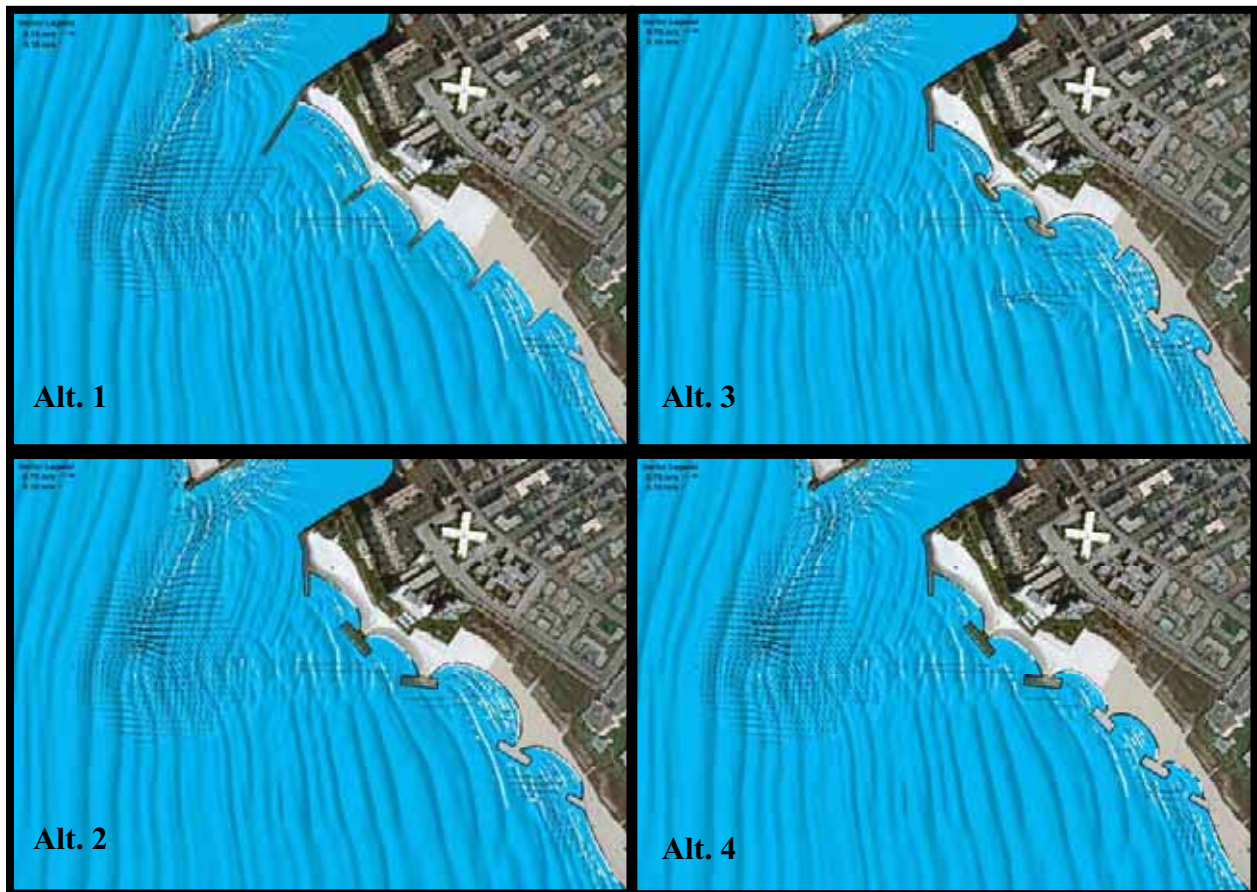
The alternatives analysis was conducted to evaluate how modifications to the existing design could affect performance and surfing impacts. In general, the results showed that T1 and T2 can be modified slightly to increase beach width at north end and that modifying groin field and/or installing an artificial reef would alter the surfing conditions. The result could be positive or negative to surfing depending on the actual modification and various opinions of local surfers. An example of the model results illustrating breaking waves and surface currents from wave case Cold Front A(b) are shown for each alternative in Figure 16. The details of each modeling run are described in the appendices to this report.

**Figure 16. Example breaking wave results from model alternatives analysis.**
