Field Trip, Step 5

Upham Beach

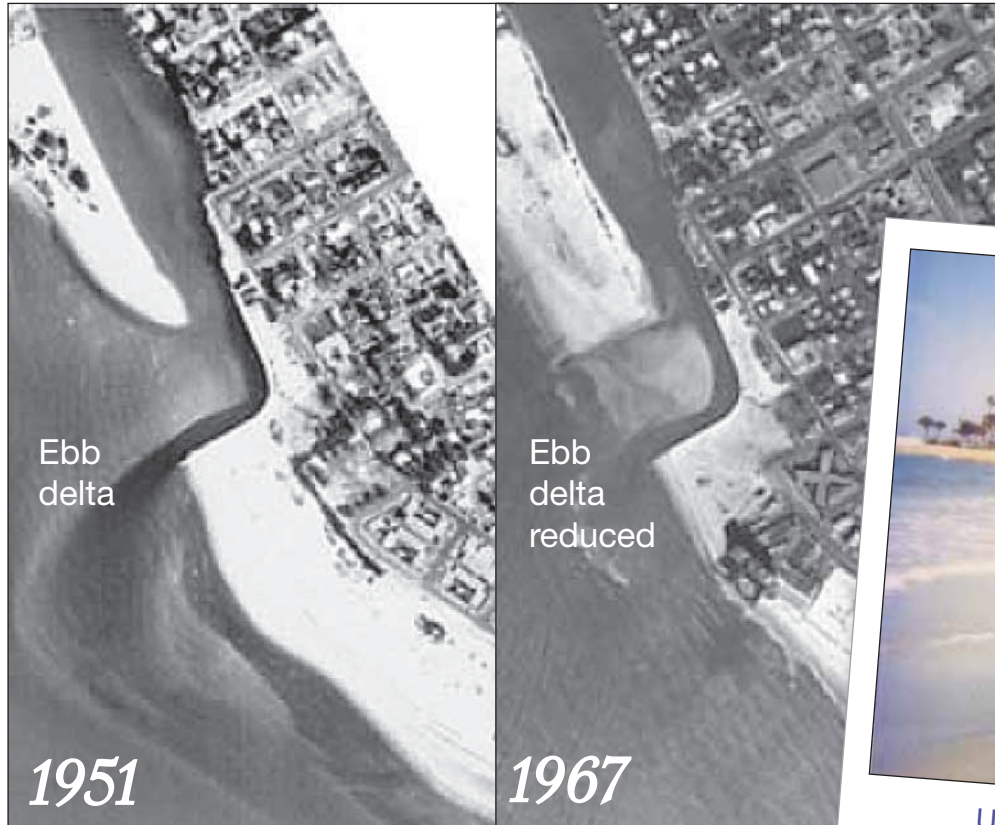
Ebb delta

Ebb delta reduced

1951

1967

Blind Pass in 1951 and 1967 illustrating the collapse of the ebb shoal and the unregulated coastal development south of the inlet

This beach was privately owned by William W. Upham but was donated to local government in a possible act of foresight in 1954 and is now called Upham Beach. During the 1950s, Upham Beach was wide and stable due to onshore sediment transport as the ebb delta collapsed and migrated onshore. No coastal construction control line building regulations existed at the time and condos were built on the beach. Due to this poorly located construction, erosion problems were imminent. Once the sediment source from the collapsing ebb shoal disappeared, erosion began to plague this region.

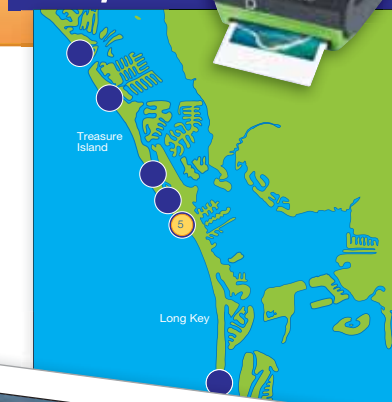
Upham Beach and Blind Pass in 2006 with newly installed geotextile T-head groins (erosion control structures)

Upham Beach has been considered a “feeder beach” by the U.S. Army Corps of Engineers. When nourished sand erodes from Upham Beach, it is transported to the south, thereby feeding the beaches along the rest of the island. In an effort to slow the erosion at Upham Beach, the Geotextile T-Head Groin Project was constructed in 2006. The project design included nourishment with over 320,000 cubic yards of sand, five geotextile T-head groins, and the closing of the jetty/breakwater gap on the south side of Blind Pass. The goal of the project was to maintain a 40-foot-wide beach while avoiding downdrift erosion of the pre-construction beach (Elko and Mann, 2005). The groins were intended to maintain the beach, increase the interval between nourishment projects and allow for the use of Blind Pass as the lone sediment source for future nourishment projects.

The University of South Florida Geology Department has monitored the performance of the T-head groins since the 2006 renourishment project. From 2006 to 2008, Upham Beach lost nearly 40 percent less sand than during the same period of time following nourishment from 2000 to 2002 (Wang and Roberts, 2009). Based on 31 months of monthly monitoring, no negative impact from the T-head groin field to the downdrift beach has been identified. Thanks to the T-head groins, only 200,000 cubic yards of sand will be required for renourishment in 2009 thereby saving significant public funds.

Focus on structures
UPHAM BEACH GEOTEXTILE T-HEAD GROINS
 Date of original construction: 2006
 Initial cost: \$1.5 million
 Constructed by: Pinellas County
 Present length: five structures ranging from 100 to 310 feet long with 100- to 170-foot-long T-head groins

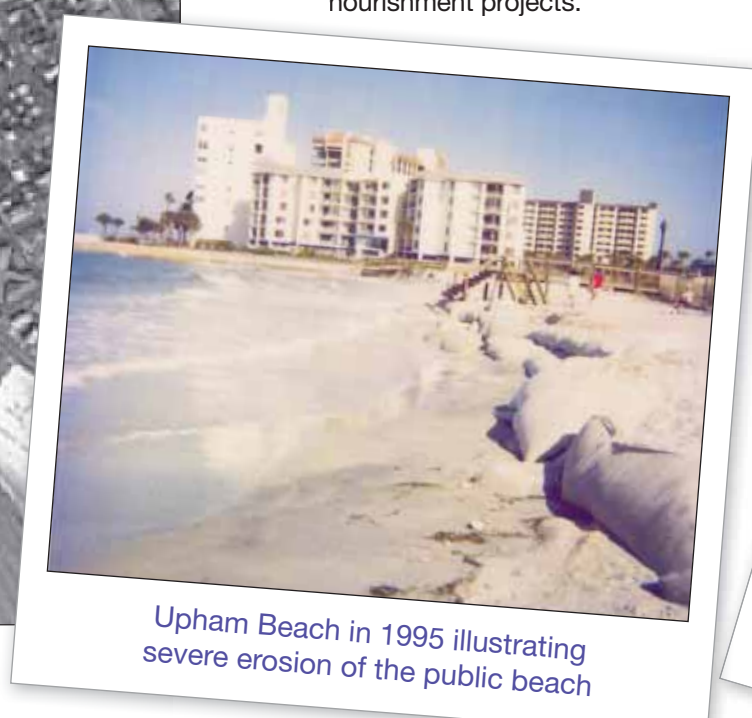
Upham Beach in 1995 illustrating severe erosion of the public beach

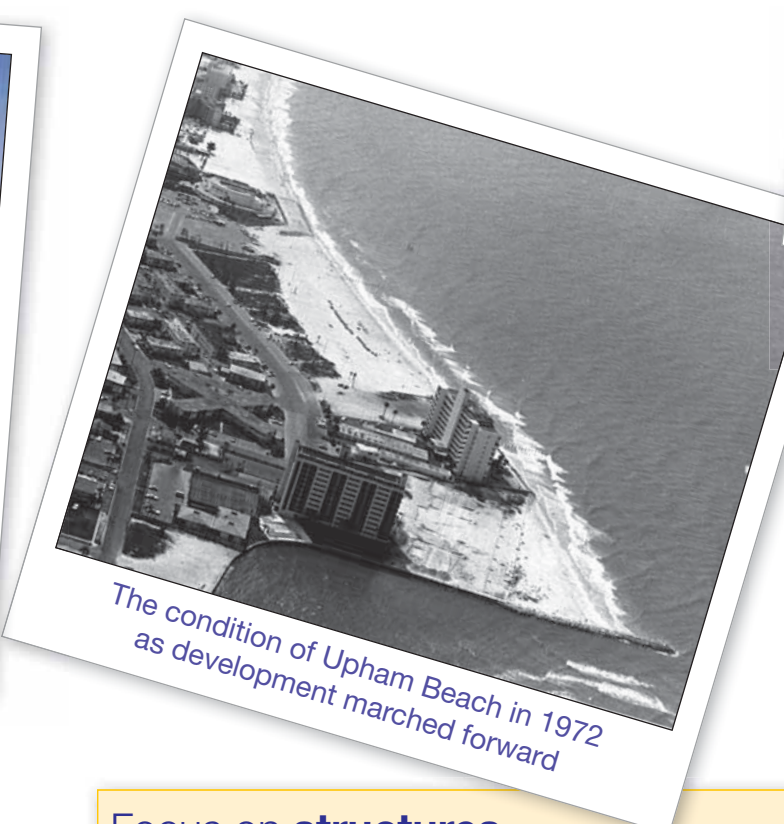
The condition of Upham Beach in 1972 as development marched forward
