St Joseph Sound & Clearwater Harbor

Status of the Seagrass Resource

Presented by:
Kris Kaufman, SWFWMD
Cynthia Meyer, PCDEM

30 March 2007

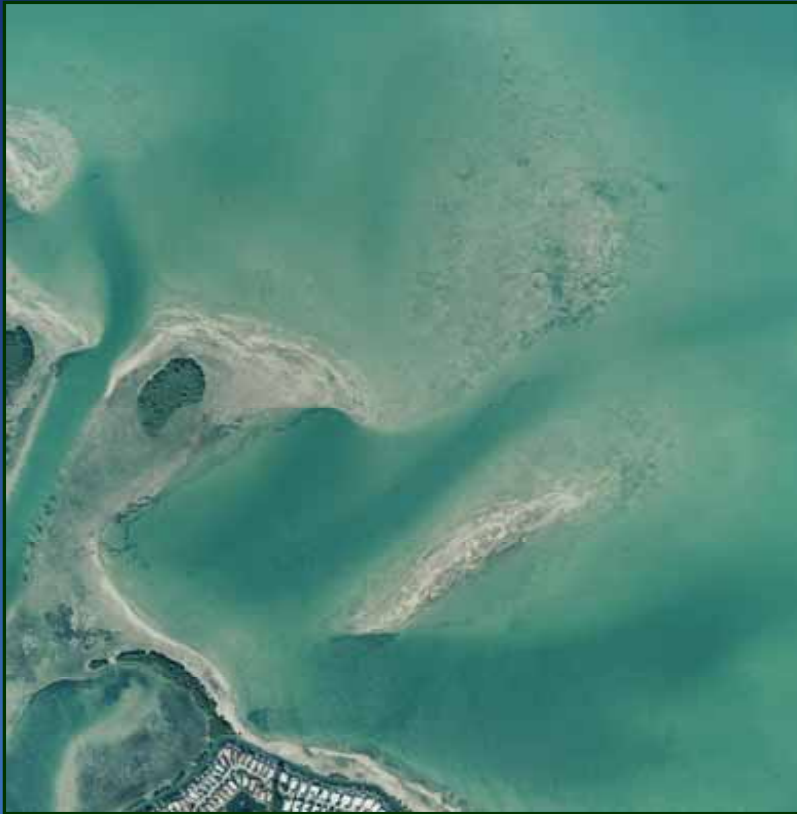
2004 Traditional True Color Film

**520 images acquired
2 ft GSD (pixel resolution)
8 Bit**

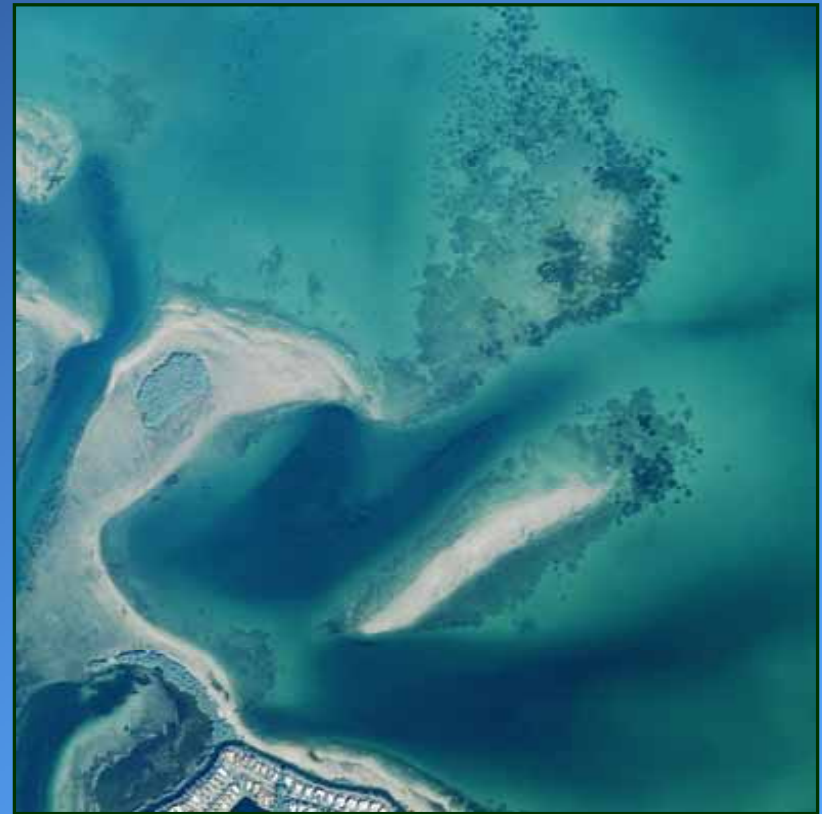
2006 Direct Digital Imagery

**2,000 images acquired
1 ft GSD (pixel resolution)
12 Bit**

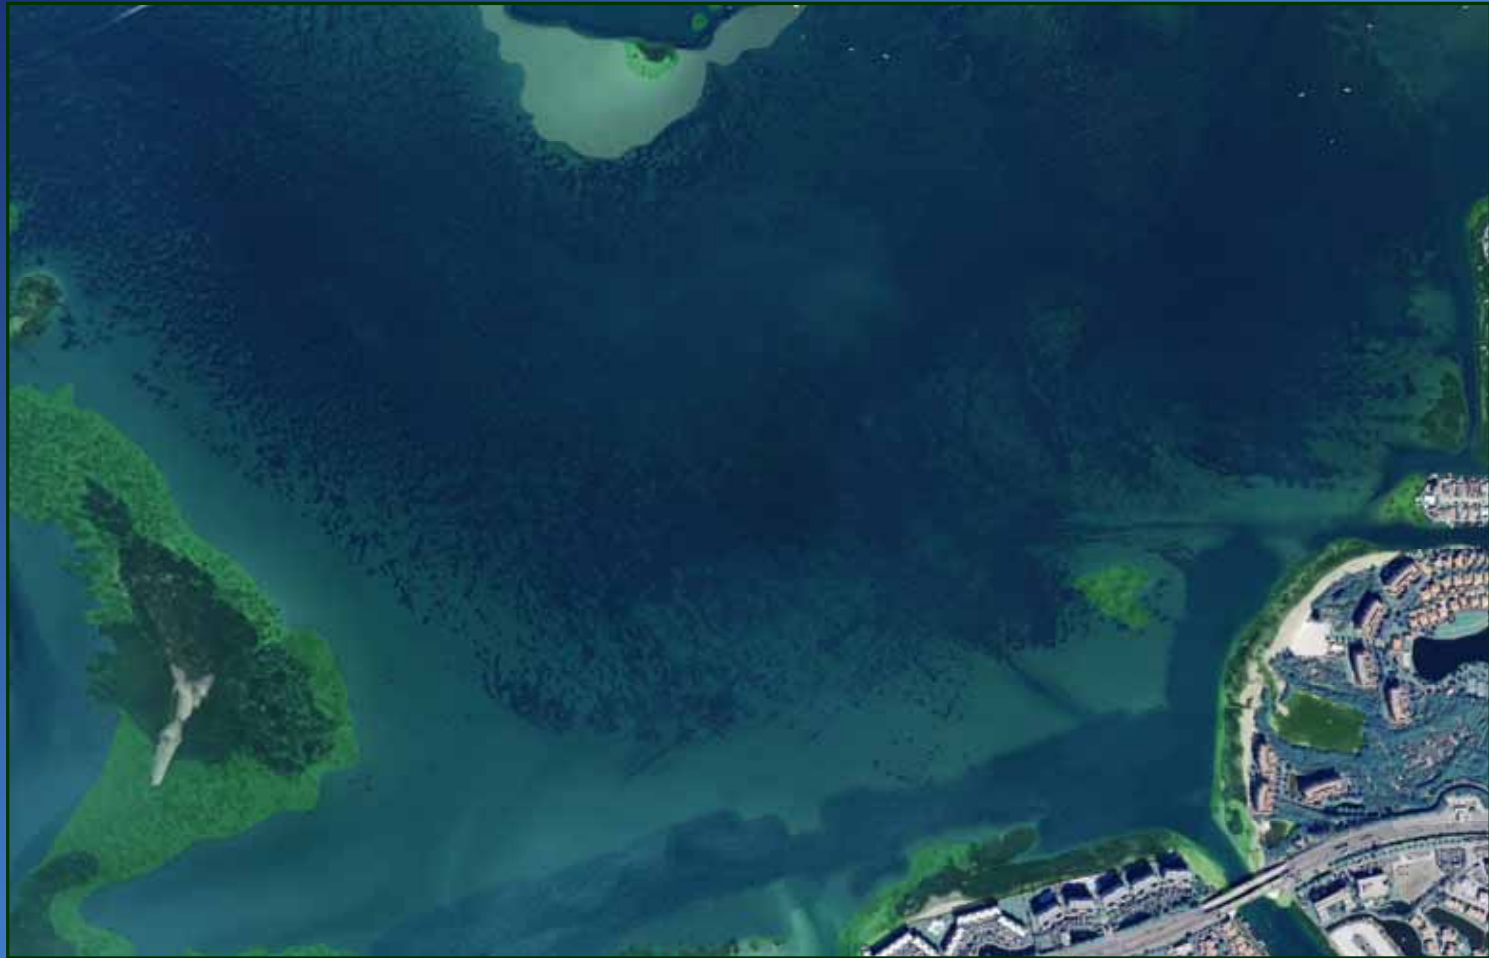
Signature Example

Location: Boca Ciega Bay, St. Petersburg FL

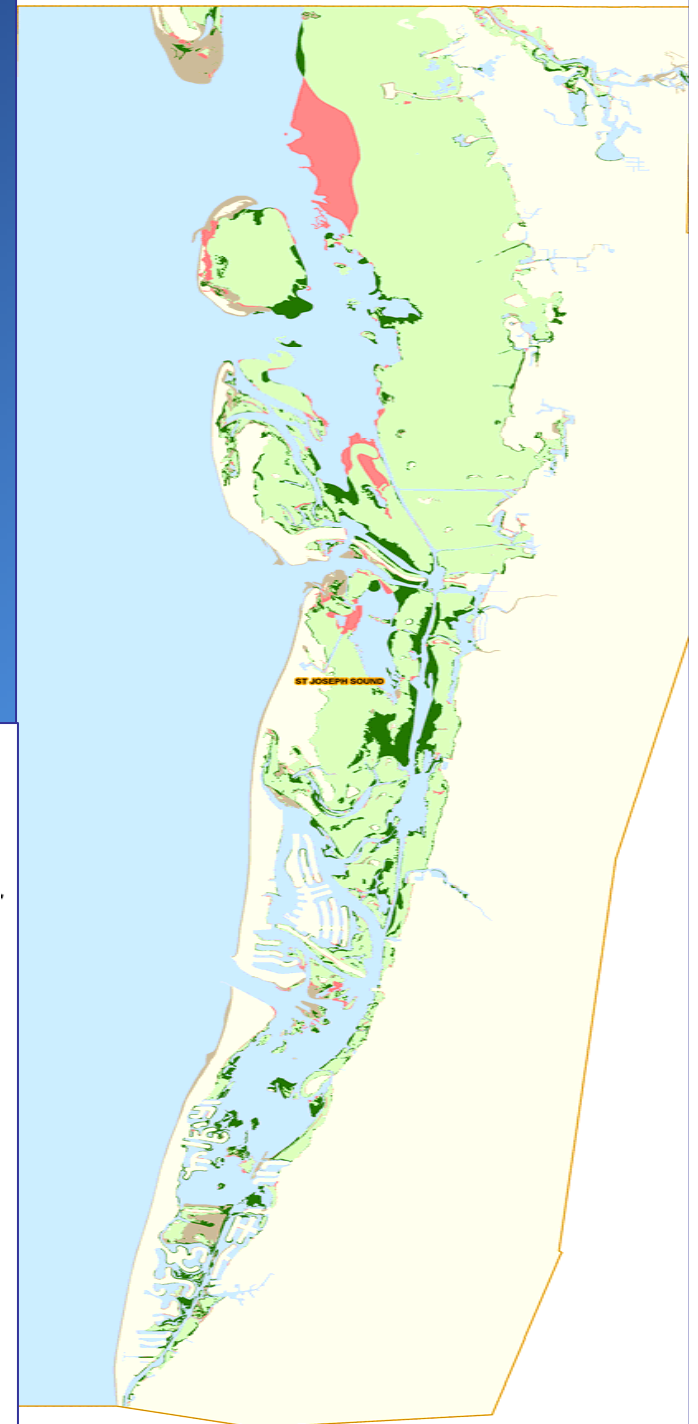
St. Joseph Sound/ Clearwater Harbor

- 14,982 acres
- 782 acre increase
- 5.5% change

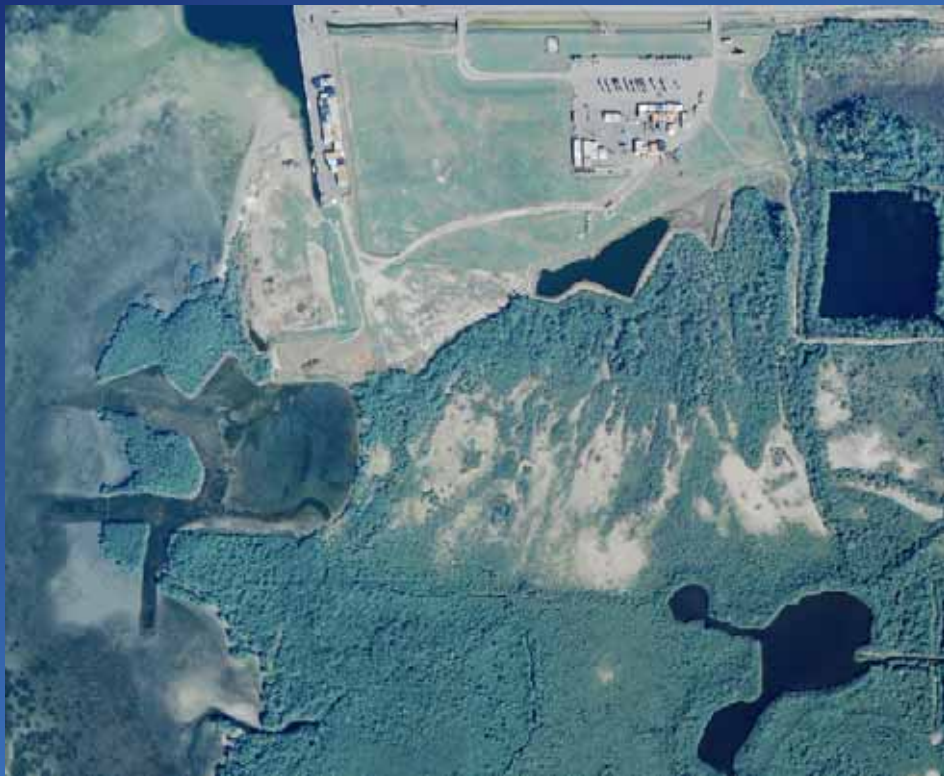
Coastline Update Example

Acres of “land” in 2004 now seagrass in 2006

- **SJS / CWH: 53.53 acres**
- **Tampa Bay: 118.88 acres**
- **Sarasota Bay: 62.85 acres**
- **Lemon Bay: 30.29 acres**
- **Charlotte Harbor: 125.21 acres**

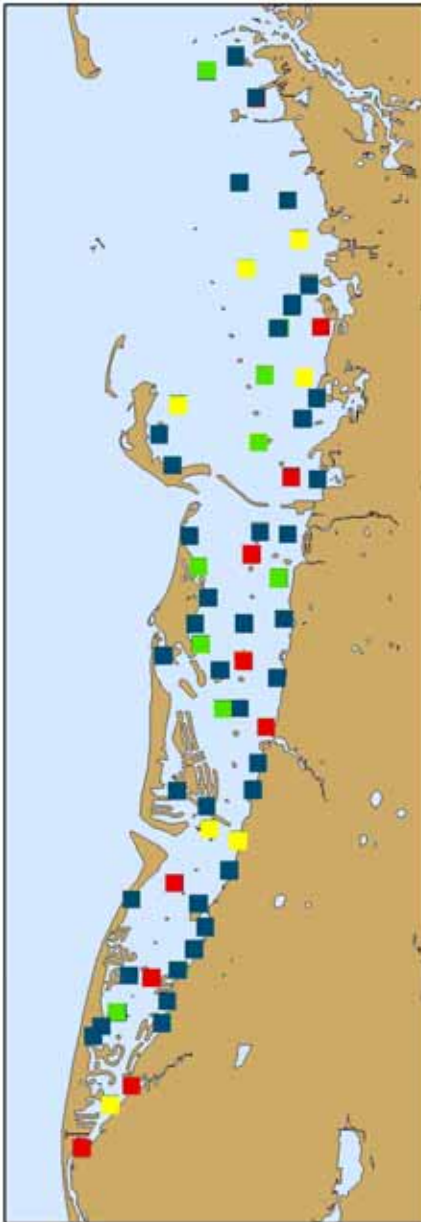
Total Seagrass

Strata	Total SAV	Halodule	Thalassia	Syringodium
STJS	71	10	30	30
CLWN	68	42	20	6
CLWS	63	43	19	1
Depth				
A _(0-0.5m)	66	33	27	5
B _(0.51-1.2m)	76	38	26	11
C _(1.2 m+)	61	24	16	20
