ROOSEVELT CREEK NUTRIENT SOURCE EVALUATION AND ASSESSMENT

**Final Report
September 2010**

Environmental Research and Design, Inc.
Harvey H. Harper, III, Ph.D., P.E.
3419 Trentwood Blvd., Suite 102
Orlando, FL 32812
Phone: 407-855-9465

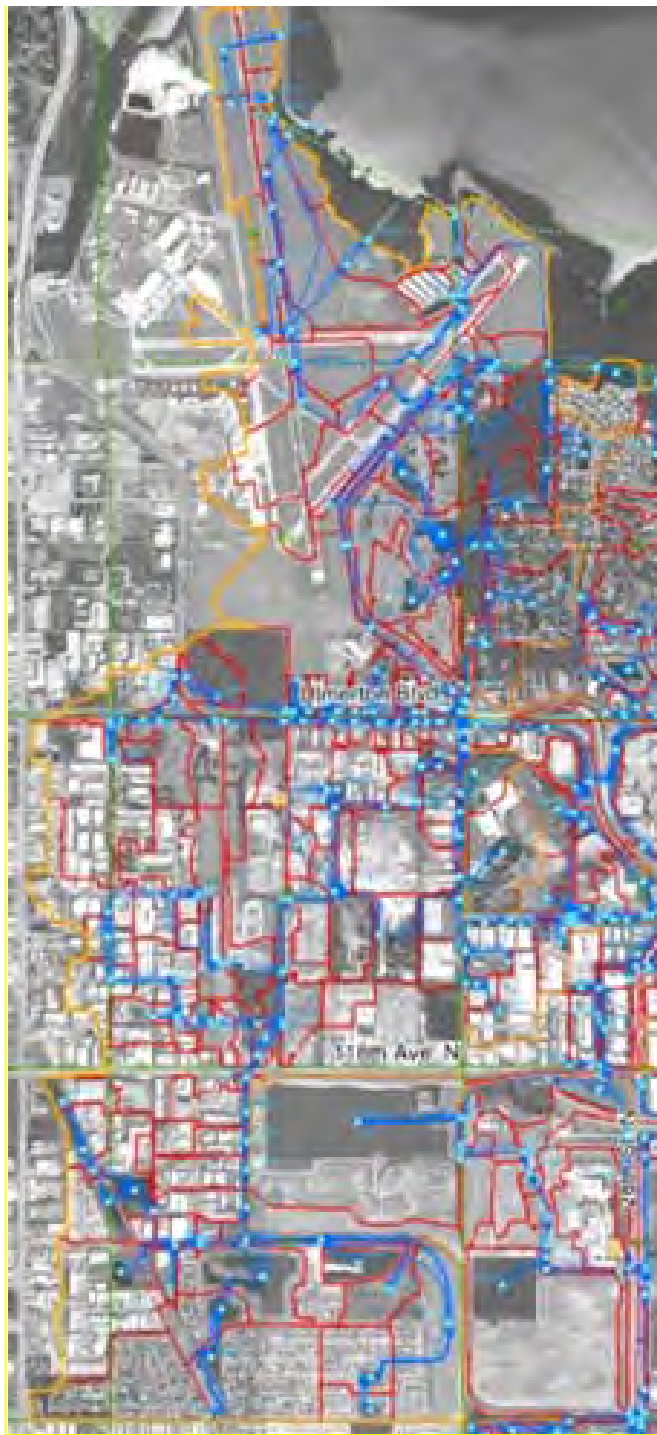
Figure 2-6. Inventory of Primary (Blue Lines) and Secondary (Red Lines) Drainage Conveyance Systems for Sub-basin H.

An inventory of primary and secondary drainage conveyance systems for Sub-basin H is given on Figure 2-6 (Parsons, 2007). This figure provides a schematic of the primary conveyance system for Channel 5, as well as secondary conveyance systems intersecting with the main channel. With the exception of the pumped inflow from the Bridgeway Acres Landfill, water movement within Sub-basin H occurs entirely by gravity.

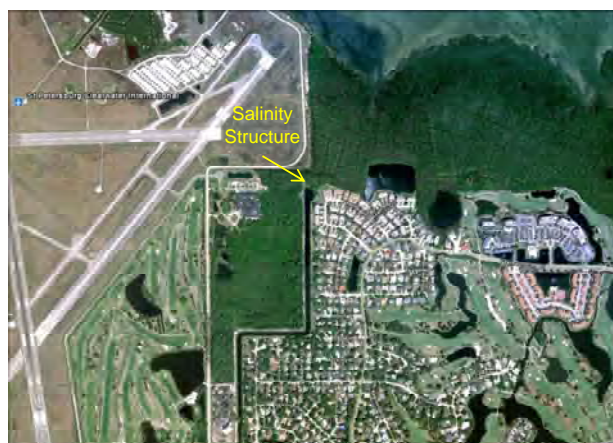
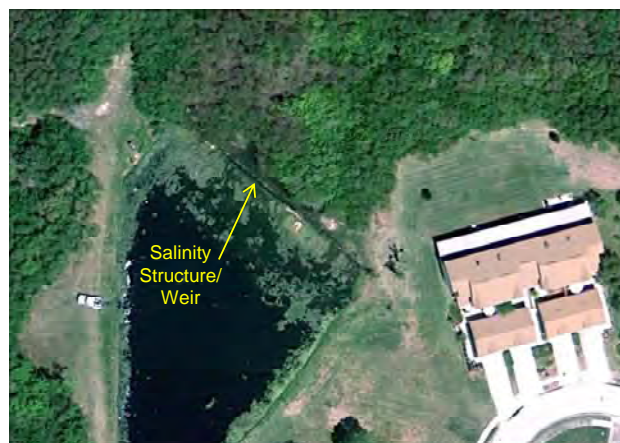
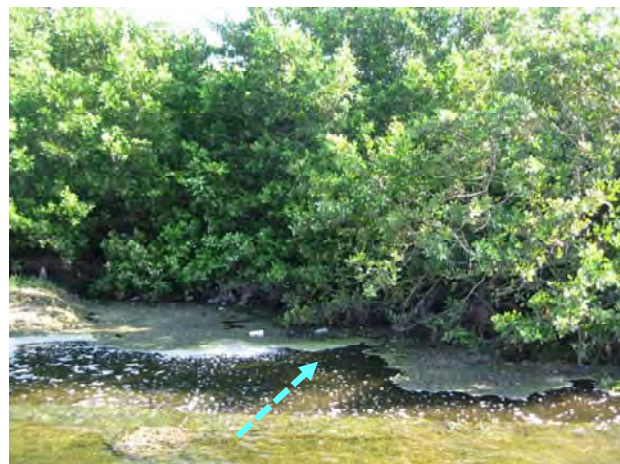
Figure 2-7. Downstream Salinity Structure/Weir for Sub-basin H (Monitoring Site 16).

Discharges through Sub-basin H consist primarily of freshwater throughout much of the year. A salinity structure at elevation 2.5 ft is located at the downstream end of Channel 5 at the point of discharge into the tidal wetlands associated with Old Tampa Bay. An overview and photographs of the salinity structure are given on Figure 2-7. The salinity structure consists of a 200-ft long broad-crested concrete weir structure. Discharges over the salinity structure enter the tidally flooded mangrove forest which is interconnected with Old Tampa Bay. This site is referred to as Site 16 for the field monitoring program.

a. General location

b. Aerial overview

d. Discharge enters tidal wetlands

The location of monitoring Site H-16 is indicated on Figure 3-21. This monitoring site is located at the salinity structure/spillway on the north end of Channel 5 prior to discharge into tidal wetlands. Photographs of this site are given on Figure 2-7.

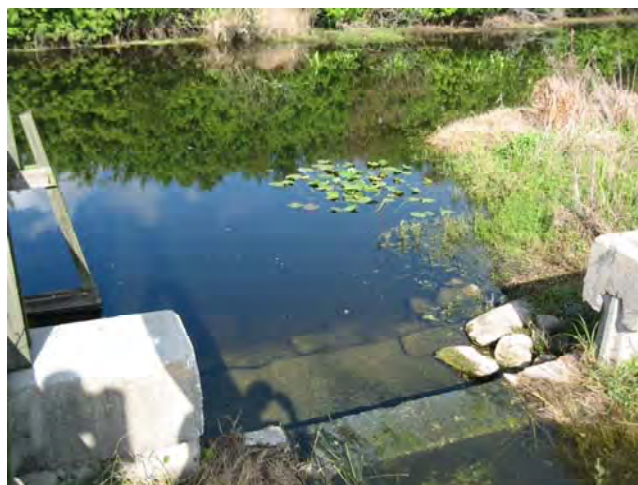
Figure 2-8. Weir Structure on Southwest Side of Bridgeway Acres Landfill (Monitoring Site 2).

Channel 5 contains at least three weir structures designed to regulate water levels in various portions of the tributary. The most upstream water control structure consists of an 8-ft wide contracted rectangular weir which is located near the southwest corner of the Bridgeway Acres Landfill. A photograph of the weir structure is given on Figure 2-8. This structure is used to control water elevations in the canal located along the south side of the landfill. This site is designated as Site H-2 in the field monitoring program conducted by ERD.

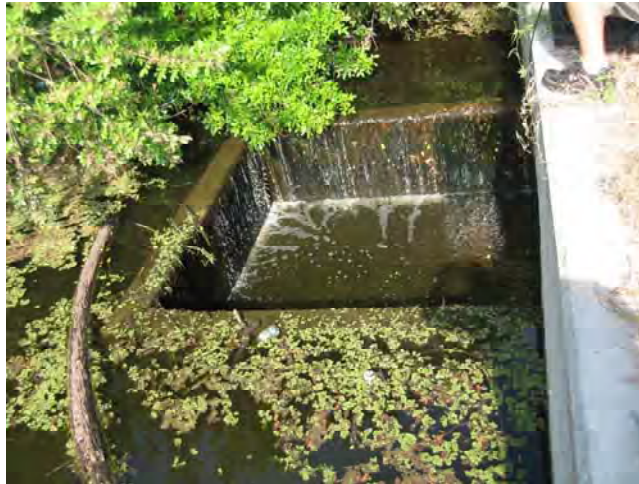
Figure 2-9. Weir Structure on Northwest Side of Bridgeway Acres Landfill (Monitoring Site 4).

The second water control structure is located on the south side of 118th Avenue North at the northwest corner of the Bridgeway Acres Landfill site. A photograph of the weir structure is given on Figure 2-9. This weir structure has a total length of approximately 24 ft and is used to control water surface and groundwater levels along the west side of the Bridgeway Acres Landfill. Discharges over the weir structure travel beneath 118th Avenue North and rejoin the open channel portion of Channel 5 on the west side of 40th Street North. The final water control structure consists of the salinity barrier/weir structure discussed previously.

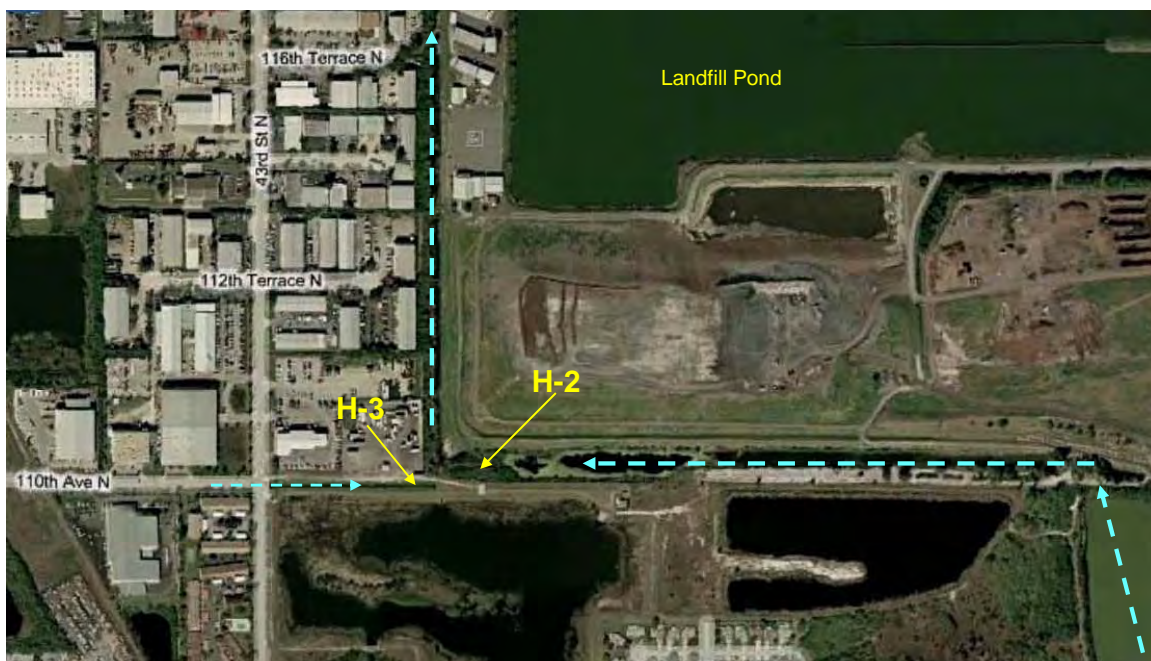
Figure 3-3. Location of Monitoring Sites H-2 and H-3.

The location of surface water monitoring Site H-2 is given on Figure 3-3. This site is located southwest of the Bridgeway Acres Landfill area and is the first site located along the main channel portion of Channel 5. This site provides background conditions for evaluation of changes in water quantity and water quality during migration through the Channel 5 system. A photograph of monitoring Site H-2 is given on Figure 3-4. Samples were collected on the downstream side of the 8-ft wide rectangular weir structure.

The monitoring location for Site H-3 is also indicated on Figure 3-3. This site represents a small tributary inflow to the main channel which includes drainage inputs originating along 110th Avenue North. Photographs of monitoring Site H-3 are given on Figure 3-5. Monitoring was conducted on the upstream side of the 72-inch RCP culvert prior to discharge into the main channel.

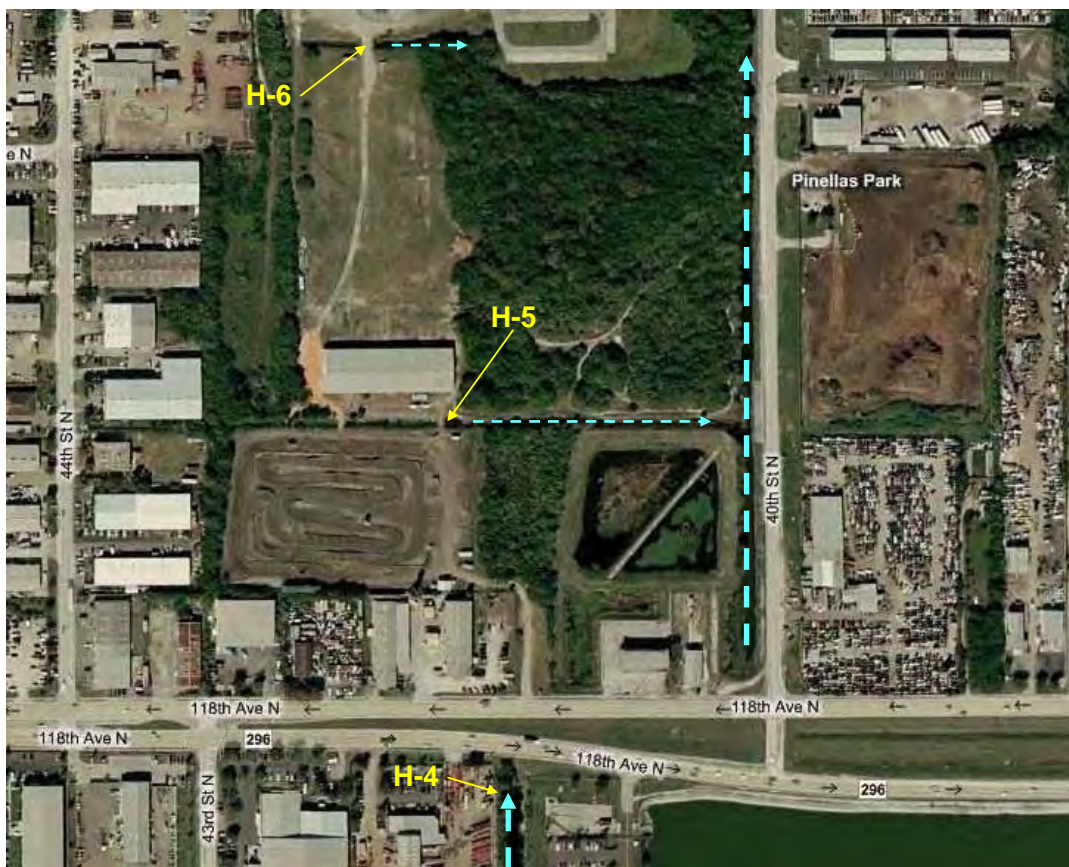
Figure 3-6. Location of Monitoring Sites H-4, H-5, and H-6.

Locations for surface water monitoring Sites H-4, H-5, and H-6 are indicated on Figure 3-6. Site H-4 is located within the main channel of Channel 5, immediately south of 118th Avenue North. This site reflects changes in water quantity or quality during migration through the main channel between monitoring Sites H-2 and H-4. This site is located at the weir structure on the northwest side of Bridgeway Acres Landfill which is illustrated on Figure 2-9. This structure contains a total of 24 ft of horizontal rectangular weir. The pumped inflow from the Bridgeway Acres Landfill is introduced into Channel 5 approximately 50 ft upstream from the weir structure and enters the channel through a submerged pipe which could not be monitored directly.

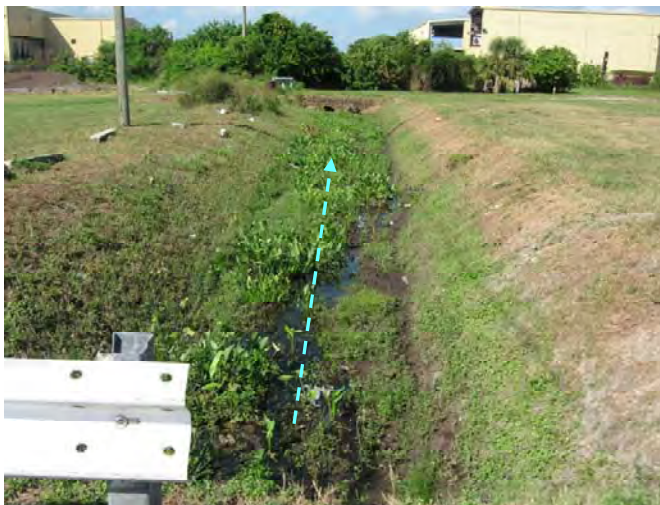
Figure 3-7. Photograph of Monitoring Site H-5.

Monitoring Sites H-5 and H-6 represent small tributary inflows into the main channel. Each of these inflows originates within the industrial areas located west of the main channel. Monitoring was conducted at these sites in culverts associated with road crossings immediately upstream of the point of inflow into the main channel. A photograph of monitoring Site H-5 is given on Figure 3-7. This site consists of a vegetated open ditch which receives inputs from an adjacent industrial area and sports complex. A photograph of monitoring Site H-6 is given on Figure 3-8. This site consists of an open drainage system, portions of which are heavily vegetated, and receives runoff from adjacent industrial activities, open areas, and a small racetrack.

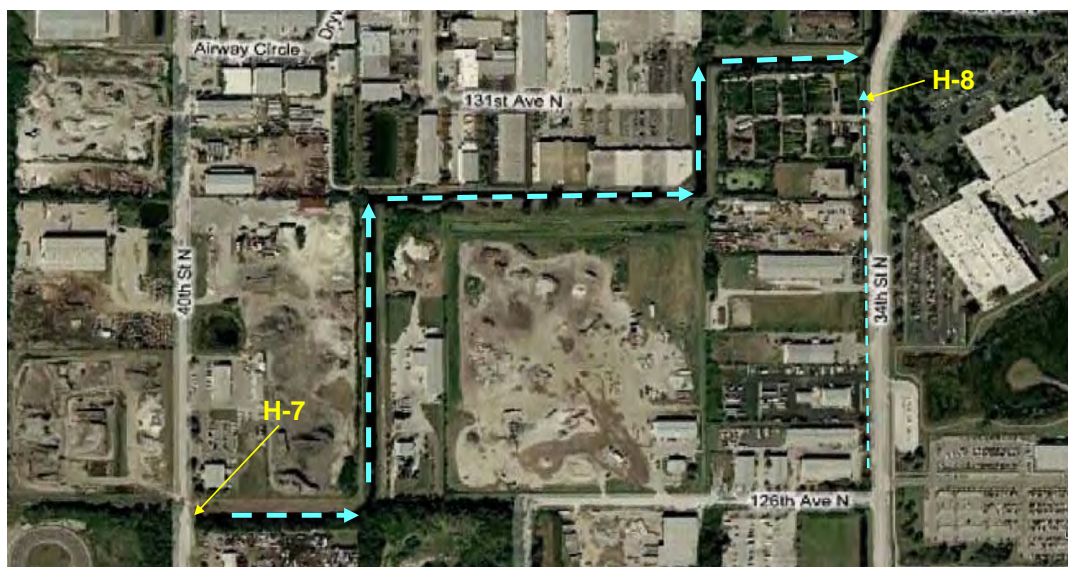
Figure 3-9. Location of Monitoring Sites H-7 and H-8.

Locations for monitoring Sites H-7 and H-8 are indicated on Figure 3-9. Site H-7 is located within the main channel of Channel 5 and is designed to evaluate changes in water quality and quantity which occur between 118th Avenue North and 40th Street North. Photographs of monitoring Site H-7 are given on Figure 3-10. This monitoring site is located on the upstream side of the four 60-inch RCPs and one 36-inch RCP which convey Channel 5 beneath 40th Street North. The channel in this area is approximately 50 ft in width with a relatively shallow flow. The bottom of the channel consists primarily of sand and muck with little vegetation.

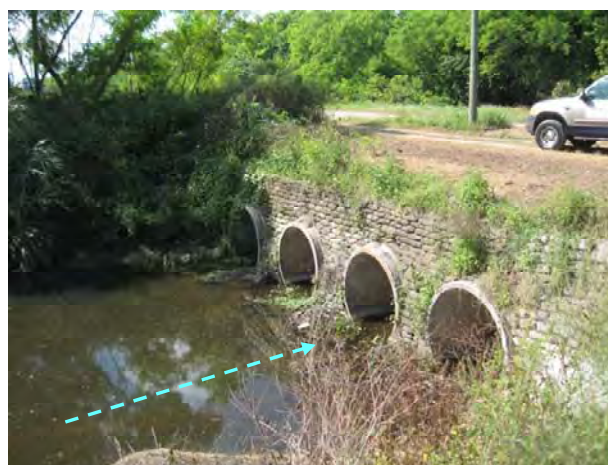
a. Upstream side of monitoring site

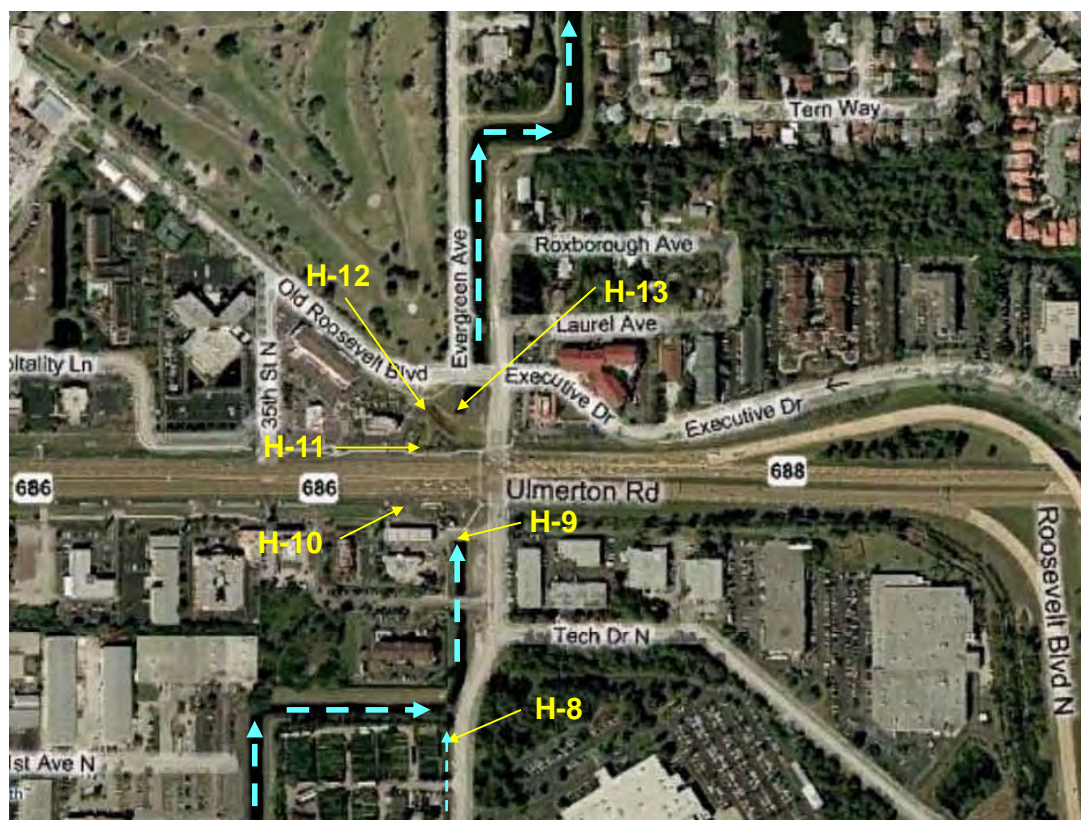
Figure 3-12. Location of Monitoring Sites H-9 through H-13.

Locations of monitoring Sites H-9 through H-13 are indicated on Figure 3-12. Monitoring Site H-9 is located within the main channel and is intended to monitor changes in water quantity and quality within the channel after migrating through the industrial areas between Sites H-7 and H-9. A photograph of monitoring Site H-9 is given on Figure 3-13. This site is approximately 400 ft south of the intersection of Channel 5 and Ulmerton Road.

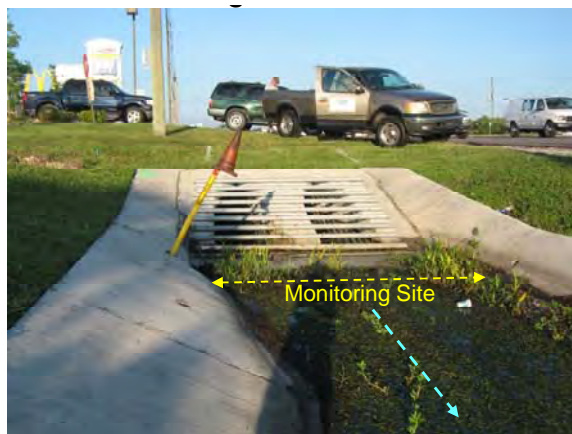
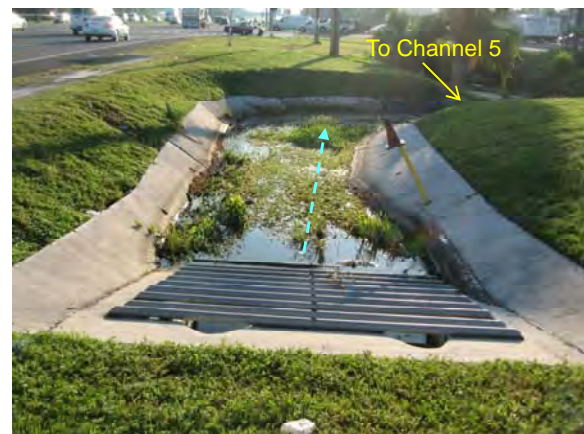
Figure 3-14. Photographs of Monitoring Site H-10.

Monitoring Site H-10 reflects a swale drainage system which collects runoff from roadway and adjacent commercial areas along the south side of Ulmerton Road. A photograph of monitoring Site H-10 is given on Figure 3-14. This swale discharges into the west side of Channel 5, south of Ulmerton Road. The conveyance channel is vegetated with a combination of grass and herbaceous wetland species along much of the channel prior to discharging through two 36-inch RCPs and converting into a concrete lined trapezoidal channel upstream of the point of inflow into Channel 5.

a. Transition from vegetated swale to lined ditch

b. Channel inflow to main ditch

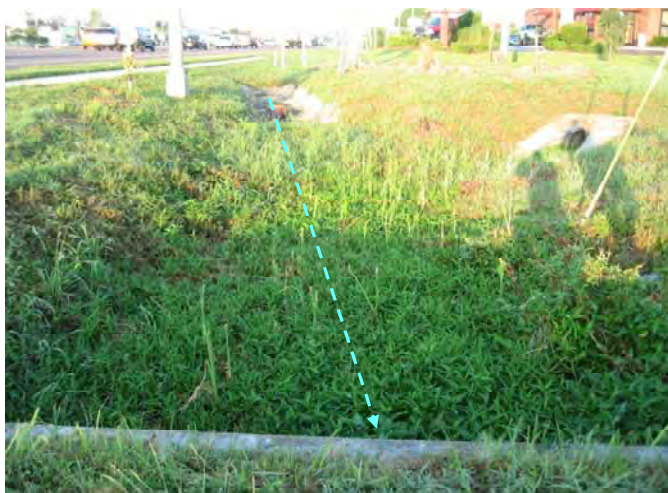
Figure 3-15. Photograph of Monitoring Site H-11.

Site H-11 reflects drainage through a 24-inch RCP from roadway and commercial areas located on the north side of Ulmerton Road, west of Channel 5. A photograph of monitoring Site H-11 is given on Figure 3-15. This inflow consists entirely of a vegetated roadside swale system which discharges into Channel 5 through a drop inlet and stormsewer system.

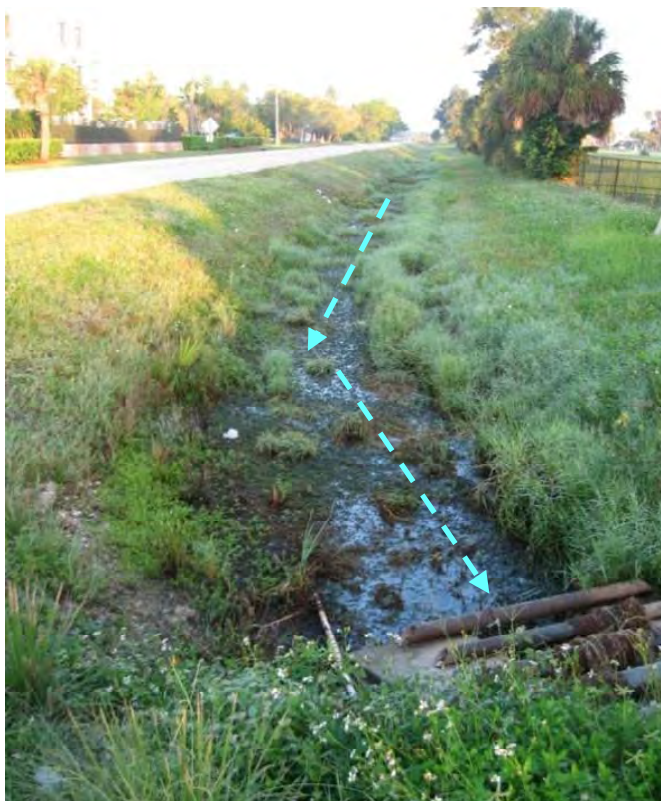
Figure 3-16. Photograph of Monitoring Site H-12.

Monitoring Site H-12 reflects drainage originating along Old Roosevelt Blvd. This inflow contributes runoff from adjacent golf course and residential areas and consists of a vegetated roadside swale system which discharges into a 36-inch RCP stormsewer. A photograph of monitoring Site H-12 is given on Figure 3-16.

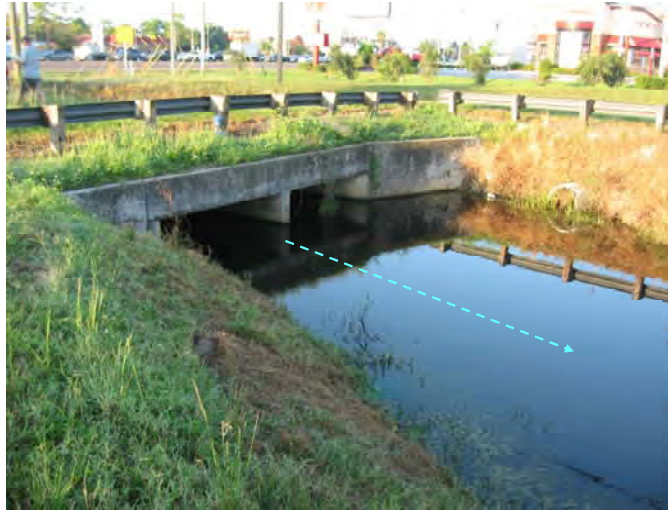
Figure 3-17. Photograph of Monitoring Site H-13.

Monitoring Site H-13 is located at the discharge from the box culvert structure which conveys Channel 5 beneath Ulmerton Road. This site is located at the north side of Ulmerton Road downstream from the cumulative inflows contributed by Sites H-10, H-11, and H-12. A photograph of monitoring Site H-13 is given on Figure 3-17.

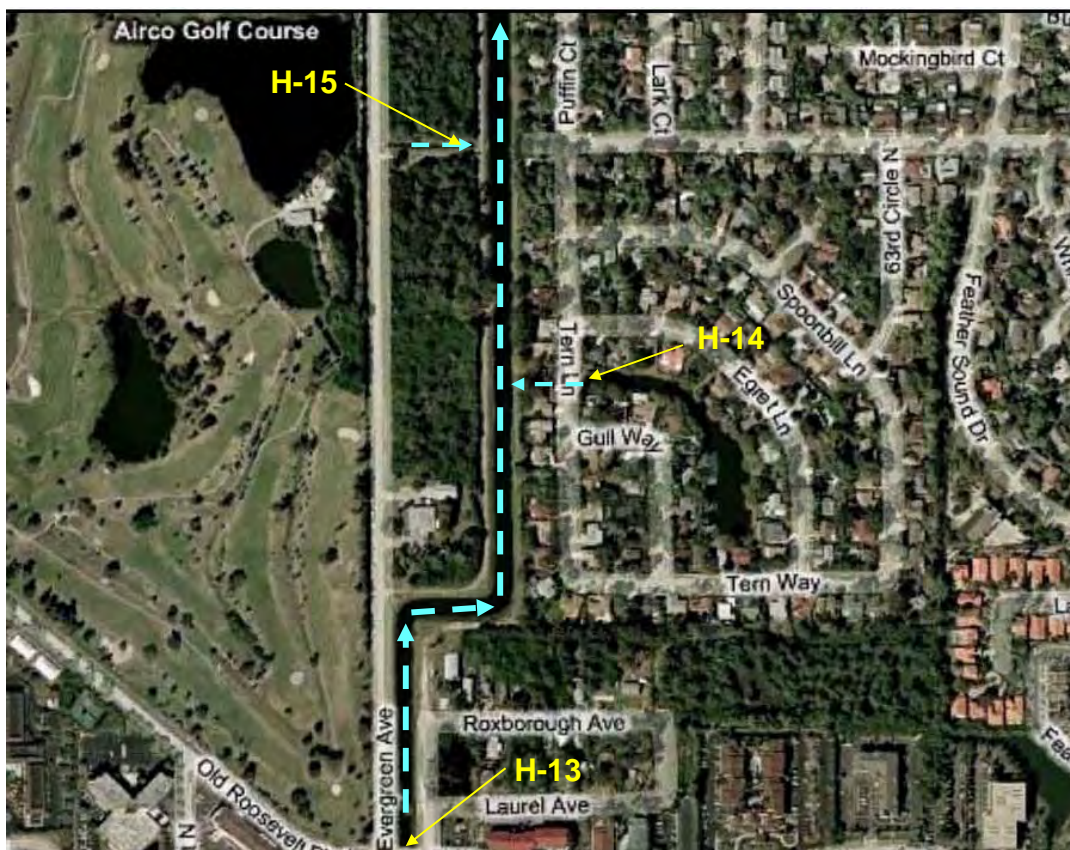
Figure 3-18. Location of Monitoring Sites H-14 and H-15 H.

Monitoring Sites H-14 and H-15 are indicated on Figure 3-18. Site H-14 reflects the outflow from a stormwater management system which provides treatment for runoff generated in a residential area east of the main channel. Photographs of the outfall structure from the residential lake system into Channel 5 are given on Figure 3-19. The outfall structure consists of three rectangular weirs (two 3-ft wide weirs and one 3.5-ft wide weir) which are used to regulate water levels within the lake system. Discharges through the outfall structure enter an underground stormsewer system and discharge directly into Channel 5.

Monitoring Site H-15 is located in a tributary which discharges from the Airco Golf Course into Channel 5. A photograph of the monitoring site is given on Figure 3-20. The channel from the Airco Golf Course consists of a shallow vegetated ditch which is conveyed into Channel 5 through a 48-inch RCP.

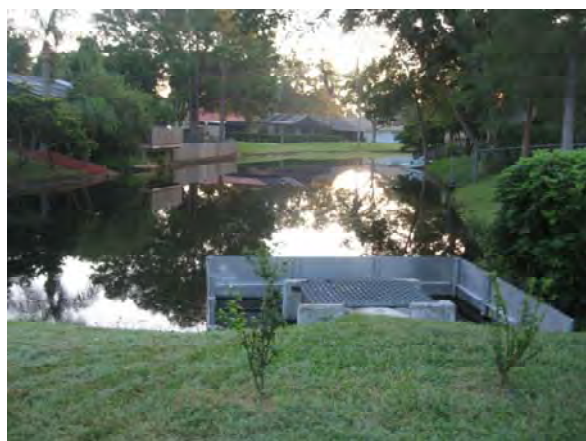
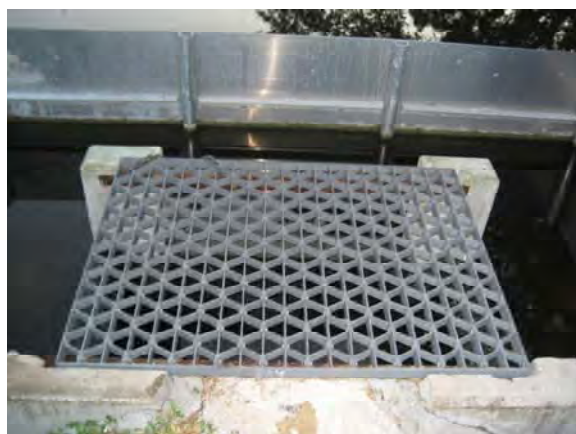
Figure 3-19. Photographs of the Outfall Structure at Site H-14.

a. Outfall structure from lake system to Channel 5

b. Outfall structure and weirs

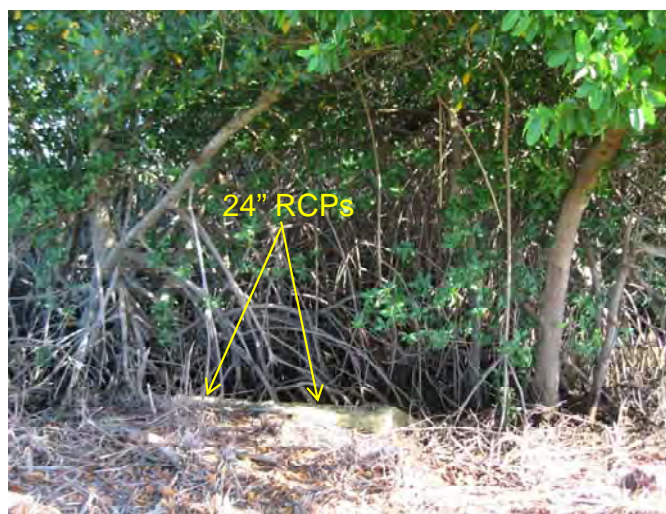
Figure 3-23. Photograph of Monitoring Site H-17.

Locations of monitoring Sites H-17 and H-18 are indicated on Figure 3-22. Each of these sites is located on the St. Petersburg/Clearwater International Airport property and reflects points of primary discharge from the airport into Old Tampa Bay. Although these tributaries do not discharge directly into Channel 5, this area is still considered to be part of Sub-basin H. A photograph of monitoring Site H-17 is given on Figure 3-23. This site consists of two 24-inch CMPs which discharge directly into a dense mangrove forest. Monitoring at this site was

conducted at the discharge from the pipes. A photograph of monitoring Site H-18 is given on Figure 3-24. This site consists of two 36-inch RCPs which convey drainage from a large portion of the airport property. Monitoring at this site was conducted at the discharge from the 24-inch RCP. Discharges at this site ultimately enter tidal wetlands before discharging directly into Old Tampa Bay.

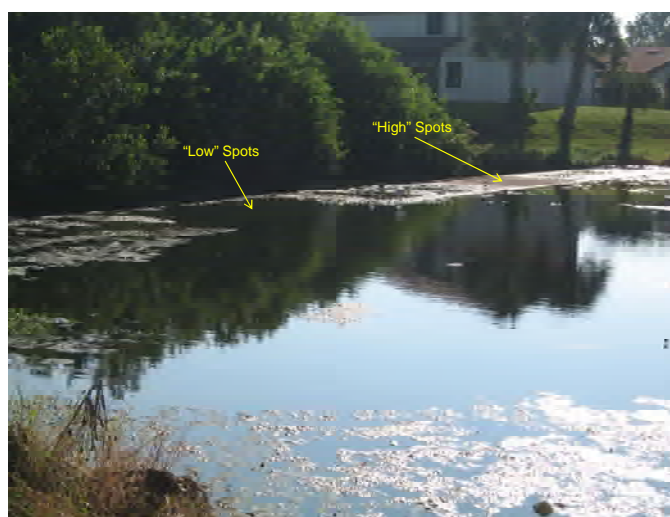
Figure 4-3. Examples of “Low” and “High” Spots on the Spillway Structure.

However, the weir structure is not exactly horizontal and contains a number of “high” and “low” spots along the length, particularly in western portions of the structure. Examples of “low” and “high” spots on the spillway structure are given on Figure 4-3. Measurements collected by ERD suggest that water levels can vary by an inch or more depending upon location along the weir. Although a difference of only an inch may seem like a small amount, this difference can have a significant impact on flow calculations due to the 183-ft width of the structure. The observed variability in elevations along the weir structure makes flow measurements at this site more of an estimate than an absolute value. This is true both for the data collected by ERD as well as the ongoing USGS data. Therefore, the observed increases in discharge rates through the canal between Ulmerton Road and the spillway structure may or may not reflect actual increases in discharge along the channel.

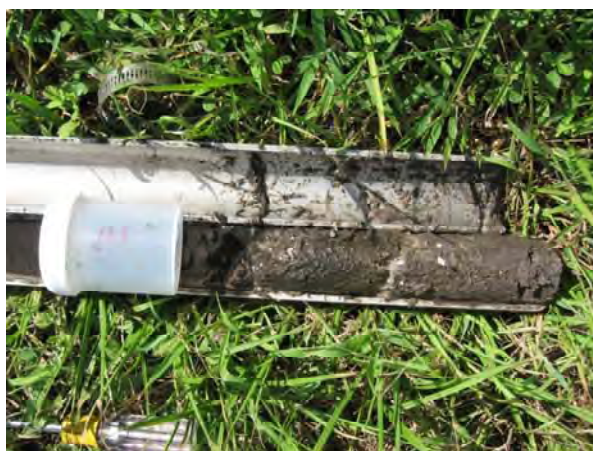
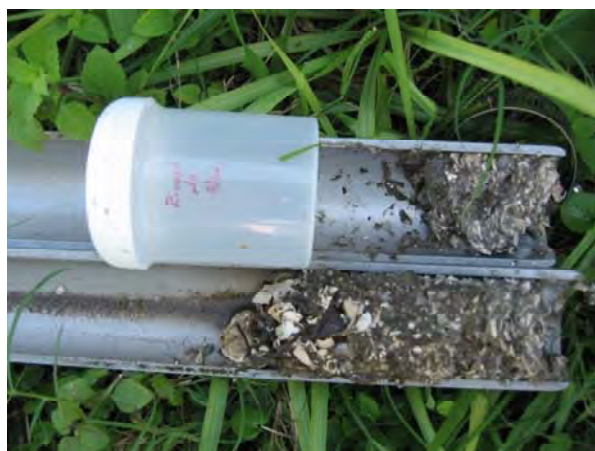
Figure 4-19. Visual Characteristics of Sediment Core Samples Collected in Roosevelt Creek Sub-basin H.

Typical visual characteristics of sediment core samples collected in Roosevelt Creek Sub-basin H are given on Figure 4-19. Sediment samples collected from tributary inflows and along main portions of the channel were characterized by a thin layer of organic muck, approximately 1-3 cm in depth. Below this surficial layer, the sediments consisted primarily of fine sands with varying degrees of organic matter. Sediments collected at the airport monitoring sites consisted of a mixture of sand and shell material, with no visible layer of organic muck. Build-up of organic muck in tributary, main channel, and at the airport sites is limited due to the periodic water movement throughout the basin.

a. Typical sediment characteristics in tributary inflows and main channel areas

b. Typical sediment characteristics at Sites H-17 and H-18

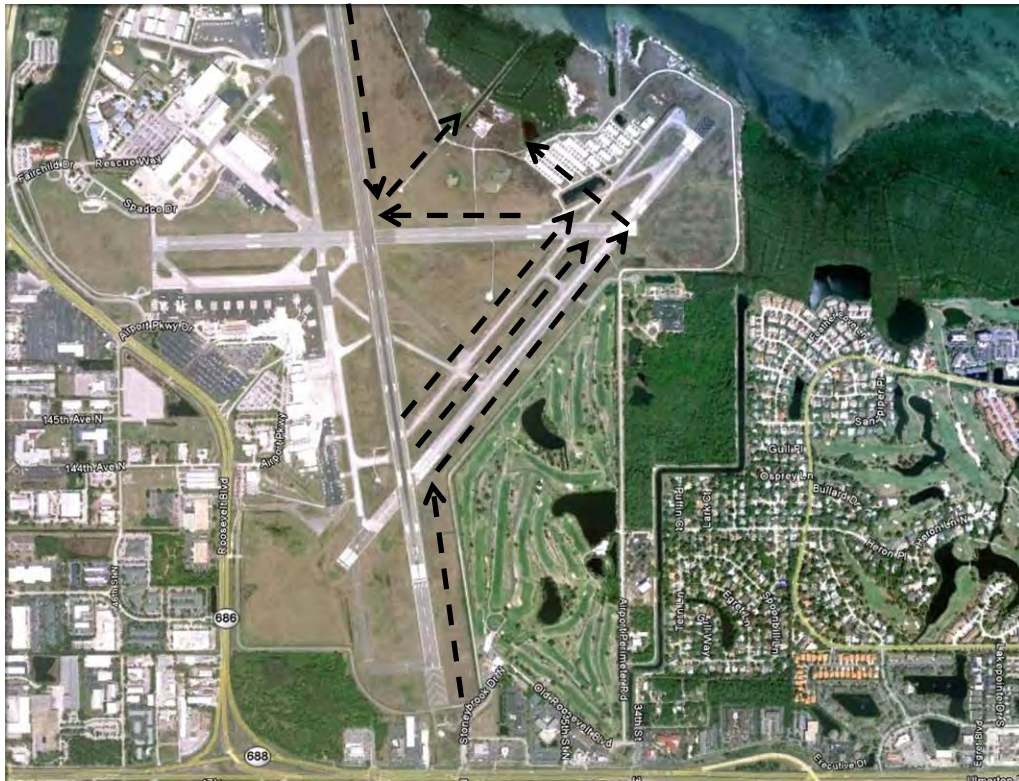
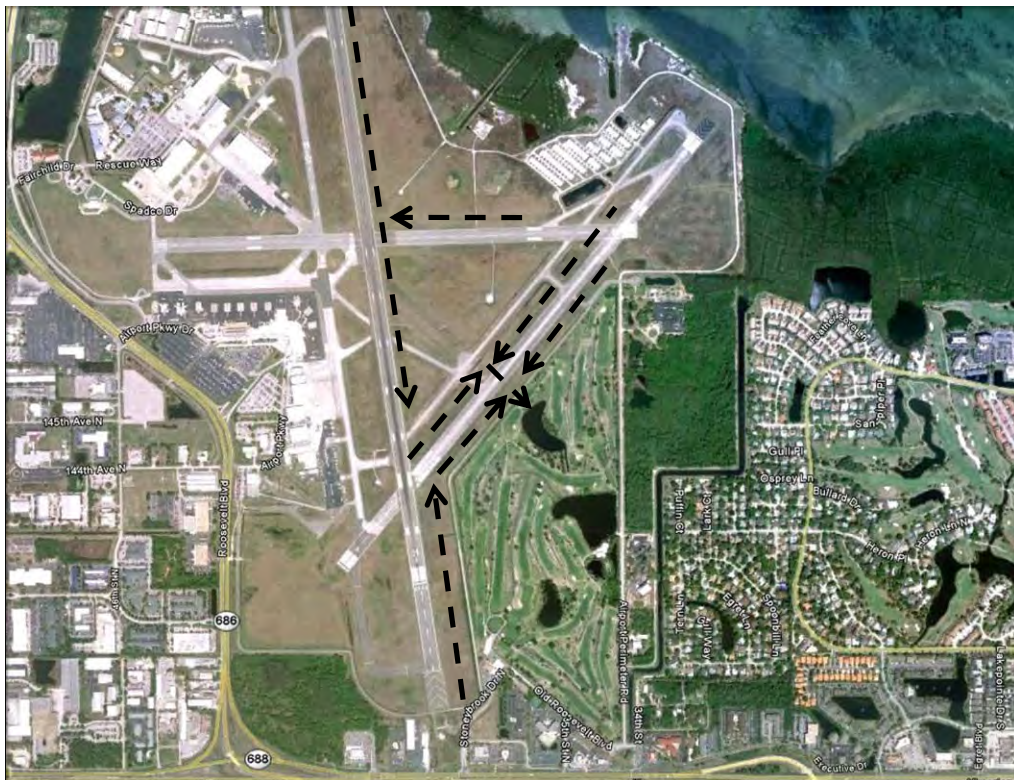
Figure 5-6. Current and Proposed Drainage Patterns at the St. Petersburg/Clearwater Airport Property.

A comparison of current and proposed drainage patterns at the St. Petersburg/Clearwater International Airport property is given on Figure 5-6. Under existing conditions, drainage generated within the airport site discharges through a series of shallow vegetated swales, ultimately discharging through two primary outfalls into Old Tampa Bay. The proposed re-grading modifications would redirect the swale drainage to a control structure which would discharge into the lake system associated with the Airco Golf Course site. The additional runoff inflow would then be used for irrigation purposes.

a. Current Conditions

b. Proposed Conditions
