# SAN MARTIN BLVD OVER RIVIERA BAY PD&E STUDY

## CONCEPTUAL ALIGNMENT ALTERNATIVES

## CONCEPTUAL BRIDGE TYPICAL SECTION

## EXISTING CONDITIONS FUNCTIONAL DEFICIENCIES

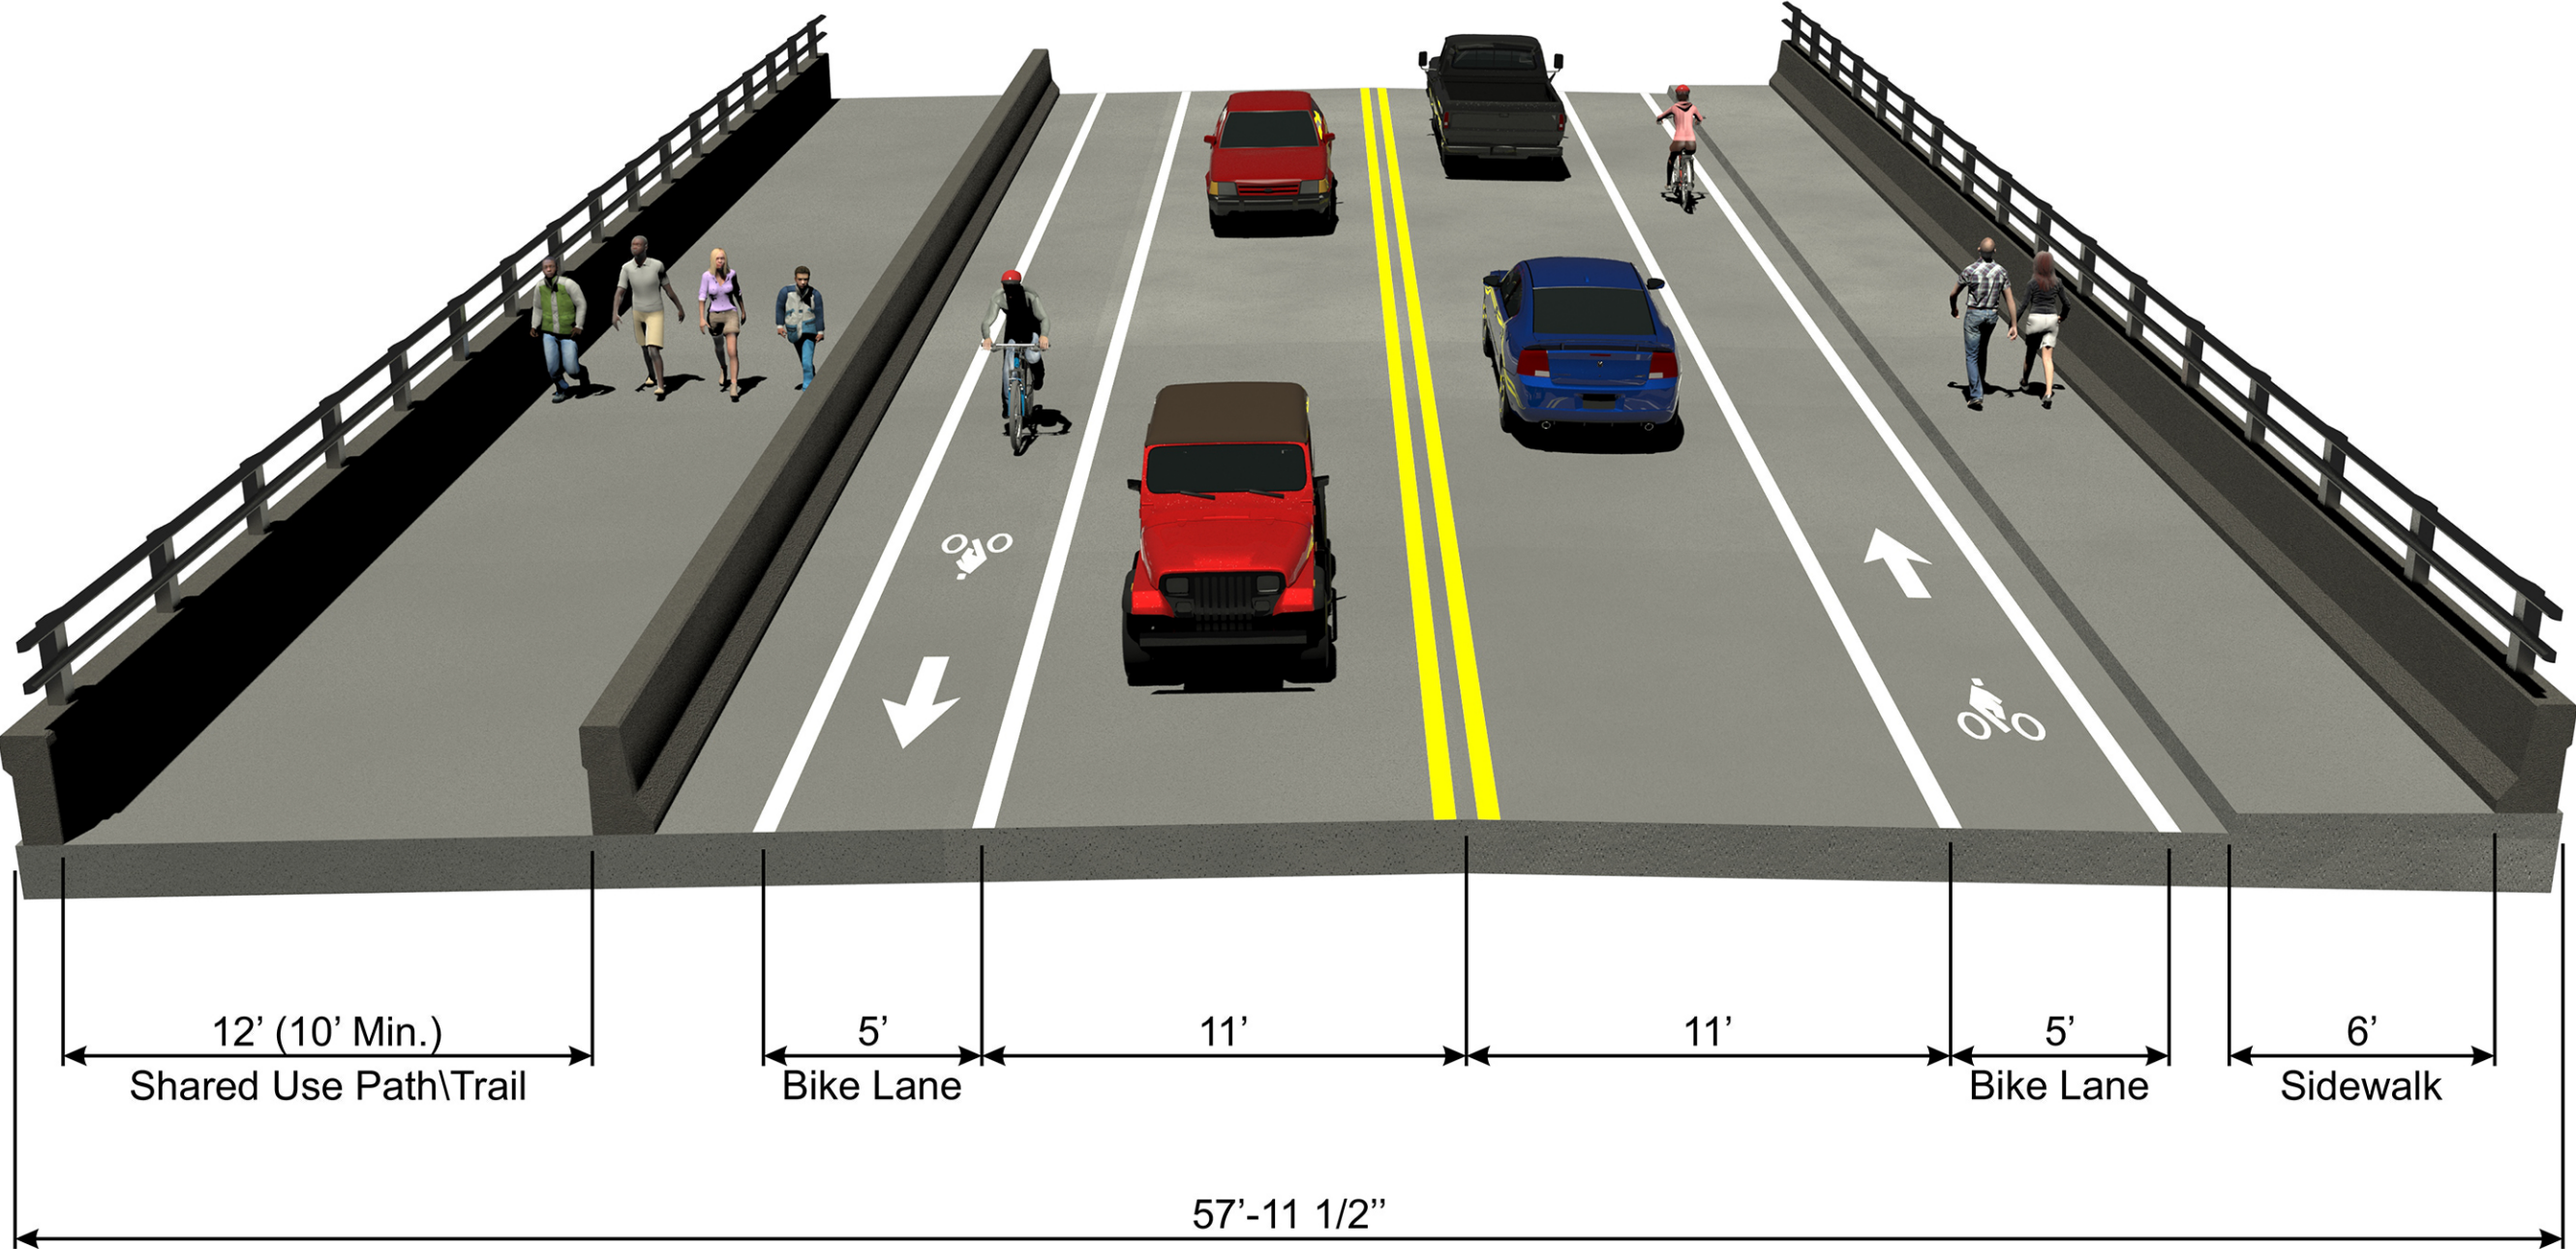
\*Final Dimensions May Vary

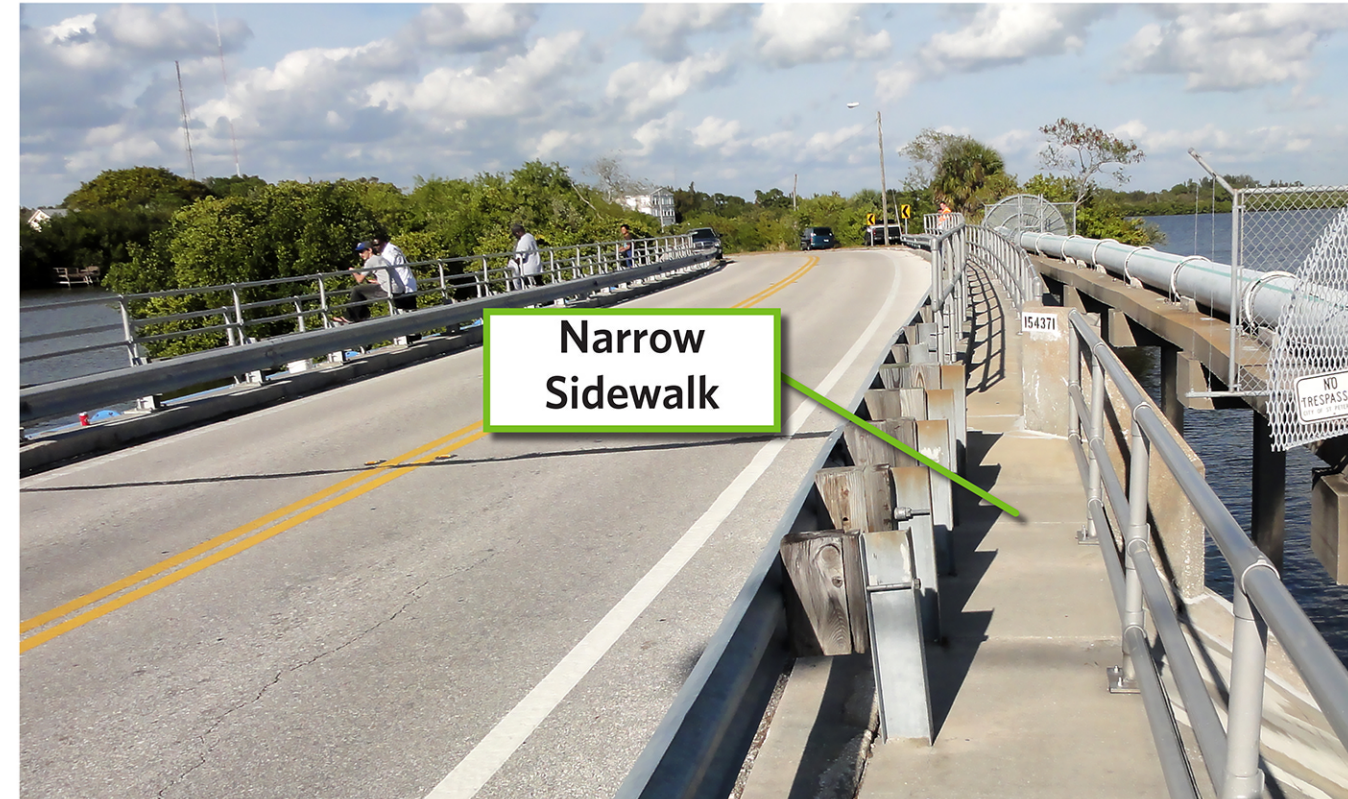
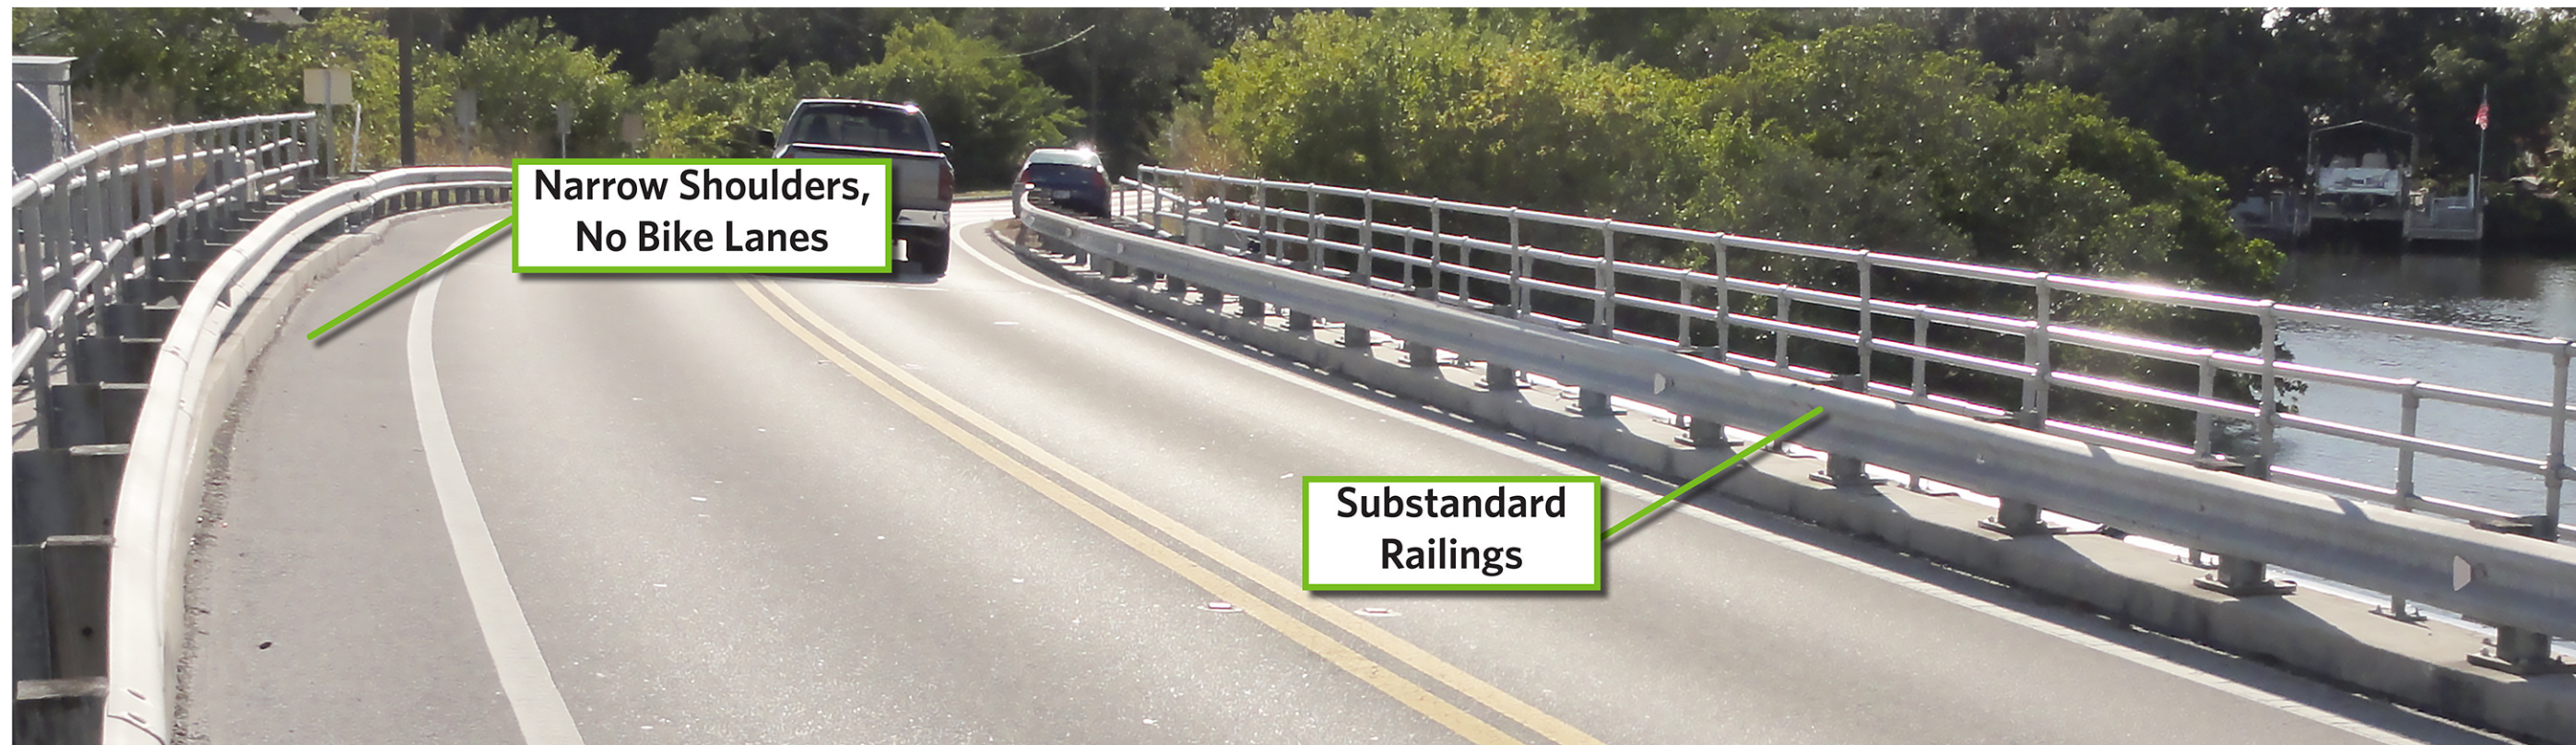
### Functionally Obsolete

- Substandard Narrow Roadway Width
  - » 24.5 ft Wide - Curb to Curb
  - » 0.5 - 1.5 ft Wide Shoulders
  - » No Bike Lanes
- Substandard Sidewalks - 3.5 ft Width
  - » Does not Meet Requirements of the Americans with Disabilities Act of 1990
- Substandard Bridge Railings and Guardrail
