Beckett Bridge

Project Development & Environment (PD&E) Study

Preliminary Engineering Report **Volume 2: Appendices**

Project #13040 - Beckett Bridge over Whitcomb Bayou (Riverside Drive)

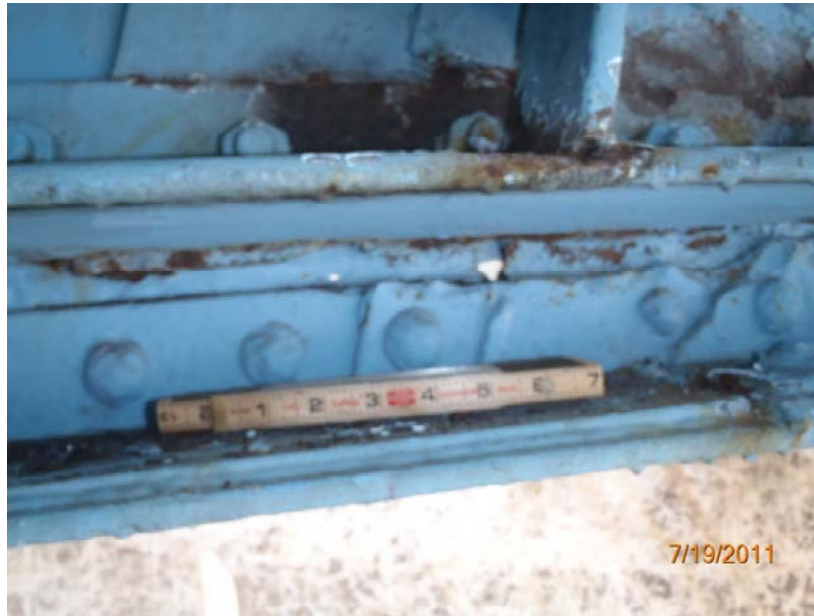
CS2: The top flanges, lower portions of the webs and bottom flanges exhibit painted over pitting with corrosion holes up to 1/4 in. diameter near the curve tracks – INCREASE. Refer to Photo 7. REPAIR.

PHOTO 7: 107/4 Paint Stl Opn Girder

The top flanges, lower portions of the webs and bottom flanges exhibit painted over pitting with corrosion holes up to 1/4 in. diameter near the curve tracks.

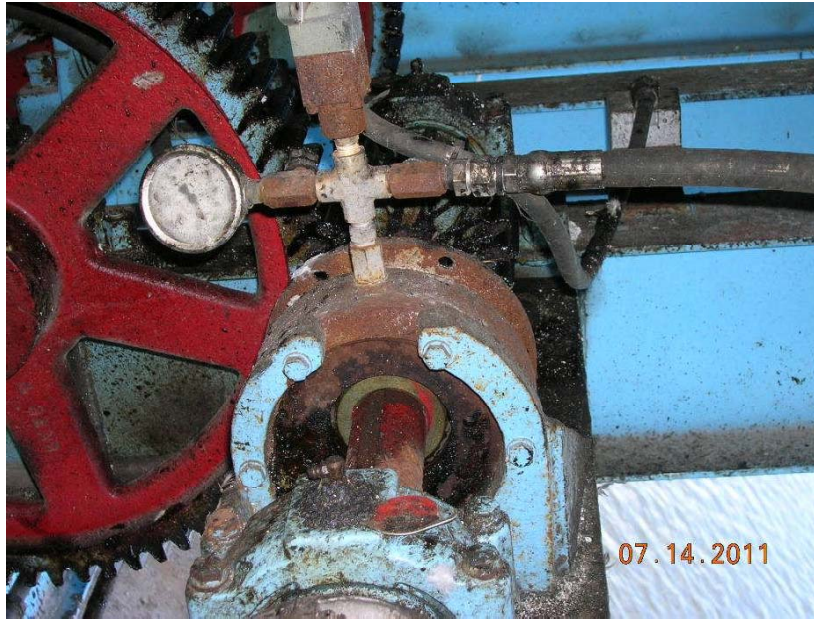
CS3: The motor brake (brake 1) is not grabbing when set. The shaft that the brake is on can be moved within the backlash of the gear sets up to the machinery brake (brake 2). The motor brake was also not releasing, intermittently. Refer to Element 548 for additional comments regarding this deficiency. Refer to Photo 12. REPAIR.

CS2: The motor brake was not releasing intermittently, there was no pressure shown on the gauge when the brake was not releasing, indicating a problem with the valve since the emergency brake (brake 2) is on the same pressure line and was releasing. Refer to Photo 12. REPAIR.

PHOTO 12: 544/4 Brakes & 548/4 Hydraulic Piping Sys

Motor brake (brake 1) does not hold and does not release, intermittently.

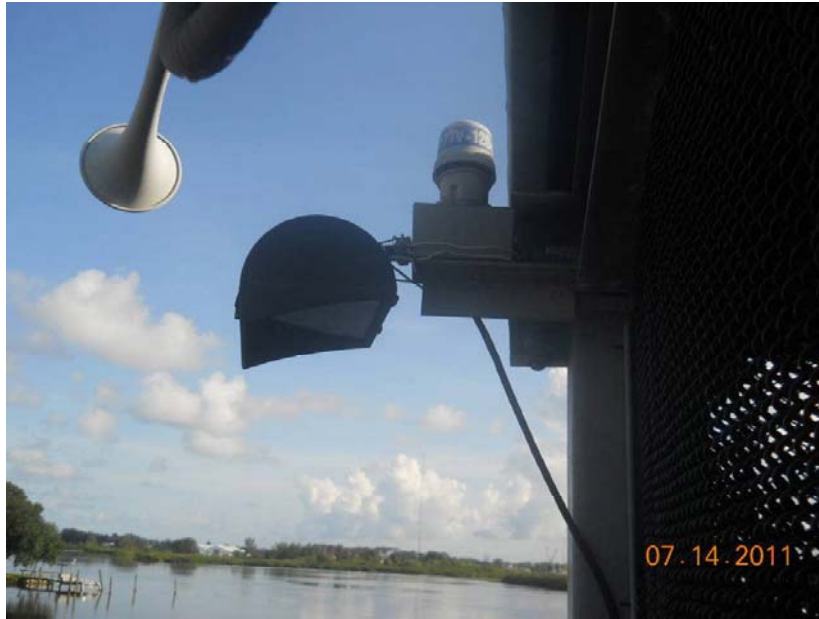
CS1: Waterway flood light is improperly fastened with electrical wire. Refer to Photo 14. REPAIR.

PHOTO 14: 563/4 Acc Ladd & Plat

Waterway floodlight held in place with electrical wire.

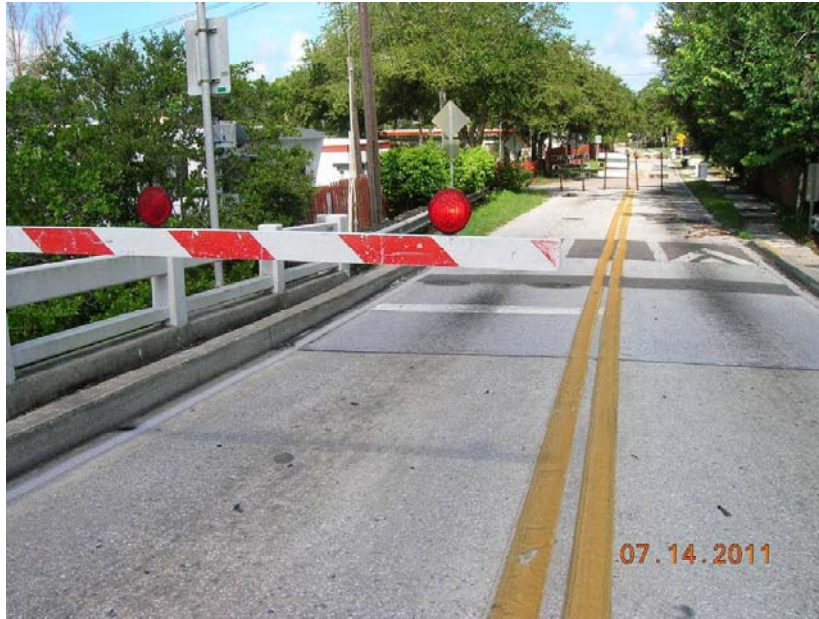
Paint is chipping off the red stripes on both on-coming gates. Refer to Photo 27. REPAIR.

The gate arm light on tip of the Far On-Coming gate is improperly secured. Refer to Photo 27. REPAIR.

PHOTO 27: 591/4 Warning Gates

The gate arm light on Far On-Coming gate is not secured properly.
Chipping paint is typical for all gates.

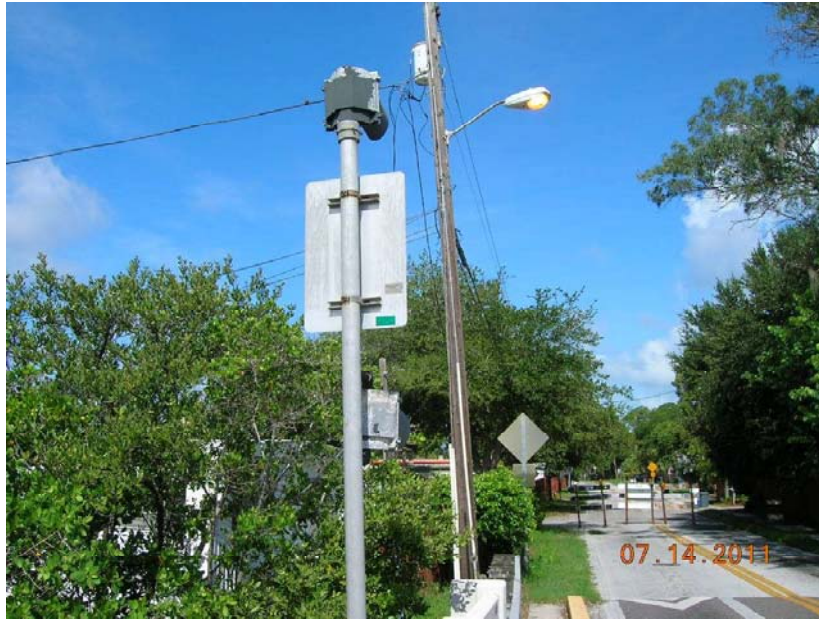
CS2: The paint is peeling off the signal heads of the traffic signals at both ends of the structure – INCREASE. Refer to Photo 30. REPAIR.

PHOTO 30: 592/4 Traffic Signals

Paint is peeling off the signal heads of the traffic signals at both ends of the structure.

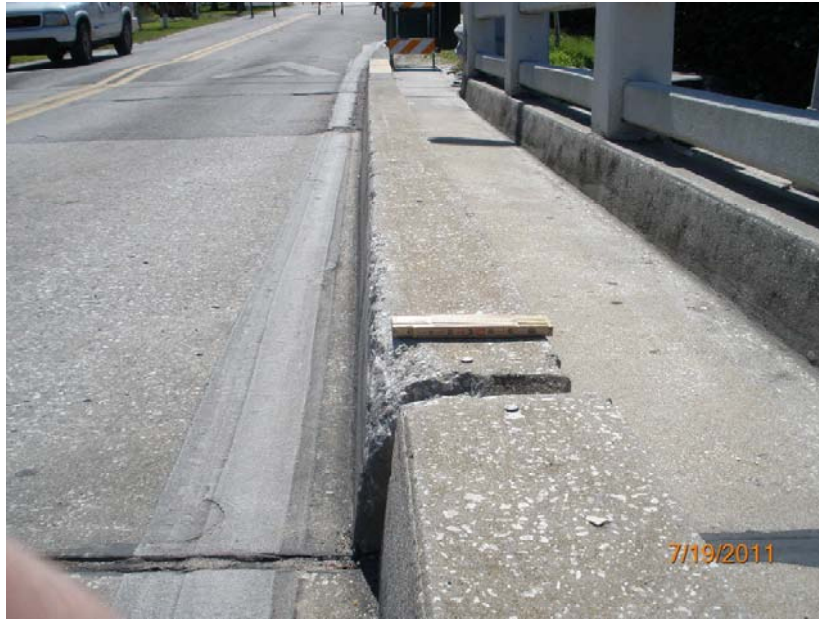
There are lateral misalignments of the approach spans up to 1-1/4 in. Refer to Table 1 in the Addendum for Deck Misalignment Measurements. Refer to Photo 31.

PHOTO 31: 12/4 Bare Concrete Deck

There are lateral misalignments of the approach spans up to 1-1/4 in.

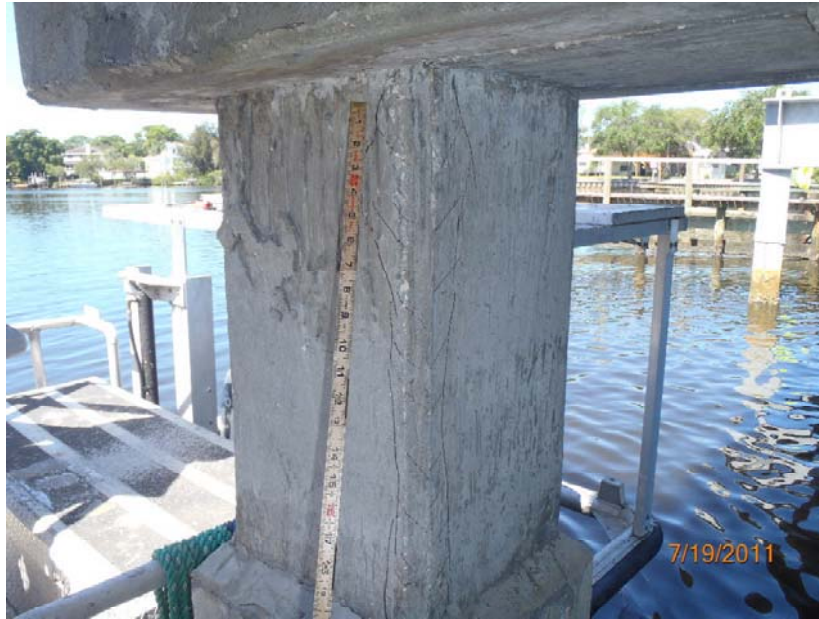
CS3: There is a 20 in. x 6 in. delamination in the NE edge above the jacket of Pile 8-5 - INCREASE. Refer to Photo 41. REPAIR.

PHOTO 41: 204/4 P/S Conc Column

There is a 20 in. x 6 in. delamination in the NE edge above the jacket of Pile 8-5.

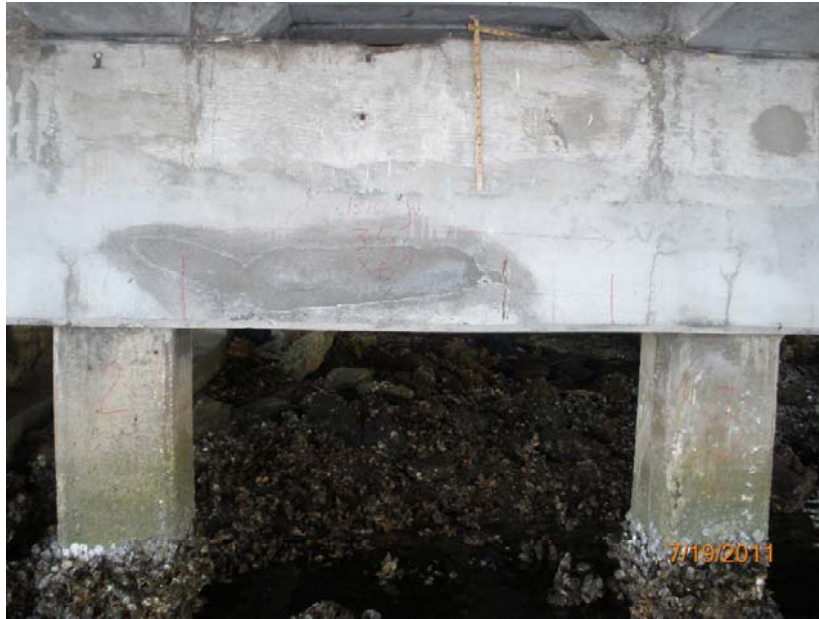
CS3: There are up to 3.5 ft. x 5 ft. delaminations in the bottom west edge of Bent Cap 10 between Piles 10-2 and 10-3 and Piles 10-4 and 10-5. Refer to Photo 45. REPAIR.

PHOTO 45: 234/4 R/Conc Cap

There are up to 3.5 ft. x 5 ft. delaminations in the bottom west edge of Bent Cap 10 between Piles 10-2 and 10-3 and Piles 10-4 and 10-5; delamination between Piles 10-2 and 10-3 shown.

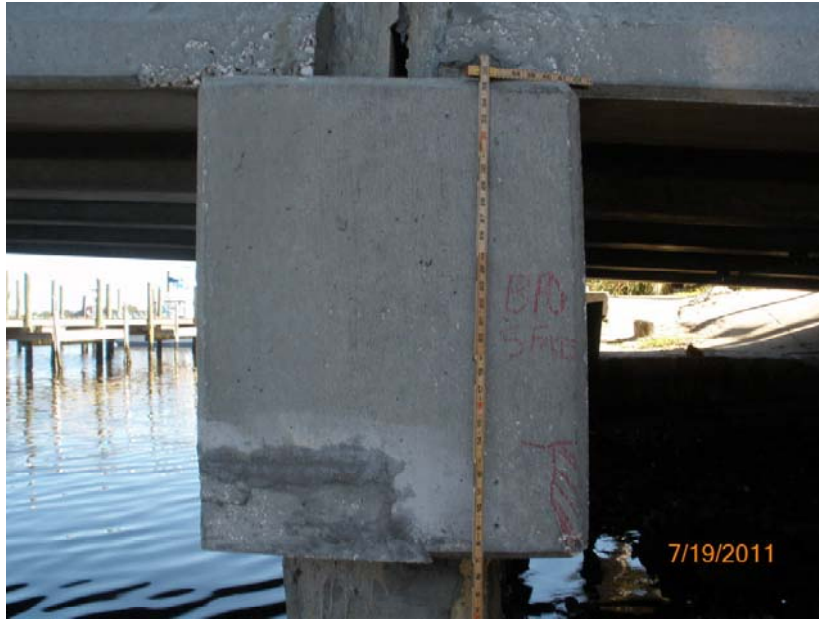
Bent Cap 10 exhibits a 4 in. x 7 in. delamination in the SE edge – NEW. Refer to Photo 46. REPAIR.

PHOTO 46: 234/4 R/Conc Cap

Bent Cap 10 exhibits a 4 in. x 7 in. delamination in the SE edge.

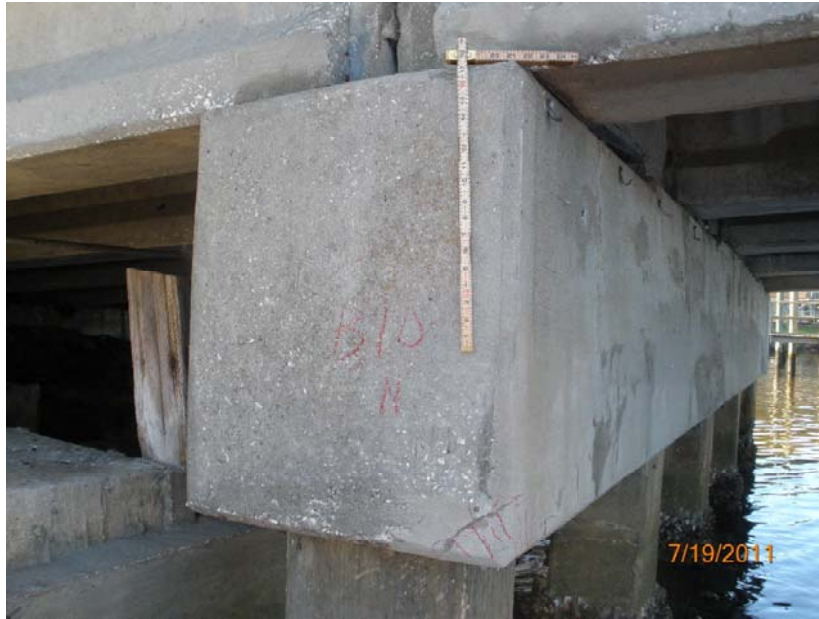
Bent Cap 10 exhibits a 4 in. x 10 in. delamination in the NW edge – NEW. Refer to Photo 47. REPAIR.

PHOTO 47: 234/4 R/Conc Cap

Bent Cap 10 exhibits a 4 in. x 10 in. delamination in the NW edge.

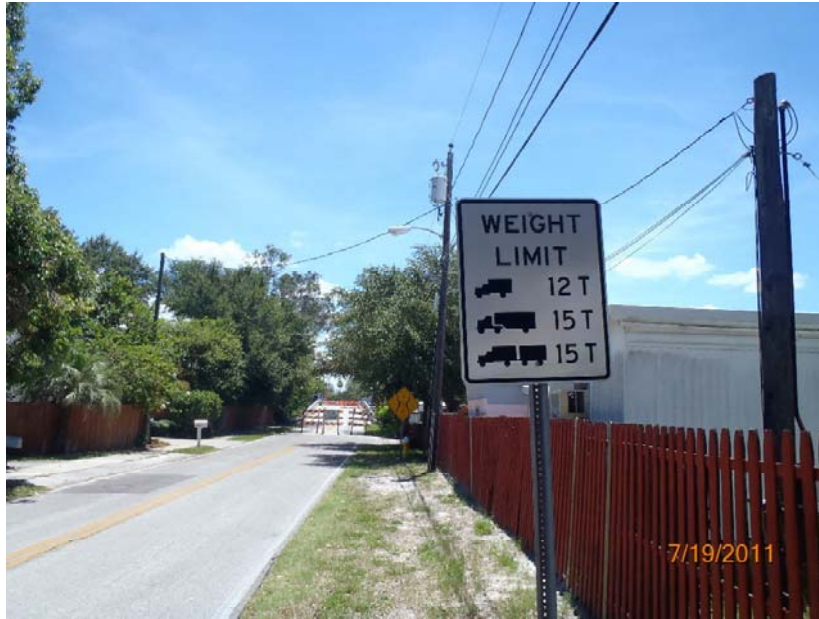
PHOTO 50: West Posting Sign

The bridge is posted. Refer to Photos 50 and 51 for the west and east posting signs respectively.

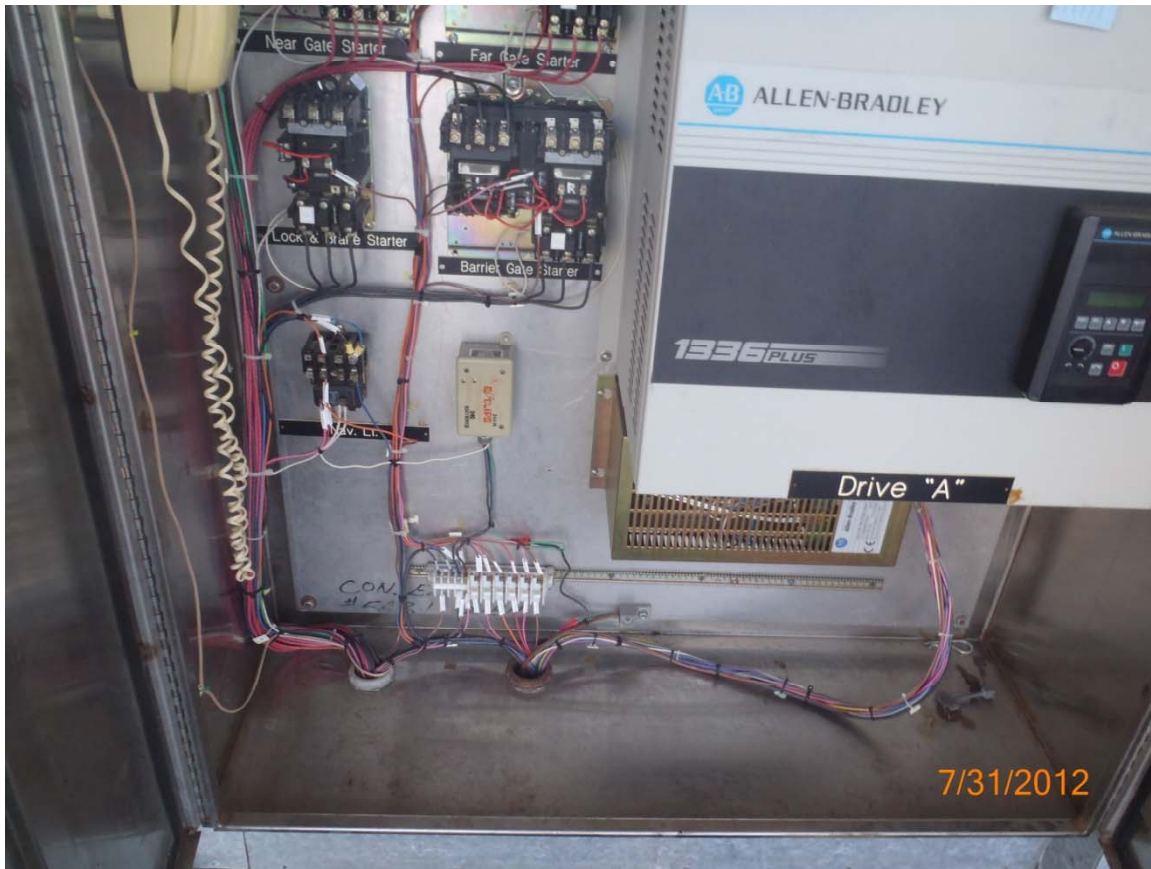
PHOTO 12: 580/4 – Navigational Lights

The UPS backup battery system for the navigational lights has been removed from the bridge. Refer to Photo 12. REPAIR

View of no UPS backup battery system for navigational lights.

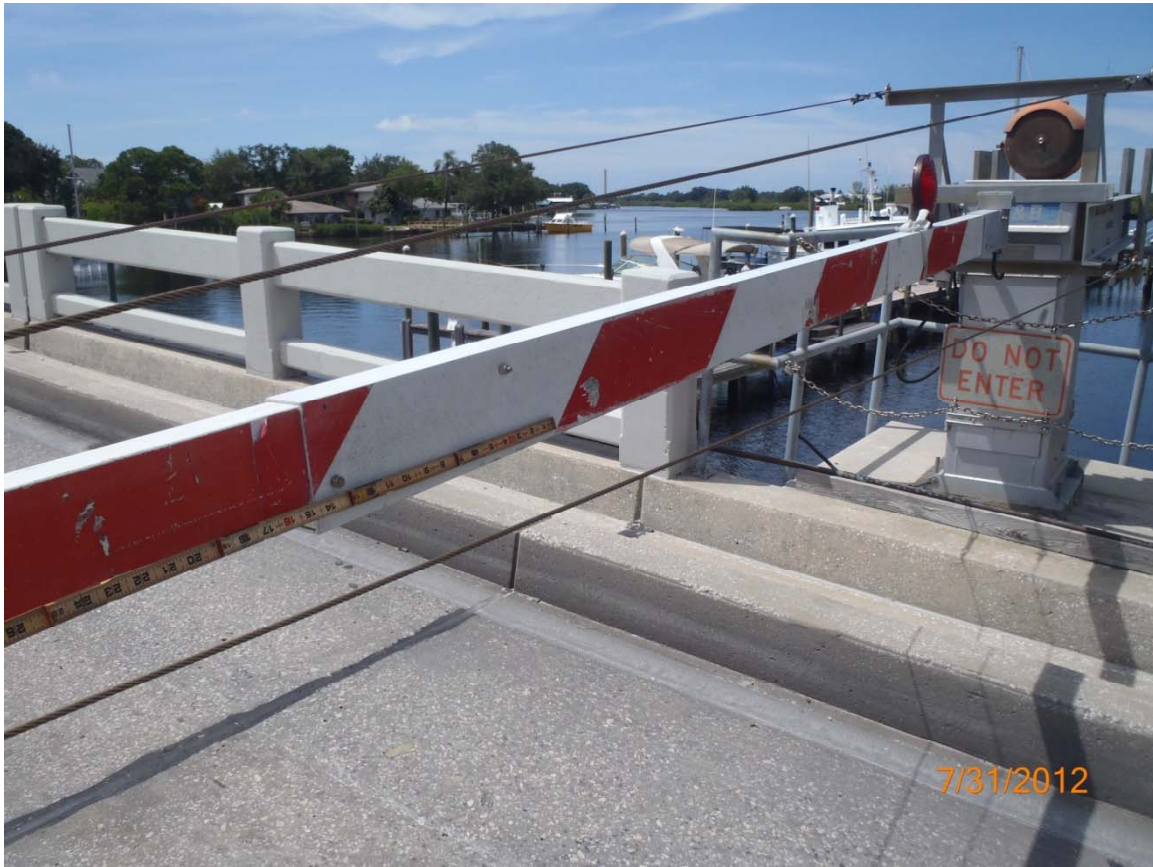
PHOTO 16: 591/4 - Warning Gates

CS2: Both warning gate arms exhibit chipped and faded paint/stripes. Refer to Photo 16. REPAIR

Typical chipped and faded paint/stripes on warning gate arms (near oncoming shown).

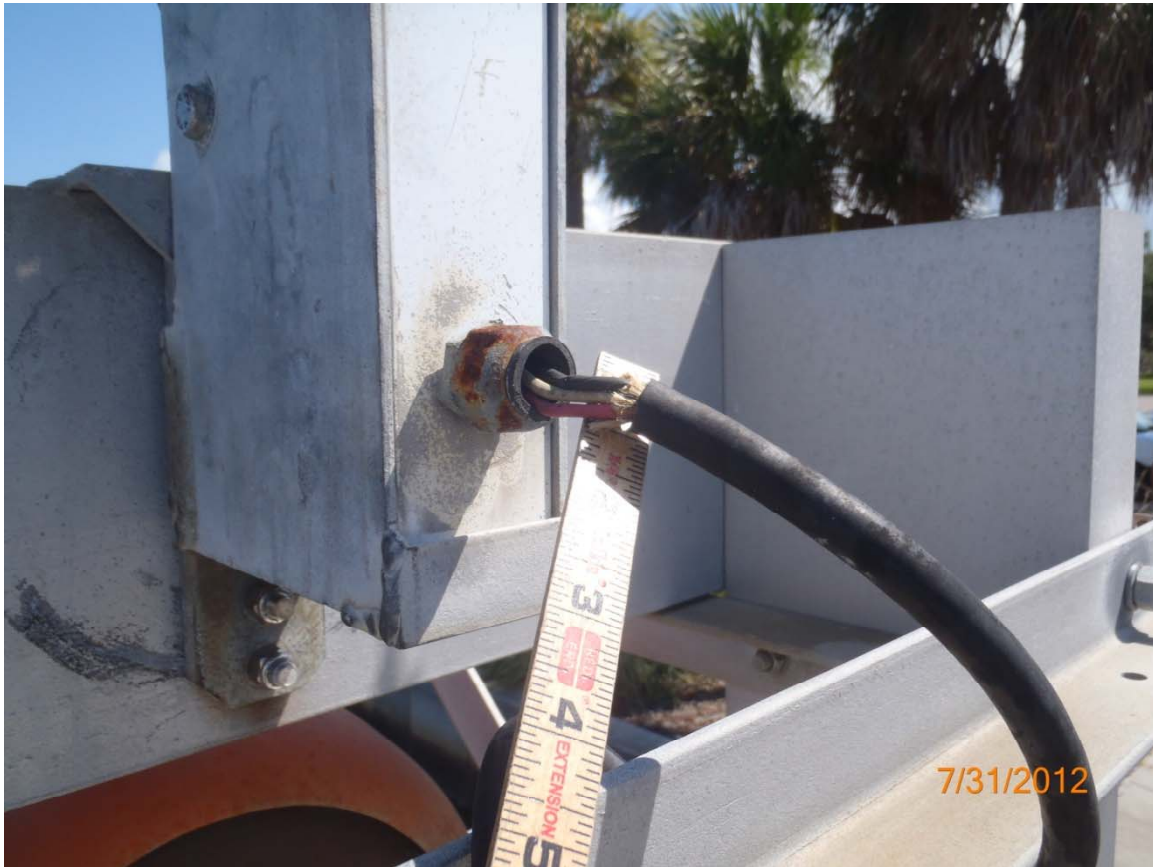
PHOTO 19: 591/4 - Warning Gates

The SO cable for the near oncoming gate has split, exposing the wires - NEW. Refer to Photo 19. REPAIR.

Split SO cable at near oncoming warning gate.

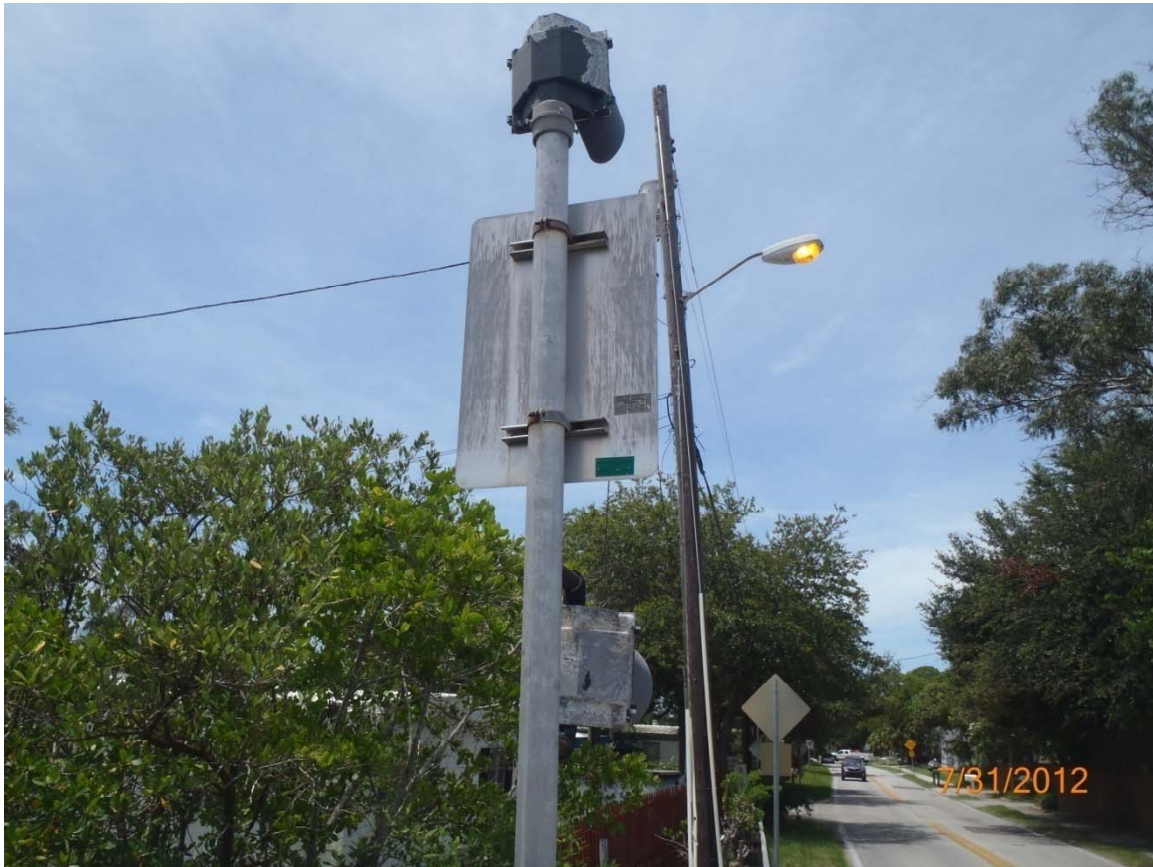
PHOTO 20: 592/4 – Traffic Signals

CS1: All traffic signal light housings exhibit peeling paint. Refer to Photo 20. REPAIR

Typical peeling paint on traffic signal light housings (southwest signal shown).
