Sediment Management Plan For the Watersheds of Clearwater Harbor and Saint Joseph Sound

Prepared for:
Pinellas County
Department of Environment
and Infrastructure

April, 2012

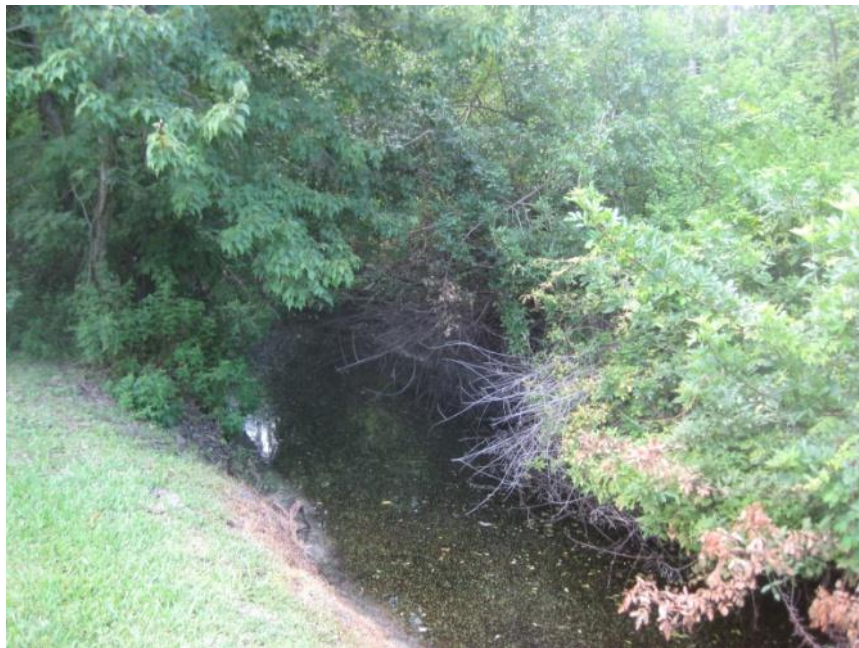
Figure 4-6. Site Klosterman 3 looking upstream.

Site Klosterman 3 was on the Innisbrook Resort grounds near the stream headwaters. The stream was channelized with grassed side slopes (Figures 4-5 and 4-6). Soft sand with fine-grained material had accumulated to a depth of 10 inches upstream of the road crossing and had shoaled to 14 inches deep downstream of the Old Post Road culvert. Although potential issues with sediment accumulation were noted, the stream was on private property and its maintenance may not be a County responsibility

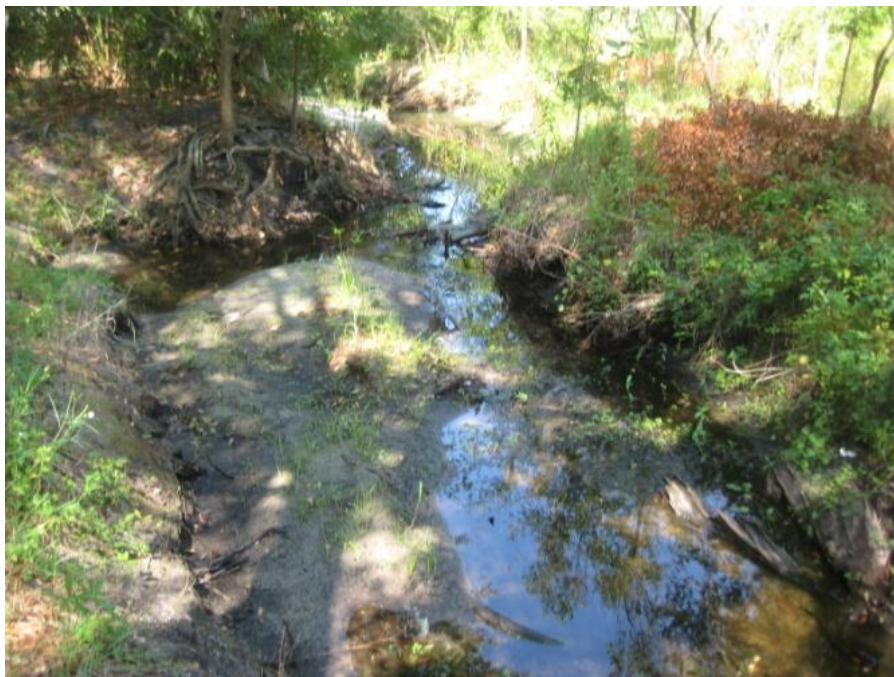
Figure 4-9. Site Bee 1 looking downstream.

Site Bee 1 is the most upstream site, and is located just west of Belcher Road south of Nebraska Ave. Loose silty sand sediment was observed to be approximately 6 inches deep, with significant shoaling as shown in Figure 4-9. Bank undercutting suggests high flow velocities.

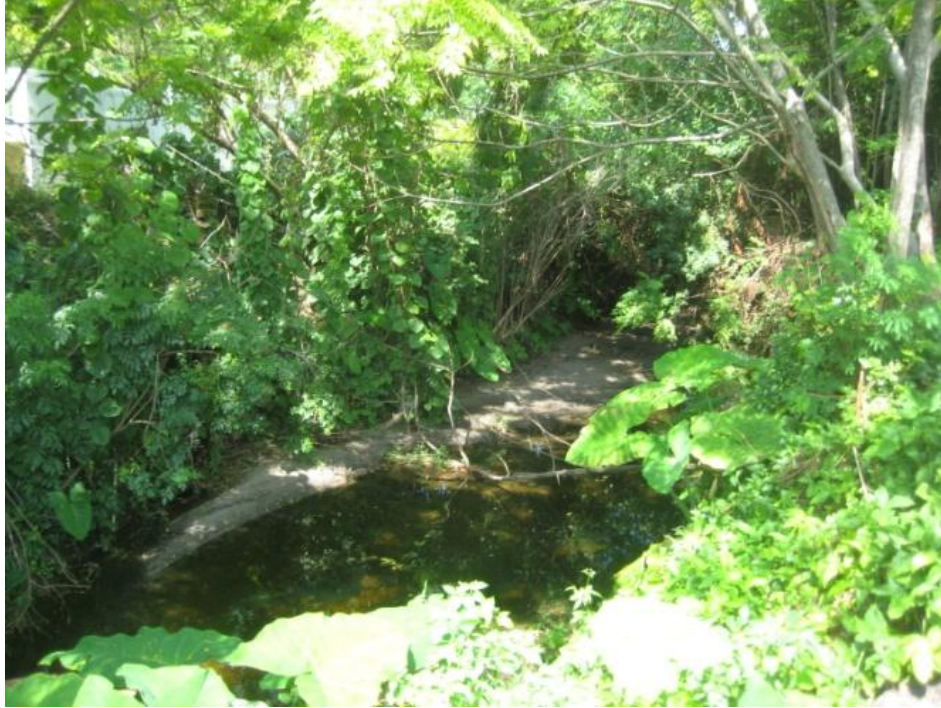
Figure 4-10. Site Bee 2 looking downstream.

Site Bee 2 is located at the 19th Street crossing south of Mary's Meadow Lane. Gabions have been installed on the channel bed, but not banks, upstream and downstream of the box culvert under 19th Street. Sand shoaling downstream of the road crossing (Figure 4-10) averaged about 7 inches deep, with apparent high fine-grained material content. This upper reach of the creek is not as steep as farther downstream, and channel morphometry indicates modest flow velocities.

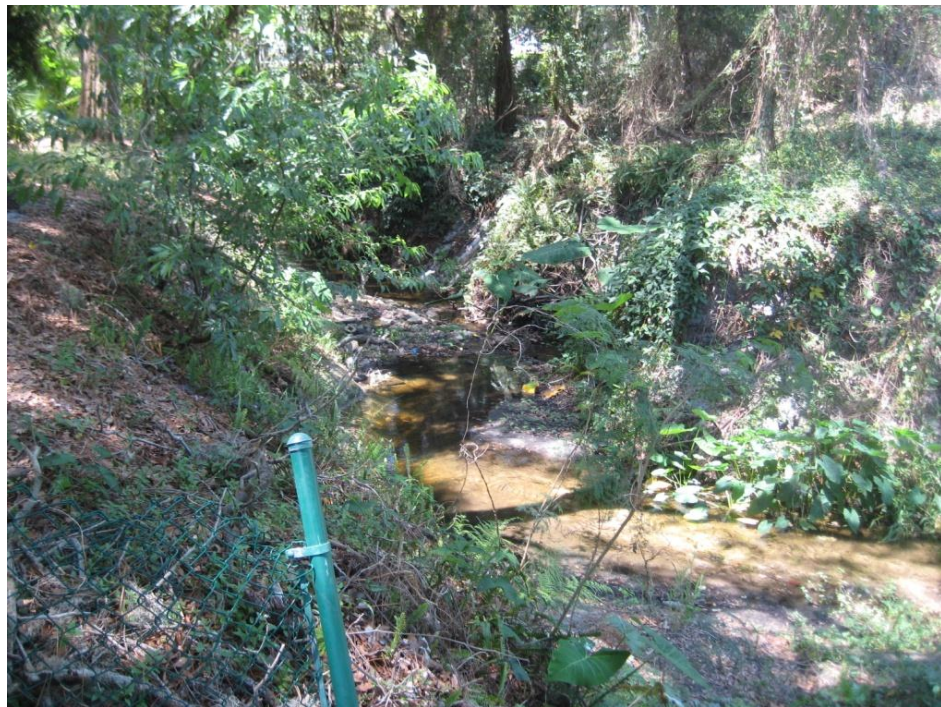
Figure 4-11. Site Bee 3 looking downstream.

Site Bee 3 is farther downstream at the 15th Street crossing, south of Ohio Avenue and north of Tampa Road. A review of a topographic map indicates that the reach downstream of site Bee 3 has a steeper slope than upstream, which would lead to higher in-stream velocities and higher erosion rates. Figure 4-11 shows the steep highly-incised channel banks. Only a thin spotty layer of loose soft sand, about 3 inches, was observed with most of the channel covered in rock and rubble. The relative lack of loose sediment and bank erosion indicates that stream flow likely reaches velocities sufficient to scour loose material and transport it downstream. The reach upstream at 15th Street was somewhat incised (Figure 4-12) but not to the extent seen in the downstream reach.

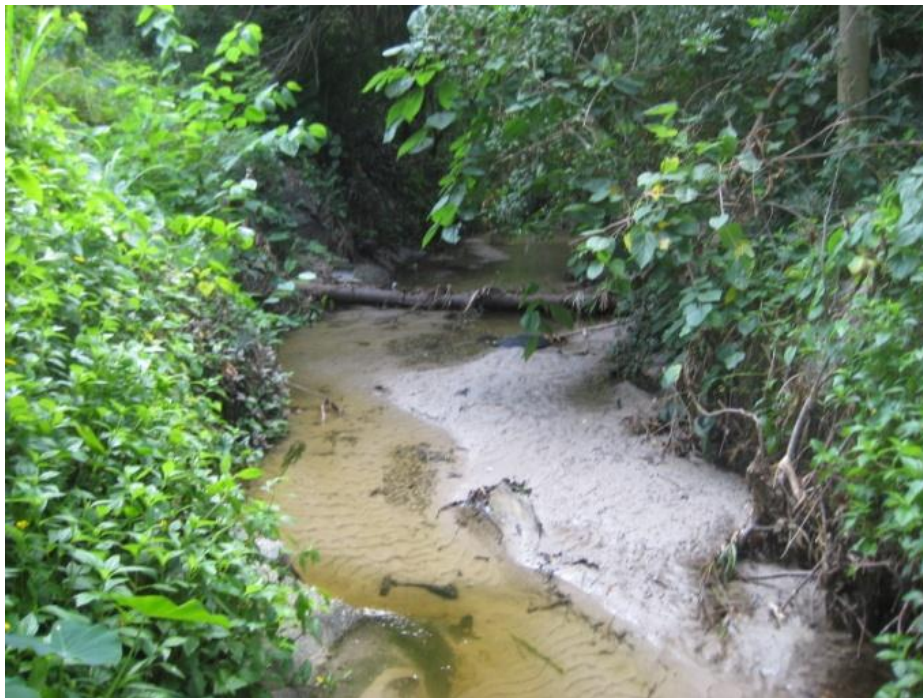
Figure 4-13. Site Bee 4 looking downstream.

Site Bee 4 is located at the downstream end of the steep portion of the creek, at Hidden Brook Drive north of Tampa Road. Figure 4-13 shows that the channel is incised but the vegetated banks indicate that bank erosion is not as high as upstream where the banks are bare in many areas. Soft sand shoals are evident at the site, indicating that flow velocities are likely not as high as upstream, allowing sediment to accumulate.

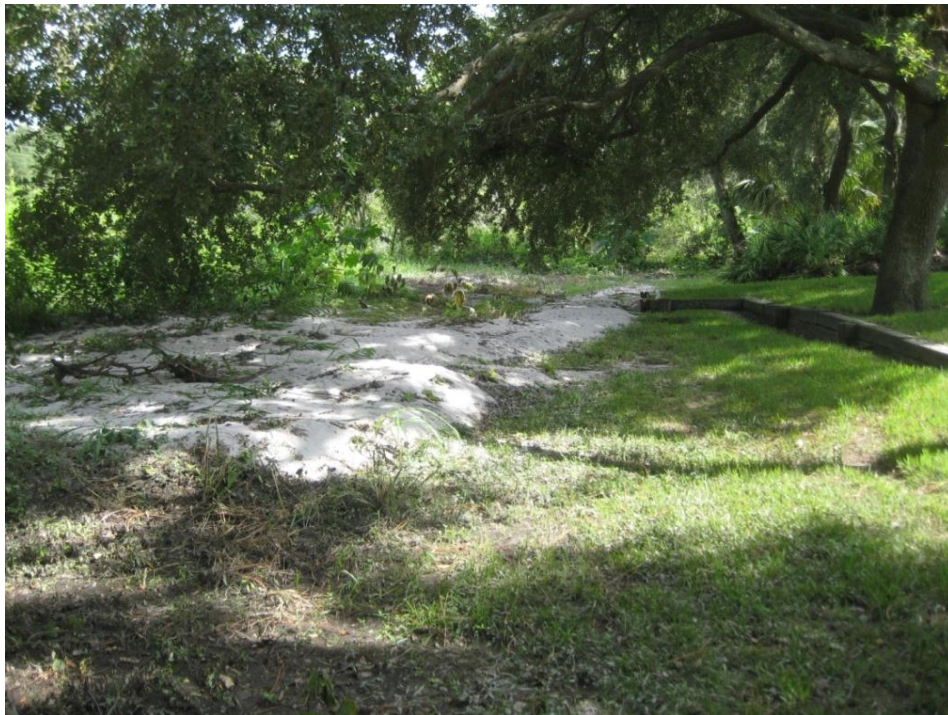
Figure 4-19. Site Curlew 3 - overbank shoaling after high flows.

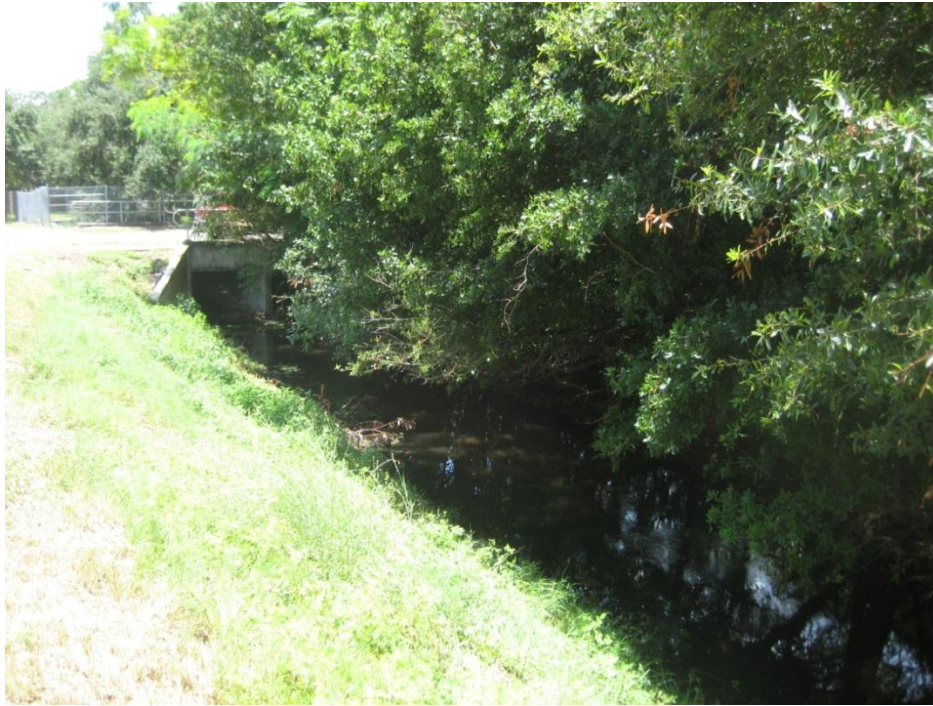
Figure 4-30. Site Curlew 13 looking downstream.

Site Curlew 13 is located east of Cypress Point Drive West, south of Cypress Point Drive North, about 0.4 miles west of Belcher Road. As seen in Figures 4-30, the north bank was overgrown but

the steep south grass bank was typically maintained with spotty bank erosion evident. A sand layer with black fine-grained material about 3 inches thick was encountered.

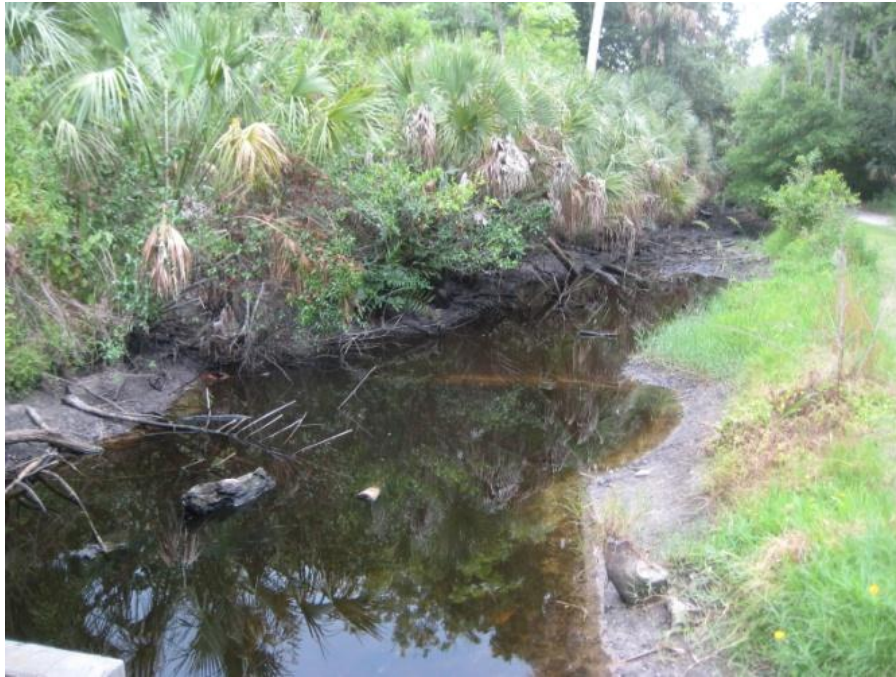
Figure 4-35. Site Cedar 3 looking upstream.

Site Cedar 3 is located in the park at Sugarberry Trail (Figure 4-35). There was substantial detritus in the shallow banked creek channel with a thin film of fine-grained silt on the bottom.

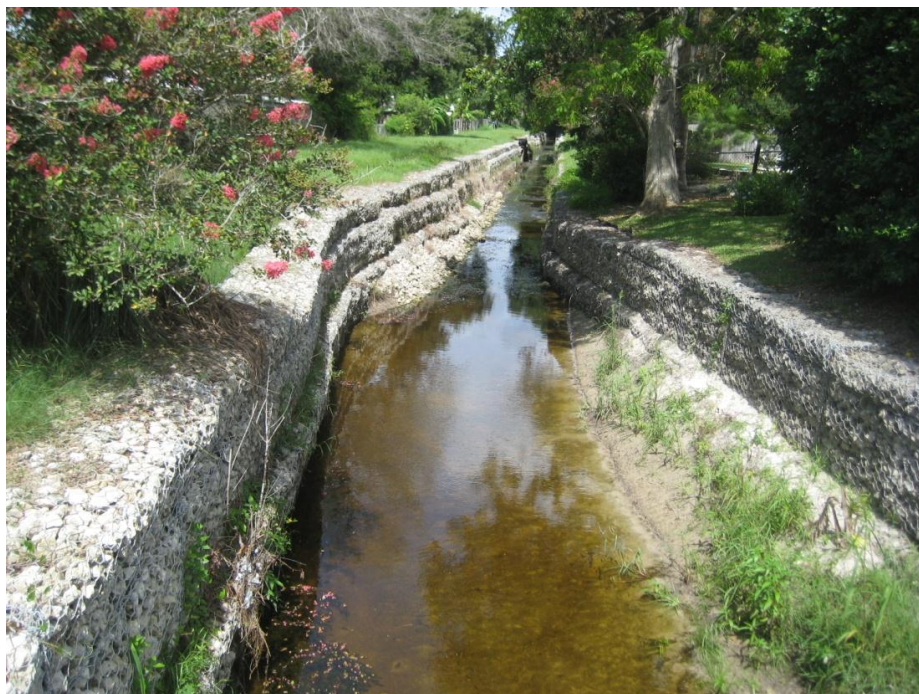
Figure 4-36. Site Cedar 4 looking upstream.

Site Cedar 4 is the most upstream site, located at the Pinehurst Road crossing (Figure 4-36). Although the channel is lined with gabions there is still sand shoaling evident.

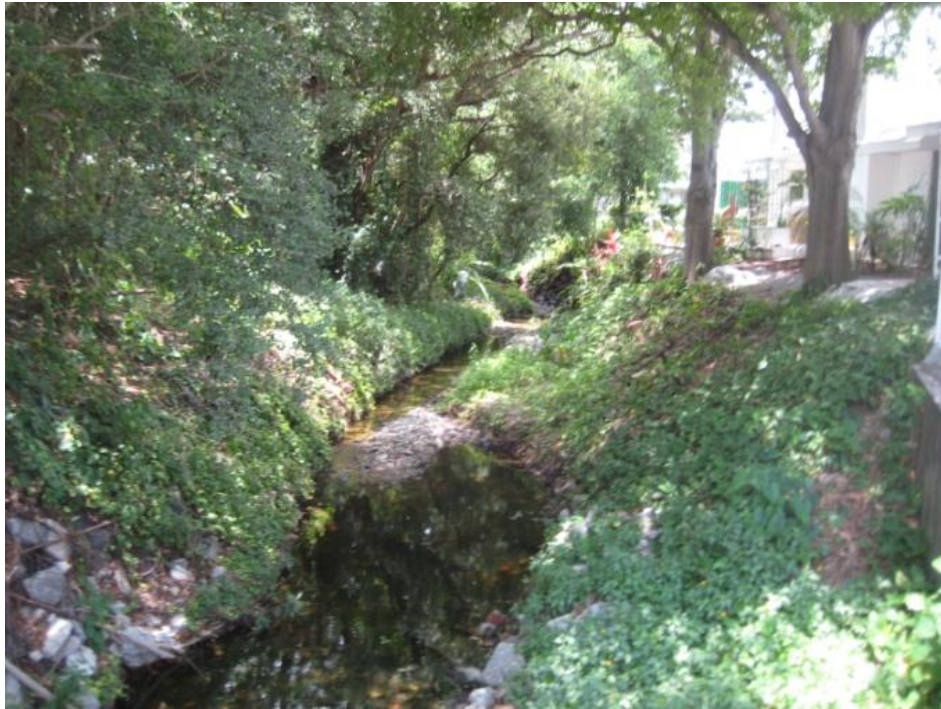
Figure 4-39. Site Stevenson 1 looking downstream.

Site Stevenson 1 is the farthest upstream, located at Bellevue Boulevard near South Evergreen Avenue. The channel was piped upstream of the site. The channel downstream had a gravel bed but did have a sandy shoal as shown in Figure 4-39. The downstream reach is subject to significant bank erosion. Local residents have had to use rip rap and rubble debris to slow erosion near homes.

Location - Upper Stevenson Creek (site Stevenson 1) downstream of Bellevue Blvd. (Figure 5-8)

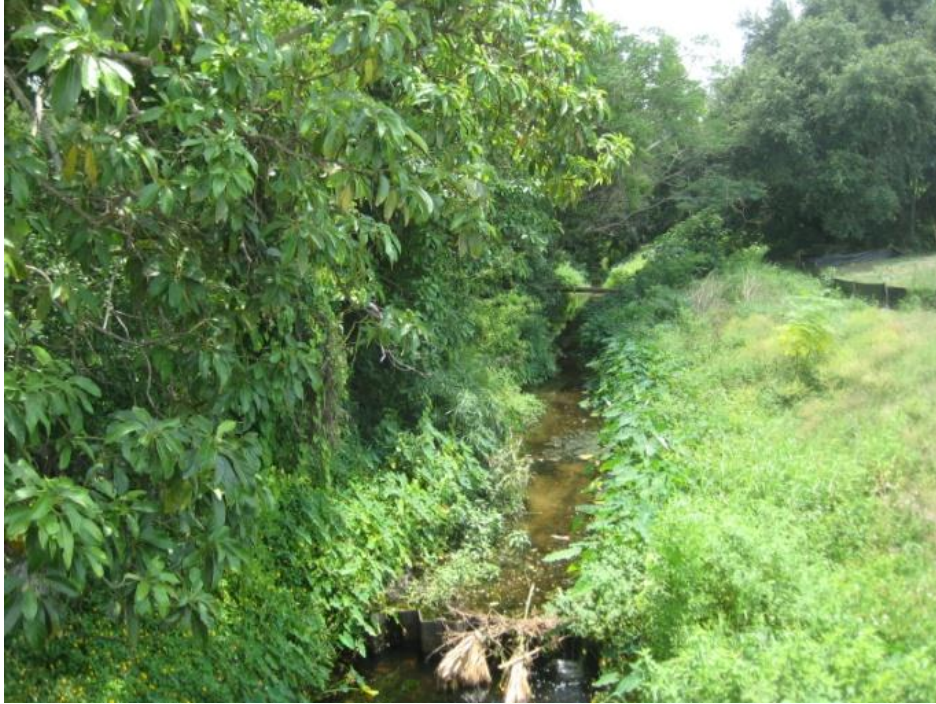
Figure 4-41. Site Stevenson 2 looking upstream.

Site Stevenson 2 is located at the Lakeview Road bridge west of Hillcrest Drive. A large sand shoal had developed under the bridge as shown in Figure 4-40. The reach is channelized with a sediment layer of approximately 5 inches of loose sandy silt and patchy fine-grained sediment (Figure 4-41). Although sediment transport is evident it is likely of nearby origin, as a stormwater in-line pond about 0.7 miles upstream of this site should act as sediment sump for material originating farther upstream.

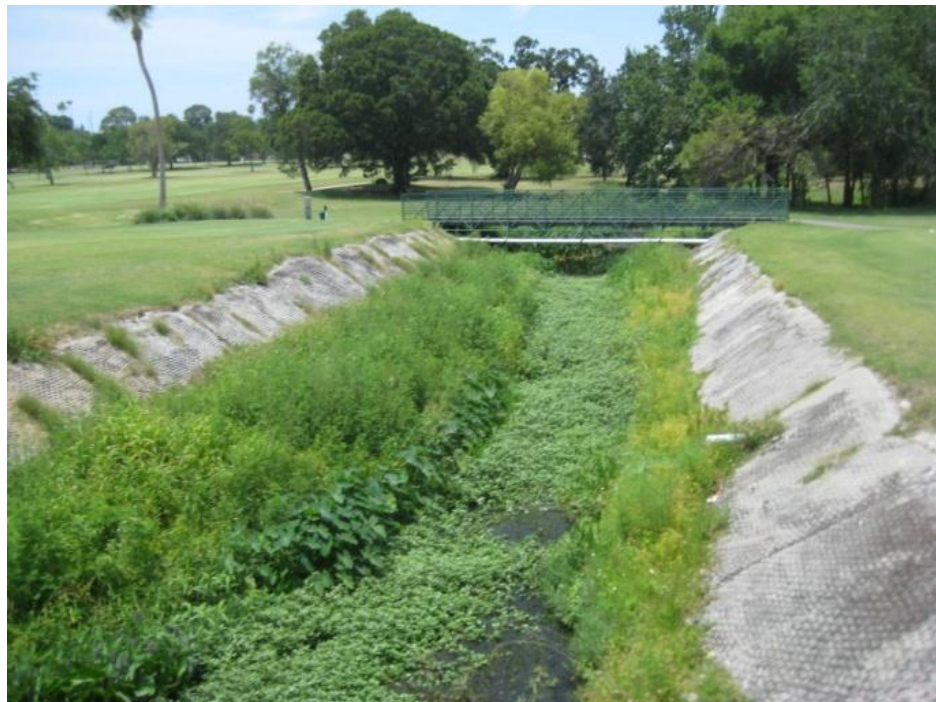
Figure 4-42. Site Stevenson 3 looking downstream.

Site Stevenson 3 is located at Drew Street east of Betty Lane (Figure 4-42). The channel is concrete-lined both north and south of the bridge but there was an average of 3 inches of silty and mucky

sand on the channel bottom. This reach receives high volumes of runoff from downtown Clearwater.

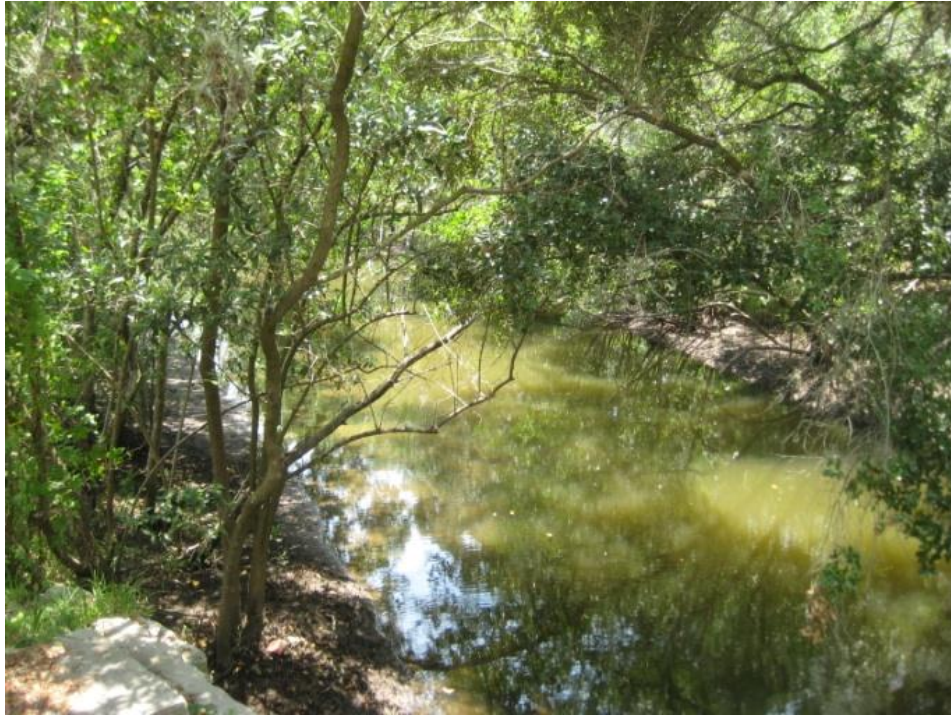
Figure 4-47. Site Spring Branch 1 looking upstream.

Site Spring Branch 1 is located at the Overbrook Avenue crossing near the stream mouth. The creek is tidal with shallow banks at this location and had a loose sand layer with substantial fine-grained content about 4 inches thick, as shown in Figure 4-47.

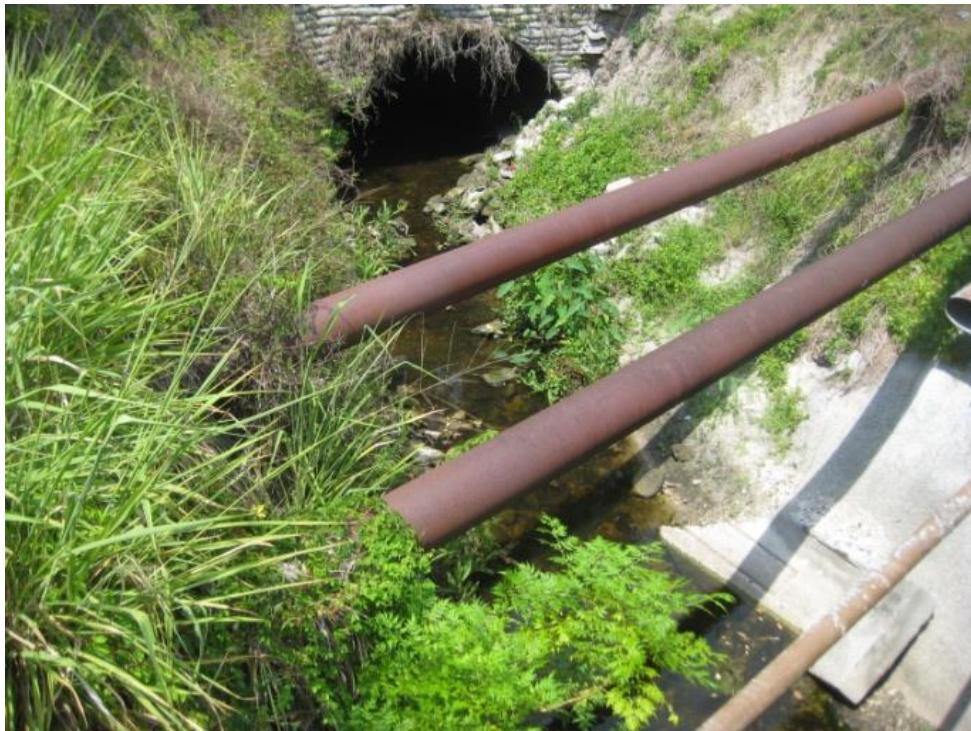
Figure 4-48. Site Spring Branch 2 looking upstream.

Site Spring Branch 2 is located at the Sunset Point crossing west of Betty Lane, shown in Figure 4-48. The site is located near Pinellas County water monitoring site 15-04. A section of the upstream channel is concrete-lined. The downstream reach has a gravel bed with minimal sediment.

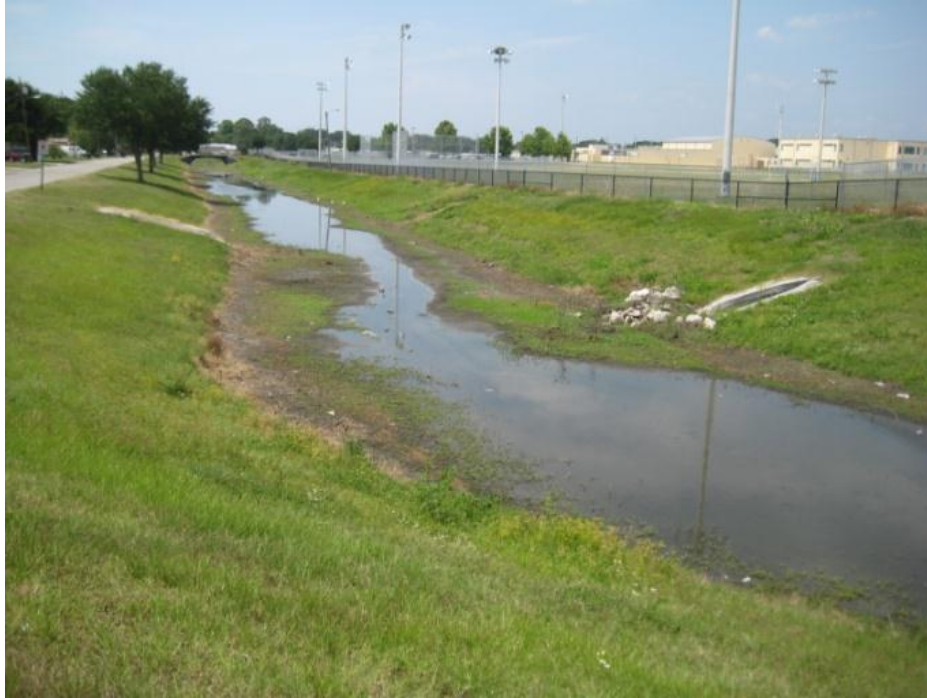
Figure 4-49. Site Spring Branch 3 looking upstream.

Site Spring Branch 3 is located north of Union Street west of the Dunedin Middle School. The channel is a shallow drainage swale with grassed banks with a thin layer of silty sand in the channel bed as shown in Figure 4-49. Water was stagnant at the time of inspection.

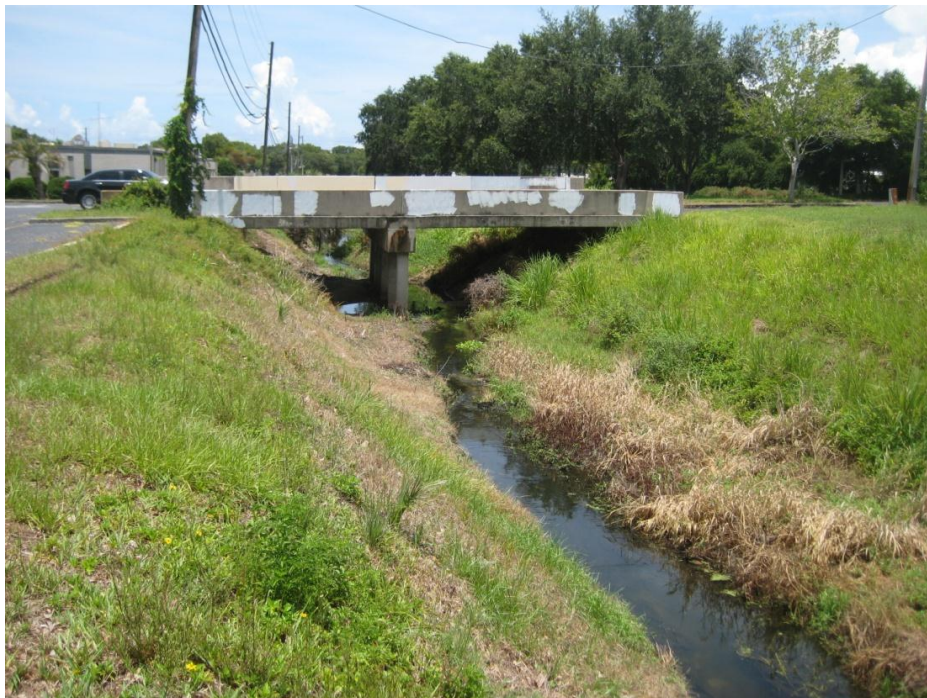
Figure 4-50. Site Spring Branch 4 looking downstream.

North of the school the creek is incorporated into a trailer park drainage system, and then continues farther east and north. Spring Branch 4 is the farthest upstream site visited, located east of Patricia Avenue and south of Cedarwood Drive (Figure 4-50). The channel is prismatic with a commonly observed trapezoidal configuration. Although the steep side slopes were grassed, isolated bank slumping was observed. The bottom contained algae mats and 1 – 2 inches of soft sand.

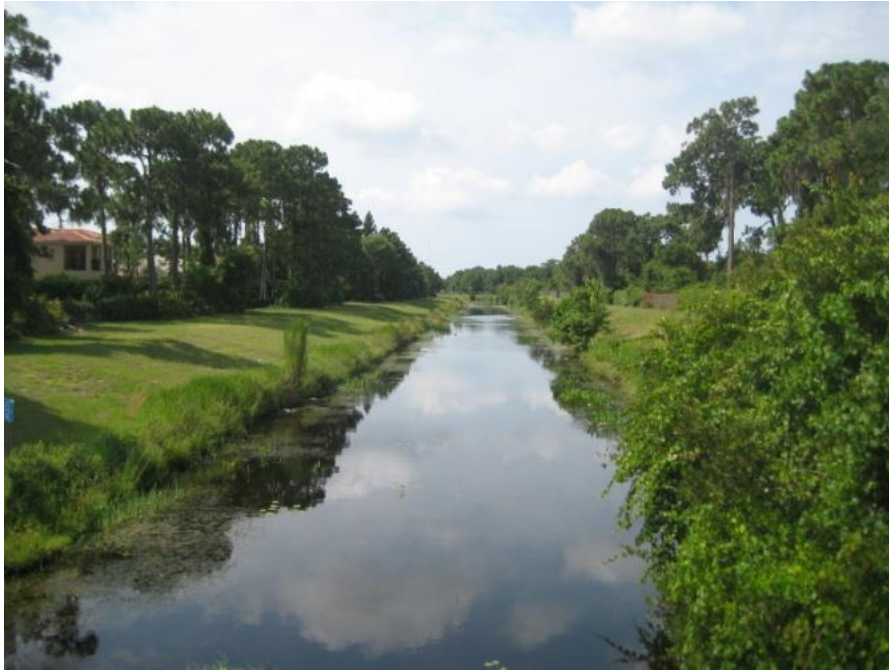
Figure 4-53. Site McKay 1 looking downstream.

Site McKay 1 is the most upstream site visited and is located at the crossing at 102nd Avenue. As shown in Figure 4-53 the channel south of 102nd Avenue has been dredged and is maintained. The depth of loose sand at the site averaged 6 inches. The channel bottom was relatively clean with only patchy silty and fine-grained material visible.

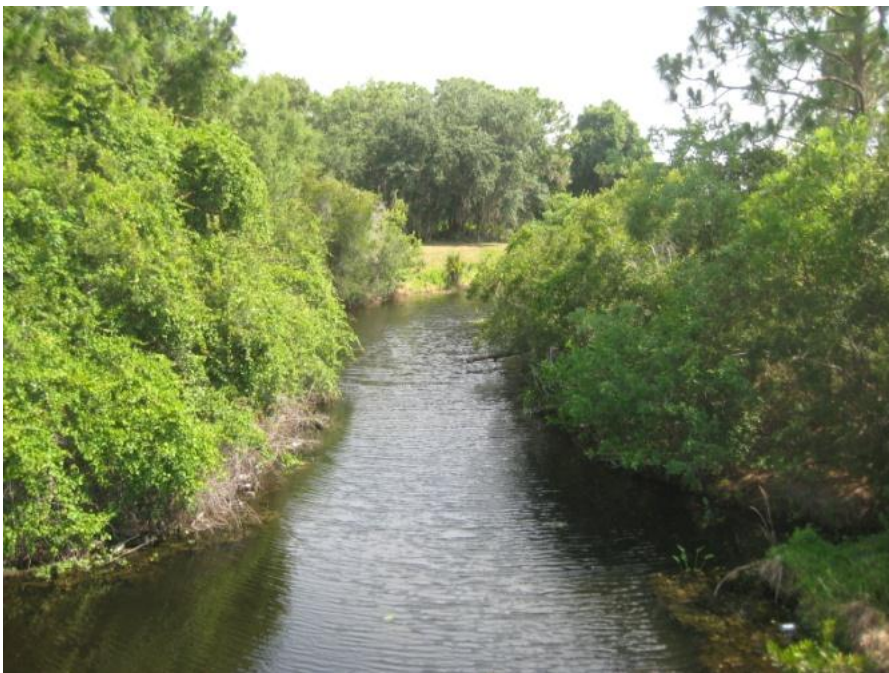
Figure 4-54. Site McKay 1 looking upstream.

In contrast, the channel south (upstream) of 102nd Avenue is much narrower and the channel sides are not so well maintained (Figure 4-54).

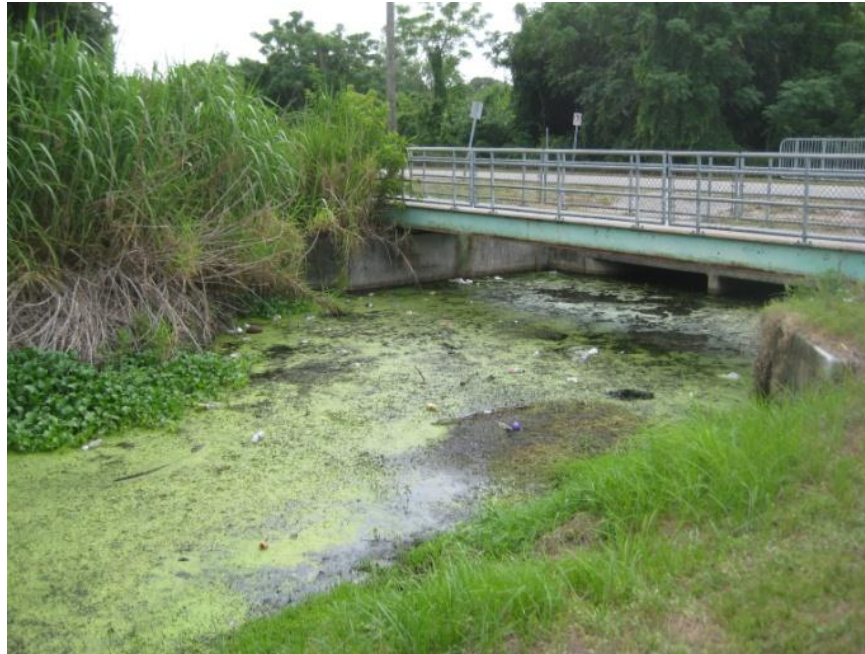
Figure 4-55. Site McKay 2 looking downstream.

Site McKay 2 is located in Heritage Park north of Walsingham Road. The creek is open water (Walsingham Reservoir) between 102nd Street and Walsingham Road. The site, which is near Pinellas County water quality monitoring site 27-10, is shown in Figure 4-55. Just upstream of the site the channel is very overgrown and had a loose sand layer with substantial fine-grained material measured to be 6 – 10 inches thick. It is likely that much of the sediment at this site is of local origin, as the upstream reservoir acts as a sediment sump.

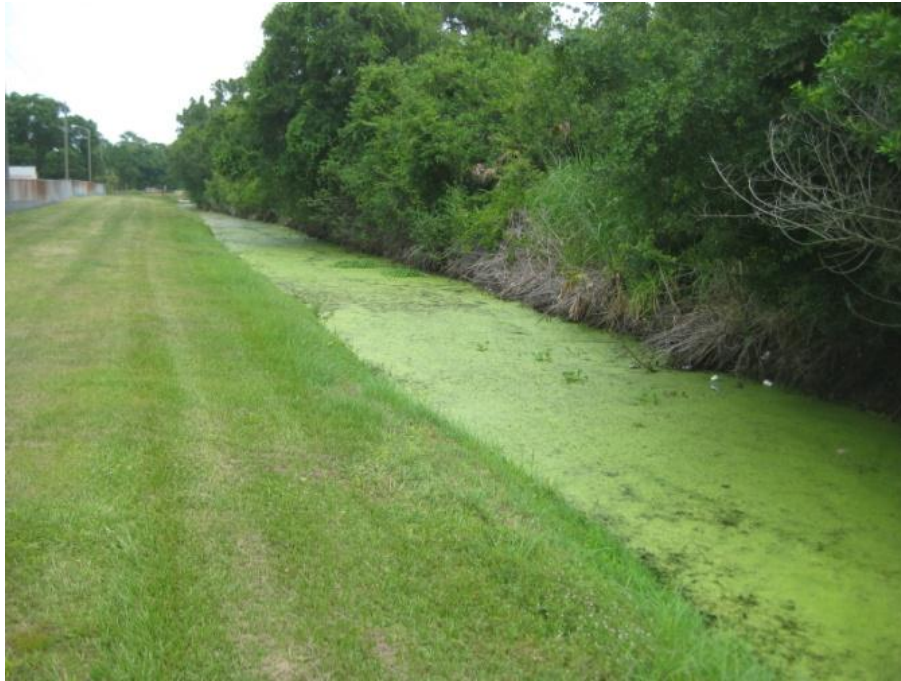
Figure 4-56. Site McKay 3 looking downstream.

Site McKay 3 is located north of 134th Avenue and west of 121st Street. As seen in Figure 4-56 the channel is maintained with a shallow grassy bank on the west side and is overgrown on the east bank. This reach had a significant fine-grained muck layer averaging 18 to 20 inches at the site. The water surface was covered with duckweed and abundant trash.

Location - McKay Creek site McKay 3 north of 134th Ave near Ulmerton Rd (Figure 5-3)

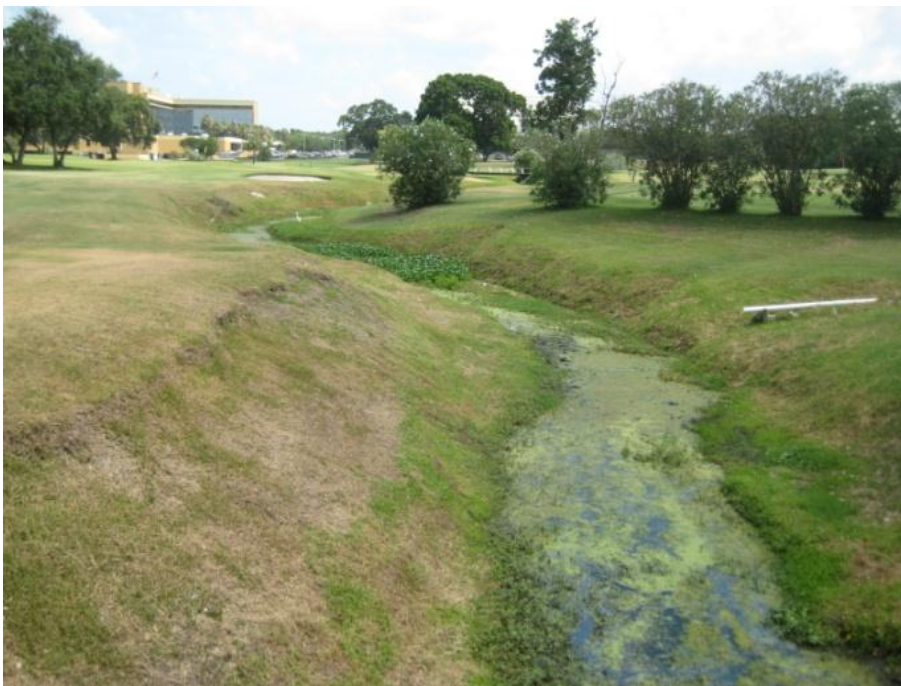
Figure 4-57. Site McKay 4 looking downstream.

Site McKay 4 is located north of 8th Avenue SW at Pine Crest Golf Course. The channel has grassy banks and crosses the golf course (Figure 4-57). A weir at the site retains water and presumably sediment upstream, as shown in Figure 4-58. Loose sand was approximately 2 inches deep below the weir and 3 inches deep above it.

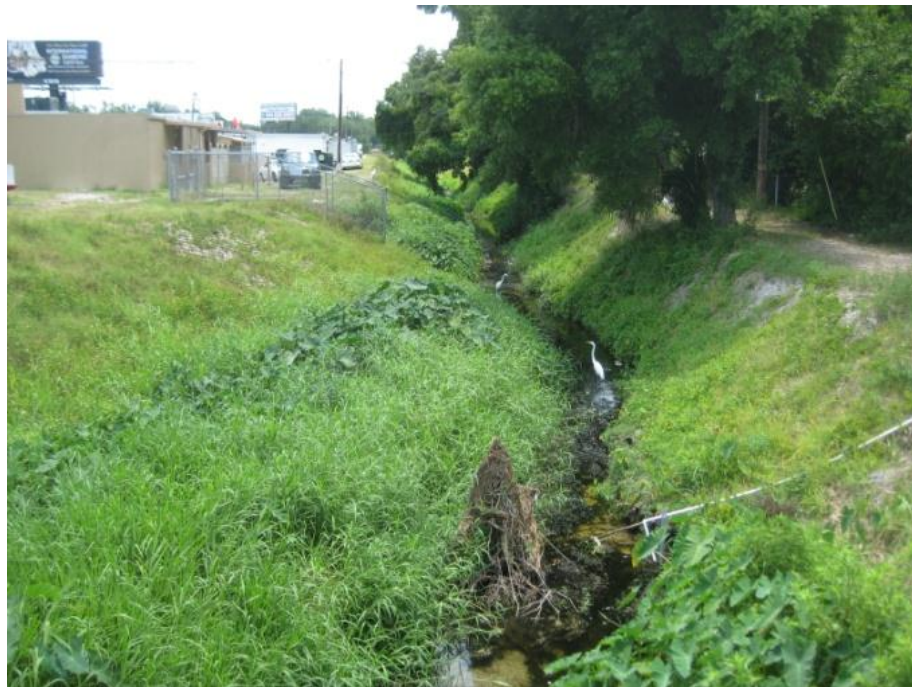
Figure 4-59. Site McKay 5 looking downstream.

Site McKay 5 is located at the 20th Street crossing south of West Bay Drive (Figure 4-59), near Pinellas County water quality monitoring site 27-09. Data indicate that the site is freshwater with salinity averaging 0.3 ppt. Whether the tide levels affect the water level in the stream at this location is unknown. This site marks the location of the channel as it turns to flow back to the south. The channel has concrete lining adjacent to the bridge and is otherwise incised with vegetated banks. The grass growing along the edges of the channel bottom supports a fine-grained layer approximately 4 inches deep. The clean channel center has a sand and gravel bottom and

minimal fine sediment was observed. This reach is narrower than several upstream reaches so flow velocities must be high at the site, leading to the scour and transport of fine grained sediments.

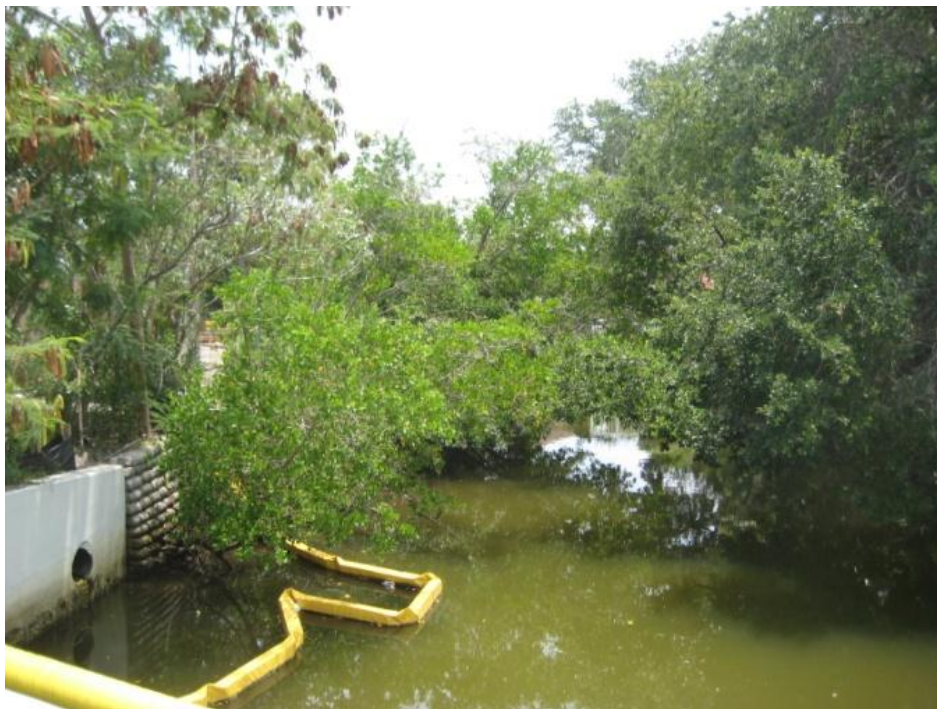
Figure 4-61. Site McKay 7 looking upstream.

Site McKay 7 is the most downstream site and is located at Indian Rocks Road. The channel is tidal and had sea walls on both sides as shown in Figure 4-61. Deep (24 inches) black anoxic fine-grained muck was observed along the seawall.

Location - McKay Creek site McKay 7 at Indian Rocks Road (Figure 5-4)

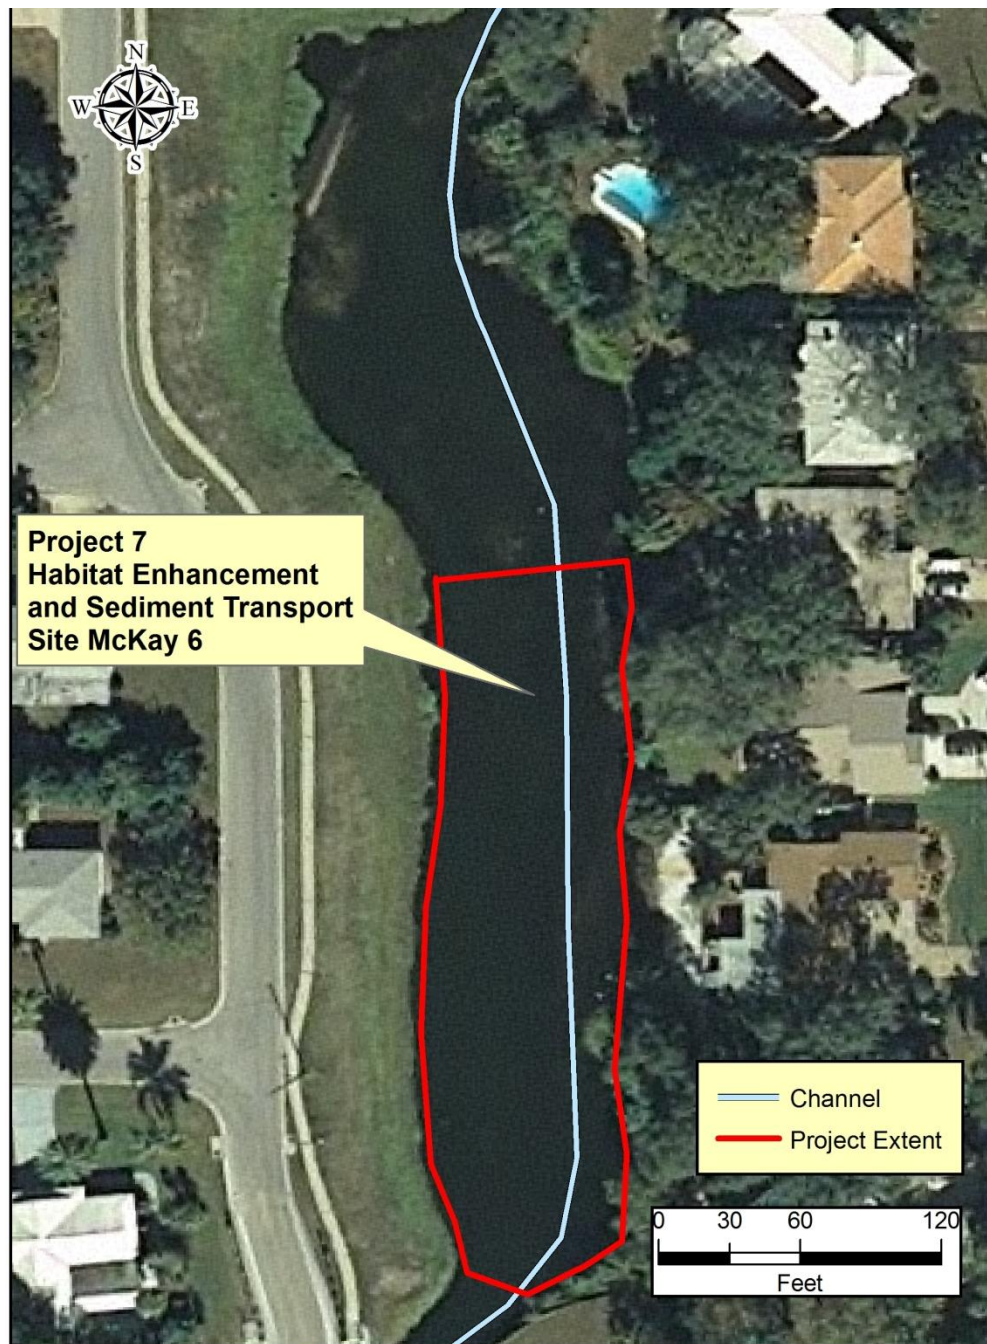
Figure 5-6. Project 7 at site McKay 6.

Description – Opportunities exist to enhance habitat and reduce sediment transport in lower McKay Creek (Figure 5-6). The subject site now acts as a sediment sump, but only by virtue of stream flow velocity slowing in the widened channel. Excess sediment is currently dredged from the water body, but the material is not confined to a portion of the site, making effective dredging operations difficult. Additionally, the site is entirely open water surrounded by private yards on the east side and a public grassed open space on the west side.

Both this issues could be addressed by transforming the water body into a multi-cell system. The upstream cell would remain deeper open water and would serve as the sediment sump. A berm constructed across the site would act to contain the sediment in a more confined space, making dredging more efficient. The berm could be constructed to be structurally sound during all flow events, with a spillway to allow high flows to pass.

Habitat enhancements could include vegetating the berm, and making the downstream portion of the site a series of wetlands with interconnecting flow paths. A high flow channel would be maintained to convey flood waters. Woody plants could be planted along the bank or on built-up hammocks within the water body. Deeper pools would provide fish and bethic refugia.
