Bridge Replacement Study (Phase 1)

San Martin Boulevard over Riviera Bay Bridge

**Project Number 154371
Pinellas County**

HDR Engineering, Inc.

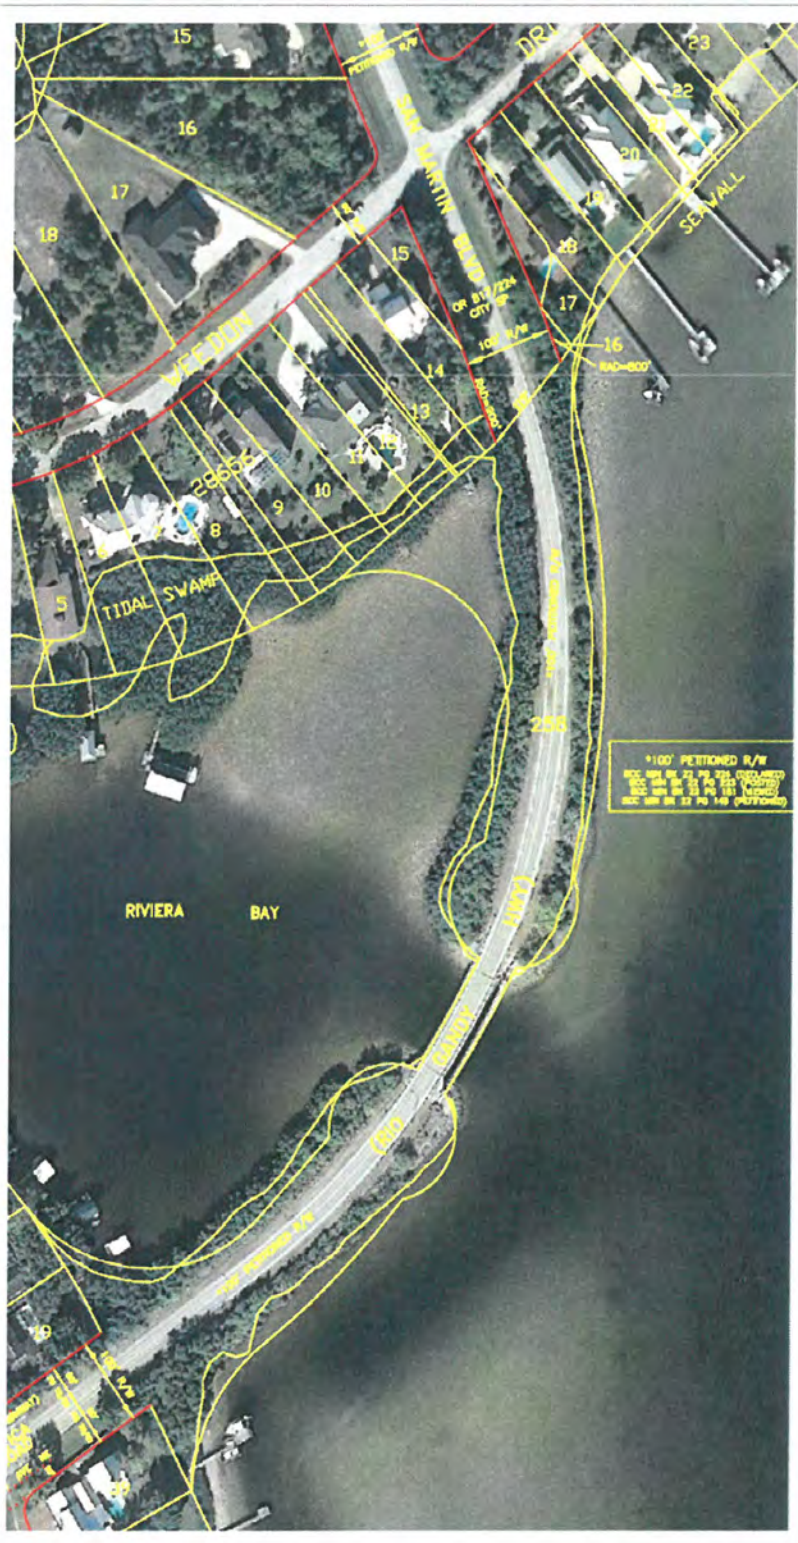
Figure 3-2 – Right-of-Way

Roadway surface, [Figure 3.1](#), consist of an asphalt surface that continues across the bridge. The existing bridge should be rehabilitated or replaced within the current alignment due to the proximity of existing homes and limited right-of-way at the proposed project location. At the approach roadway locations, the right-of-way is 100-ft and restrained due to the existing homes on either side of the Bay, [Figure 3.2](#). For this initial Phase 1 work, Right-of-way maps were not provided. The posted speed for this area is 35 mph.
