Beckett Bridge

Project Development & Environment (PD&E) Study

February 2015

Preliminary Engineering Report **Volume 1: Documentation**

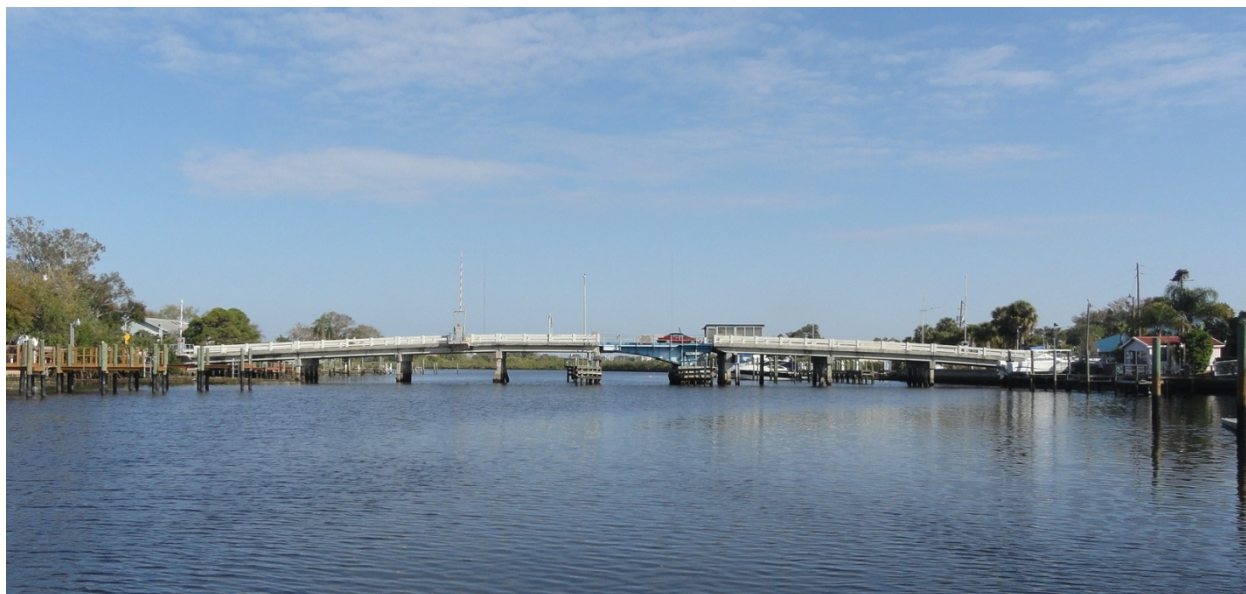
Beckett Bridge – Elevation View

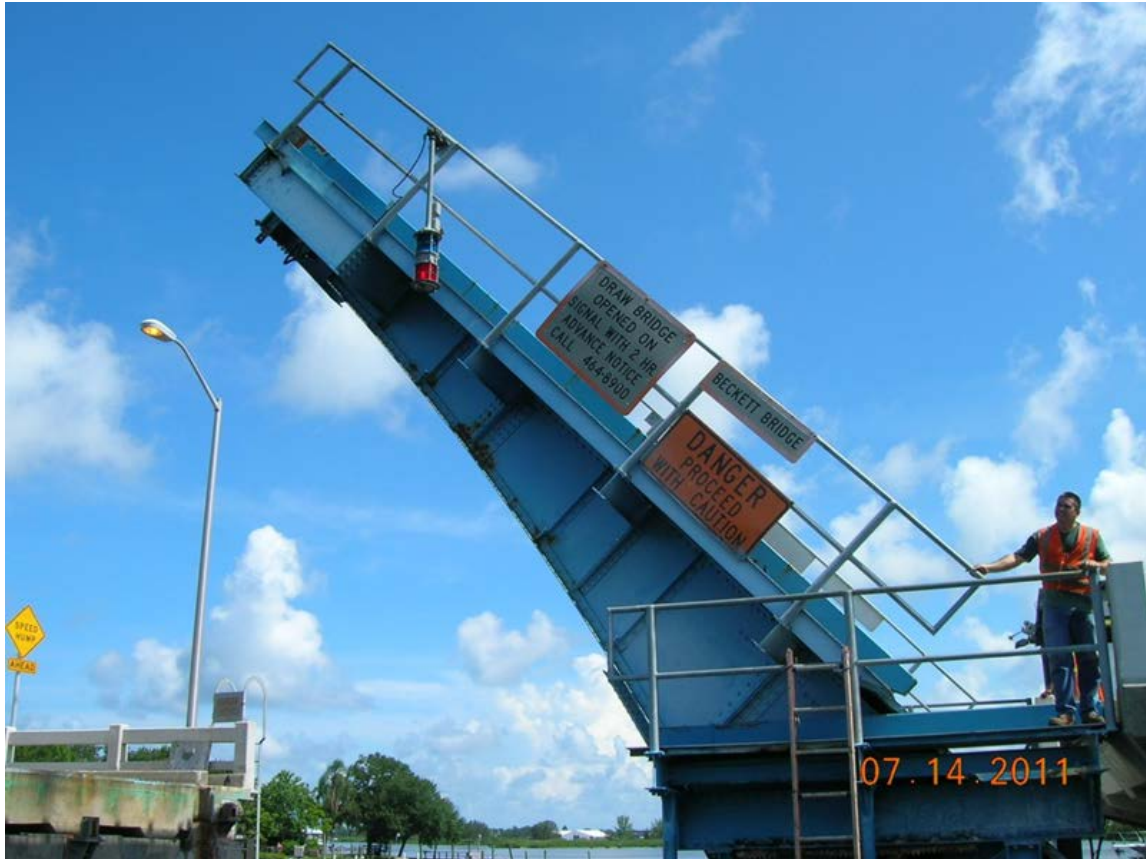
There are no official USCG navigational clearance guidelines for this waterway at this location. The existing vertical clearance at the fenders is six feet. The tip of the bascule leaf overhangs the fender with the leaf fully raised, limiting the clearance for a portion of the channel between the fenders. It is likely that unlimited vertical clearance was provided for the entire width of the channel when the bridge was originally constructed. The existing horizontal clearance between the fenders is 25 feet.

Bascule Leaf in Full Open Position

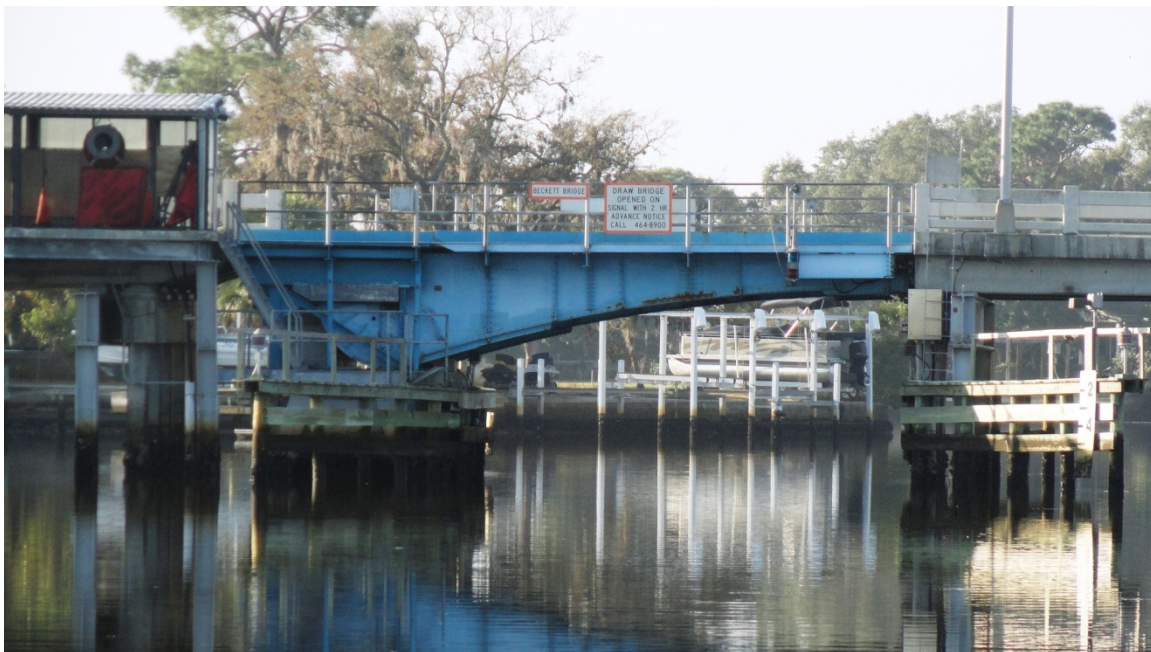
Bascule Leaf in Closed Position

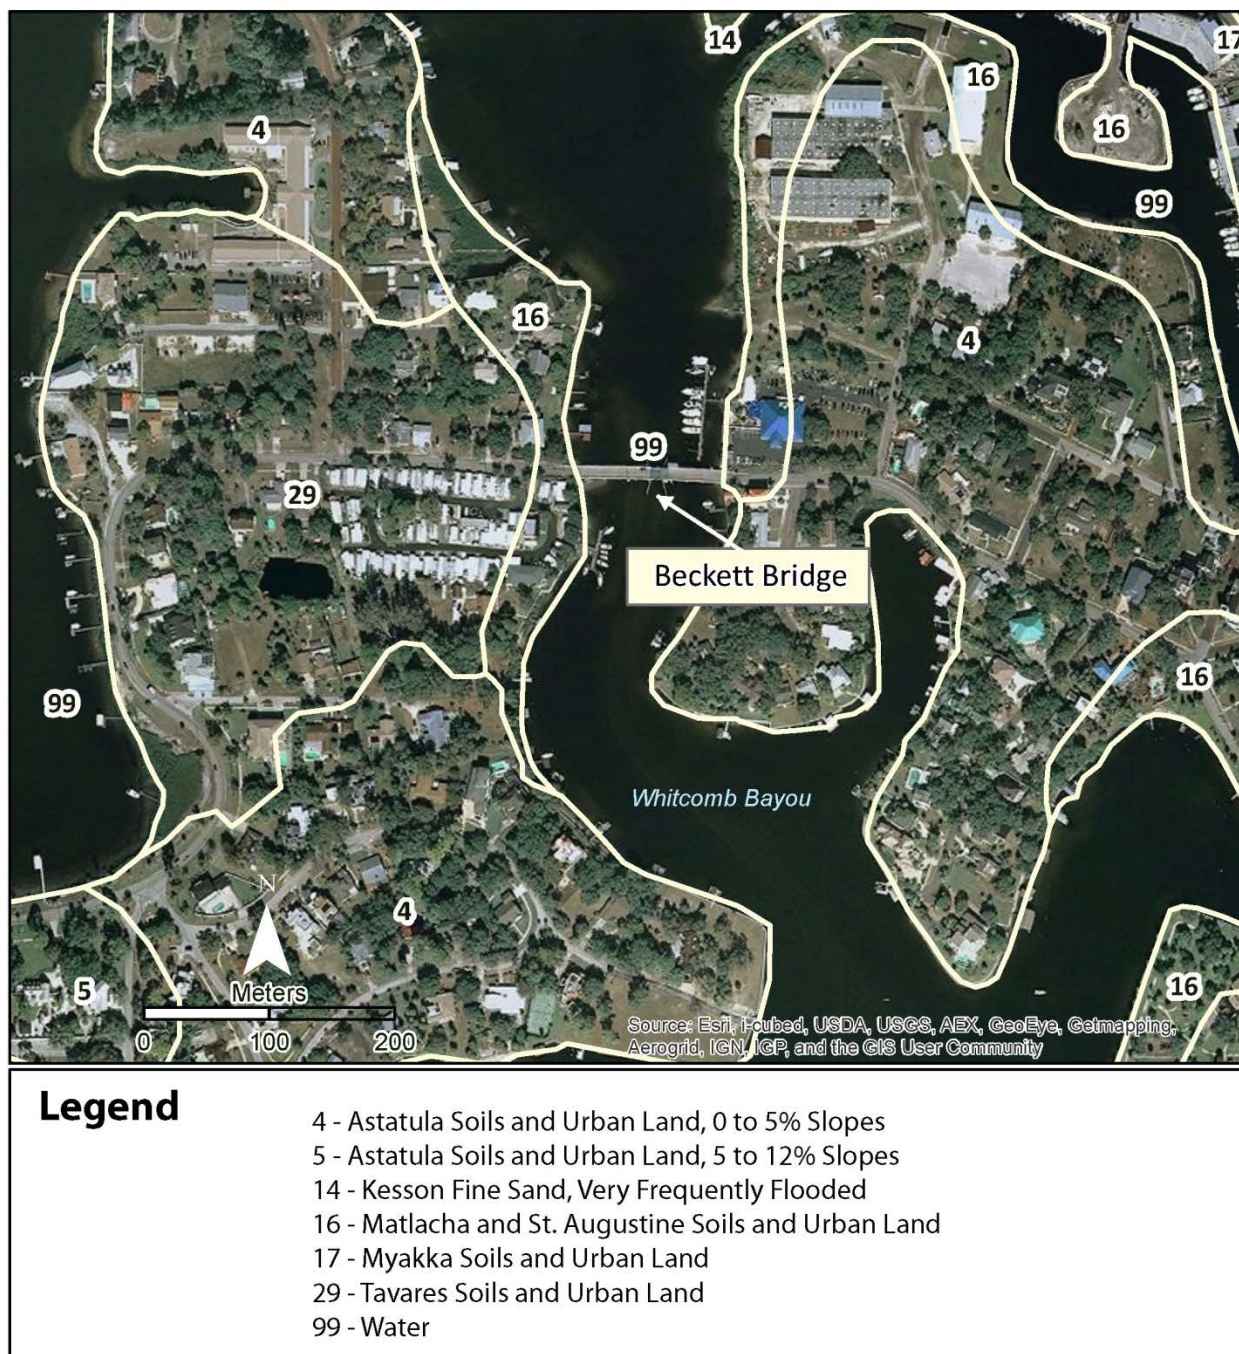
Figure 3-1 – USDA Soils Map

Based on a review of the Pinellas County Soil Survey published by USDA Natural Resources Conservation Service (NRCS), it appears that there are three soil-mapping units noted within the project limits. A detailed soil survey map is shown in **Figure 3-1**. The general soil descriptions are presented in the sub-sections below, as described in the Web Soil Survey. **Table 3-1** summarizes information on the soil mapping units obtained from the Web Soil Survey.

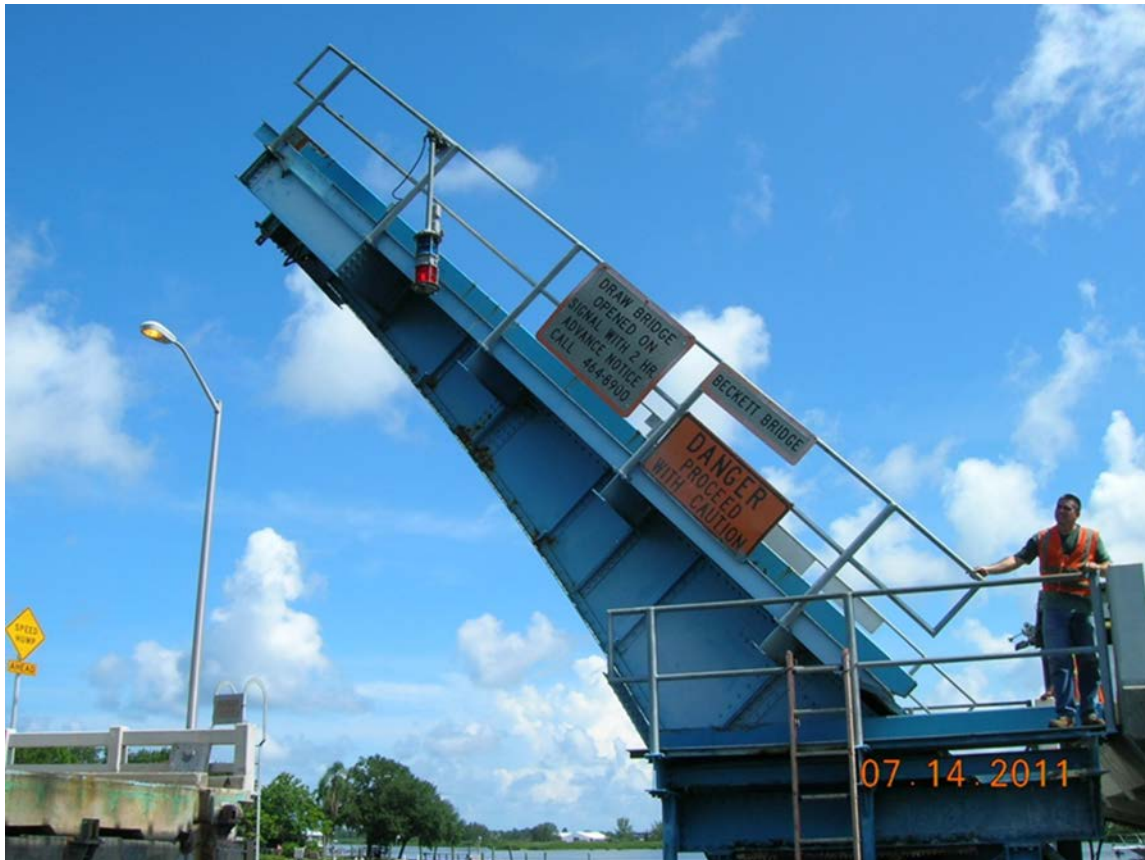
The existing bascule bridge crosses Whitcomb Bayou approximately perpendicular to the channel. Waterborne vessels are guided between the bascule piers by a fender system consisting of timber rub rails attached to driven timber piles. Navigation lights mounted to the fender system and the bascule leaf provides a warning indication. The channel has a minimum horizontal width of 25 feet between faces of fenders. When the bascule leaf is in the closed position there is approximately six feet of vertical clearance at the face of the east fender for the entire width of the channel. When the bridge opens, the leaf rolls away from the channel and rotates to a 49 degree angle. In this open position the bridge provides unlimited vertical only between the west fender and the tip of the span of approximately 14 feet. The remaining 11 feet of the channel is obstructed by the raised bascule span.

Bascule Leaf in Full Open Position – Unlimited Clearance Restricted
