Beckett Bridge *PD&E Study*

Rehabilitation Alternative (No Widening)

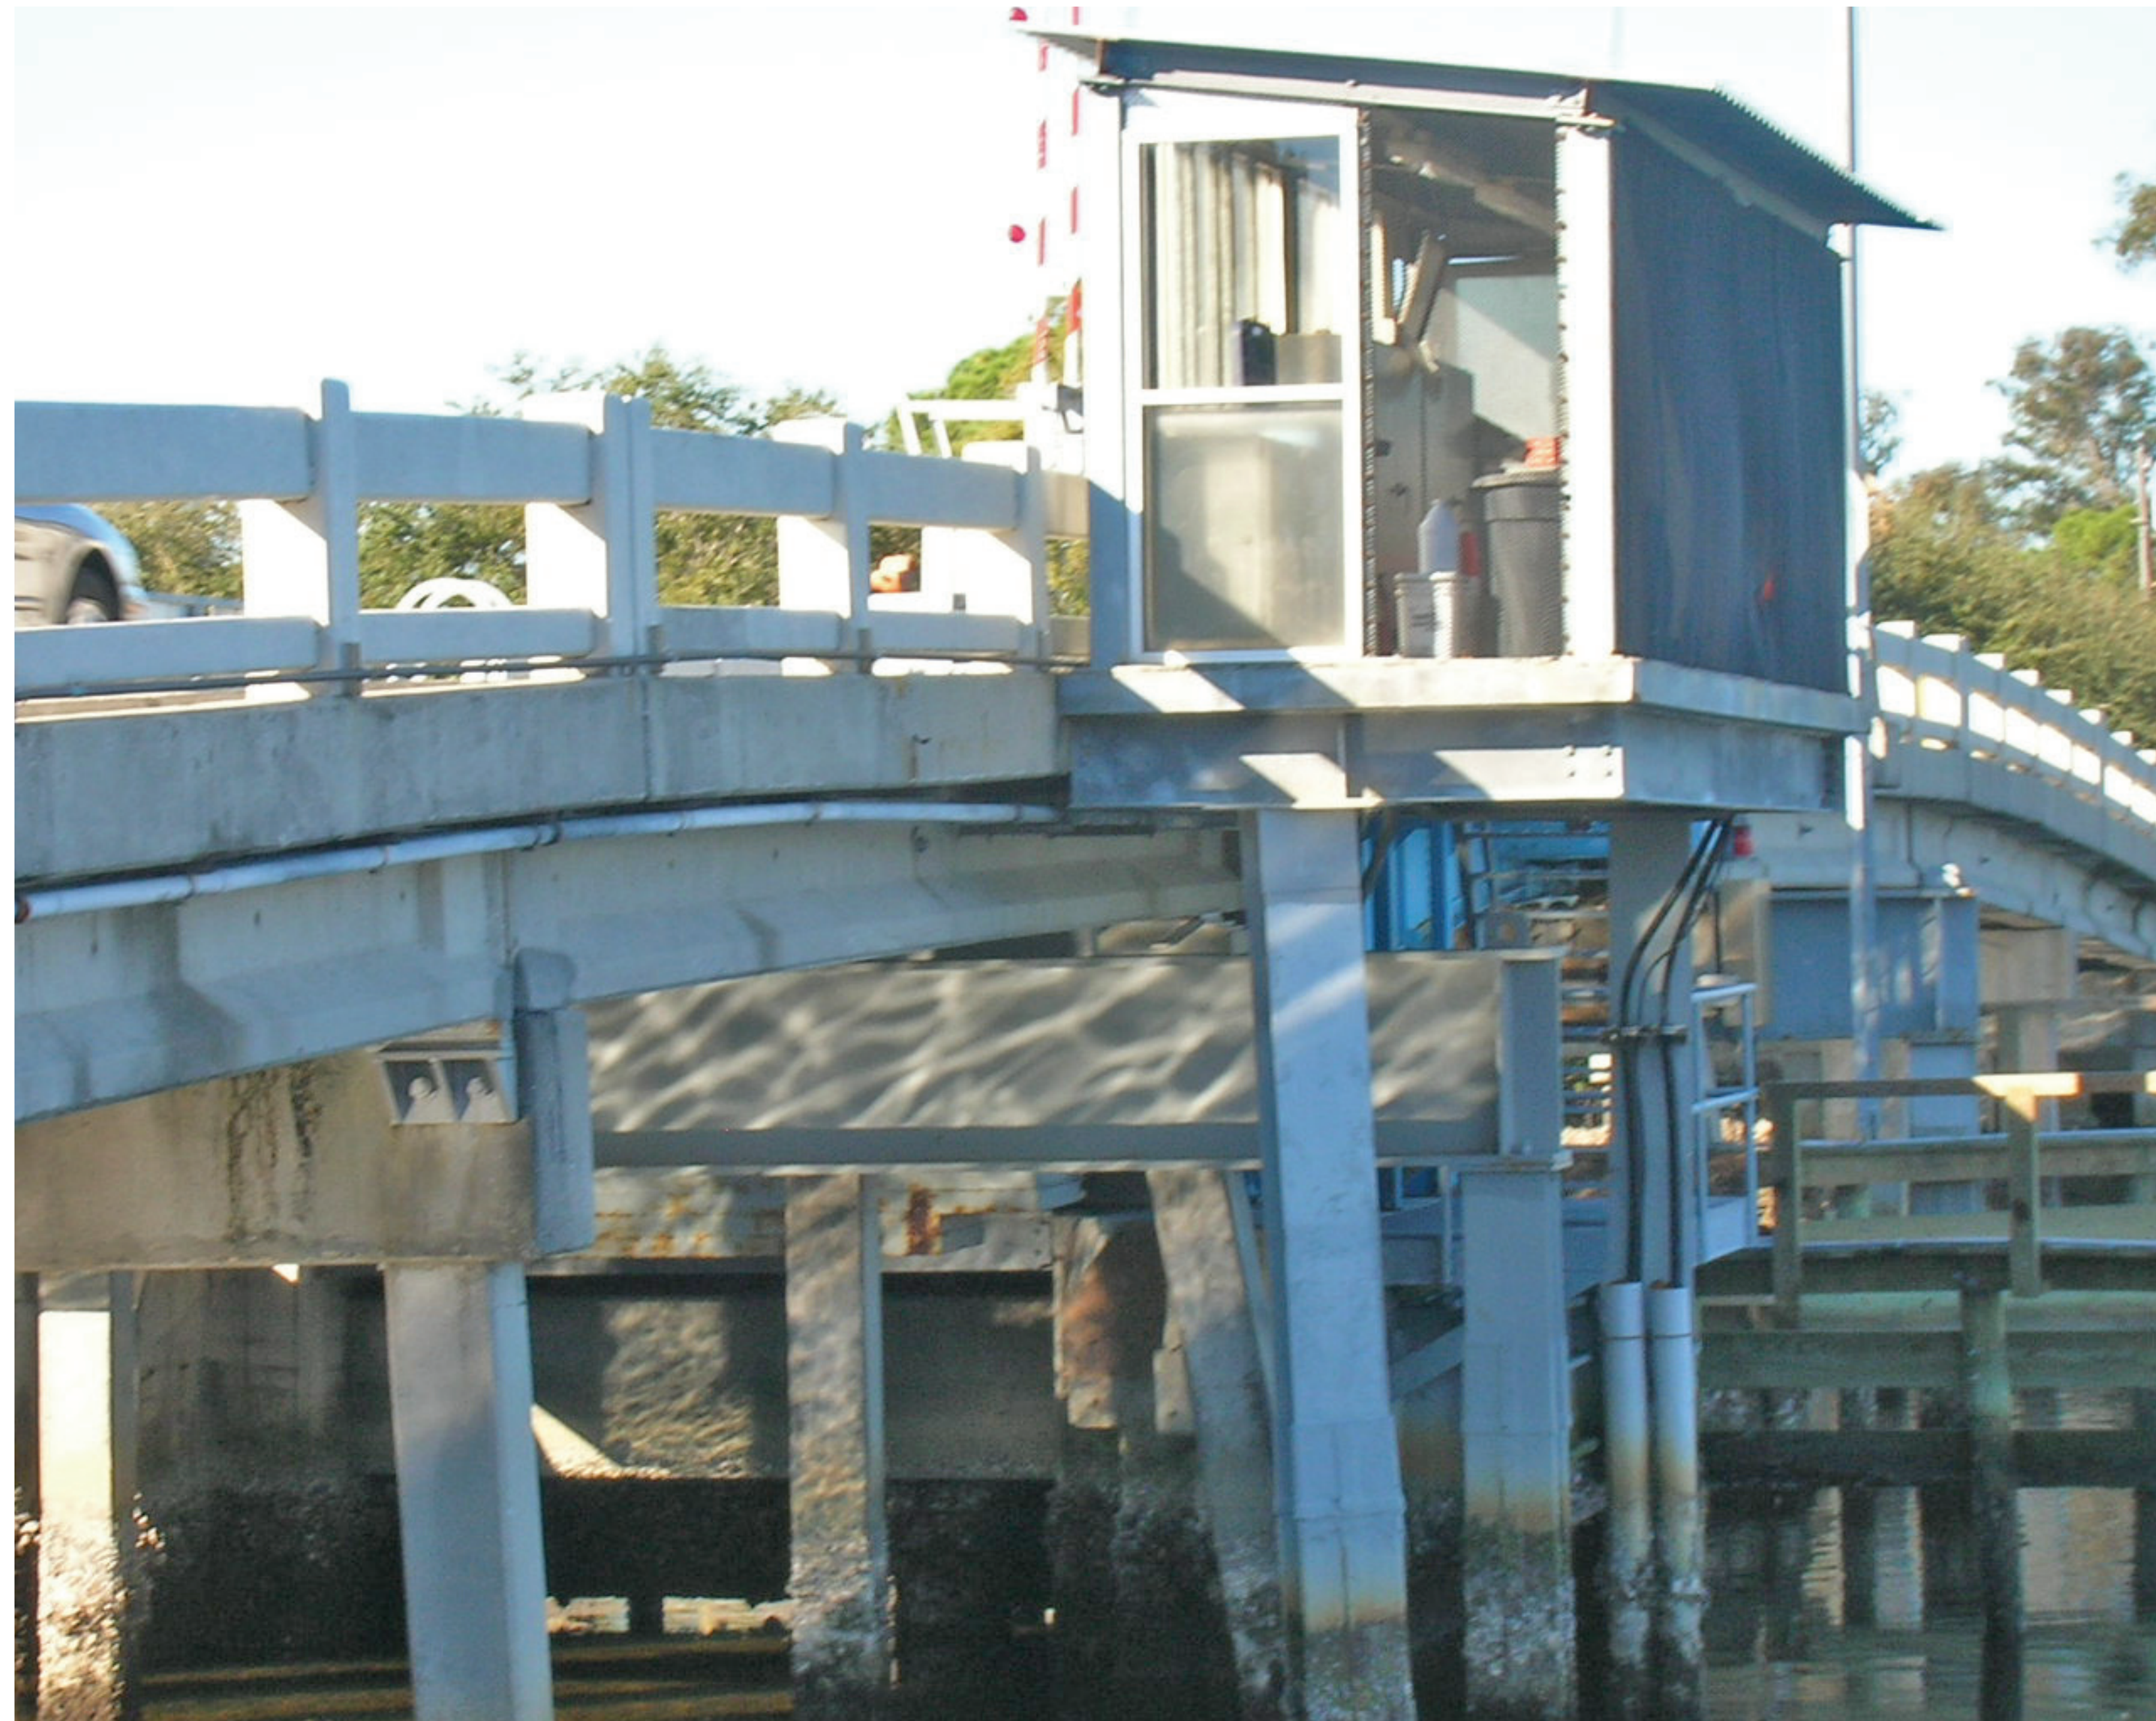
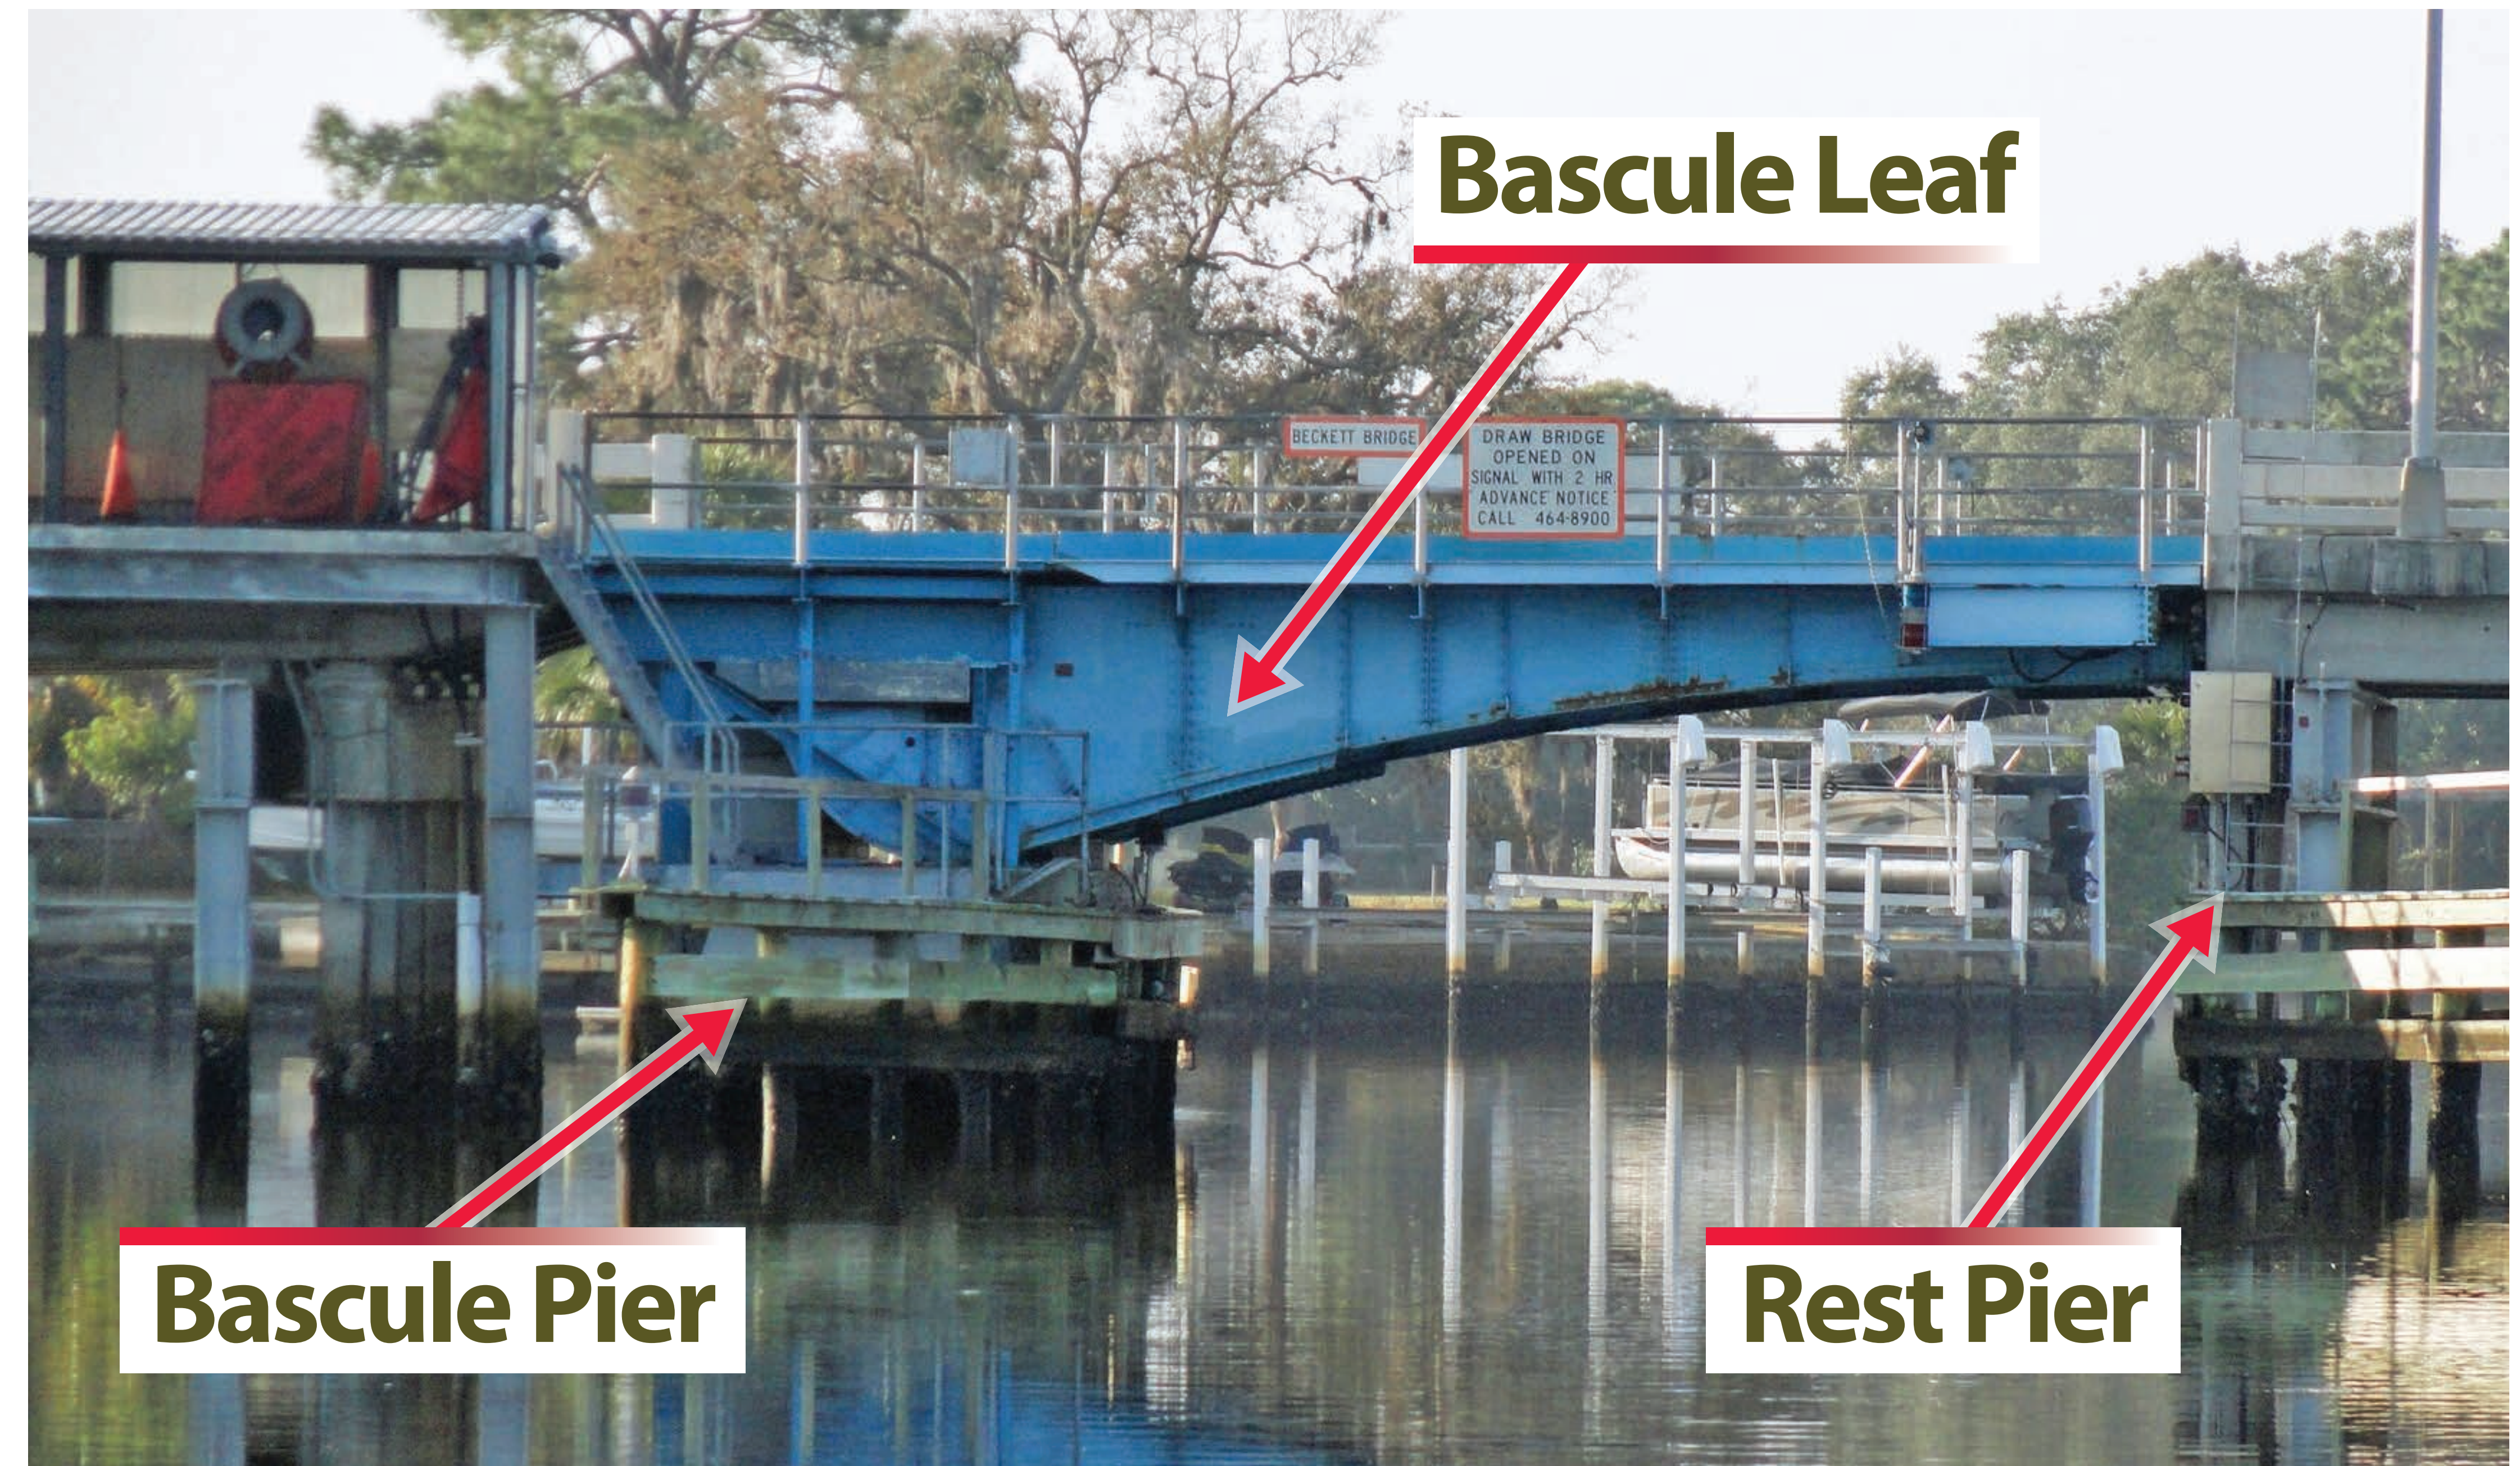
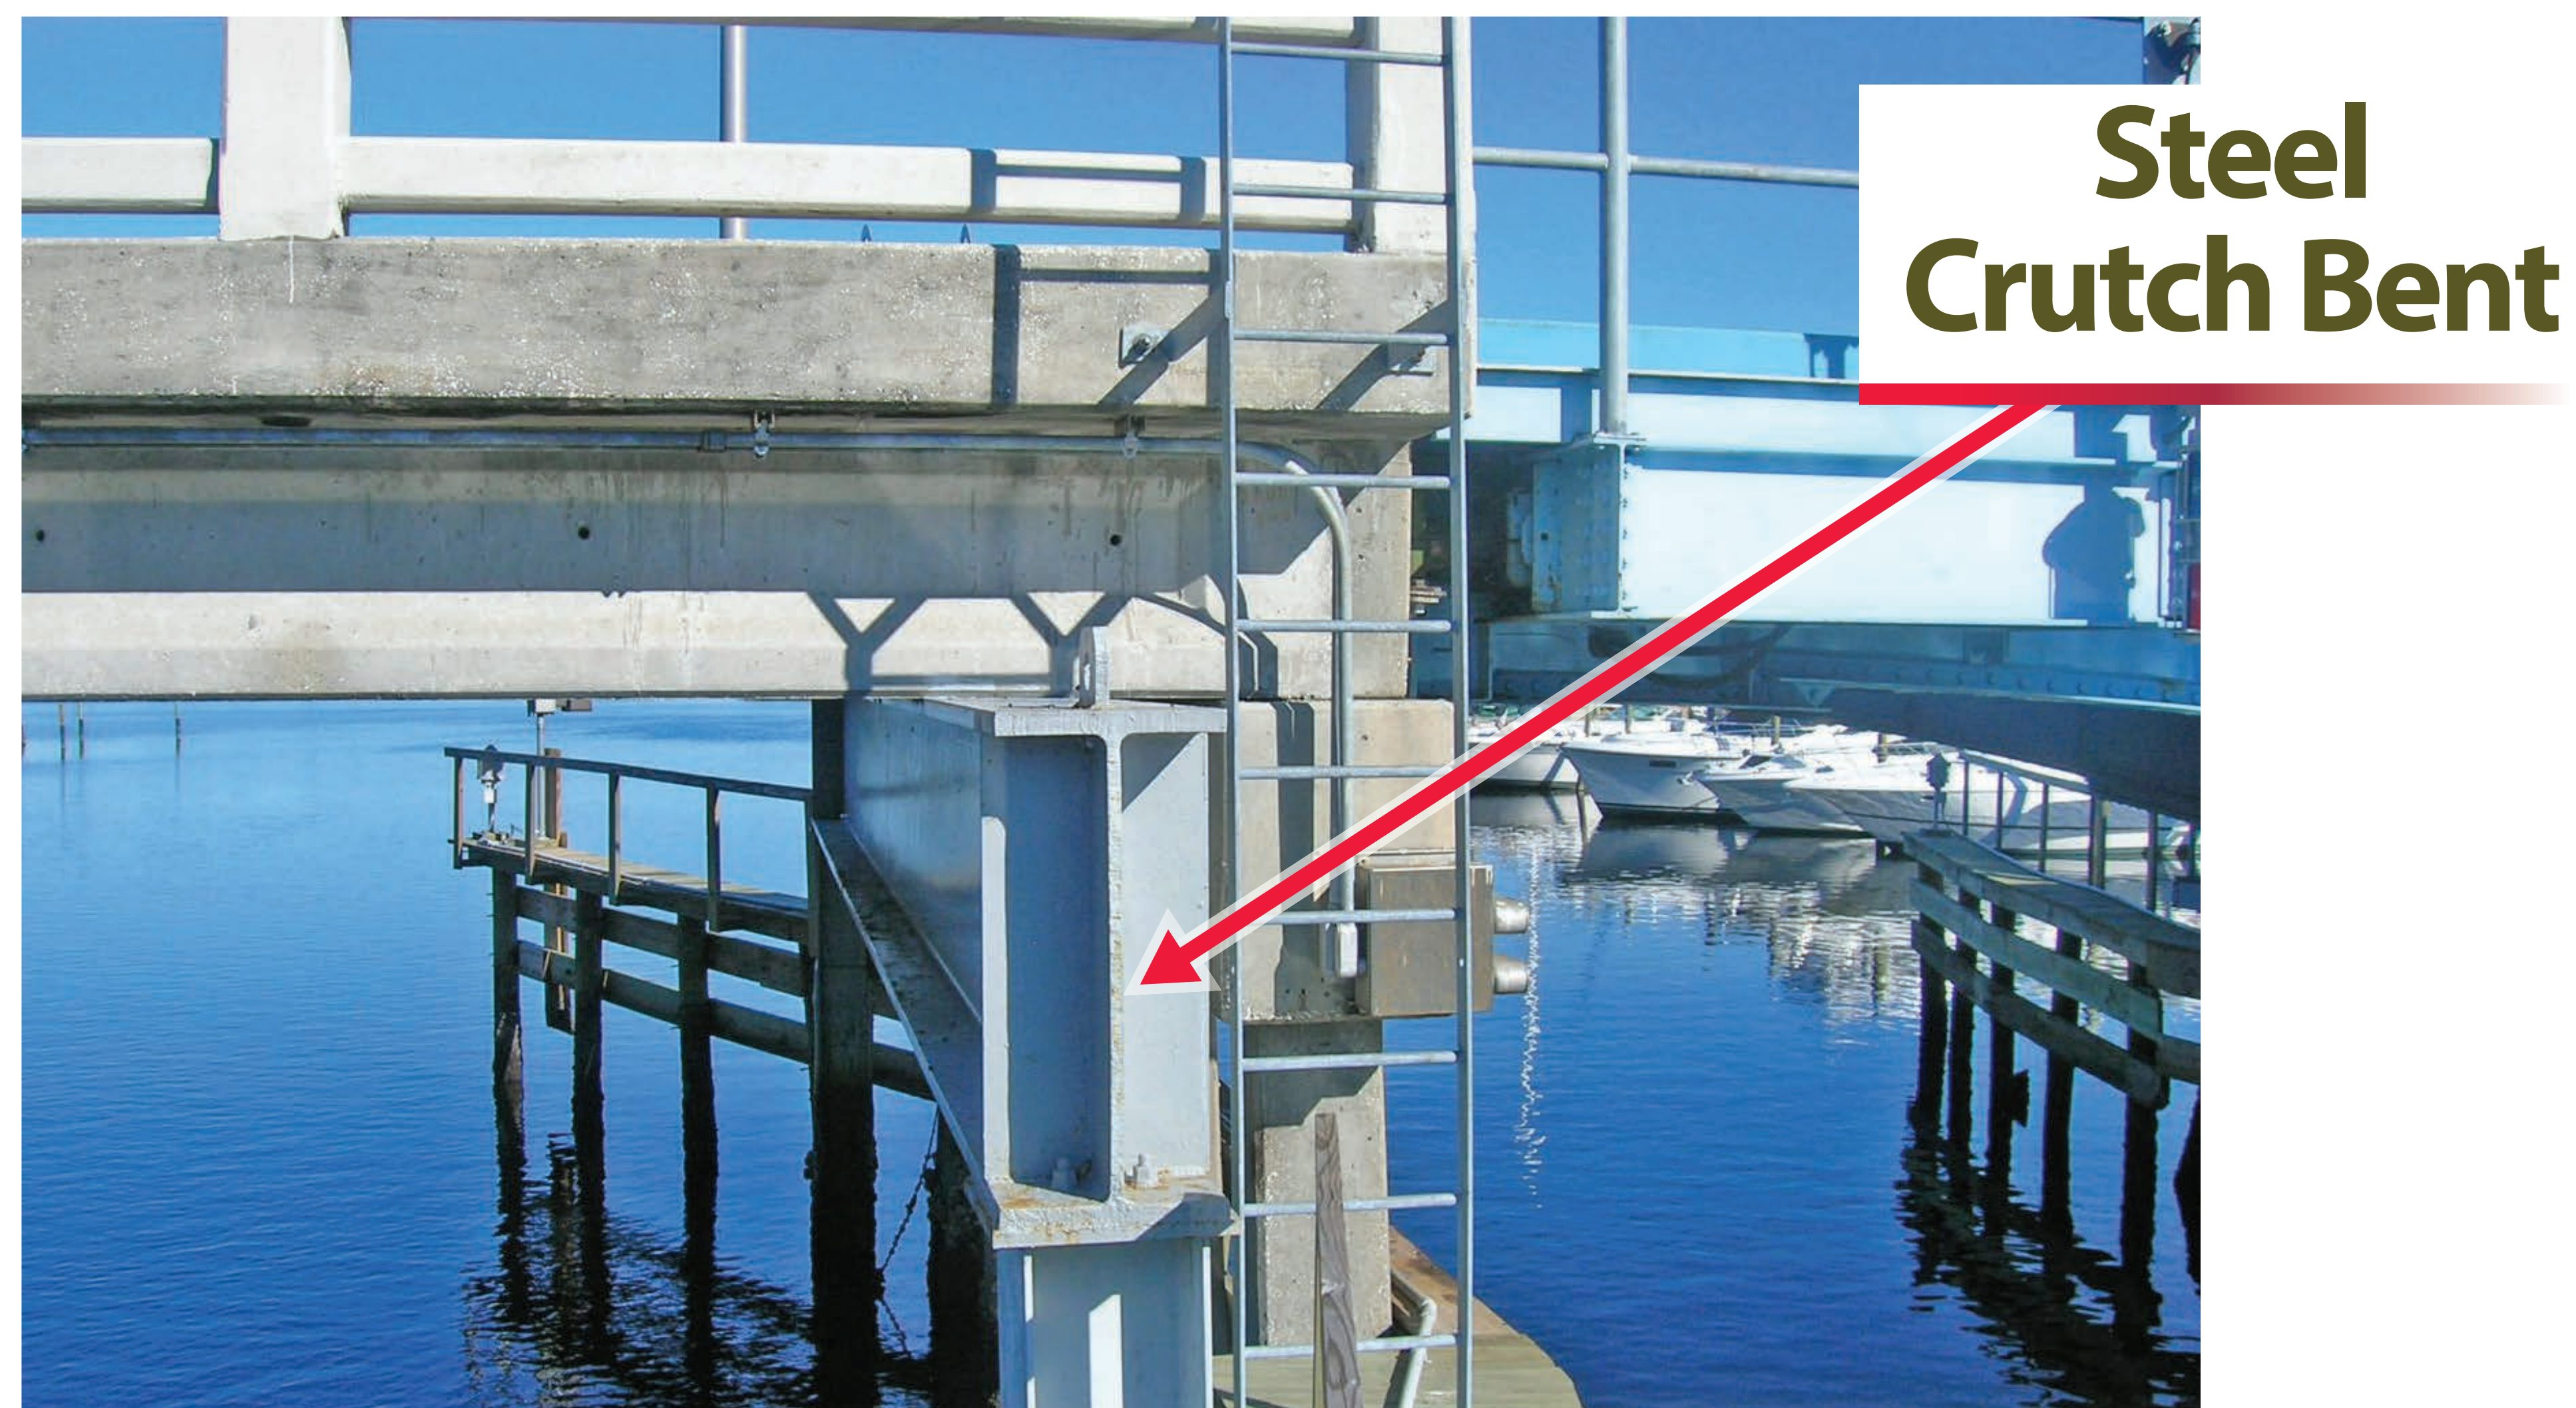
- Rehabilitate or Replace Control House
- Install cathodic (corrosion) protection jackets on steel bascule pier helper piles (crutch bents)
- Replace the bascule leaf (movable span)
- Repair deteriorated concrete of the bascule pier and rest pier, and provide cathodic (corrosion) protection

Note: The bascule leaf and bascule pier are the only remaining elements of the original 1924 Bridge
