**Pinellas County, Florida
Waste-To-Energy Facility**

**Draft Operations Report for the
1st Quarter of Billing Year No. 1
(October - December 2014)**

April 2015

**CDM
Smith**

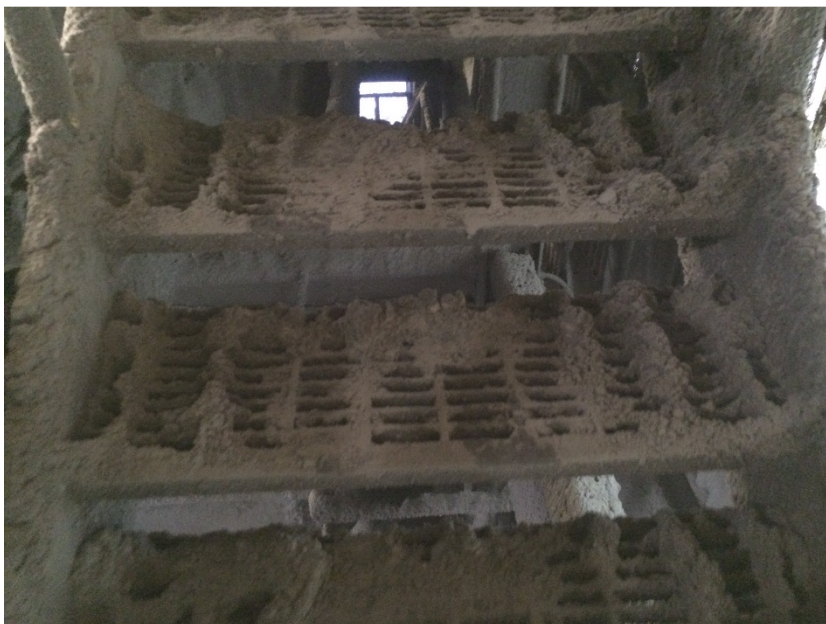
Figure 2-7
Poor housekeeping on stairs around Grizzly Scalper in RSPB
(October 2014)

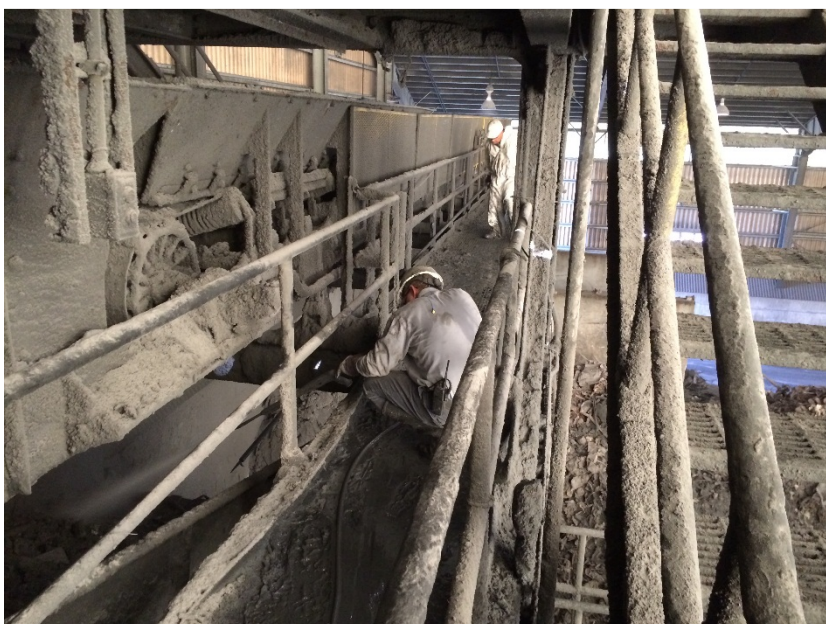
Figure 2-8
Poor housekeeping around Grizzly Scalper in RSPB
(October 2014)

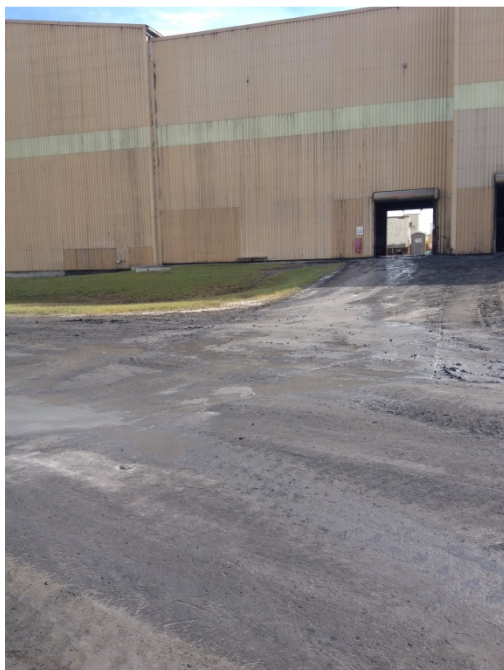
Figure 2-9
Ash from under inclined gallery belt conveyor on Facility roads
(October 2014)

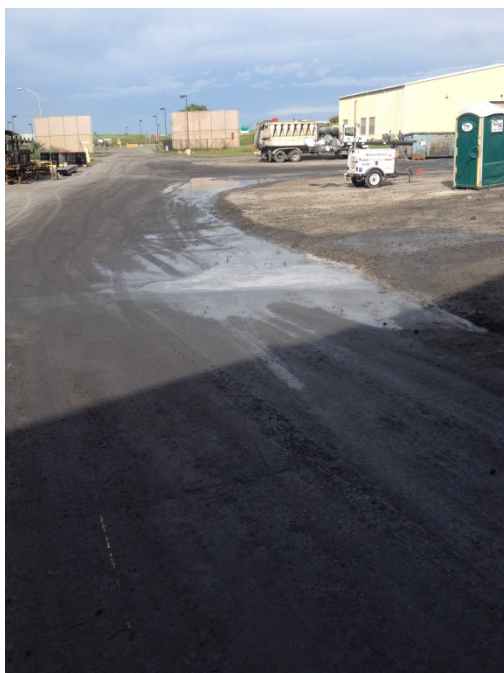
Figure 2-10
Ash from under inclined gallery belt conveyor on Facility roads
(October 2014)

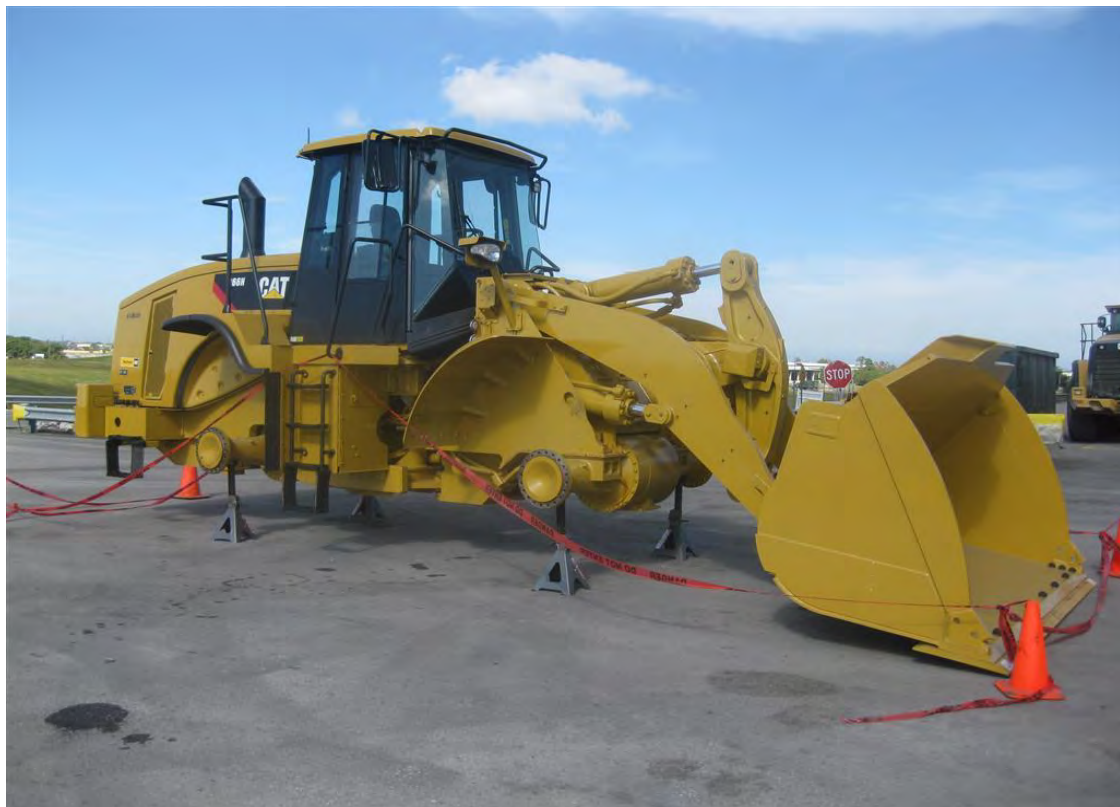
Figure 2 It appears as though someone has absconded with the tires and wheels which were on one of the new Cat front end loaders

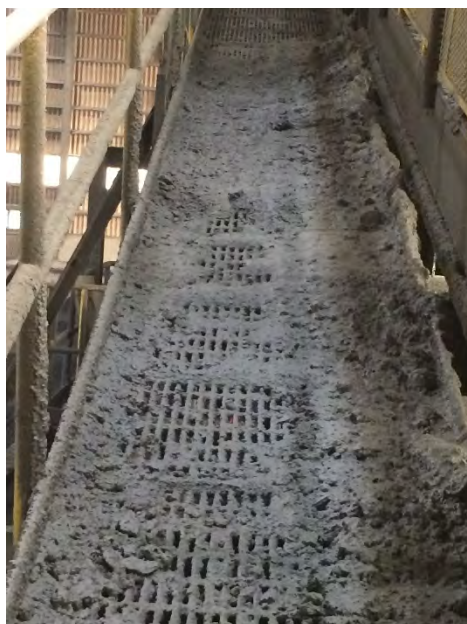
Figure B-1

**Poor housekeeping on inclined grating along belt conveyor feeding -5" ash to metal recovery system
(October 2014)**

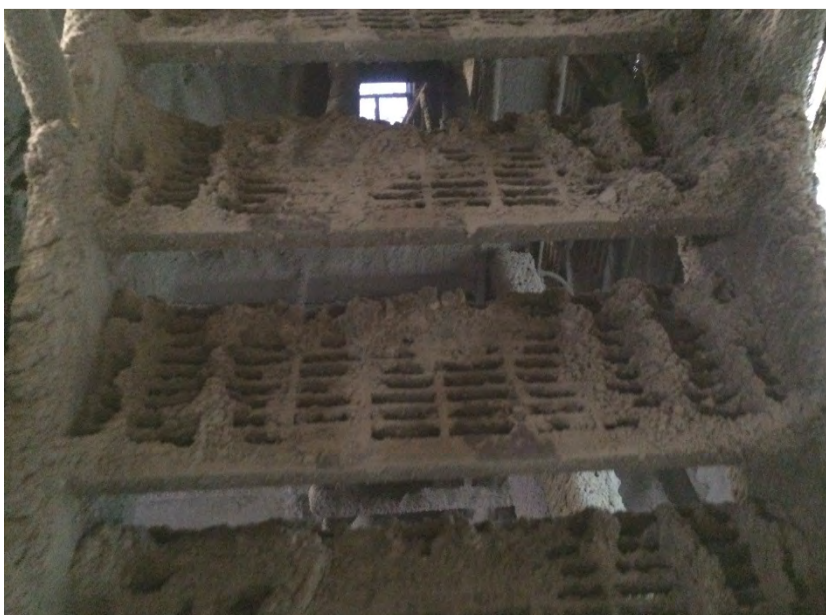
Figure B-2

**Poor housekeeping on stairs around Grizzly Scalper in RSPB
(October 2014)**

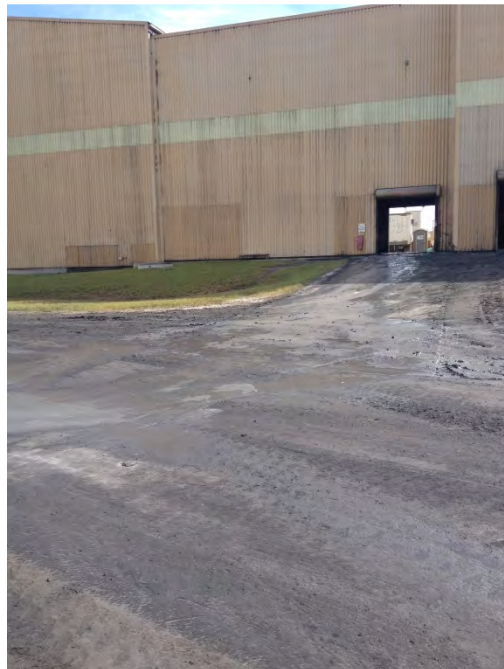
Figure B-4
Ash from under inclined gallery belt conveyor on Facility roads
(October 2014)

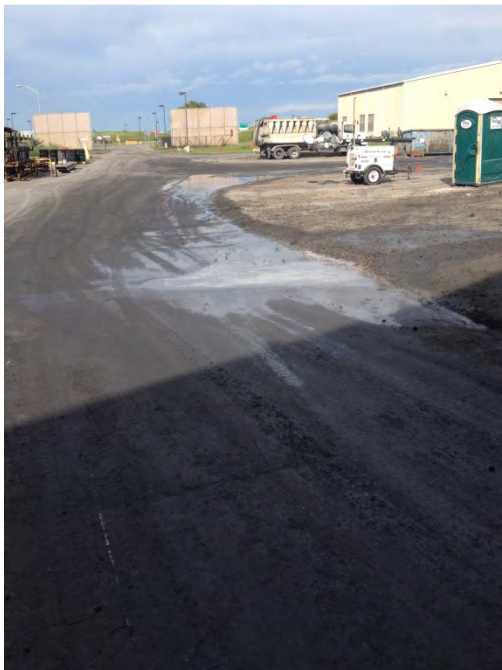
Figure B-5
Ash from under inclined gallery belt conveyor on Facility roads
(October 2014)

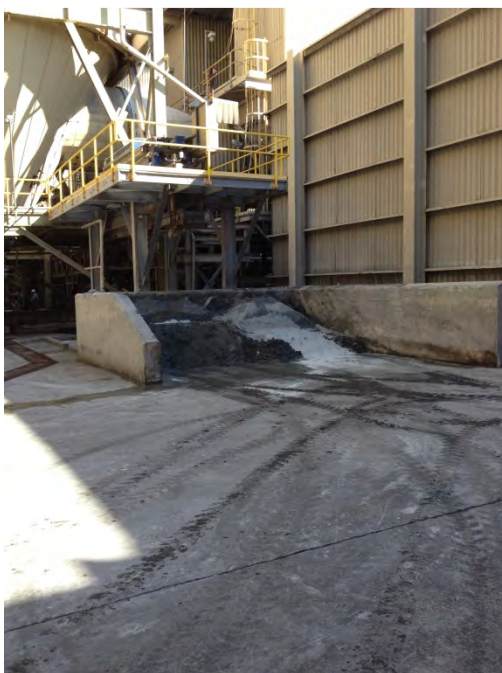
Figure B-6
Dumped fly ash stored in belt filter press bunker for transfer to RSPB
(October 2014)

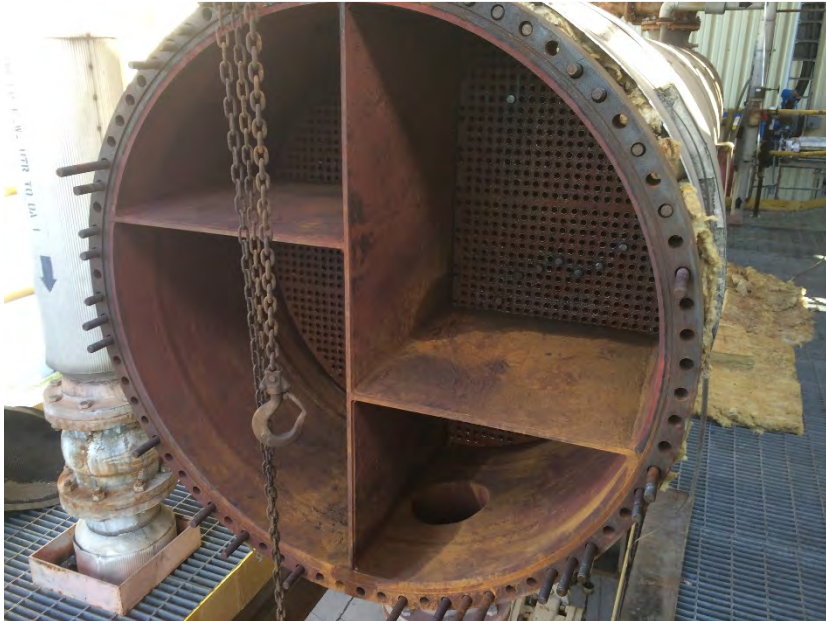
Figure B-38
Bypass condenser No. 2 open for eddy current inspection of tubes
(December 2014)

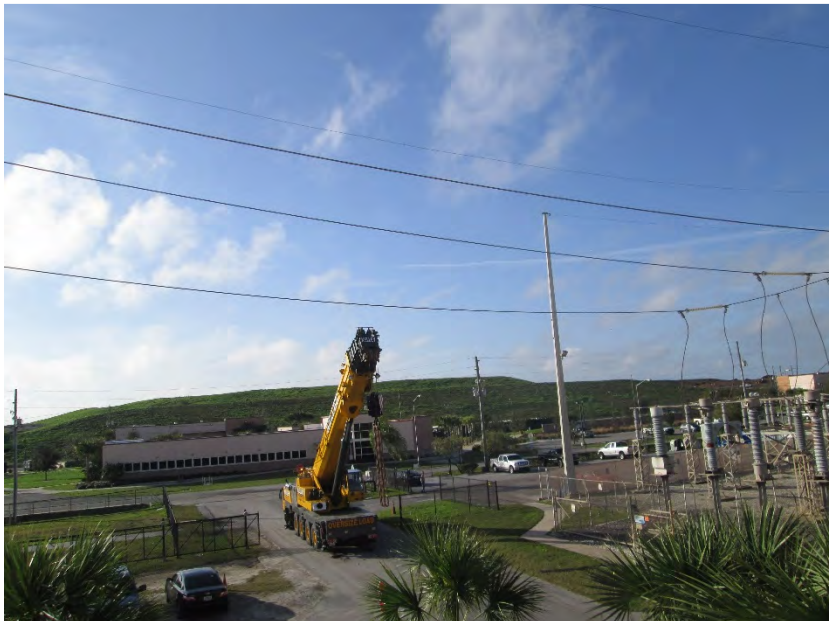
Figure B-50
Arc flash incident with mobile crane too close to overhead transmission lines from switchyard
(December 2014)

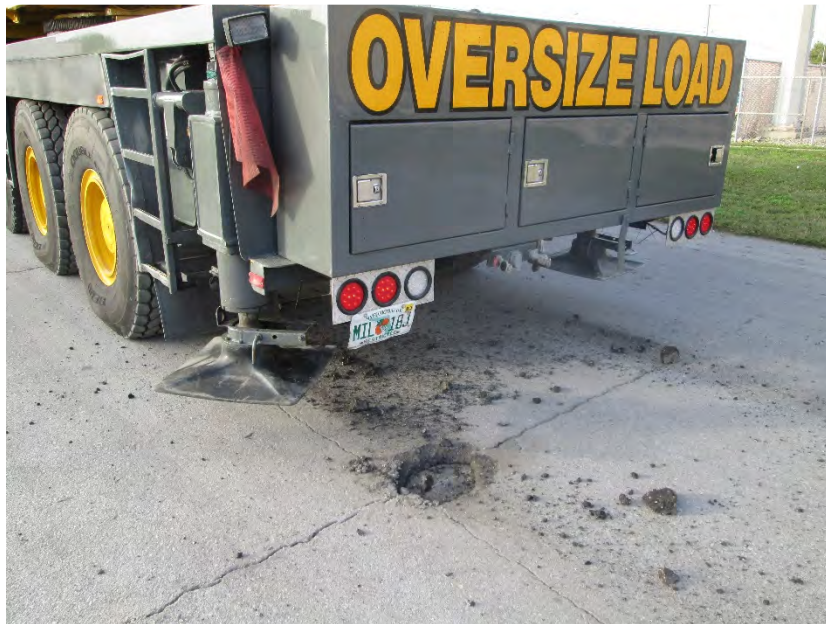
Figure B-51
Location of ground discharge under mobile crane
(December 2014)
